# Preliminary Field Assessment of Sinkhole Damage in Pokhara, Nepal

**ABSTRACT:** Since November 2013, numerous sinkholes have been forming in the Armala area of Pokhara Valley, Central Nepal, posing serious threat to local residents. In order to provide measures aimed at reducing sinkhole risk, investigations into the cause and features of the sinkholes are crucial. This paper presents early research results based on two damage surveys conducted in June 2014 and November 2014 in the Armala area. Comparison of photos, taken in the two surveys, clearly indicates not only the formation of new sinkholes, but also the re-activation of filled sinkholes. By means of dynamic cone penetration tests and surface wave method investigations, qualitative characterization of the soil profile was attained, and shallow weak soil layers which are believed to be the location for future sinkholes could be identified. On the basis of the field investigation results, possible sinkhole formation mechanisms are identified for the Armala area. Furthermore, results of a reconnaissance survey conducted in the Armala area in early May 2015 (following the 2015 Gorkha Nepal Earthquake, which occurred on April

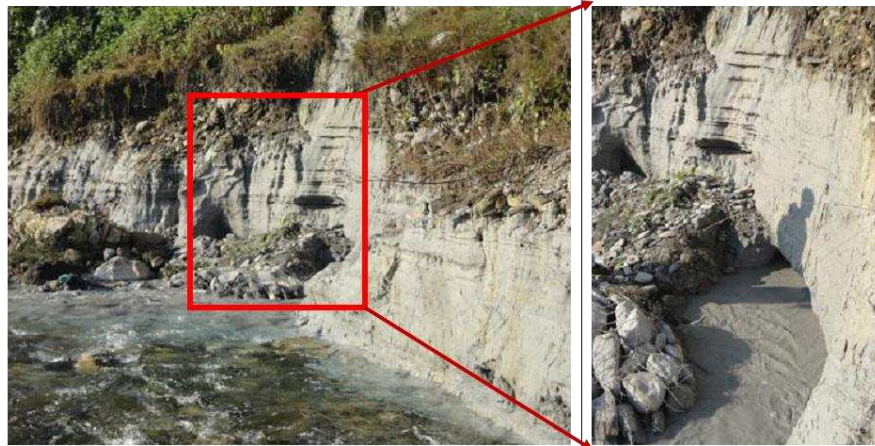
According to local residents, a muddy silty water outlet (shown in Figure 4 corresponding to photo point 1) was observed at the Kali Khola (Small River) riverbank about a week before the first sinkhole appeared in November 2013 (Figure 2). Since then, more than 150 sinkholes developed in this area until June 2014 and more than 200 sinkholes were reported up to November 2014.

Figure 4. Muddy silty water outlet at the riverbank of the Kali Khola (photo point 1) (Photo Courtesy: Technical Research Team, 2014).

Nevertheless, in November 2013, suddenly, a water spring was observed for the first time by local residents (Figure 4). It was rapidly followed by the formation of a number of sinkholes, as already described previously. The authors believe that the formation of the water spring induced a change in the groundwater level i.e. water table decline (Figure 16(b)). The drastic fall in groundwater level and its fluctuation during rainy season, accelerated the erosion process (as evidenced by muddy water observed at the water spring outlet) and cavity enlargement (Figure 16 (c)). The evidence of the erosion process in the ground is shown in Figure 17. The water sample collected from different points in the study area in June 2014 has different turbidity. The water sample collected at the stream or seepage location (water sample (WS) point 3 in

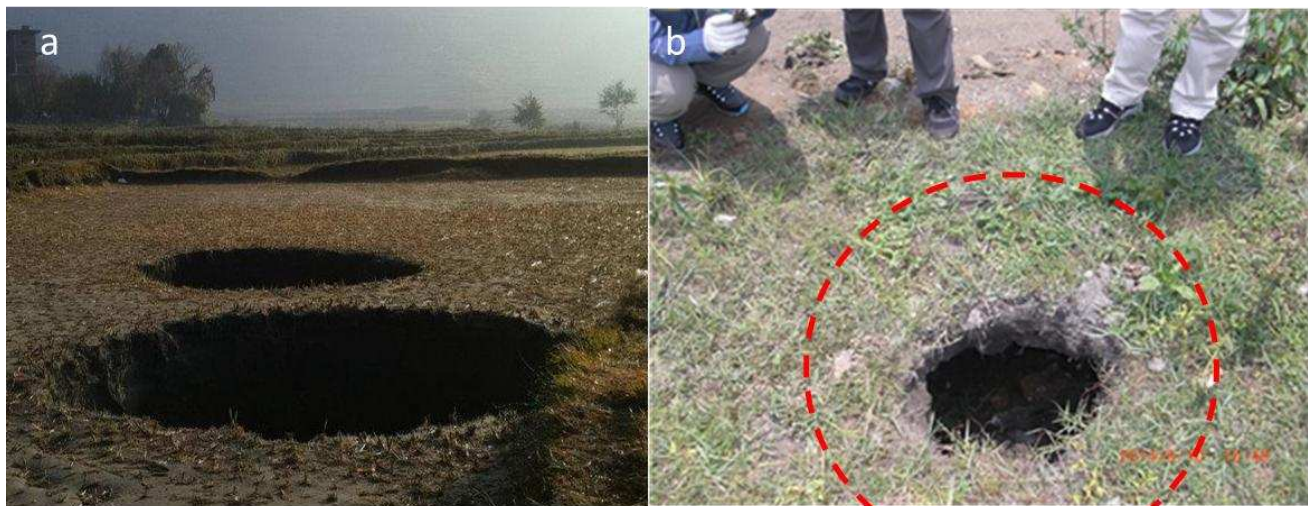
Typical circular-shaped sinkholes that appeared in November 2013 are shown in Figure 5(a). Although the first sinkhole appeared in the northern part of the investigation site, the majority of the sinkholes actually were formed along the Duhuni Khola nearby the main road (as shown by the green dots in Figure 2) between November 25<sup>th</sup> and December 5<sup>th</sup> 2013. Later on, the formation of sinkhole extended towards the western side. The depth and size of the sinkholes on level ground along Duhuni Khola were bigger than those developed on sloped ground and increased with time. Eventually, large-size sinkholes ended to connect each other along the Duhuni Khola.

Figure 5. (a) Typical sinkholes formed in November 2013 (Photo Courtesy: Keshab Sharma); and (b) a sinkhole formed in June 2014 (photo point 2).

Figure 5(b) shows a small sinkhole that appeared, at photo point 2, just one day before the survey team visited the damaged area in June 2014. Note that although the sinkhole in Figure 5(b) has a small diameter at the surface, its diameter is in reality much larger in the subsurface (as indicated by the red dashed line). Such spherical shape is due to the fact that the soil in the upper part of the sinkhole was retained by the grass root system supporting the surface soil.

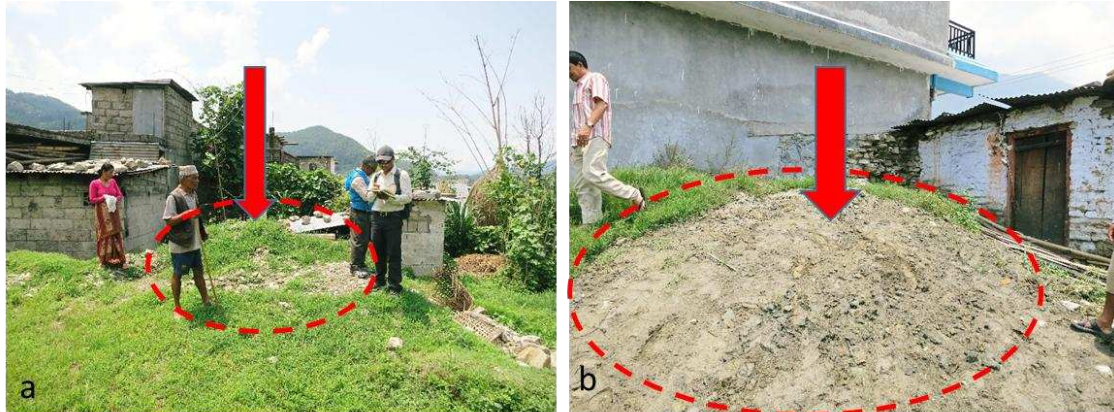
The sinkholes affected not only agricultural farmland. They also caused the collapse of manmade structures like the cowshed shown in Figure 6(a) (corresponding to photo point 3), and the masonry kitchen shown in Figure 6(b) (corresponding to photo point 4). The homeowner reported that about 60 m<sup>3</sup> of filling material were used to fill the sinkhole shown in Figure 6(a).

Figure 6. Typical effects of sinkhole formation on residential properties observed on June 2014 included the collapsed of (a) a cowshed and (b) a masonry kitchen.

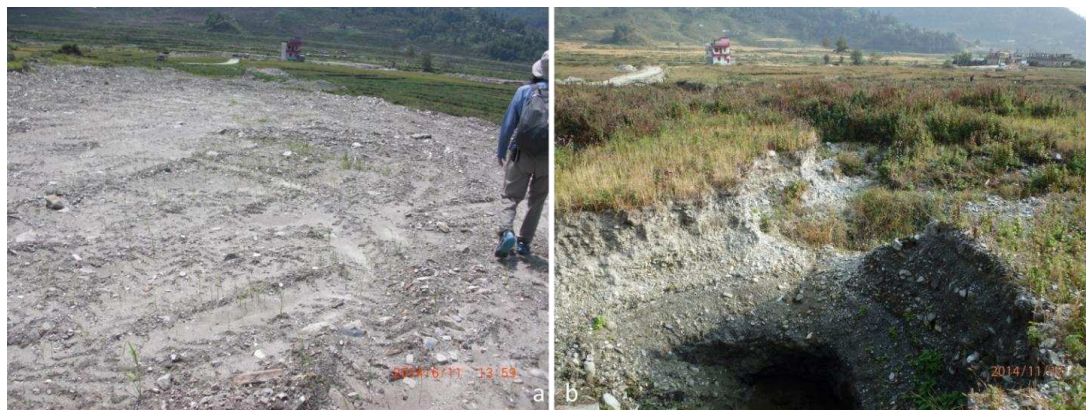
Immediately after the occurrence of the sinkholes, a wide area affected by the cave-in was backfilled by using gravelly soil retrieved from nearby quarries, which is identified by a yellow color filled area in Figure 2. Though, at the time of the first damage survey in June 2014, most of the sinkholes had been fully backfilled (Figure 7a corresponding to photo point 5), the photos taken in November 2014 at the same location clearly show that the backfilling was not an adequate solution as most of the former sinkholes were re-activated (Figure 7b) likely in August 2014 during the peak rainy season in Pokhara Valley.

Figure 7. (a) Sinkholes backfilled area (photo point 5) as seen in June 2014; and (b) Re-activated sinkholes as observed in November 2014.

As mentioned earlier, as an immediate mitigation work, all the old sinkholes were filled by the local government. This practice could disrupt the underground water flow so that ultimately the caving process caused the re-activation of sinkholes. Note that due to loose conditions of backfilled material, it is expected that the development of a re-activated sinkhole is much quicker than that of the original sinkhole where natural compacted soils was gradually eroded by water.

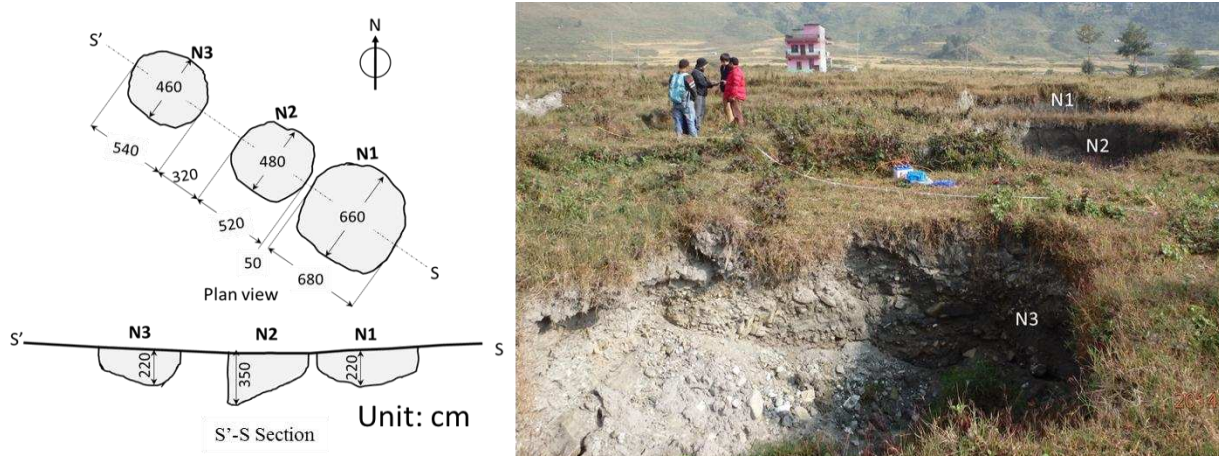
Among many, sinkholes N1, N2 and N3 in the area X shown in Figure 2 were found to be of particular interest. They were developed in a delimited area of approximately  $10 \text{ m} \times 20 \text{ m}$ , as shown in the schematic map shown in Figure 8. They have a circular pattern and diameters ranging from 4.6 m (N3) to 6.8 m (N1). Their depth measured at the top of the collapsed soil varied from 2.2 m (N1, N3) to a maximum of 3.5 m (N2). According to witnesses, N1 was the first sinkhole to be formed. A few days later, N2 caved-in and finally N3 developed. This progressive formation of several sinkholes along a straight line (moving along the uphill direction from N1 to N3) may suggest that the collapse of N1 caused the complete disruption of underground water flow. Consequently, water started to erode the soil just adjacent to N1 until a new cave-in (N2) was formed. In a similar way, N3 was later developed. The same pattern of sinkhole formation occurred often since November 2013. Most of the newly developed sinkholes are located on the upstream side of the underground water flow.

Figure 8. Series of sinkholes appeared in the area X in Figure 2 (photo point 6).

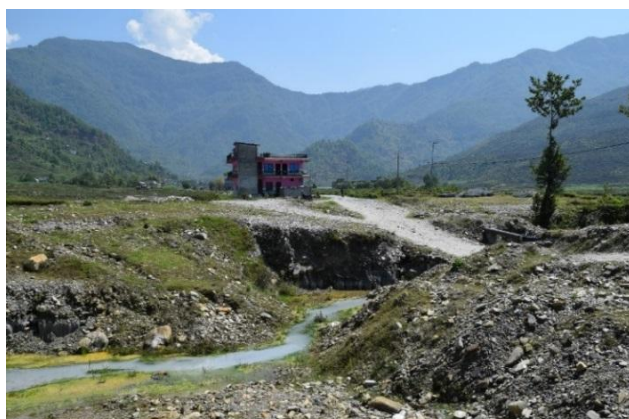
Figure 9. Muddy silty water observed in the sinkhole damaged area (photo point 7) following the 2015 Gorkha Nepal Earthquake.

Following the earthquake, muddy water was observed at the outlet of the local spring (Figure 9) in the Armala area (photo point 7), indicating that the earthquake had altered the subsoil conditions in some ways. Nevertheless, a field survey confirmed that no new sinkholes were formed and the size of existing sinkholes did not change. Yet, as mentioned earlier, muddy water indicates a high content of silt and fines in the water, and thus a process of erosion occurring in the subsoil. The earthquake may have induced a change in groundwater level and/or an increase of pore pressure that re-activated the erosion process. For this reason, the formation of new sinkholes may be anticipated in the near future, especially during the rainy season.

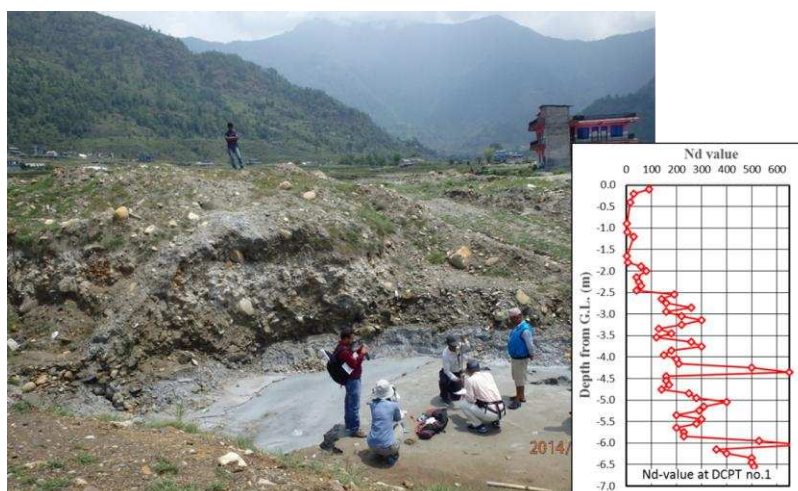
DCPT-1 was carried out at the bottom of a non-filled sinkhole as shown in Figure 10 (corresponding to photo point 7 in Figure 2). As already mentioned, this area is composed of recent flood plain deposits, including a thick gravel layer at shallow depth. Thus, DCPTs could not penetrate more than 6.55m. However, the test results would suggest that the probable depth of the sinkholes should be approximately 4.5-5m, or more precisely 6.5-7 m below the ground level considering that the actual ground level was approximately 2m above the sinkhole bottom.

Figure 10. Result of the Dynamic Cone Penetration Test at DCPT no. 1 at the bottom of a sinkhole.

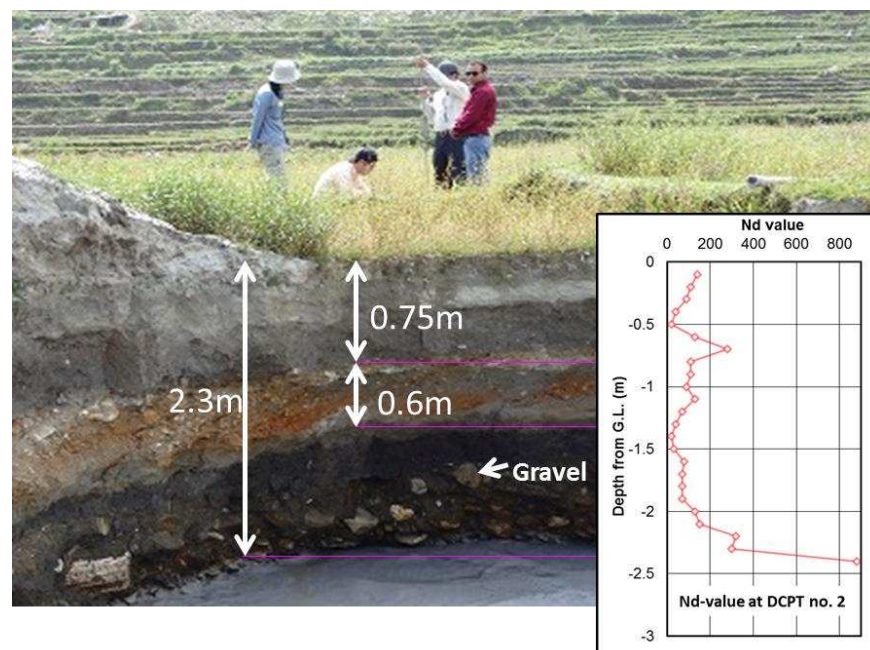
On the other hand, DCPT-2 (Figure 11) was carried out just adjacent to the sinkhole at photo point 8 in Figure 2. The test results were correlated with stratigraphy and structure of the deposits (Figure 11). The converted DCPT  $N_d$ -values are plotted in Figure 11. The upper layers of the surface soil could be penetrated until reaching a layer of gravel at a depth of 2.4 m, where even by hitting more than 150 times the penetration process stopped.

By comparing the  $N_d$  -values obtained from DCPT-2 and DCPT-3, it is noted that the filled materials are looser than the natural soil. Therefore, the filled material can be easily caved-in and induce the re-activation of filled sinkholes during the rainy season.

Figure 11. Soil profile and DCPT result at DCPT-2 obtained for the sinkhole in photo point 8 (Photo in June 2014).

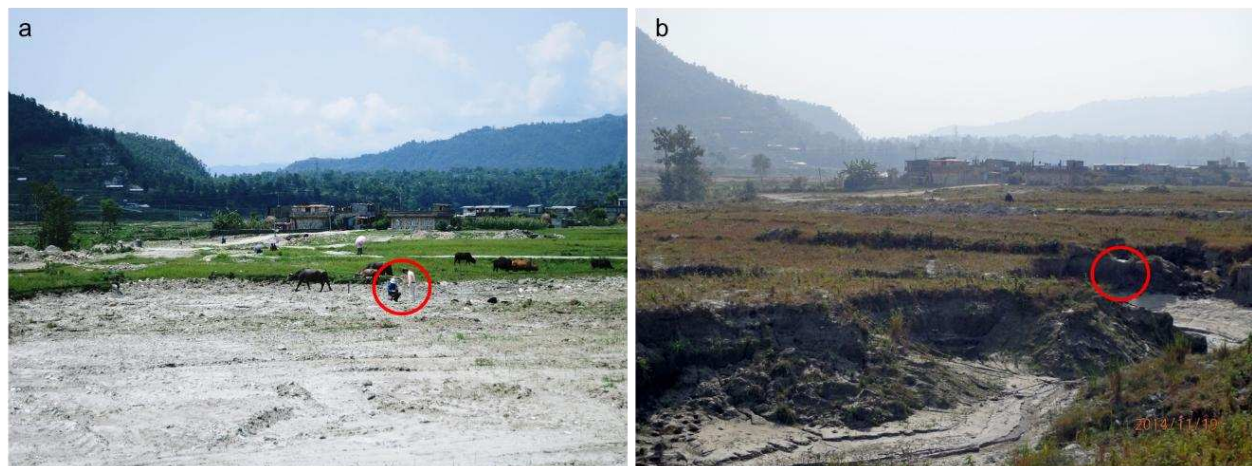
DCPT-3 was carried out at the top of the filled material at photo point 9. As shown in Fig. 12a and 12b, the testing location disappeared due to the collapse of filled material during the rainy season between June and November 2014. From the test results shown in Fig. 13, it is concluded that the used filling materials are sand and gravelly soils. However, the compaction at the surface is not good enough because the  $N_d$ -value measurement is low. The DCPT results suggest that the cavity bearing formation is below the gravel layer, and then progressively the cavity size increased and finally the loose upper layer collapsed.

Figure 12. a) Dynamic Cone Penetration Test at DCPT no. 3 (photo point 10) on the filled material (photo taken in June 2014) and b) re-activated sinkhole at the same location (photo taken in November 2014).

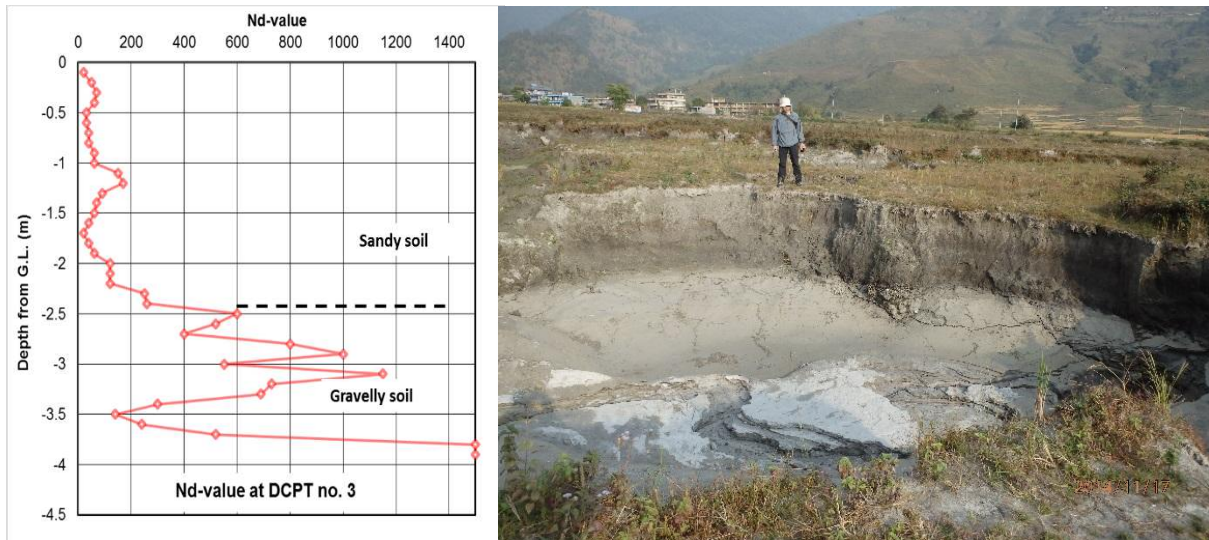
Figure 13 (a) Result of DCPT 3 conducted in June 2014 and (b) its location collapsed after the test.

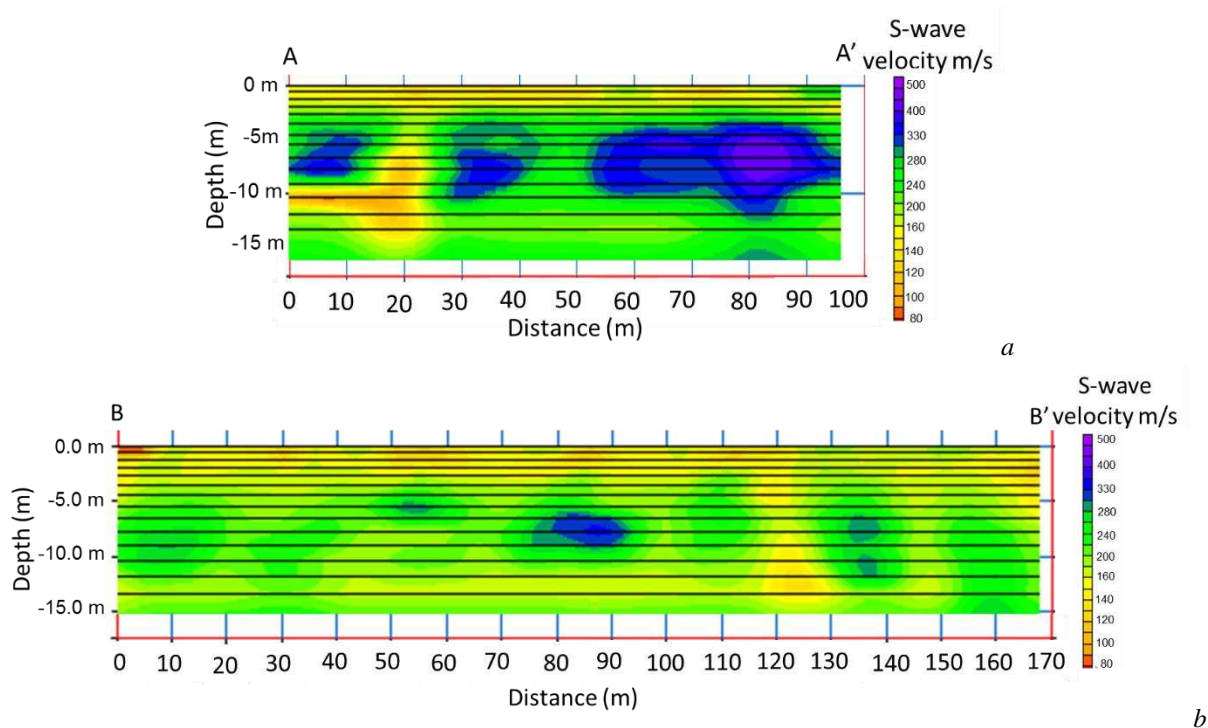
The results of SWM test along sections A-A' and B-B' are shown in Figure 15. It can be seen that the shear wave velocity for the surface layer is in the range of 100-160 m/s, confirming the presence of a loose sand layer of 1.5-m thickness. The underlying gravel has a higher velocity than the surface layer with a shear wave velocity of about 240 m/s. Moreover, the stiff soil below 4 m depth has a shear wave velocity greater than 300 m/s. The velocity of the layer around 10 m depth denotes water flowing path and loose material. A low velocity section observed 20 m far from the starting point in profile A-A' indicates possible cavities in the ground. Similarly, in profile B-B' the loose material at a depth of about 12 m indicates a possible water flowing layer and the weak strata between 120 m to 130 m is a possible future sinkhole.

Figure 15. Profiles of surface wave method: (a) section A-A'; and (b) section B-B'.

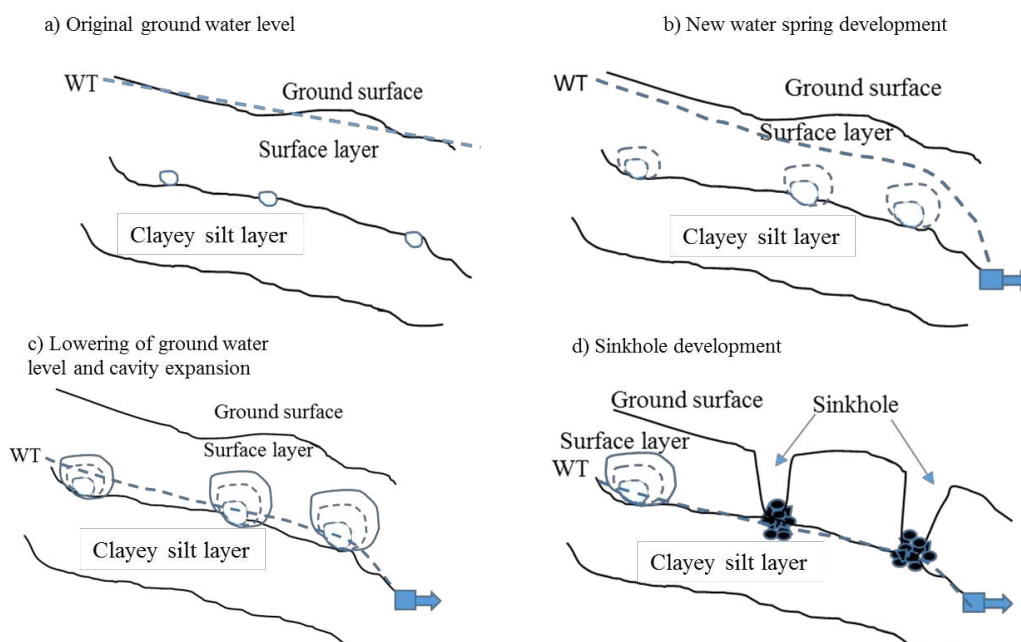
The groundwater flow is the triggering factor involved in the generation of sinkholes observed in this study. In fact, it is assumed that in the Armala area, there has been an active erosion process (probably lasting hundreds of years), where water gradually dissolved soluble soil, creating cavities beneath the ground surface (Figure 16a). However, such cavities were stable and likely small in size. In fact, despite the high sinkhole risk, the formation of sinkholes was rarely observed in past decades in the Armala area.

Figure 2) is clear and has no sediments. On the other hand, water samples collected at WS point 1 and 2 shows high turbidity (Figure 17). This indicates that underground water continues to dissolve the silt and there was a continuous caving process till June 2014. As the process continued, the loose, unconsolidated soil and sand above was gradually washed into the cracks and voids. Depending on how thick and strong the top layer was and how close to the surface the void beneath was, the ground was not able to sustain its own weight. Thus, cavities that before were stable, suddenly became unstable and collapsed (Figure 16(d)).

Figure 16. Probable mechanisms of sinkhole observed in the Armala area.

- prevent irrigation;
- using an effective drainage system and diverting surface runoff;
- remediating existing sinkholes and clogging shallow holes;
- identifying cavities in the soil and filling them by grouting;
- improving the ground by compaction or ground injection to increase the strength and bearing capacity of the soils.

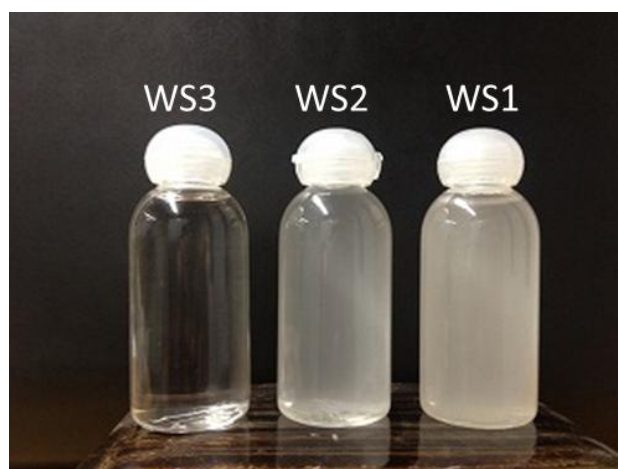
Figure 17. Turbidity of sampled water collected at different point in the Armala area in June 2014 (the water sample locations at ws1, ws2 and ws3 respectively in Figure 2).
