# A Large Scale Landslide in a Coal Mine in Marly Formations: Evaluation, Analysis and Rehabilitation

**ABSTRACT:** *This paper describes a large scale landslide in a coal mine in Servia area in Kozani, Greece, which occurred in February 2011. The landslide, of ~250m width and ~350m length, took place in marly lacustrine sediments. The main factors for the manifestation of the landslide were a temporary interruption of works, the existence of a specific weak surface, the clayey nature and the sensitivity of marl to environmental agents, the action of water and the large slope height. Due to the magnitude and the position of the failure, a geotechnical solution was proposed that involved rearrangement of ground masses. The proposed solution led to successful rehabilitation and unimpeded continuation of the exploitation process.*

Reference: Prountzopoulos, G., Fortsakis, P., Marinou, V. and Marinou, P. (2016). *A Large Scale Landslide in a Coal Mine in Marly Formations: Evaluation, Analysis and Rehabilitation*. International Journal of Geoengineering Case histories, Vol.4, Issue 1, p.29-45. doi: 10.4417/IJGCH-04-01-03

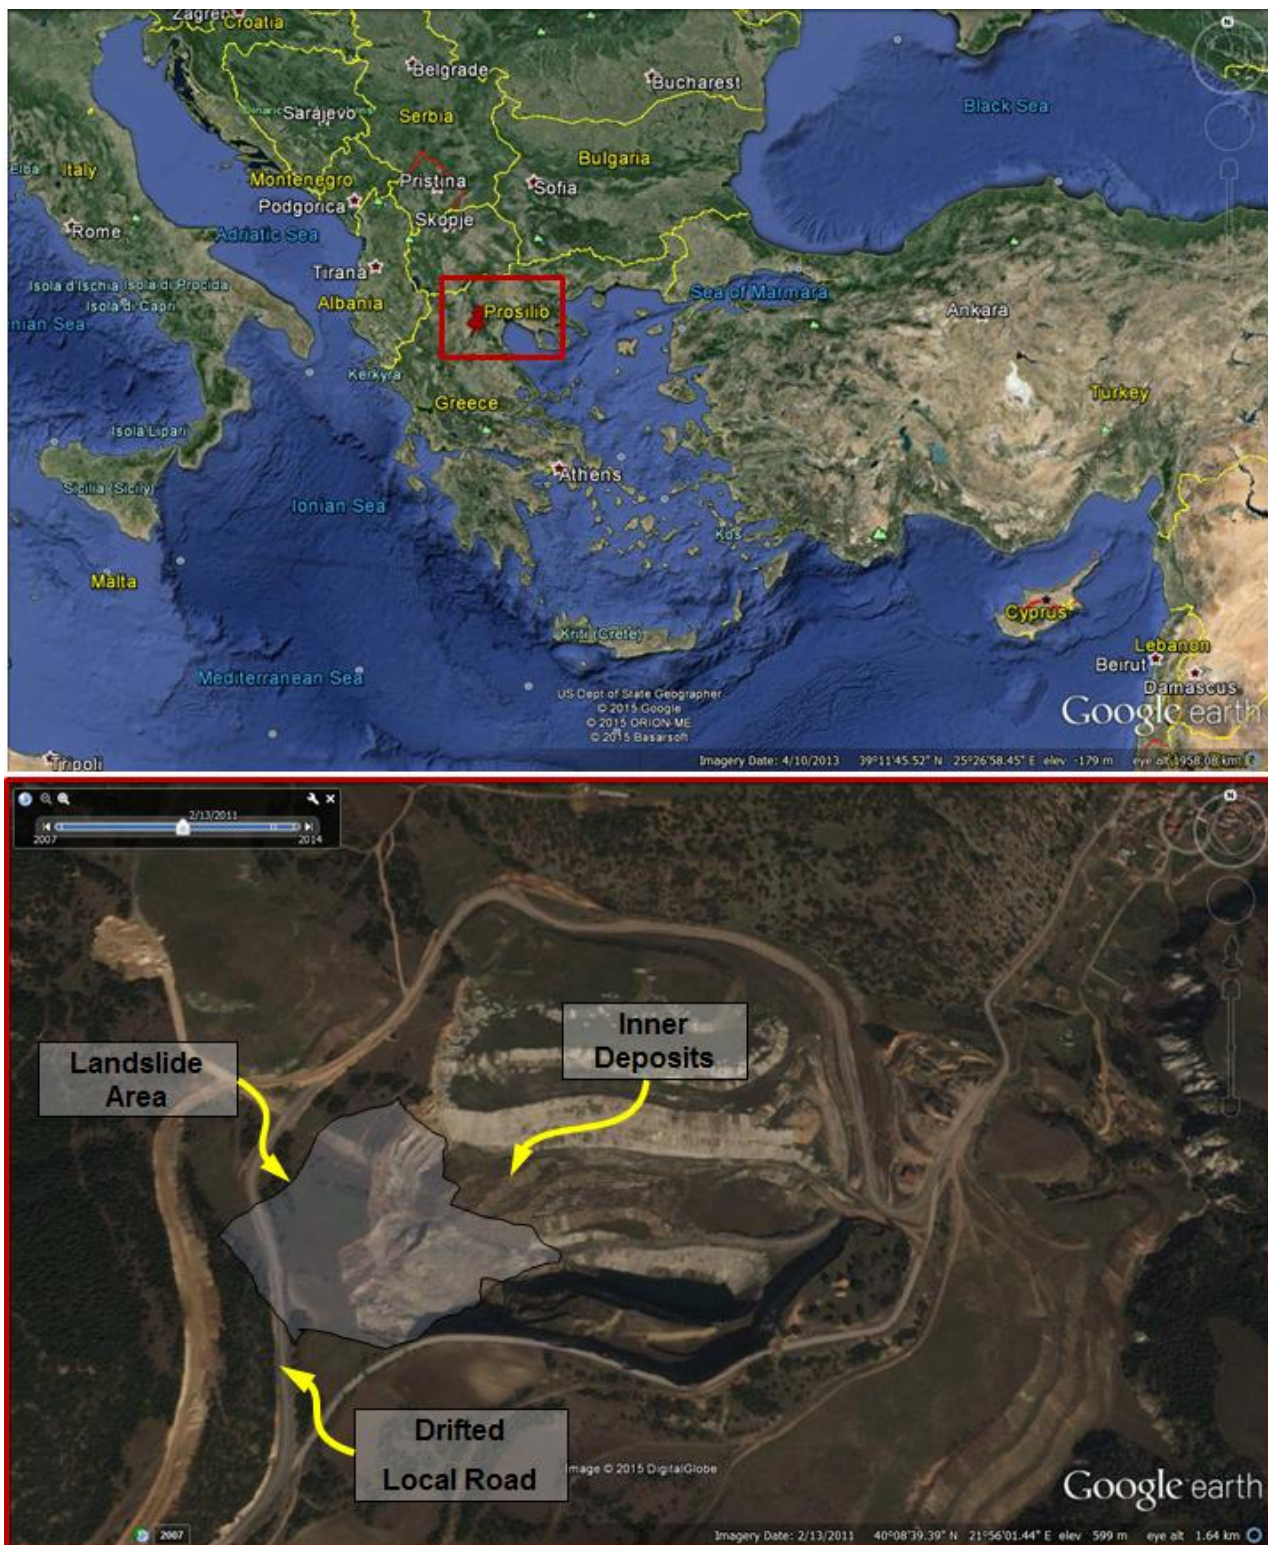
Figure 1 includes a demarcation of the position of the landslide, together with an aerial photo of the coal mine, only few days before the landslide. The landslide area, the local road affected by the landslide and the initially placed deposits for lateral retaining action to the mine slope are indicated on the satellite photo.

Figure 1. Position of landslide (up – red pin inside the red rectangle) and aerial photograph of the coal mine 2 weeks before the landslide (down). The area that was later occupied by the landslide is indicated with the transparent shape.

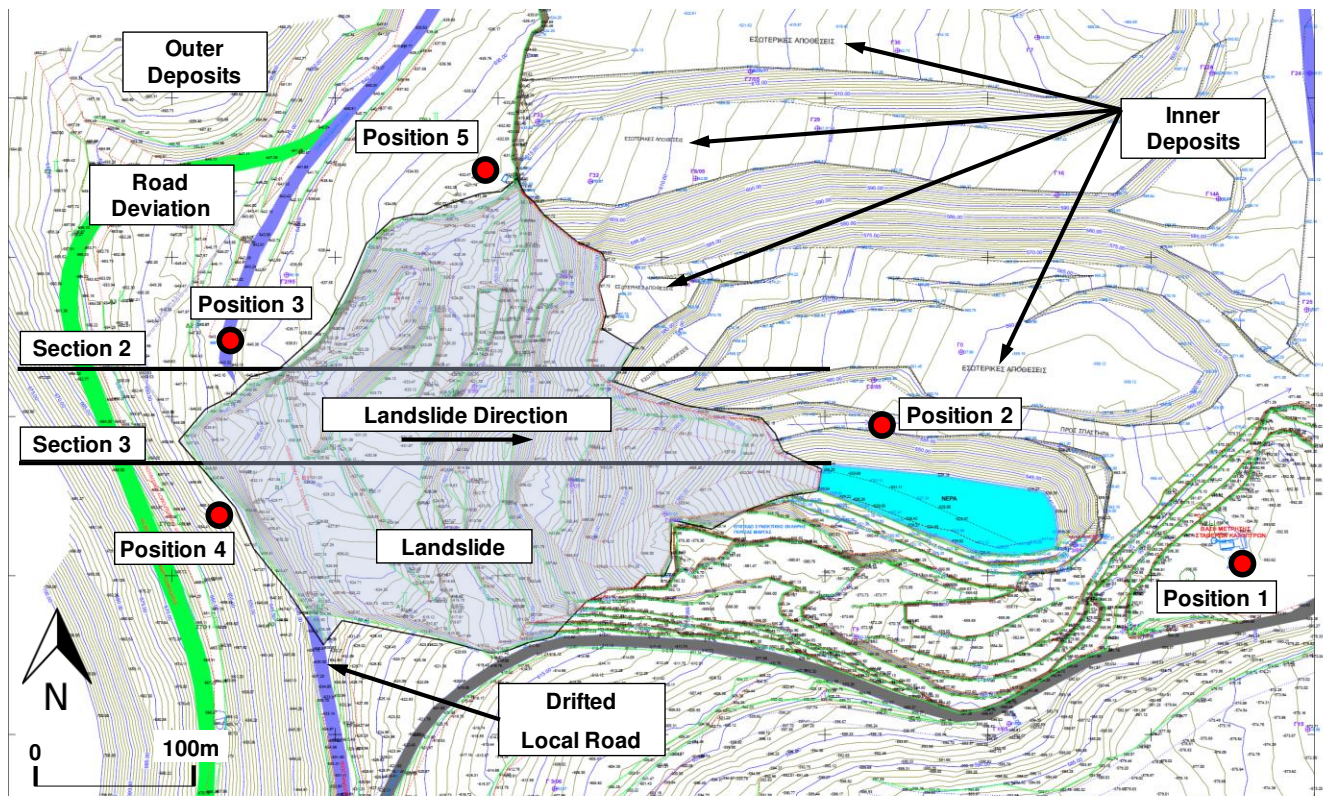
Figure 2 shows a plan view of the landslide area, with demarcation of the main features of the incident, as mentioned or referred to in the present paper. After examination of historical, geometrical and geotechnical data provided by the exploitation contractor, in-situ inspections and evaluation of the available information, it was concluded that the factors that played an important role in the initiation and triggering of sliding movement and the evolution of the landslide were:

Figure 2. Topographic mapping (plan view) of the coal mine after the landslide with demarcation of some key features

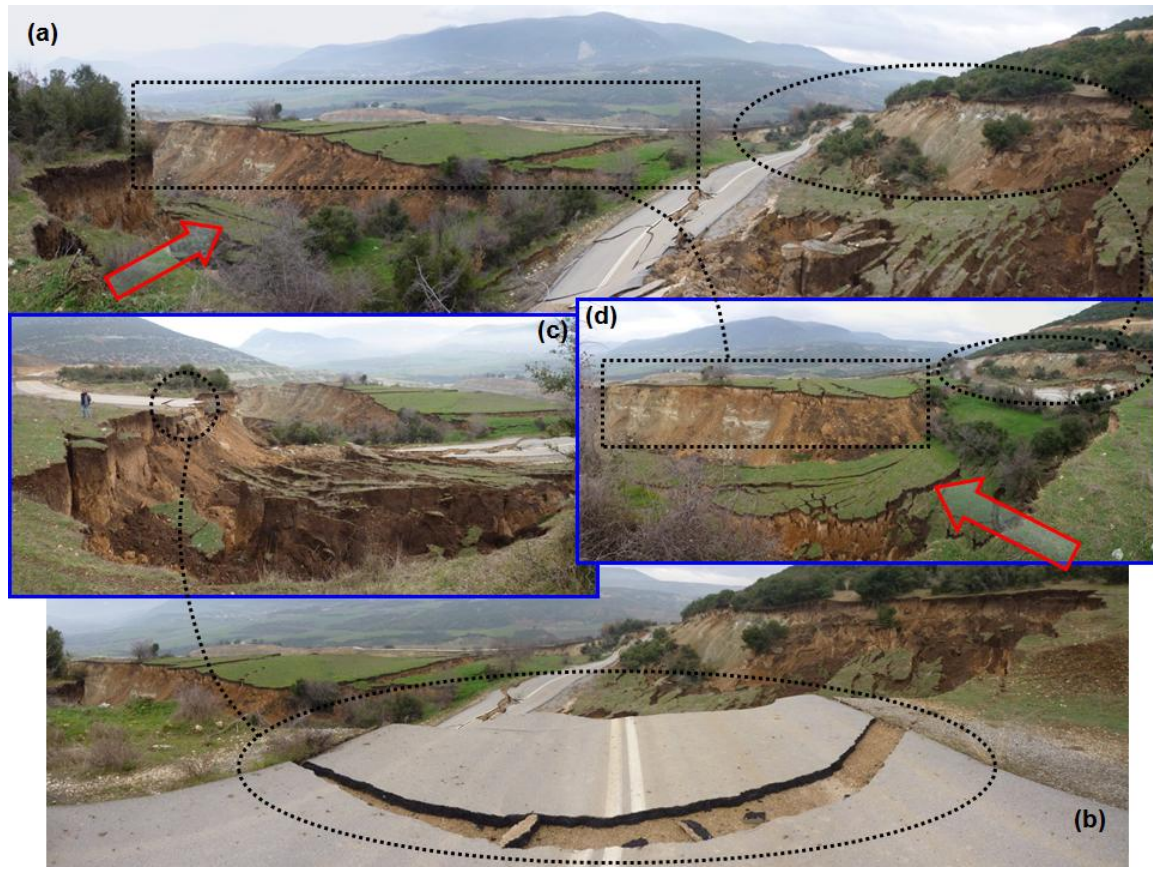
Figure 4. Aspect of the landslide from Position 3 (a & b), Position 4 (c) and Position 5 (d), the landslide crest (oval shape in a & d), the block that moved almost monolithically downstream (rectangle in a & d) and the mass that sank behind the block (arrow in a & d).

To evaluate the stability conditions of the landslide before any intervention, it was assumed that the critical failure surfaces either pass through the total failure envelope of the event, or through zones where significant shearing and relative movements were observed between “intact” parts of the marl formation, such as the zone downslope of the large scale trench that is shown in Figure 4.

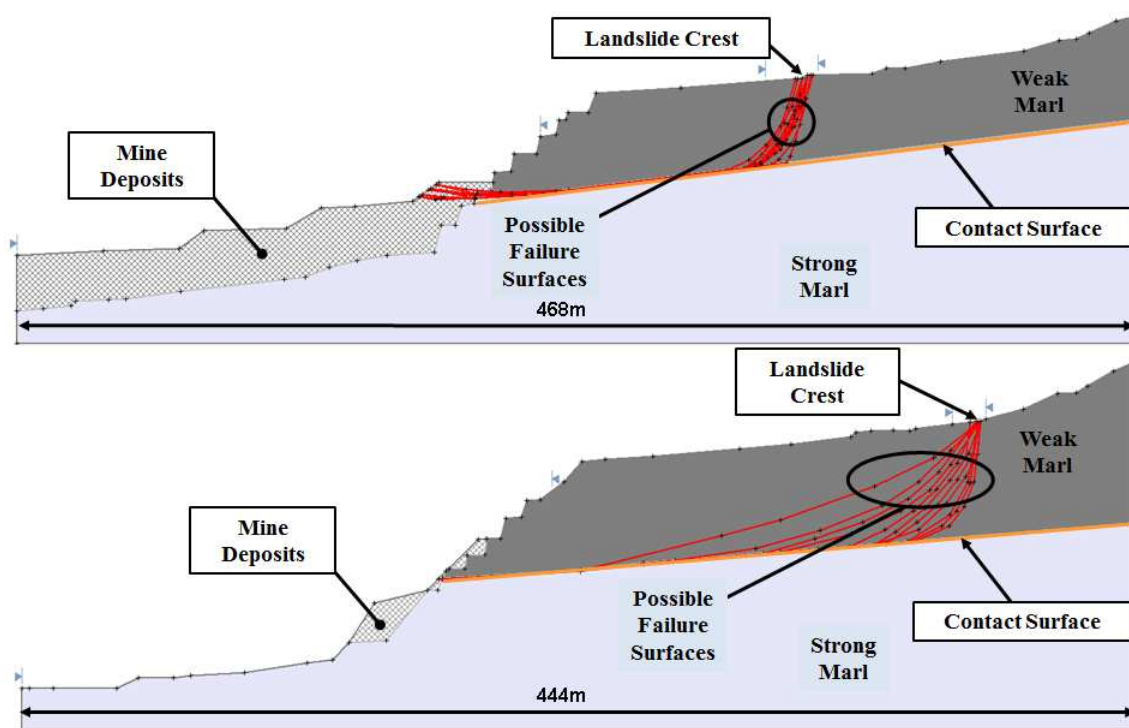
1. After in-situ inspection and study of available surveying mapping, conclusions were reached concerning the general shape of the failure surface along Section 2 (subvertical near the crest) and Section 3 (with more gentle slope near the crest). Based on these conclusions, a set of possible failure surfaces was considered for each Section, with varying inclination and part of the surface passing through the weak marl formation and along the contact surface between the weak and the competent marl.

Figure 5. Analysis Section 2 (up) and 3 (down). Slide software model.

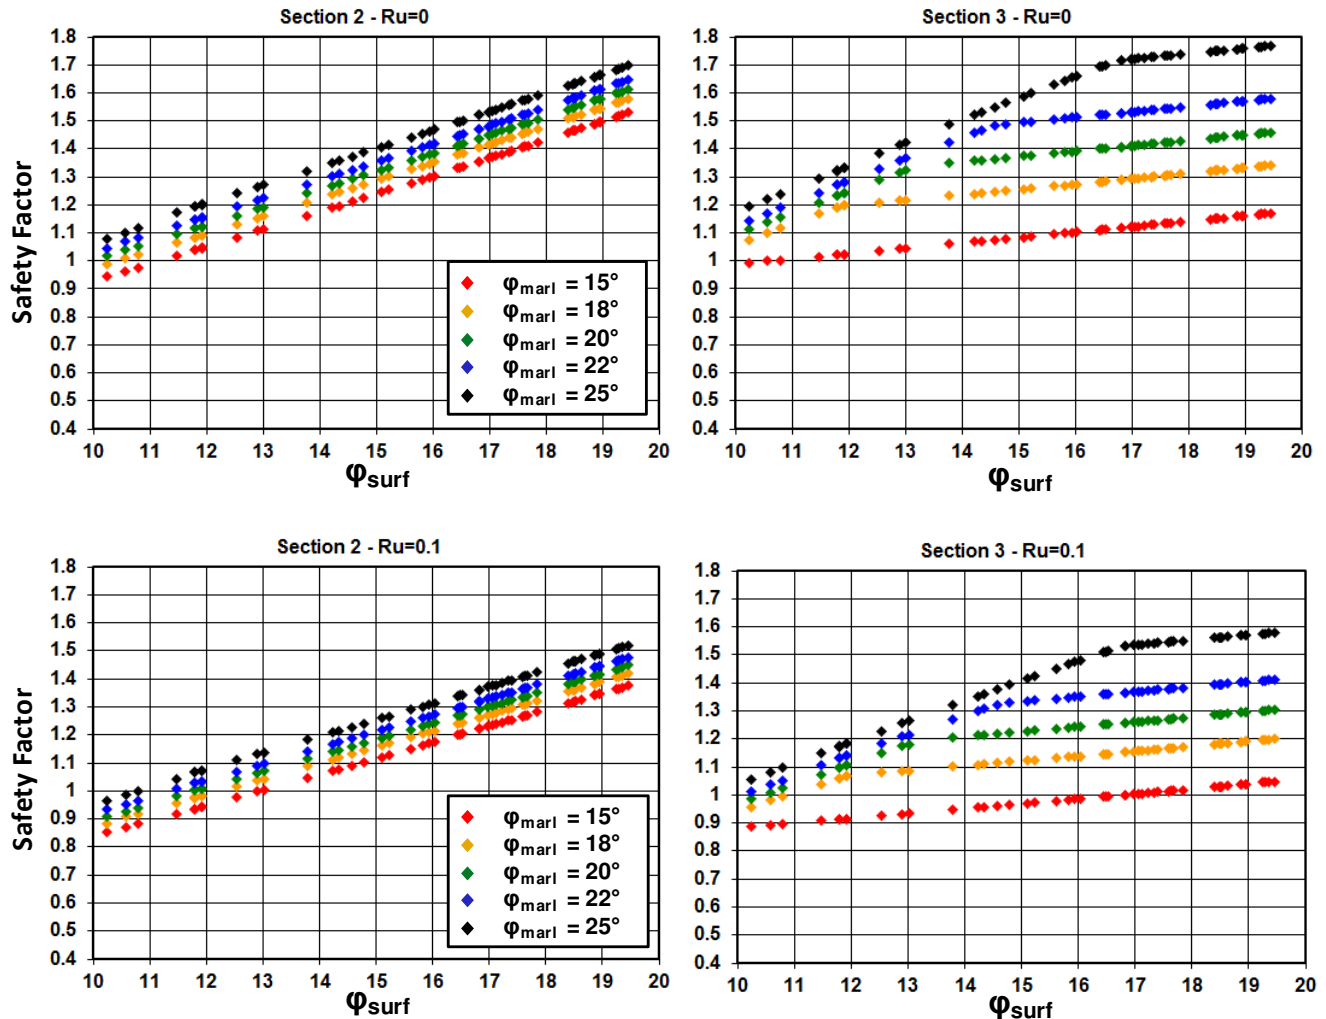
2. Values of the safety factor for values of pore pressure ratio  $R_u=0-0.1$  generally lie above unity for both Sections analyzed (see Figure 6), especially for  $\phi_{surf} > 13^\circ$  and were therefore excluded. This result was actually anticipated, since water seemed to have had a major role in the landslide triggering.

Figure 6. Variation of safety factor for different values of  $\phi_{marl}$  and  $\phi_{surf}$  for  $R_u=0.0$  (up) and  $R_u=0.1$  (down), as computed for Section 2 (left) and Section 3 (right)

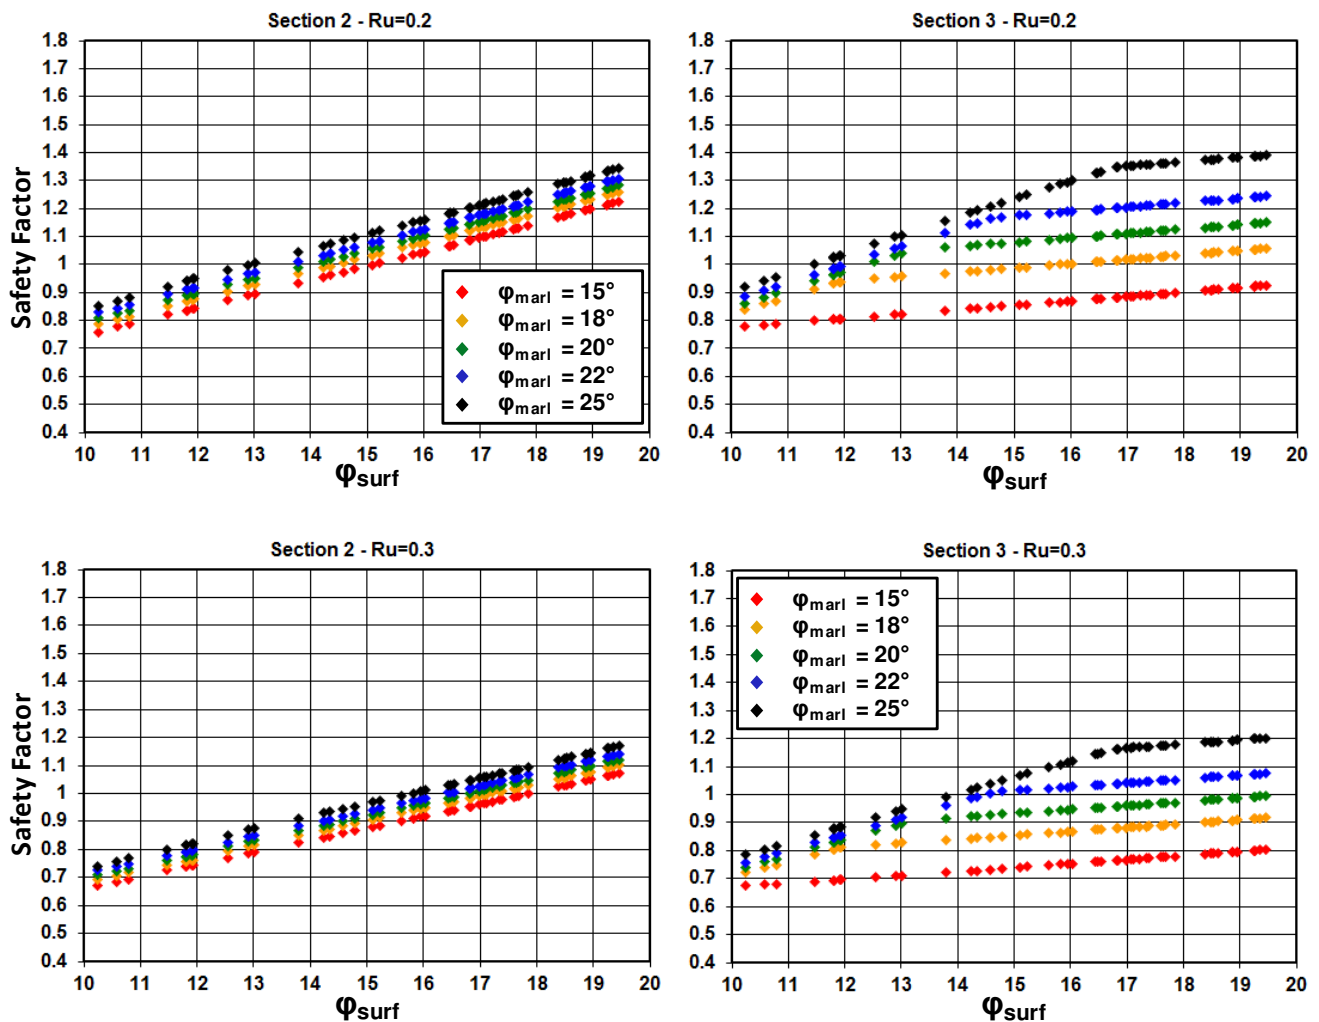
Figure 7. Variation of safety factor for different values of  $\varphi_{marl}$  and  $\varphi_{surf}$  for  $R_u=0.2$  (up) and  $R_u=0.3$  (down), as computed for Section 2 (left) and Section 3 (right)

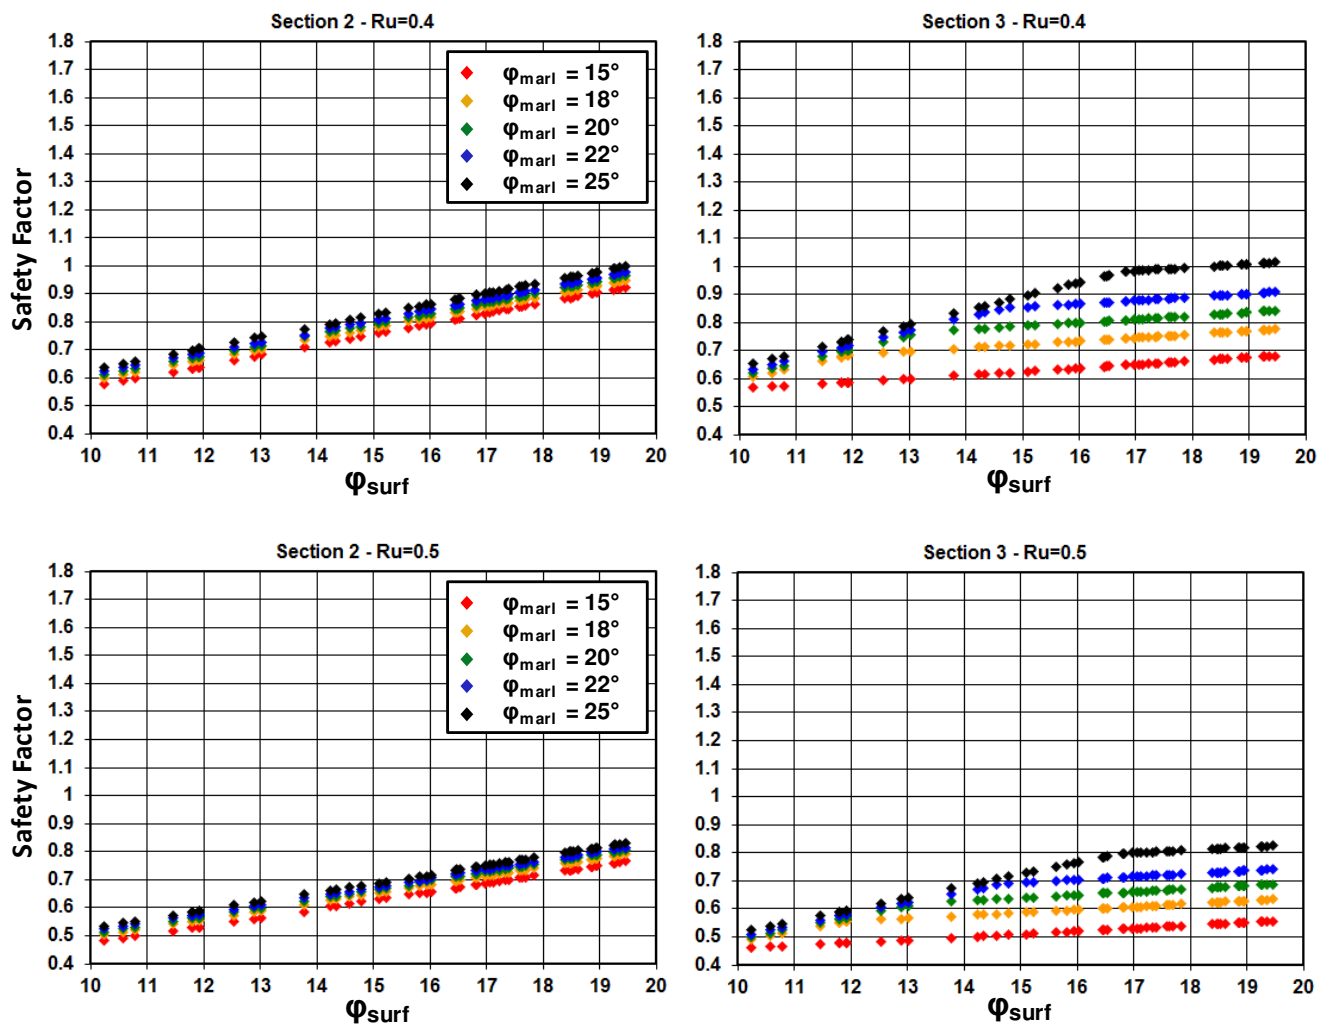
3. Values of the safety factor for values of the pore pressure ratio  $R_u=0.4-0.5$  were generally well below unity for both analysis Sections (see Figure 8), especially for  $\phi_{surf} < 17^\circ-18^\circ$  and were not considered likely. Values of the safety factor for  $\phi_{surf} > 18^\circ$ , given the nature of the specific surface and the fact that are assumed to refer to residual strength, were not considered reasonable.

Figure 8. Variation of safety factor for different values of  $\phi_{marl}$  and  $\phi_{surf}$  for  $R_u=0.4$  (up) and  $R_u=0.5$  (down), as computed for Section 2 (left) and Section 3 (right)

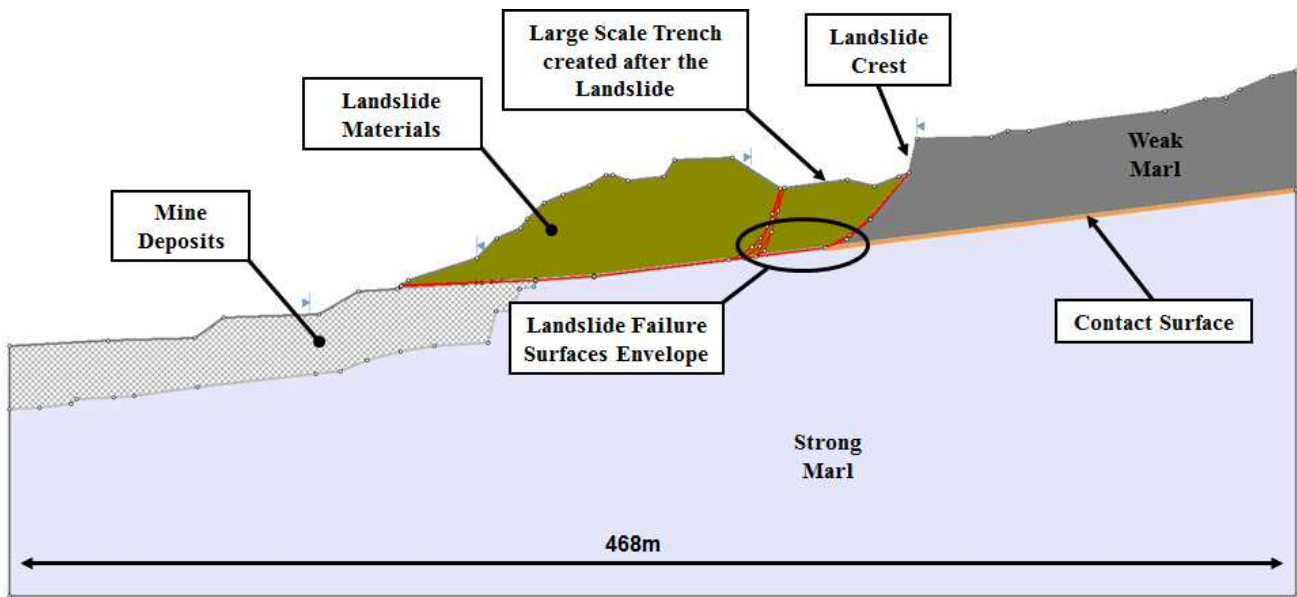
Figure 9. Analysis Section 2 after the landslide

The relevant analyses yielded results of the safety factor between 1.06 and 1.11, which were considered marginal, given the possible further deterioration of the shear strength of the materials involved in the slides, due to ongoing movements, especially during the rainy season in the area. Specifically, analyses of Section 2 resulted in a minimum value of the safety factor equal to 1.11, whereas the corresponding minimum value from Section 3 was 1.06. Analyses with free selection of surfaces by the software were not performed, as these would yield unrealistically low values of the safety factor (considerably <1), under the assumption that the total mass included in the landslide envelope had been downgraded to its residual strength (zero cohesion and low friction), which was not the case due to monolithic, undisturbed blocks existing within the slid mass. The fact that the resulting safety factor values were rational, i.e. marginally larger than unity, indicating a temporarily stable situation after a main landslide event, enhanced our confidence in the assumptions that were made.

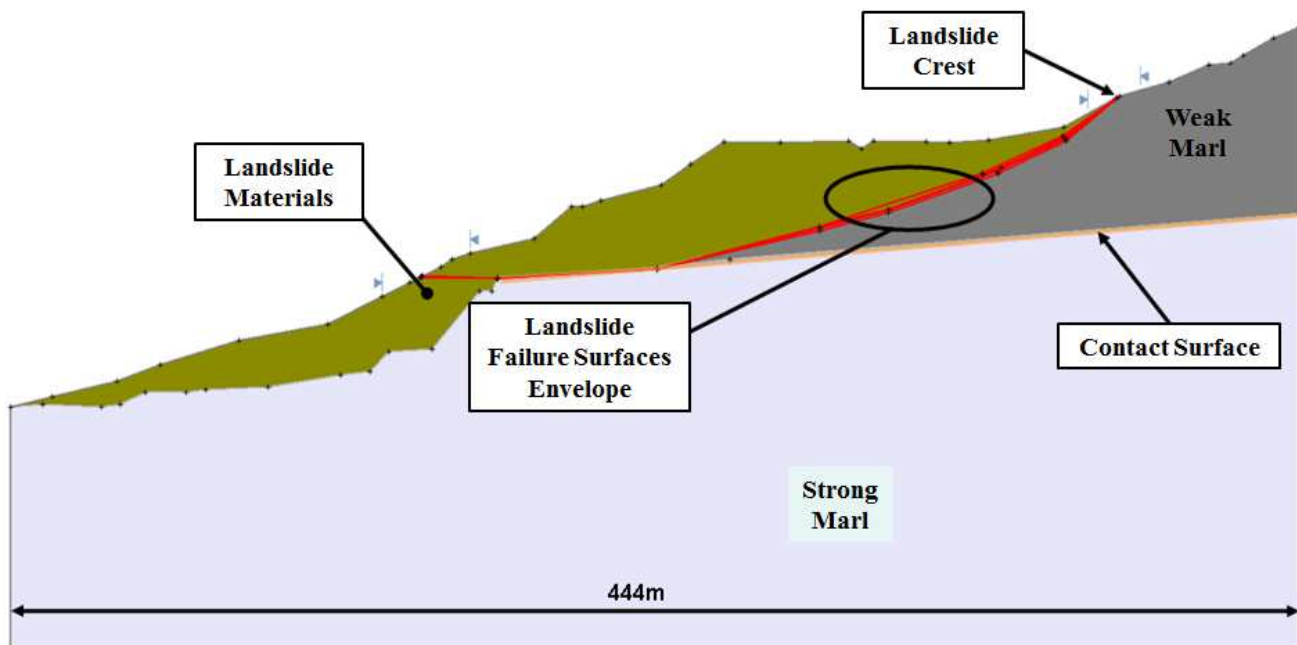
Figure 10. Analysis Section 3 after the landslide

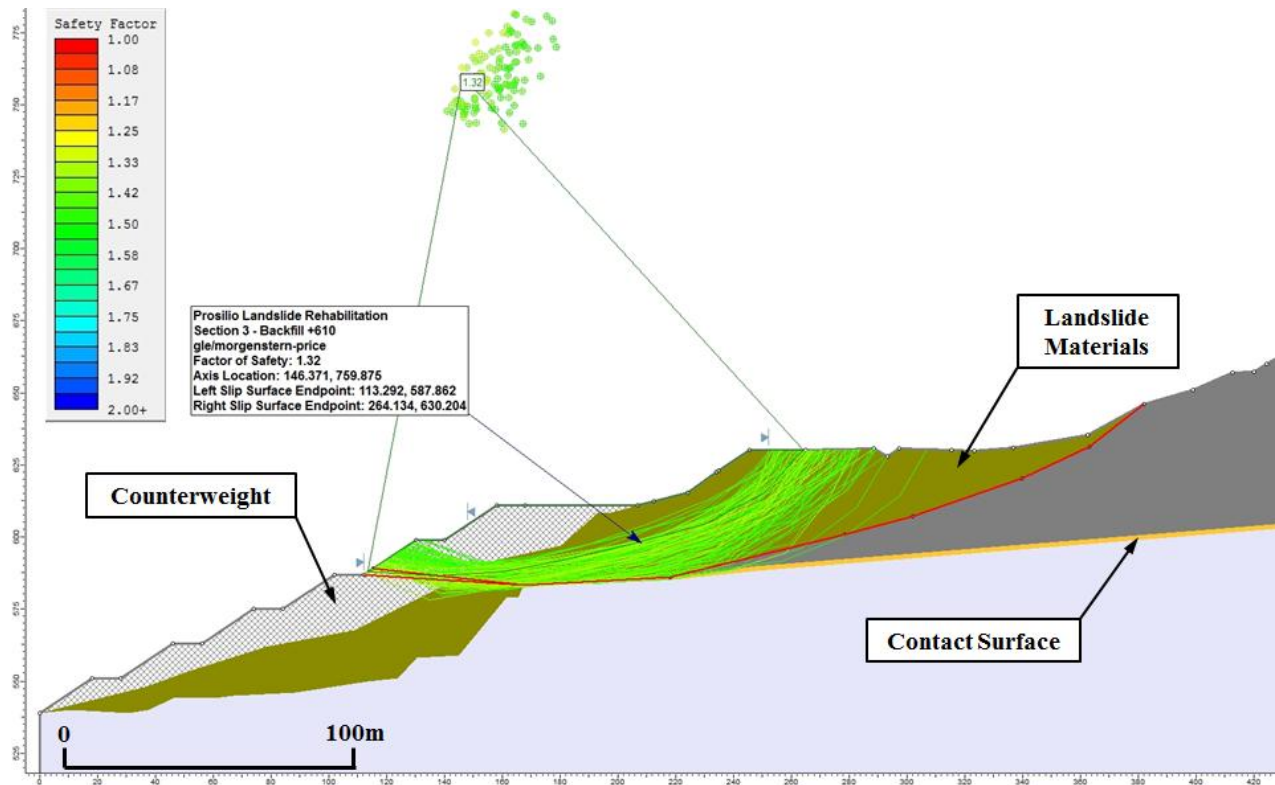
Figure 11. Analysis Results for Section 3 with backfill at the toe up to elevation +610 (F.S. = 1.32)

1. Placement of non commercial deposits at the toe of the landslide up to an elevation approximately 25 m above the contact surface between the upper weak and the underlying competent marl (~+610 m absolute elevation), significantly increased the safety factor. Specifically, considering the envelope of the landslide or surfaces along obvious large scale movements within the total landslide mass as potential failure surfaces, the computed values of the safety factor ranged between 1.52 and 1.63. Assuming that any failure surface within the total landslide envelope was possible (a quite conservative approach, since residual shear strength parameters were assigned in the analysis model) the safety factor ranged between 1.32 and 1.56. These values, even with the second, conservative approach, were considered adequate.

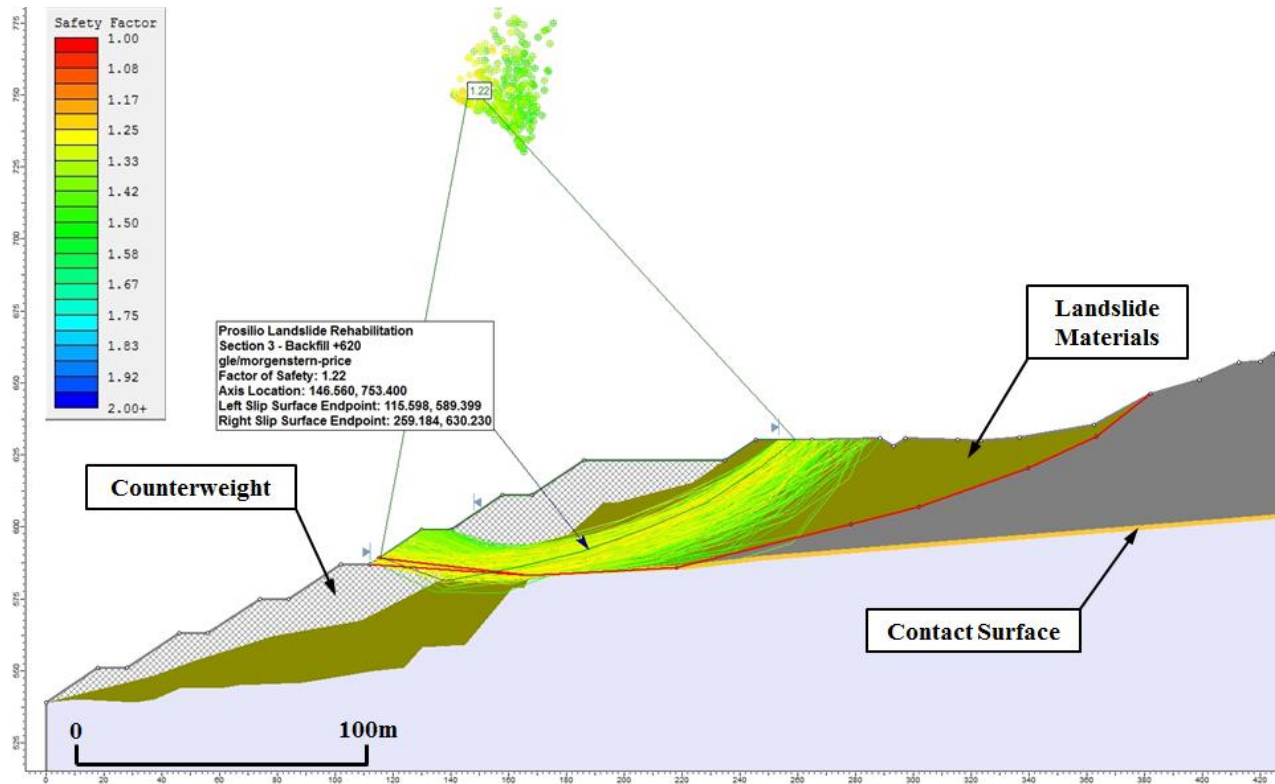
Figure 12. Analysis Results for Section 3 with backfill at the toe up to elevation +620 ( F.S. = 1.22)

2. Placement of non commercial deposits at the toe of the landslide up to an elevation approximately 35 m above the contact surface between the upper weak and the underlying competent marl (~+620 m absolute elevation), did not significantly differentiate the safety factor. Specifically, considering the envelope of the landslide or surfaces along obvious large scale movements within the total landslide mass as potential failure surfaces, the computed values of the safety factor ranged between 1.56 and 1.70. Assuming that any failure surface within the total landslide envelope was possible, the safety factor ranged between 1.22 and 1.57. Therefore, it was shown that the additional placement up to the specific level was only to facilitate the landslide removal and exploitation procedures and was not necessary for the stabilization of the landslide. In fact, locally, due to the existing geometry and morphology of the landslide, this additional placement could somehow reduce the available safety factor, as part of the deposits would actually increase the sliding moment for certain potential failure surfaces (pose additional loading to the landslide - see Figure 12 above).

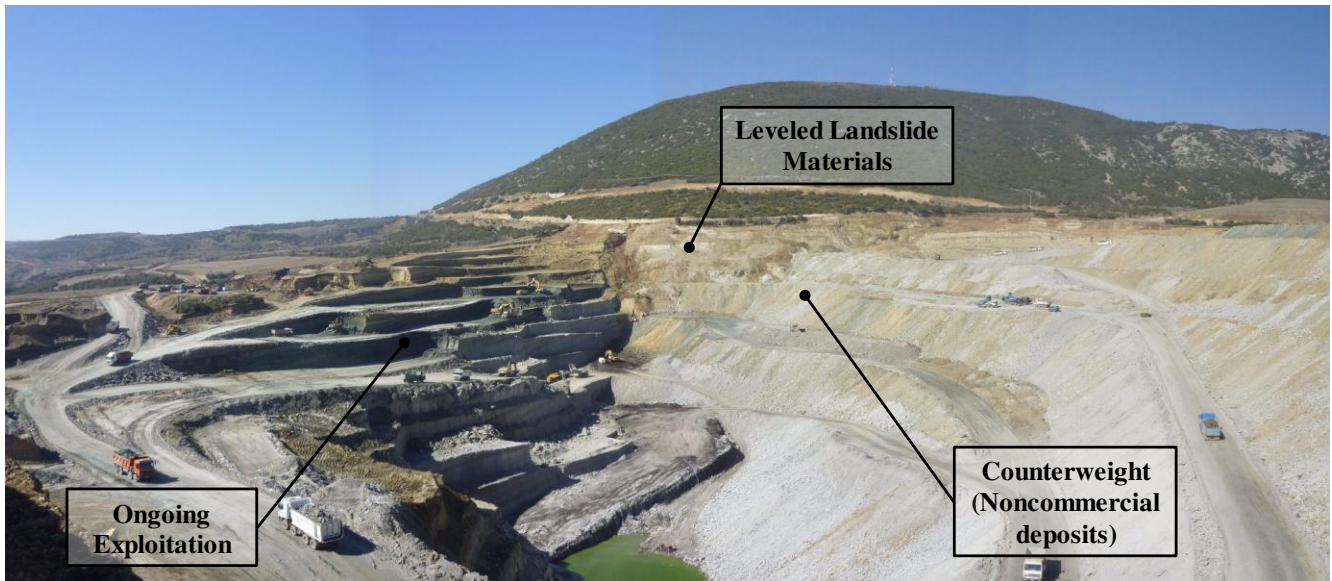
Figure 13. Aspect of the coal mine area after completion of counterweight construction and leveling works (March 2012).

The proposed rehabilitation scheme was successfully applied in order to stabilize the landslide before any intervention to its mass. The operation of the coal mine has continued without significant instability incidents ever since. The following figures show an aerial photo of the coal mine area and an aspect of the same from within the mine area, after completion of landslide counterweight construction and leveling of the landslide materials.

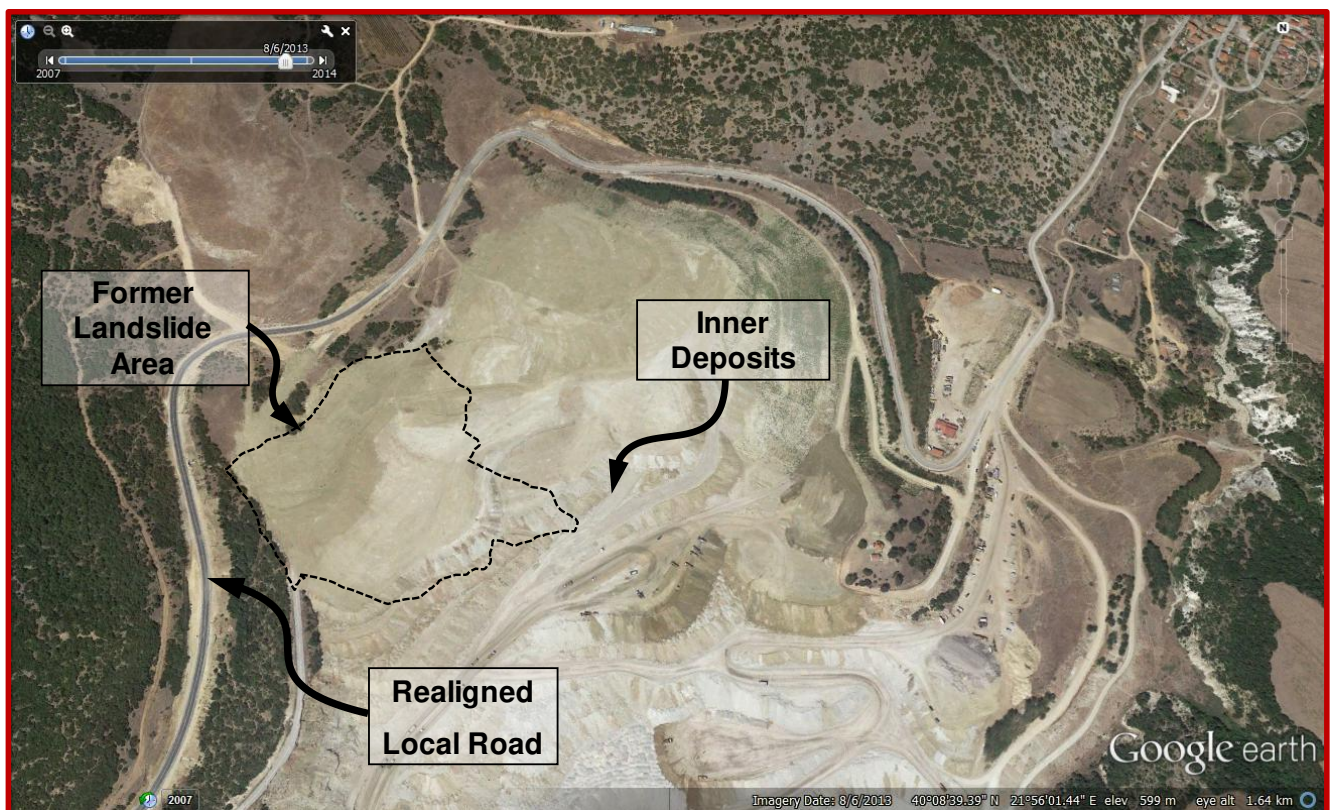
Figure 14. Aerial photo of the coal mine area after completion of counterweight construction and leveling works.
