Remediation of The Pissouri Landslide in Cyprus

ABSTRACT: During the winter of 2001-2002, a landslide of 80.000 m³ was activated and moved downslope at the Northeast outskirts of the Pissouri village in Cyprus (Limassol prefecture), displacing a section of a country road that was crossing the upper part of the sliding mass and destroying three newly built residences. This paper presents the geologic and hydrogeologic regime of the landslide and its implication on the landslide's mobilization. Geotechnical site investigation and post failure monitoring, in conjunction with slope stability back analysis formed the basis for the study of the slide and subsequently guided the remediation strategy. Various possible interventions to stabilize the slope and allow the safe reconstruction of the displaced road have been investigated and compared considering both economic and environmental criteria. The performance of the remediation measures has been studied in terms of stability safety, using numerical models previously calibrated via back analyses. Observations made during the execution of the stabilization works provided additional data verifying and supplementing the original design.

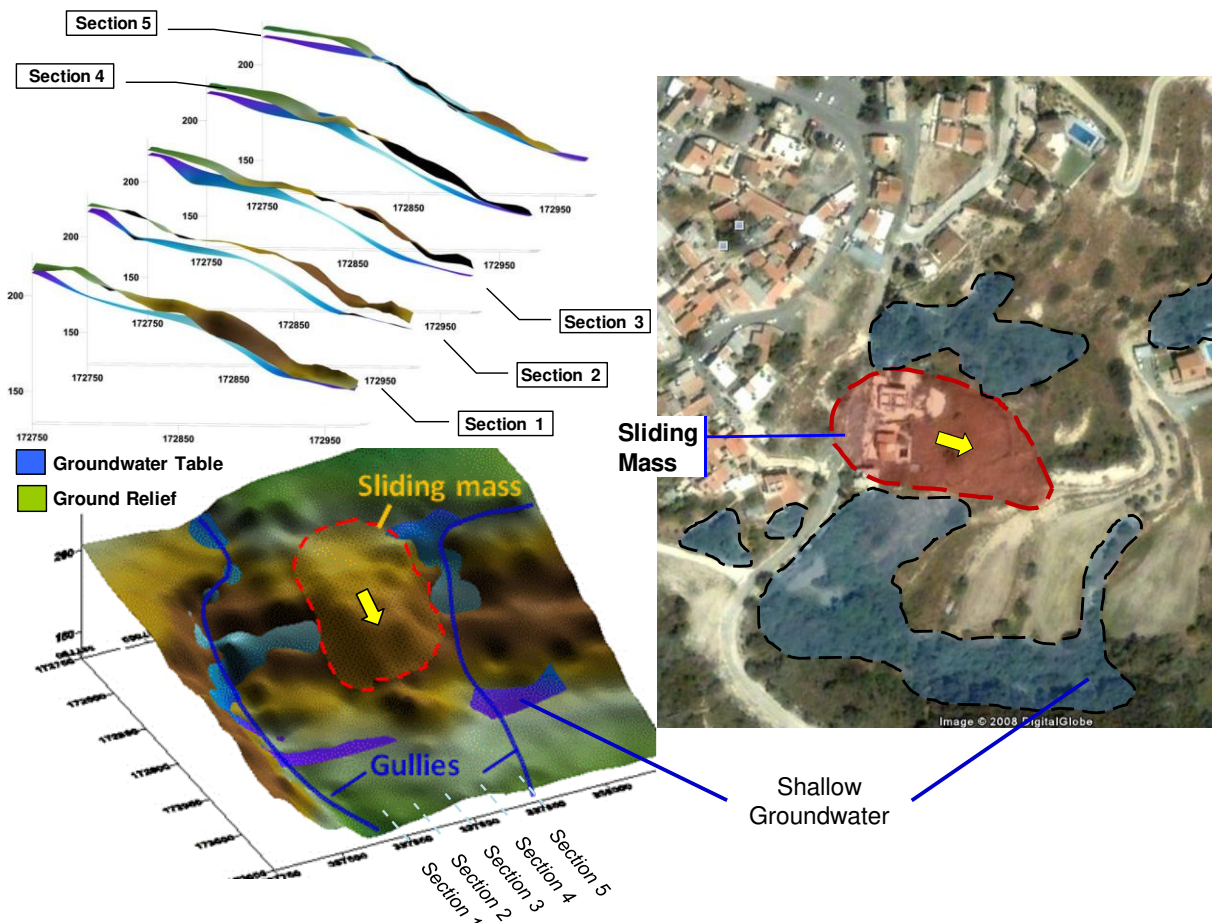
photographs, (Figure 12) and compares well with groundwater level measurements from piezometers installed in the vicinity of the landslide. The piezometric surface of Figure 13 represent the average dry season water table. During a wet season the water table within the landslide mass is expected to rise significantly and the development of a perched water table during thunderstorms should also be considered.

Figure 13. Left: A digital elevation model of the landslide area, overlain to the surface of the computed groundwater table. The groundwater table geometry is also presented as a series of sections in the upper figure. Right: Blue areas in satellite image indicate areas where the ground water table is at shallow depth and coincide with the most densely vegetated areas.

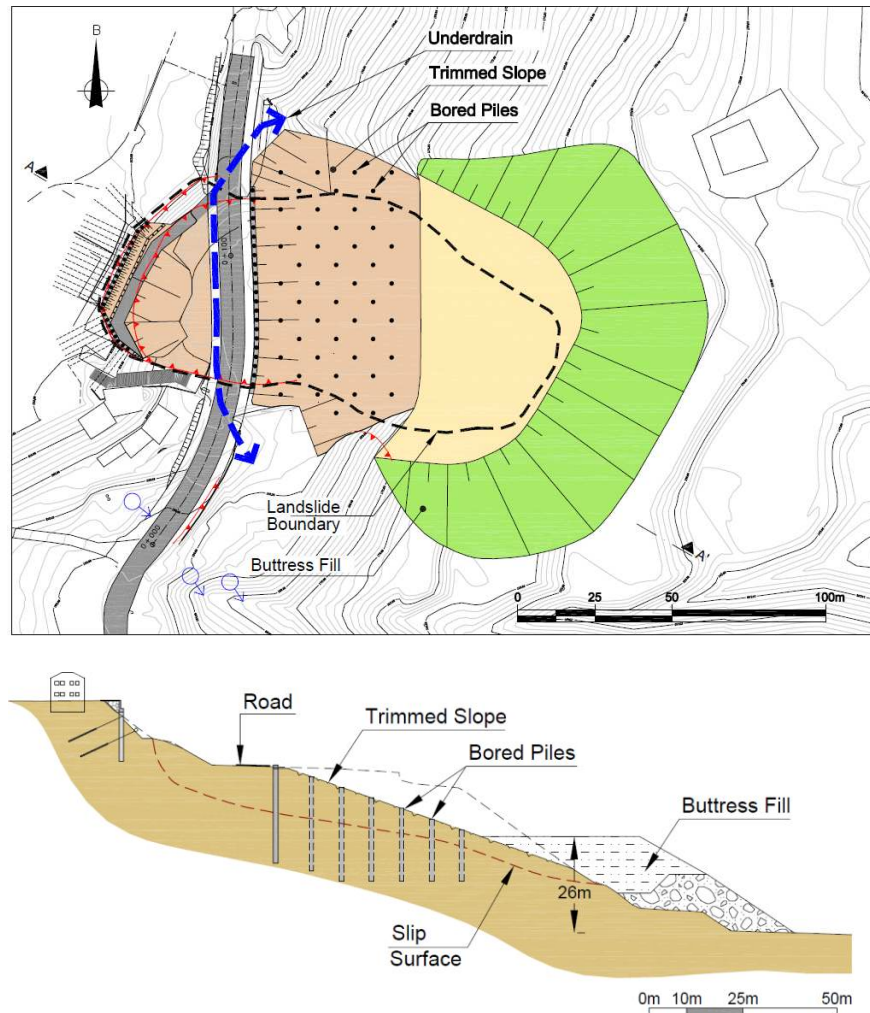
Figure 16. Landslide remediation – Upper Figure: Plan view of the toe buttress fill and the trimmed slope area. Dashed lines indicate general direction of subdrains. Lower figure: a cross section along the landslide.

The last option proved to be more robust, reliable, cost effective, and better fit to the constructability requirements, since it required materials, equipment and expertise available locally on the island. It was also found that it had a smaller impact to the landscape and the environment in general. After deciding to adopt this solution, the design was further developed, the construction procedure was studied more thoroughly and every construction stage was checked by means of detailed stability calculations. The layout of the adopted solution is presented in figure 16. The lower part of the landslide is stabilized first by means of a toe buttress fill resting on a drainage blanket, to allow for unobstructed drainage of the natural ground behind it. For the existing gullies running along the two sides of the sliding mass, erosion protection works (lining of the stream courses with gabions) were foreseen to protect the native soils and the toe buttress. Bored piles 1.20 m in diameter were placed in a staggered, 12x12 m pattern further up on the trimmed slope, to dowel the existing slide surface, but also to prevent shallower slides on pre-sheared surfaces from being mobilized, especially during the anticipated development of perched water tables during the more intense rainfall events anticipated. Along the downslope borderline of the road, a row of bored piles, 1.20 m in diameter at 3.0 m spacing, was designed, to reduce the amount of fill necessary for resetting the road pavement at its initial elevation and to ensure the integrity of the road pavement from ground movements. Sewage pipes running under the road pavement were carefully constructed to ensure that no leakage would escape and infiltrate within the sliding mass. The back scarp area which was left by the landslide movement as a degrading steep slope was protected and stabilized by means of a permanent anchored wall. This intervention fulfilled also the requirement to protect the buildings situated on the upslope crest. Groundwater within the remaining sliding mass was decided to be controlled by constructing a trench drain at the back scarp area of the landslide, which would collect the water seeping from the uphill area and discharge it towards the neighbouring gullies.
