A High Rock Cut Stabilization in Muscat City, Oman

Reference: Hayat, T.M., Bhatti, T.J. and Goldsmith, R. (2017). *A High Rock Cut Stabilization in Muscat City, Oman*.

International Journal of Geoengineering Case histories, <http://casehistories.geoengineer.org>, Vol.4, Issue 2, p.96-112.

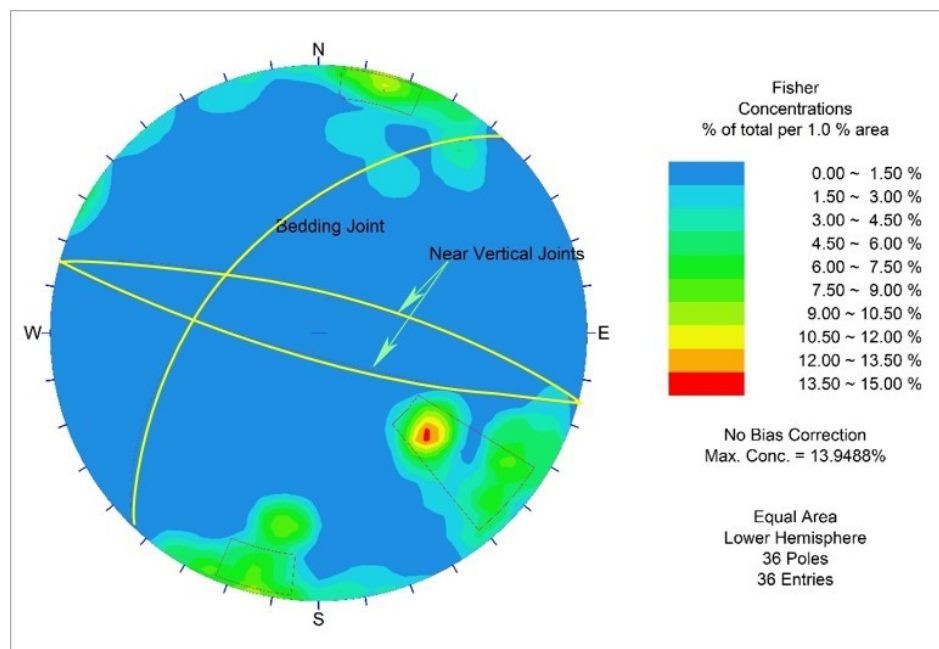
In Box Cut #1, from approximately RD 0+220 to 0+500 m, the interlayering of the beds is quite prominent and dips at 30° to 45° daylighting out of the face and within +/- 20° of the face orientation. In addition to the bedding, there are joints and faults that are steeply dipping at 70° to 90° and strike NE-SW or SSW. These joints have high persistence over all cut benches to the full 40 m height. Some of these features are faulted with noticeable displacements. Figure 5 shows the pole plot of the joints and great circles drawn through the centre of poles concentration by visual examination.

Figure 5. Stereoplot of the discontinuities representing the left slope in Box Cut 1.

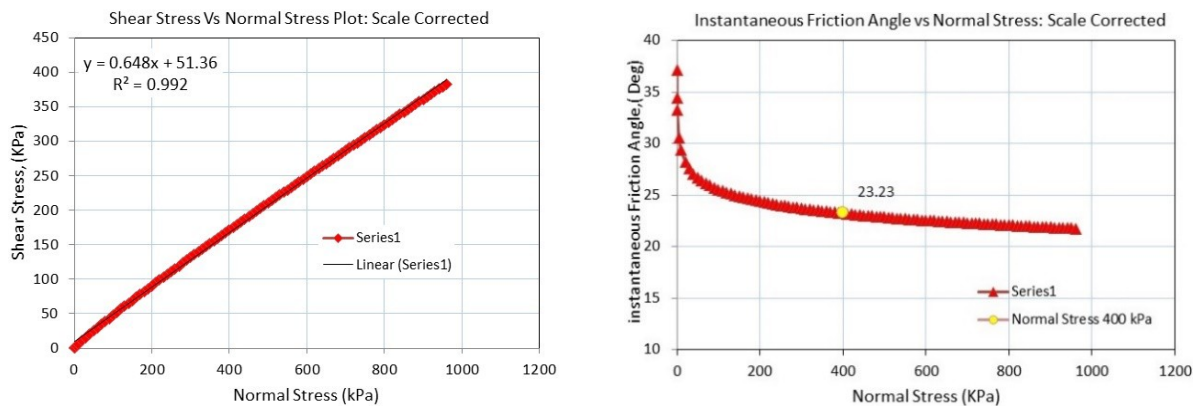
Figure 7. Friction angle at various stress levels for a deep seated sliding plane.

The average normal stress range was found to be about 400 kPa. Considering this, the corresponding friction angle (ϕ_L) was selected as 23.2° from Figure 7. In addition, based on site observations of intact rock bridges and test results, a cohesion value of 80 kPa was selected for analysis in deep seated failures. Similarly, for small scale failure, the ϕ_L value was calculated as 28° and zero cohesion was assumed in this case.

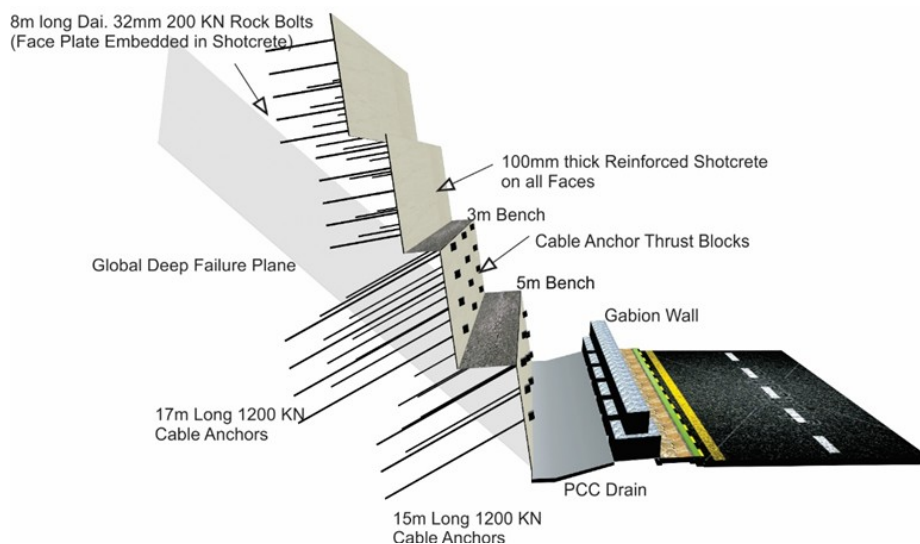
It was therefore concluded that the ends of box cut #1 were most vulnerable as at these locations large and deep seated failures were kinematically possible, whereas in the middle of these slopes, only shallower failures would be possible, the unstable wedges being confined at both ends. It was therefore decided to reinforce only the terminus of the 500 m long vulnerable slope with 1200 KN cable anchors. Other intermediate and cut faces above the cable anchored slopes were, however, reinforced with 200 KN rock bolts to control the comparatively smaller scale failures. The rock bolt heads were tensioned on steel plates resting on epoxy cement base. For long term durability, the steel plates were embedded in the shotcrete. The anchor heads of high capacity cable anchors were installed on specially constructed reinforced concrete anchor blocks. A typical arrangement of the reinforcement pattern at cut slope ends is shown in Figure 15.

Figure 15. 3D Conceptual arrangement of reinforcing elements at both the 20 m terminus of 500 m long left slope of Box Cut #1.

The arrangement of stabilization measures shown in Fig. 15 were implemented and are performing satisfactorily for the last six years.
