Geotechnical Damage Caused by the 2016 Kumamoto Earthquake, Japan

ABSTRACT: On the 16th of April 2016, the Kumamoto earthquake (M_w 7.0) hit the Central Kyushu Region, Japan, following a M_w 6.2 shock on the 14th of April. The earthquake sequences caused severe damage in Kumamoto Prefecture. This paper presents quick reconnaissance results focusing on geotechnical damage features, which were observed during field investigations immediately after, one, and two weeks after the main shock. The damage surveys were carried out in southern Kumamoto City, Mashiki Town, Aso Caldera area and their suburbs. In southern Kumamoto City, evidence of liquefaction was found at many locations, and some buildings and river levees suffered from significant settlement and deformation; damage to an embankment of Kyushu Highway also seemed to be the result of liquefaction. The majority of the damaged residential houses were found in Mashiki Town and its suburbs, which may be linked to intense earthquake motions associated with the seismic fault location. In Aso Caldera area, a number of moderate to large scale landslides and their significant impact to structures were observed. The greater part of land

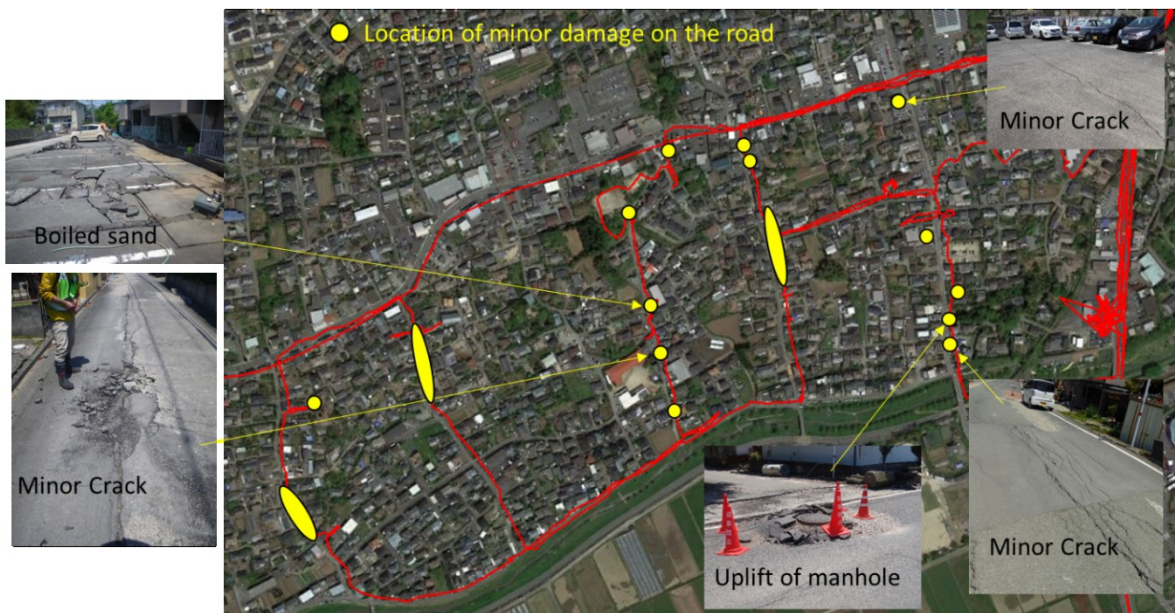
Figure 15 shows the result of the authors' quick survey. The spatial distribution of the collapsed houses was concentrated in the sloped area which consists of terrace and talus deposits, whereas ground deformation observed on the roads near the damaged houses was limited, therefore a large scale landslide might not have occurred. The cause of significant damage to the houses in this area was likely due to earthquake motion and the residual displacement of the entire sloped ground had an insignificant effect on the damaged houses. Although some houses were found to be damaged by ground deformation, as shown in Fig. 16 and 17 (sites 8 and 9), they were likely caused by localized failure of filled soil. On the other hand, the damage to the houses in the alluvial deposit area was limited whereas evidence of liquefaction was found frequently as shown in Fig. 15. It is inferred that the liquefied soil incidentally behaved like a seismic isolation system for the residential houses in this area.

Figure 15. Result of survey on ground deformation of sloped residential area in Mashiki Town (c.f. Figs. 12 and 14).

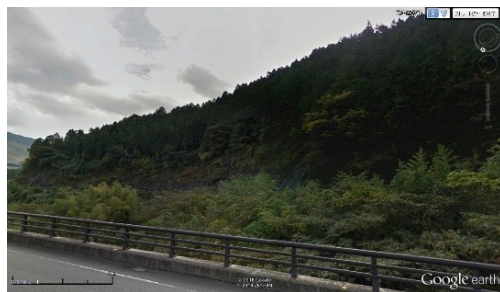
Figure 22. Slope failure along prefectural road No. 28 (site 14 in Fig. 12) ($32^{\circ}50'32.96''N$, $130^{\circ}55'40.65''E$).

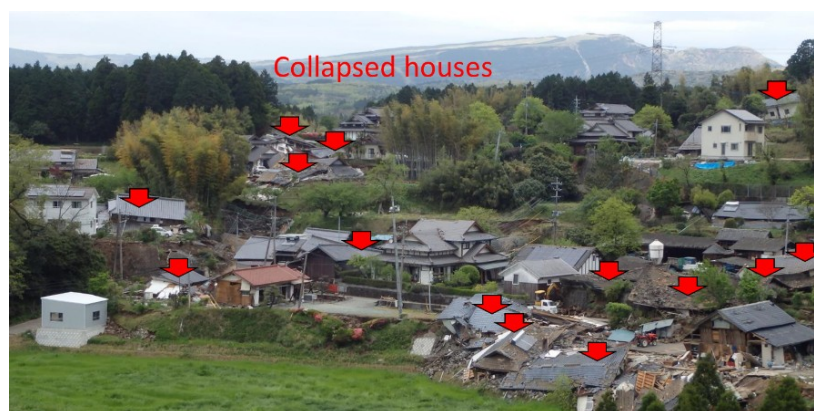
A number of residential houses along road No. 28 suffered from significant damage. As shown in Fig. 23, high collapse ratio of houses can be seen in the small village (site 15). In addition, modern bridges and a tunnel along road No. 28 suffered from serious damage. The girder of Ohkiri-hata Bridge moved about 1-1.5m and fell off its rubber bearings (Fig. 24, site 14). About 4 km north-east of Ohkiri-hata Bridge, Tawarayama tunnel suffered from a compressive axial failure and falling of lining concrete about 250 m from the tunnel portal (Fig. 25, site 16). The cause of compression of the tunnel was thought to be a surface fault movement in right lateral component, which was confirmed at the damaged location (Shirahama et al., 2016; Yoshimi, 2016). More information about the structural damages along road No. 28 due to the earthquake is reported in a separate report (Ikeda, et al., 2016).

Figure 23. Damage to residential houses in Ohkiri-hata area (site 15 in Fig. 12) ($32^{\circ}50'36.91''N$, $130^{\circ}55'43.16''E$).

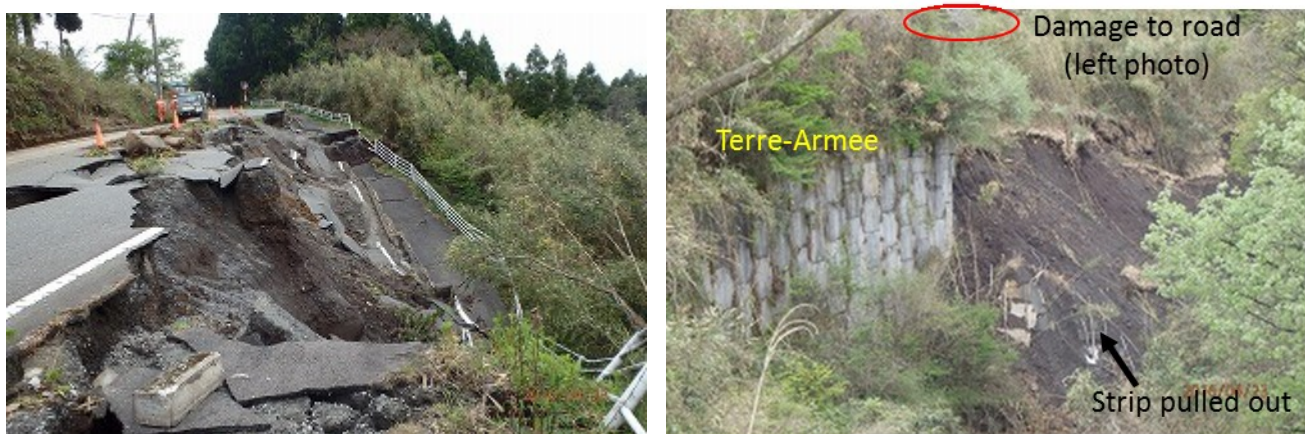
A 50 m-long embankment on prefectural road No. 149 (site 22 in Fig. 26) suffered from damage in the form of slope failure. Ground fissures and road pavement damage were also found there. This embankment (about 10-15 m high) was constructed along the small river by using a reinforced soil retaining wall technique (Terre-Armee), the wall was also damaged significantly as shown in Figure 35. Steel strip materials pulled out from the backfill soil were found on the failed slope surface. The reason for the failure of the reinforced soil retaining wall is not yet identified.

Figure 35. Damage to road embankment and reinforced retaining wall (Terre-Armee) (site 22 in Fig. 26) ($32^{\circ} 52'52.01''N$, $131^{\circ} 00'14.84''E$).
