Uplift of an Underground Tank in Northern Malabar Region, India

ABSTRACT: *An underground reinforced concrete tank was constructed for a project in the southwest region of India. The tank was 90 m x 35 m in plan and 7.3 m deep resting on partly filled-up and partly native soil. During the peak monsoon, a sudden uplifting of the base slab by about 300 mm and subsequent failure of the foundation raft and a partition wall was observed. Laboratory testing was executed and hydrogeological survey was carried out using ground penetrating radar, seismic refraction and infiltrometer testing, and an analytical study was carried out to identify the root cause of the tank uplifting. Based on this study, it was observed that the uplifting and structural failure was essentially due to the peculiar land terrain and soil properties and the development of excess hydraulic head below the bottom of the tank. After considering different options, the rectification measures were carried out by provision of dewatering wells along the tank periphery to release the excess hydrostatic pressure and stabilize the foundation raft. The structural repair of the top of the foundation raft and partition wall was

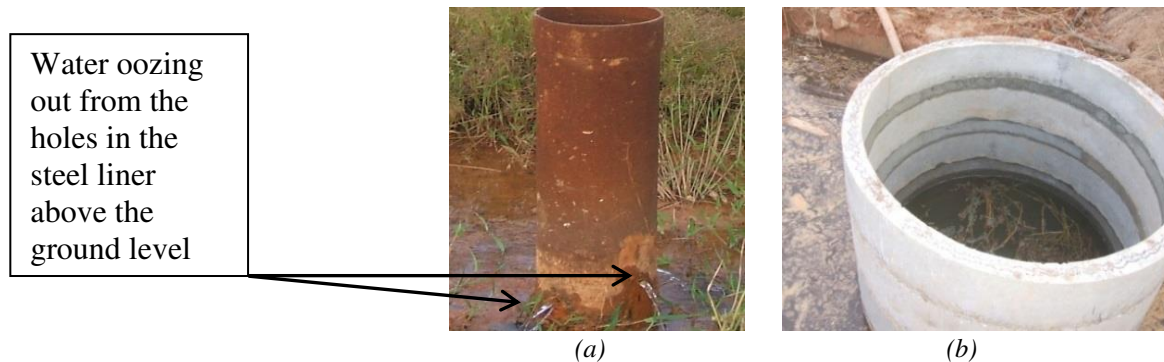
In the meantime, when the tank filling was ongoing and the rainfall intensity reduced, the boreholes with steel liner were drilled along the tank periphery and a 1.2 m diameter and 4 m deep ring well was also dug near the tank. The groundwater was observed to be coming out from the perforations in steel liner above the ground level due to high hydraulic head (Fig. 3a). The water level in an open well was also observed to be at the ground level (Fig. 3b).

Figure 3. Groundwater level in (a) borehole with steel liner and (b) ring well
