Uplift of an Underground Tank in Northern Malabar Region, India

ABSTRACT: *An underground reinforced concrete tank was constructed for a project in the southwest region of India. The tank was 90 m x 35 m in plan and 7.3 m deep resting on partly filled-up and partly native soil. During the peak monsoon, a sudden uplifting of the base slab by about 300 mm and subsequent failure of the foundation raft and a partition wall was observed. Laboratory testing was executed and hydrogeological survey was carried out using ground penetrating radar, seismic refraction and infiltrometer testing, and an analytical study was carried out to identify the root cause of the tank uplifting. Based on this study, it was observed that the uplifting and structural failure was essentially due to the peculiar land terrain and soil properties and the development of excess hydraulic head below the bottom of the tank. After considering different options, the rectification measures were carried out by provision of dewatering wells along the tank periphery to release the excess hydrostatic pressure and stabilize the foundation raft. The structural repair of the top of the foundation raft and partition wall was

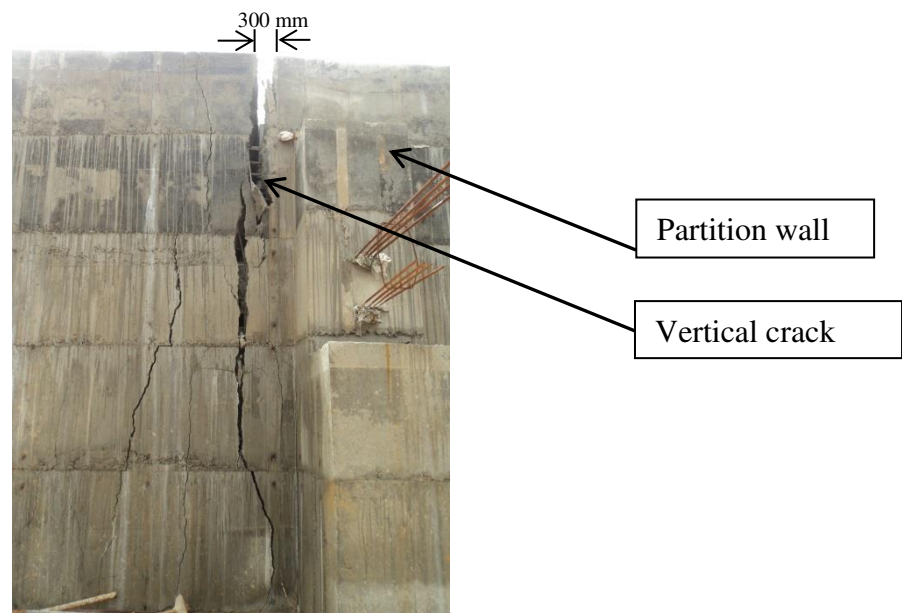
Figure 2. Uplifting and cracking of tank partition wall.

In the southern part of India, the monsoon is at its peak in the months of June & July every year. In mid-June of 2013, the foundation raft of the tank suddenly got uplifted by approximately 300 mm at the center. The review of past rainfall data revealed higher rainfall intensity in June 2013 compared to rainfall in the previous three years as shown in Table 2. During the failure of the tank, the 0.9 m thick reinforced cement concrete (RCC) partition wall inside the tank got cracked in tension at the center due to the uplifting and bending of the foundation raft. However, no uplifting was noticed at the four edges of the tank. Thus, the tank took an inverse saucer shape due to the uplifting at the center.

Fig 2 indicates the curved and cracked partition wall due to the tank uplifting. Several other cracks were observed along the height of the partition wall on either side of the middle 300 mm wide crack, with the crack width decreasing away from the center. Based on daily measurements taken on top of the partition wall after the failure, the uplifting of bottom slab and the crack width of partition wall was observed to be increasing at a rate of 30 mm per day. The cracks, which were observed on top of the foundation raft inside the tank, had maximum width of 12 mm. The seepage of groundwater inside the tank was not observed through these cracks. Thus, the depth of cracks was limited only to the top portion and not penetrating the entire thickness of the foundation raft.

As the crack width in the partition wall was increasing at a rate of 30 mm per day, it was necessary to take immediate corrective measures to stop the cracks from further widening. It was therefore suggested to drill boreholes of 200 mm diameter up to 8 m depth (as the depth of tank is 7.3 m) around the tank periphery so as to reduce the water pressure acting on the bottom of foundation raft by allowing the water under pressure to get released through these boreholes. However, due to the heavy rains, the contractor could not position the drilling equipment near the tank to drill the boreholes. Considering the practical delays in carrying out the borehole activity, another suggested option was to fill the tank with water up to approximately 5.5 m height which would generate additional weight within the tank, to counter the upward buoyant force of groundwater. Thus the accumulated water within the surrounding area was diverted inside the tank. As soon as the tank started filling with water, the settlement of the tank started taking place due to the weight of water. It took more than a month to fill the tank with water up to a height of 5.50 m after which the tank was observed to be completely settled to its original position and the crack width in the partition wall was reduced to 25 mm from 300 mm.

The structural rectification of damaged partition wall was carried out by demolishing the damaged portion, providing new reinforcement, applying epoxy bonding coating on old concrete and reconstructing the demolished portion of the wall.

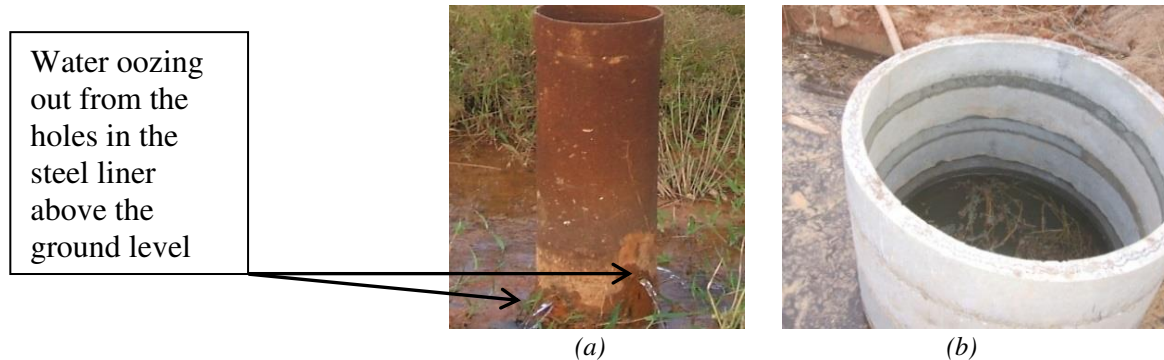
Figure 3. Groundwater level in (a) borehole with steel liner and (b) ring well

In the meantime, when the tank filling was ongoing and the rainfall intensity reduced, the boreholes with steel liner were drilled along the tank periphery and a 1.2 m diameter and 4 m deep ring well was also dug near the tank. The groundwater was observed to be coming out from the perforations in steel liner above the ground level due to high hydraulic head (Fig. 3a). The water level in an open well was also observed to be at the ground level (Fig. 3b).
