Lessons Learned from Dike Failures in Recent Decades

ABSTRACT: *The paper describes five different dike failures that occurred in recent decades. The case histories were located on different rivers and involved different loading conditions. The observed failure mechanisms involved erosion and stability problems. The types of erosion observed were both internal erosion due to extreme groundwater flow and external erosion caused by the river flow and wave action. The case involving instability was caused by uplift, i.e., increased hydraulic head led to a sharp reduction in maximum shear strength between subsoil layers. Two cases demonstrate the importance of dike management and maintenance. Despite the variations in the loading conditions and failure mechanisms, all the cases show that the strength of a dike depends not only on the material used to build the dike but also on the strength of the subsoil.*

Lessons Learned from Dike Failures in Recent Decades. International Journal of Geoenvironment Case histories, Vol.4, Issue 3, p.203-229. doi: 10.4417/IJGCH-04-03-04

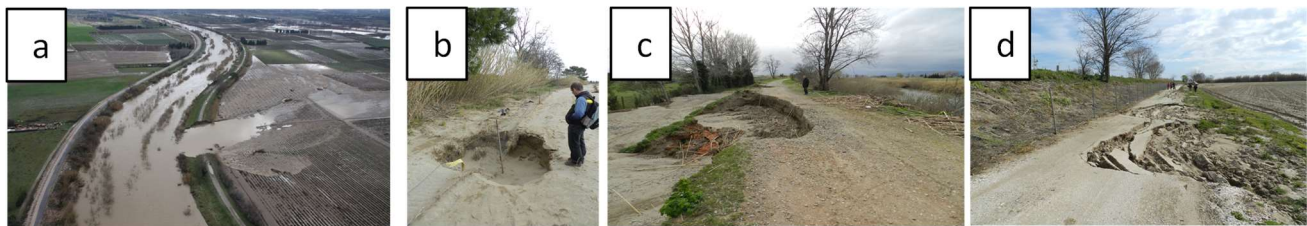
The discharge during this event is also estimated to have been approximately 1000 m³/s. There was a breach over a 75-m section in one of the areas prone to sand boils (Figure 14a). The dike itself was eroded, as well as its foundations down to the depth of the minor river bed. The exact cause of the breach is not known because there were no eyewitnesses close to the dike at the time of the breach initiation about 2 hours after the maximum discharge. The breach may have been caused by internal erosion in the dike or the foundation soils, with possible local overtopping following internal erosion and collapse. A large sinkhole was found close to the breach (Figure 14b). Significant additional damage was observed as a result of overflowing (Figure 14c), internal erosion and foundation instability (Figure 14d), as well as internal erosion in the dike itself at one location.

Figure 14. a) The March 2013 breach at the Pia location on the right of the river (photo: DREAL Languedoc-Roussillon), b) A sinkhole close to the breach (photo: Patrice Mériaux, Irstea), c) Damage caused by overflowing (photo: Patrice Mériaux, Irstea), d) Damage to a track on the landward side of the dike caused by under-seepage (photo: Patrice Mériaux, Irstea)

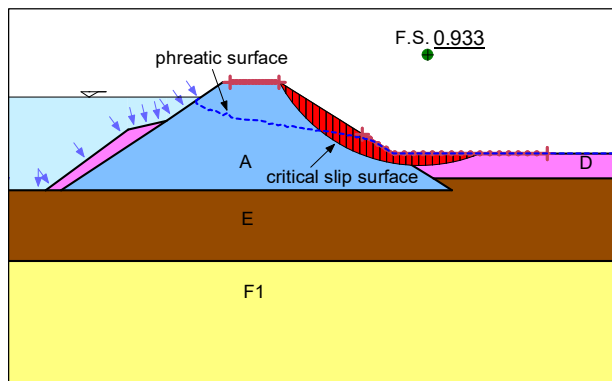
Figure 24. Stability analysis and relevant soil parameters at flood peak and transient flow condition of the section at km 124.62 in Laag; $c' = 0 \text{ kN/m}^2$

where σ_n is the normal stress, \mathcal{G}_w is the volumetric water content, \mathcal{G}_s is the saturated volumetric water content and \mathcal{G}_r is the residual volumetric water content. The results of the stability analyses at flood peak for the two cross-sections based on transient flow conditions are shown in Figures 24 and 25. The stability analysis consistently returns factors of safety < 1 for these sections, which proved to be unstable in 1981.

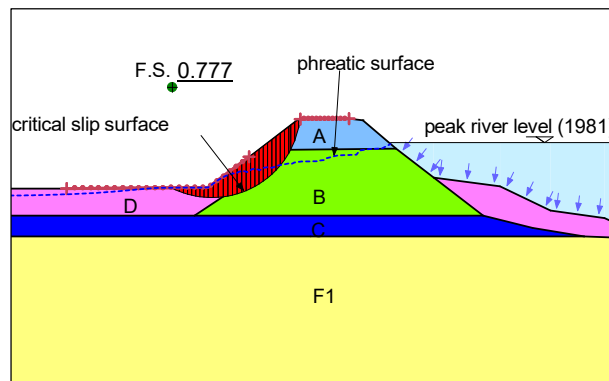
Figure 25. Stability analysis and relevant soil parameters at flood peak and transient flow conditions of the section at km 122.248 in St. Florian; $c' = 0 \text{ kN/m}^2$.

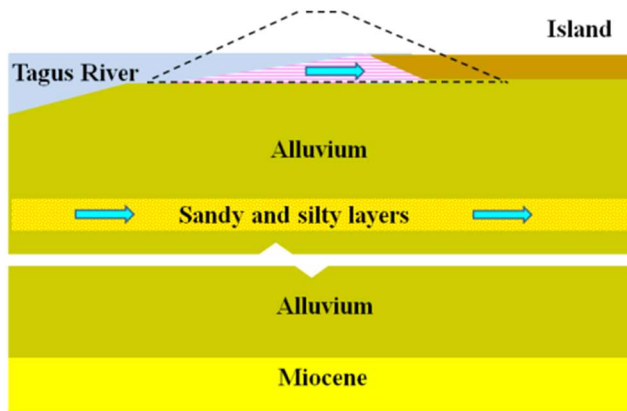
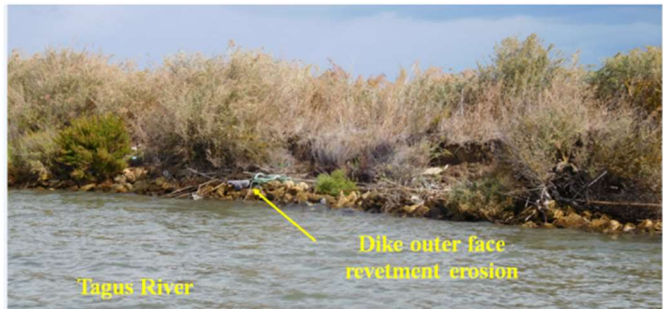
The main failure mechanism is related to the erosion of the clay fill due to water inflow and the mechanical action of the waves on the outer face of the dike. Failure originated with the erosion of the riprap revetment (Figure 39). The presence of a permeable sandy layer below the dike foundations also contributed to the failure mechanism. The actual dike failure began during the severe winter of 2015 - 2016 and involved a section with an overall length of approximately 30 m. When the failure occurred, the water level in the Tagus River was approximately Mean Sea Level, MSL, +4.20 m. In October 2016, the overall length of the dike failure line had increased to approximately 80 m.

Dike Cross Section – Failure
 Failure due to the clay fill erosion (Tagus river waves start to erode the rip rap revetment)

Figure 40. Dike failure due to the erosion of the clay fill, cross-section and view of the outer face.
