# Geological Engineering Reconnaissance of Damage Caused by the October 15, 2006 Hawaii Earthquakes

**Edmund W. Medley**, Senior Consultant, Geosyntec Consultants Inc., Oakland, CA, USA, Email: [emedley@geosyntec.com](mailto:emedley@geosyntec.com)

**ABSTRACT:** *Two strong earthquakes shook the Island of Hawaii, Hawaii on the morning of October 15, 2006. Peak Ground Accelerations reached 1.2g, and earthquake felt intensity of MMI VIII. Earthquake damage of public and private property totaled about \$200 million, with no fatalities. Geological engineering reconnaissance of earthquake damage resulting from the earthquakes focused on the apparent relationships between the observed geology and the damage. Some roadway embankments failed causing temporary closure of Island highways. Landslides were common at steep coastal cliffs. Liquefaction and lateral spreading occurred in coralline fill at Kawaihae Harbor. There were extensive road cut failures, in which the performance of road cuts in soil slopes was generally better than that of rock slopes. Where a'a clinker underlay massive a'a basalt blocks in road cut slopes, the loose clinker dislodged thereby undermining the blocks, and ca

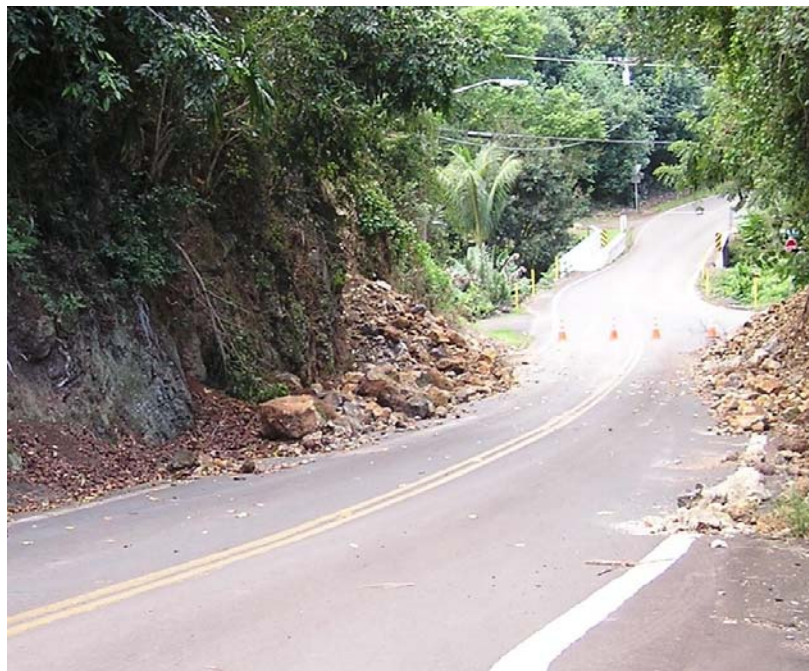
*Figure 7. Hwy 270, Station 18, near Kēōkea Bay Beach Park access road. Highway was blocked by rock falls after the earthquakes.*

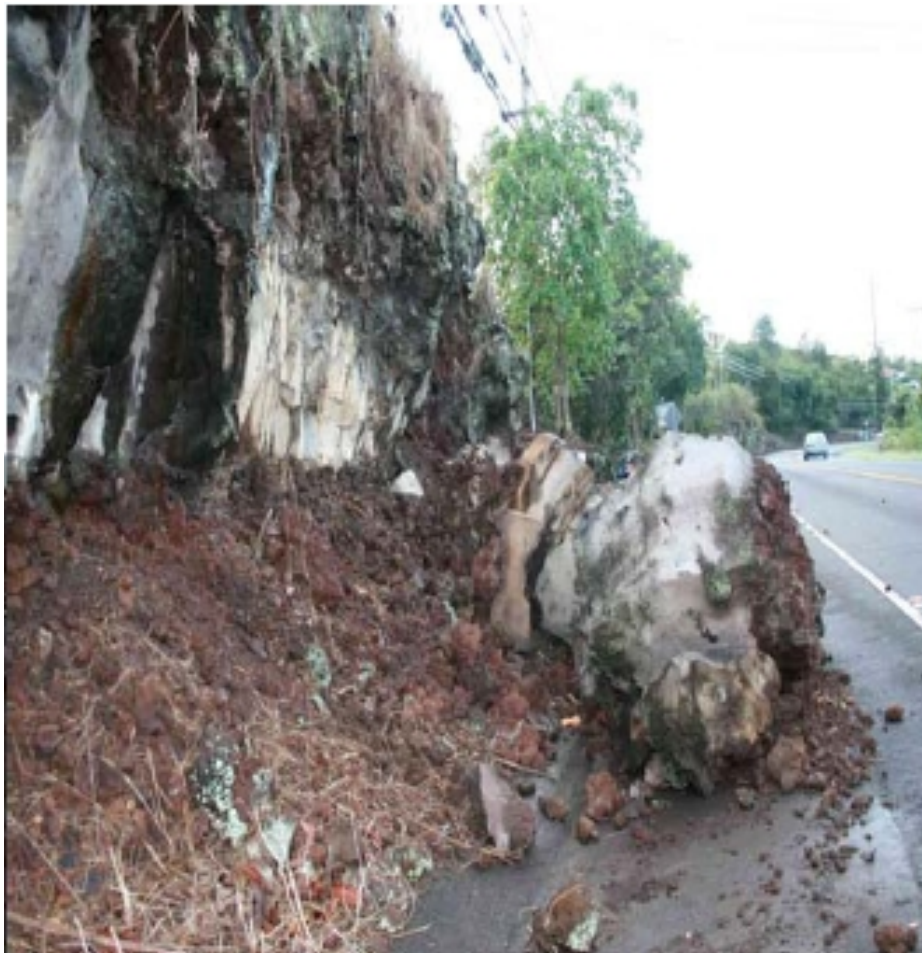
There is a considerable difference in the mechanical properties of the a'a clinker and massive basalt. During the earthquakes, loose a'a clinker raveled, removing support from the overlying massive blocks, some of which failed during the earthquakes as shown by Figures 9 through Figure 17 (includes 3-D stereo versions). It was the large and heavy blocks, rather than the soil-like clinker, that represented the greater hazard to traffic, and required greater effort to move. Consequently, where heavy equipment was not immediately available, fallen large rock blocks obstructed roads for longer periods than the finer debris.

Figure 8. Failed rock cut: massive a'a block undermined by raveled a'a clinker (Chock, 2006; after Robertson et al, 2006).

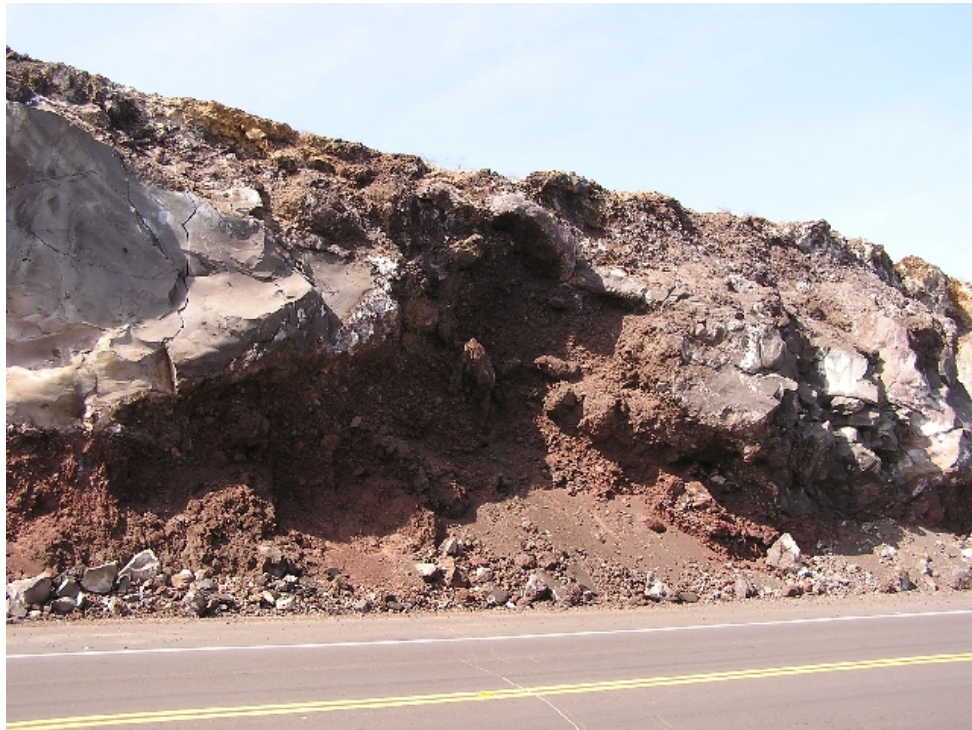
*Figure 11. Location 32, Hwy 11. Failure of massive basalt blocks overlying weaker rock (weathered a'a clinker and baked zone).*

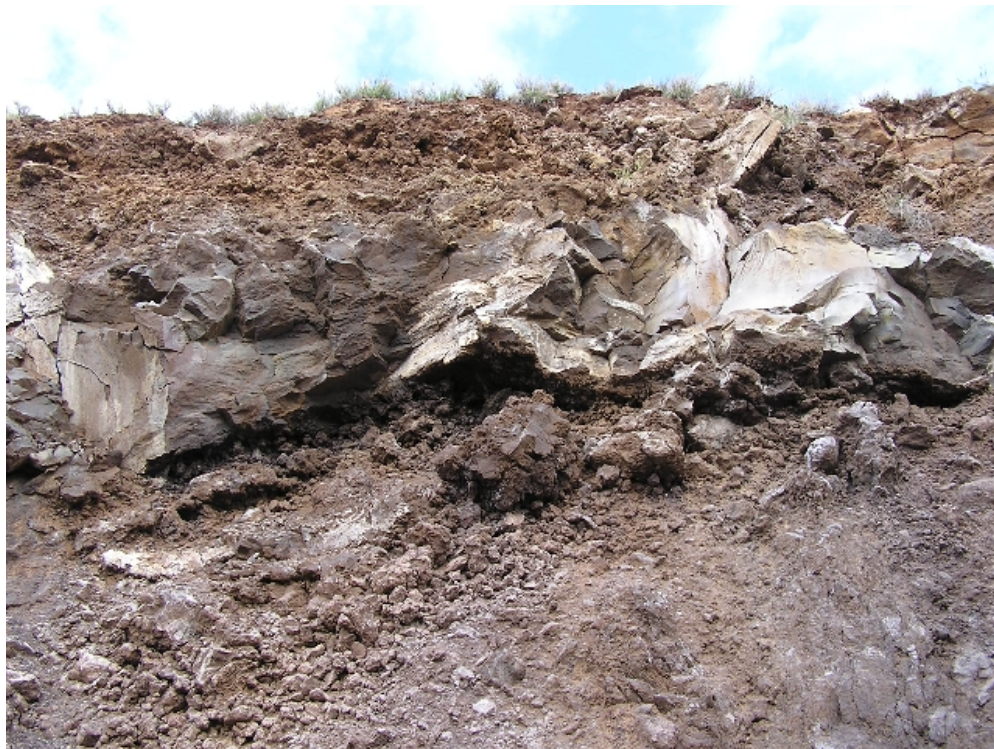
*Figure 12. Location 2, near Kohala Ranch Estates, Hwy 270. View from road of excavation in mixed massive a'a and clinker. See stereo 3-D photographs of Figure 13 and Figure 14.*

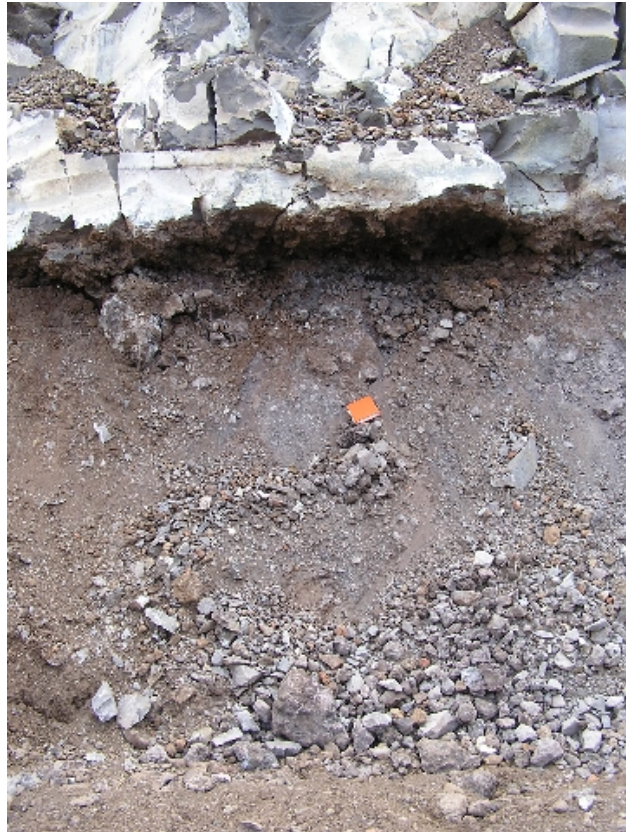
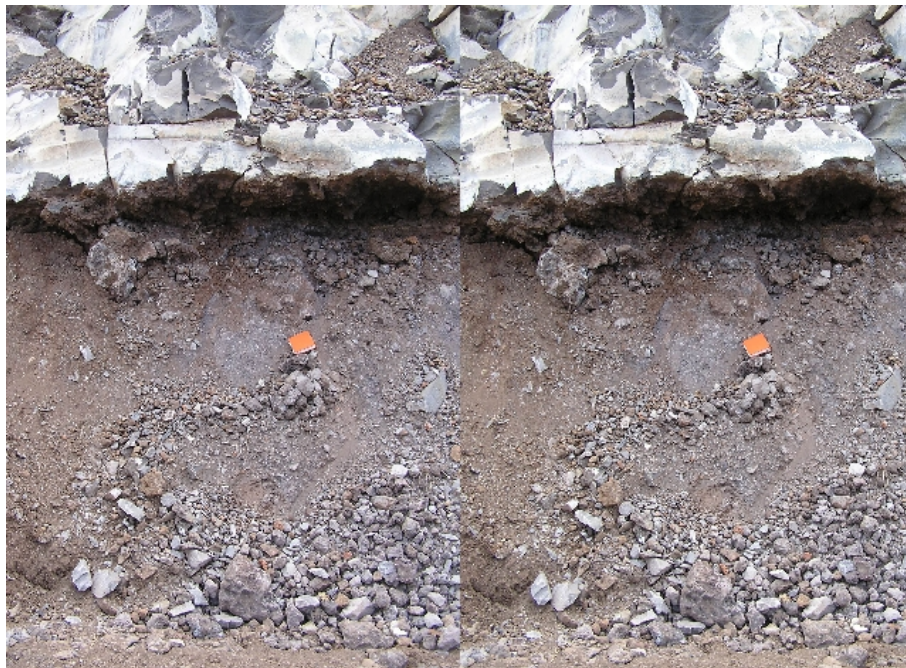
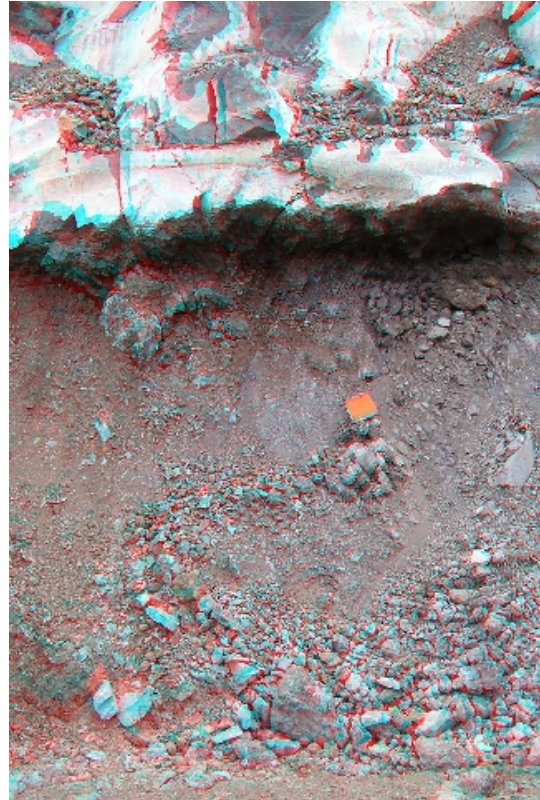
*Figure 15. Location 25, Hwy 270 north of Kawaihae. Cantilevered block of massive a'a basalt, undermined by clinker that raveled during the earthquakes. See 3-D stereo images of Figure 16 and Figure 17.*

*Figure 16. Location 25, Hwy 270 north of Kawaihae. 3-D stereo pair version of Figure 15. Cantilevered block of massive a'a basalt, undermined by clinker that raveled during the earthquakes.*

*Figure 17. Location 25, Hwy 270 north of Kawaihae. 3-D anaglyph stereo version of Figure 12. Cantilevered block of massive a'ā basalt, undermined by clinker that raveled during the earthquakes.*

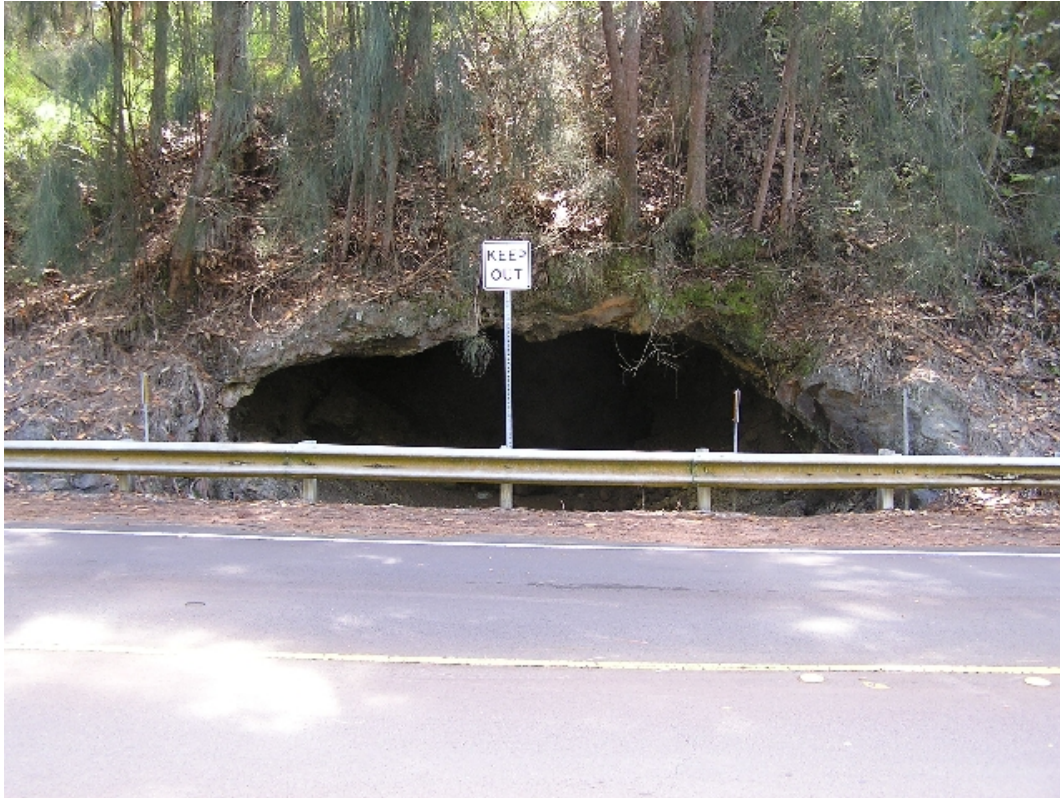
Lava tubes are common in pāhoehoe. One lava tube beside Highway 240 (Figure 23) showed little apparent disruption of wall and roof rock mass, despite a span of about 10 m, height of to 3 m and the fractured rock exposed at the cave surfaces. The degree of rock mass failures in caves and tunnels due to the earthquake is unknown. The vulnerability of tunnels to rockfall during large earthquakes is an important lifeline issue given that Statewide, many water supply routes occupy tunnels. Water supply to the Waipio area was interrupted by collapse of a major ditch in the Kohala area, according to news reports.

*Figure 23. Location 7, Hwy 240, near Kapulena, north of Honokaa. Lava tube with apparently little rock fall from roof and walls.*

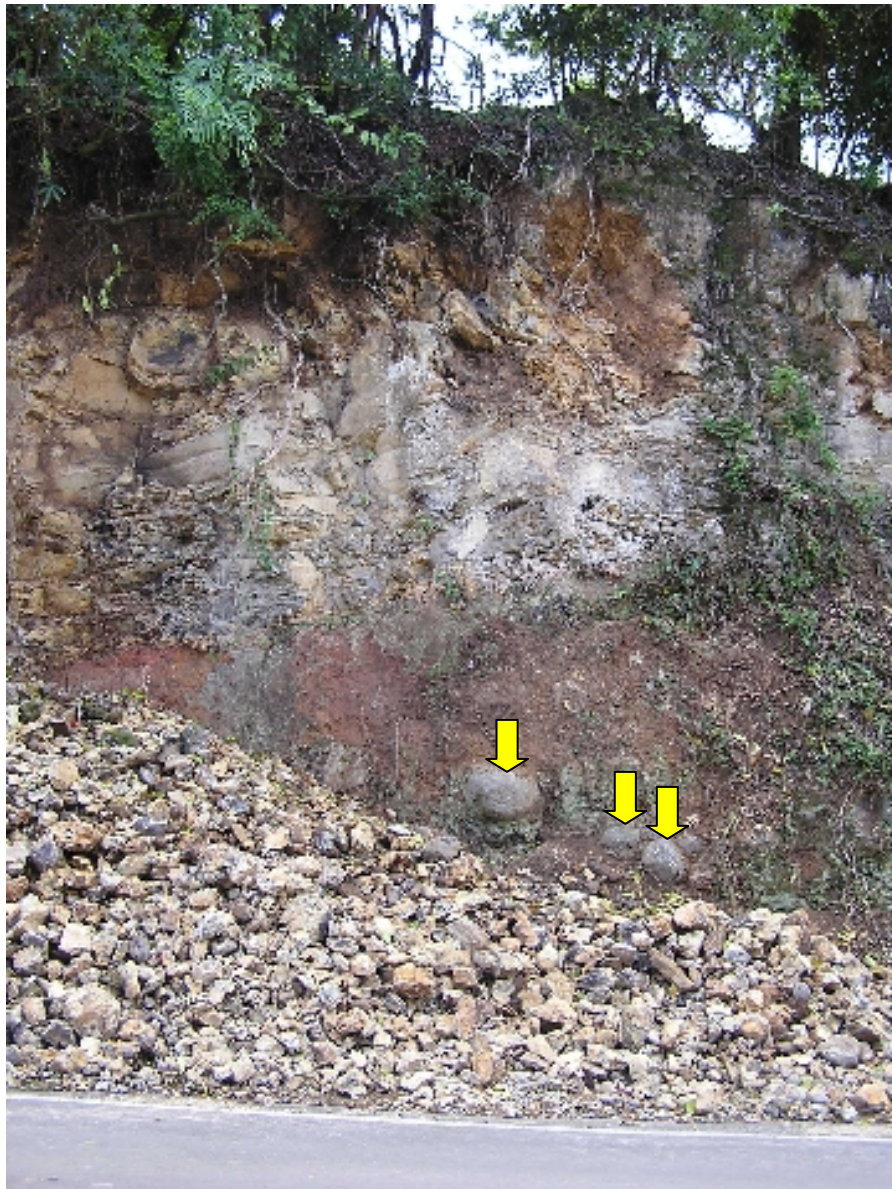
*Figure 24. Location 18, Hwy 270 at Makapala. Failure (pile of rock fragments at front) of stronger rock underlain by baked zone soil, with weathered corestone boulders (arrowed).*

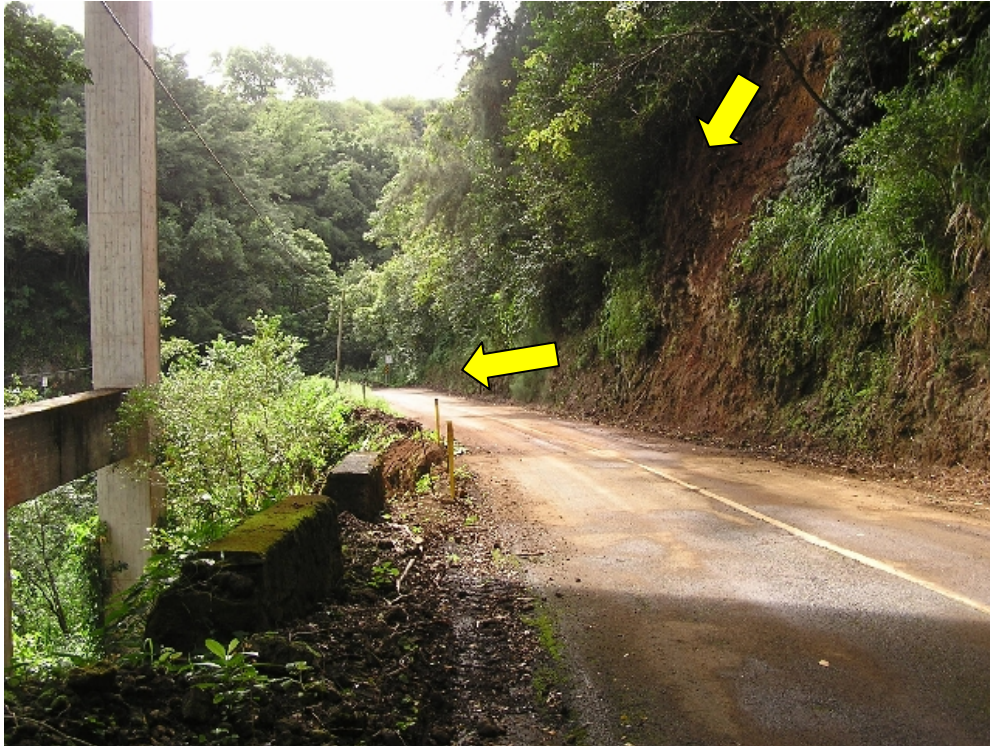
Figure 25. Location 4, old Hwy 11 near Ōōkala, Modern Hwy 11 viaduct above. As evident from red stains in road, soil failed onto and across across Road (arrows) from very steep road cut; typical of many such slides along this road.

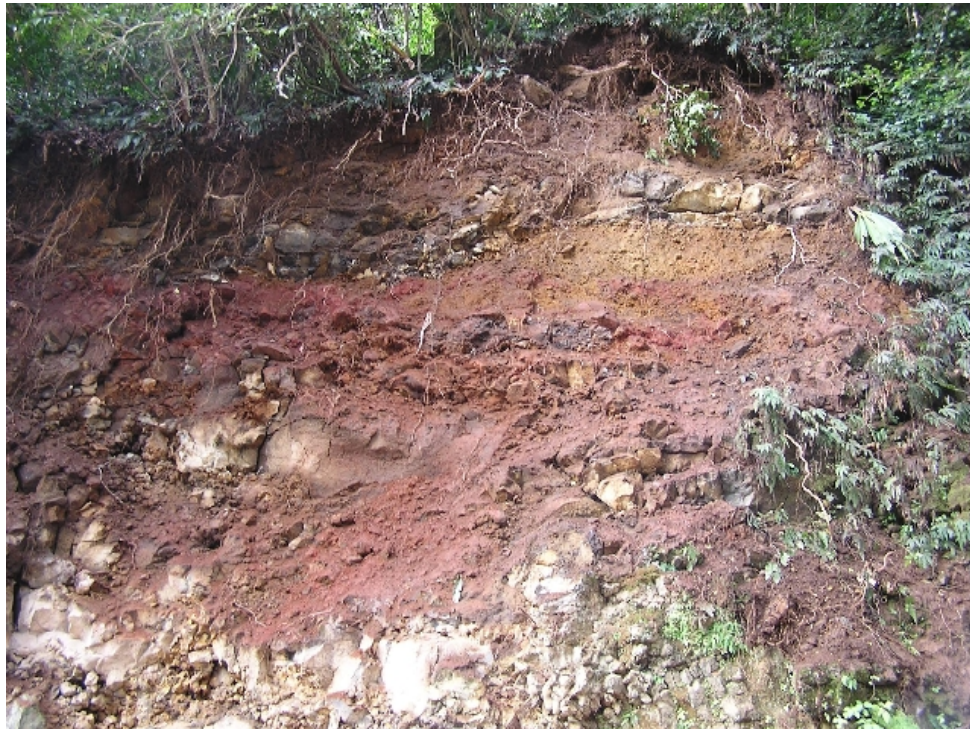
Composite slopes, where soil overlay rock or weathered rock, generally showed failure of the soil only (Figure 26). Where the soil/rock profile varied laterally at road cuts, failures predominated in the soil sections.

Figure 26. Location 4: old Hwy 11 near Ōōkala. Failure of soil above rock. Note inclusions of corestone rocks within soil.

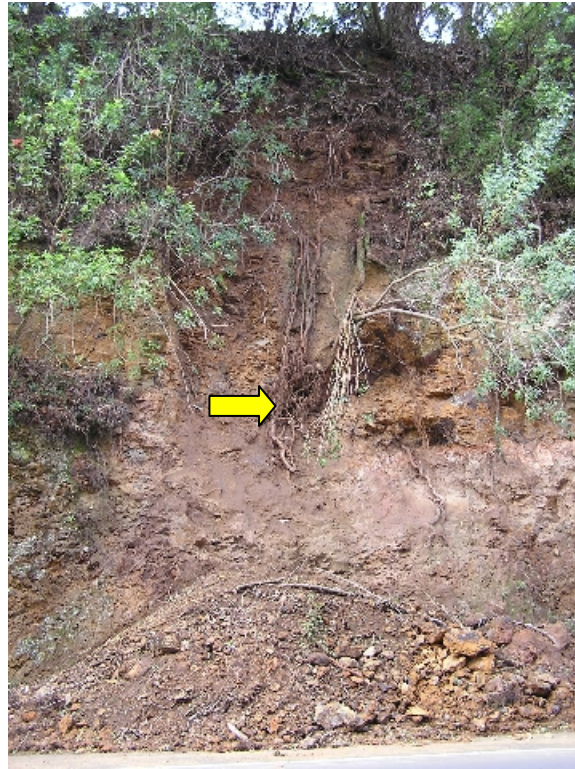
Weathered rock was often found to have failed along fractures occupied by tree roots. Where slopes had been stable long enough for tree roots to take hold in fractures, sections of the slopes peeled off to expose the roots (Figure 27, and Figure

*Figure 27. Location 16, Near Kapa'au (Kohala), Hwy 270. Tree roots (arrowed) within relict rock mass fractures degraded the stability of road cuts in soil.*

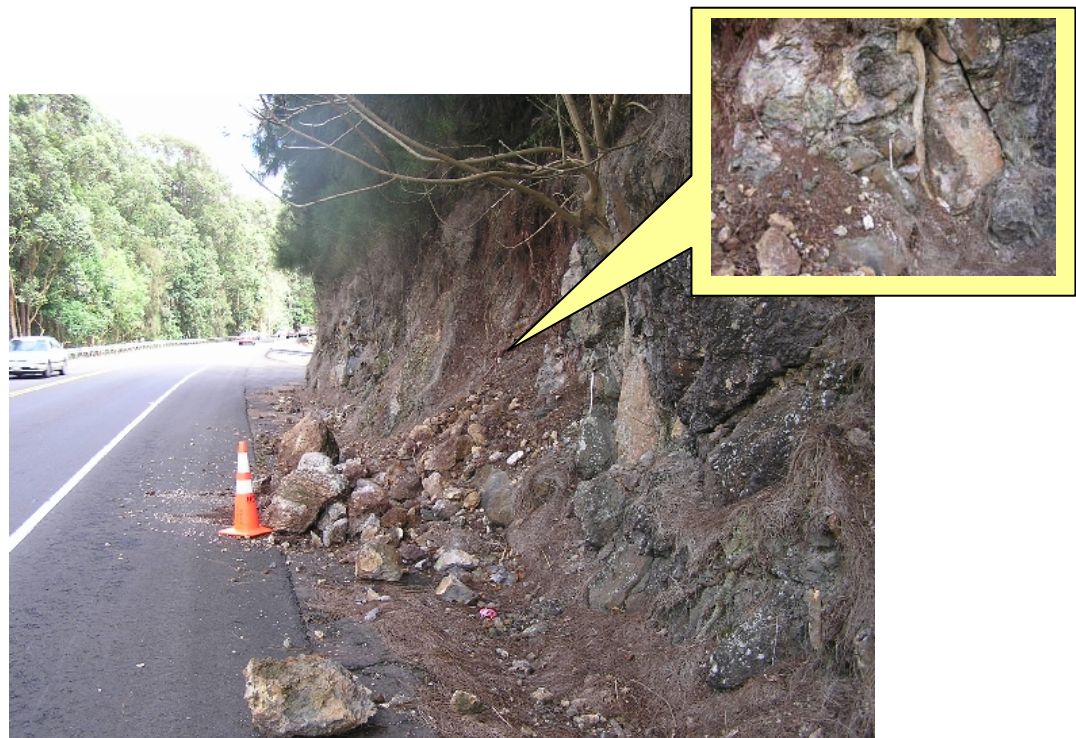
*Figure 28. Location 9, Hwy 19 near Honoka'a. Weathered rock. Fractures occupied by tree roots, as shown in insert.*

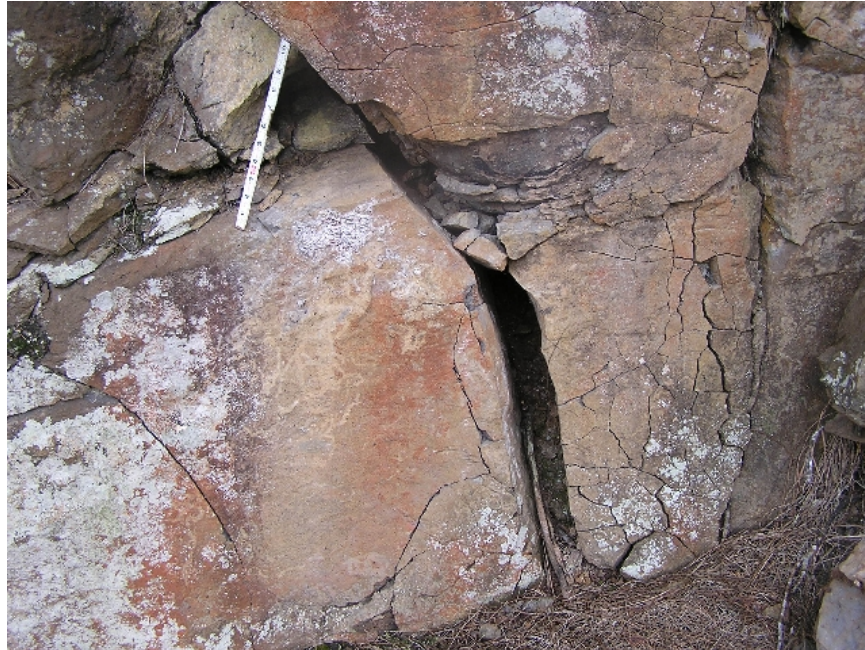
Figure 29. Location 9, Hwy 19 near Honoka'a. Wide fracture likely not caused by earthquake- note debris and tree root.

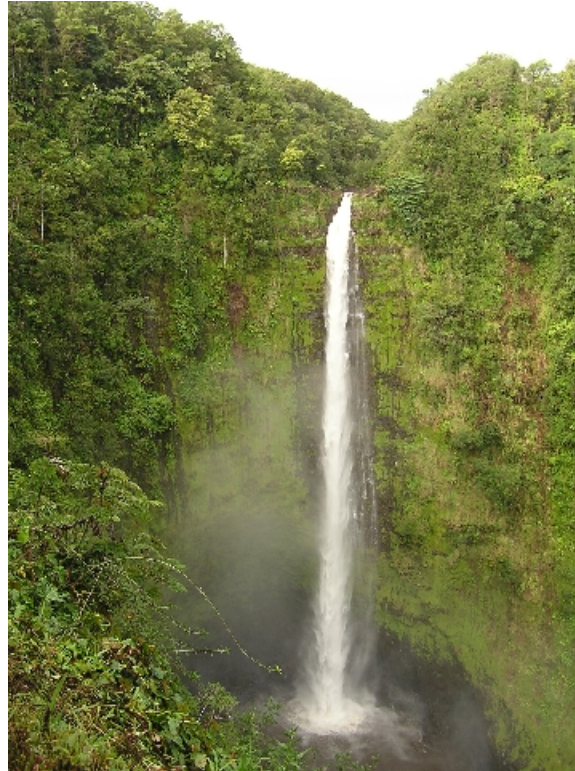
Apparently recent slides were observed on the cliff face of the Akaka Falls (Figure 30). Other earthquake effects at the State Park property were apparently limited to fallen trees and damaged hand railings.

Figure 30. Location 2, Akaka Falls, Hamakua Coast. Scars in the cliff face may not be attributable to the earthquakes.

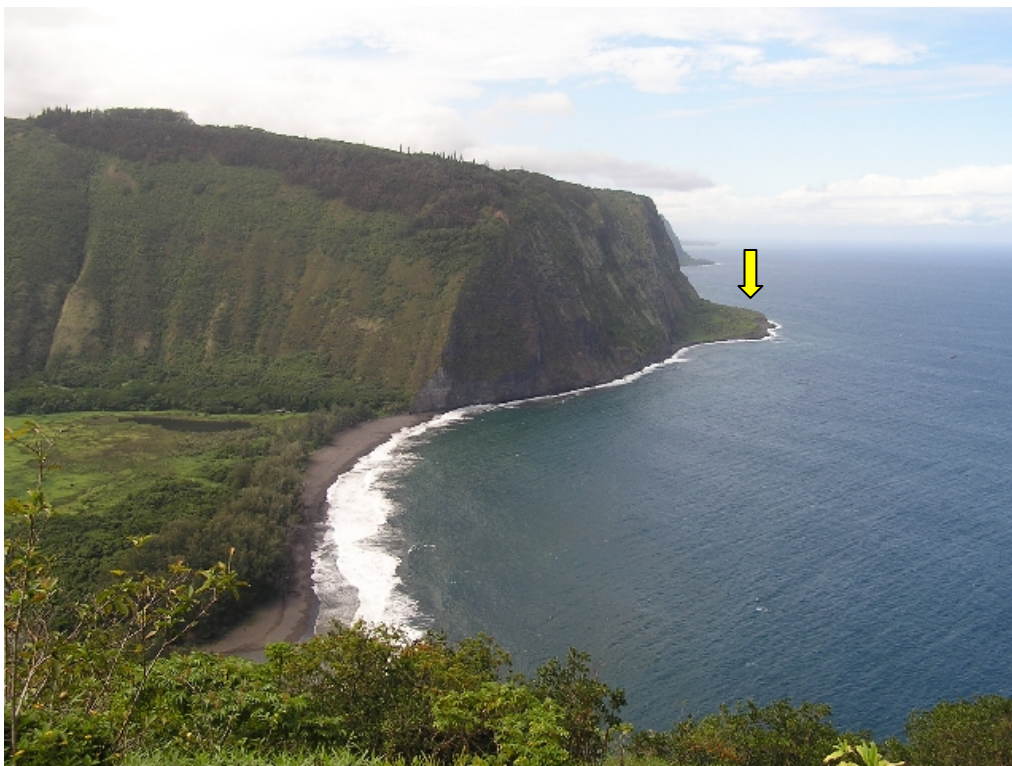
Figure 31. Location 8, Waipi'o Valley cliffs. Debris from an older slide (arrow) intrudes into the sea in the background. Scars in the closer, truncated spur are apparently not a result of the earthquakes since the water is not muddy.

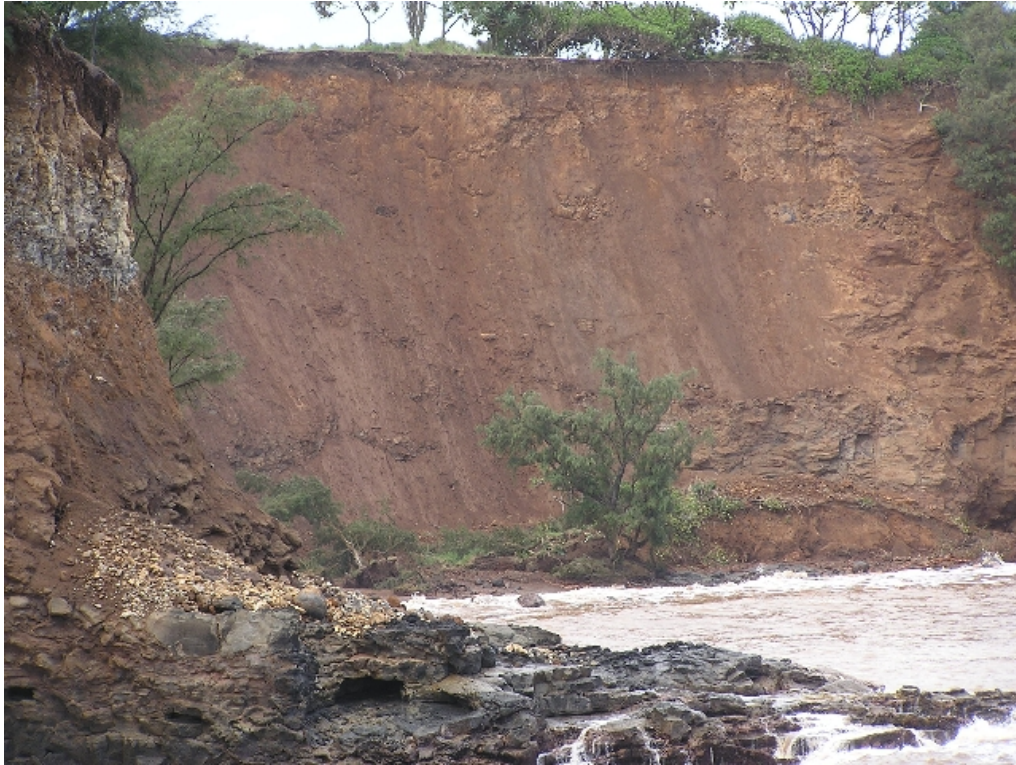
Figure 32. Location 19, Kēōkea Bay. Cliffs failed during the earthquake with displaced trees at base of slope and slide scars.

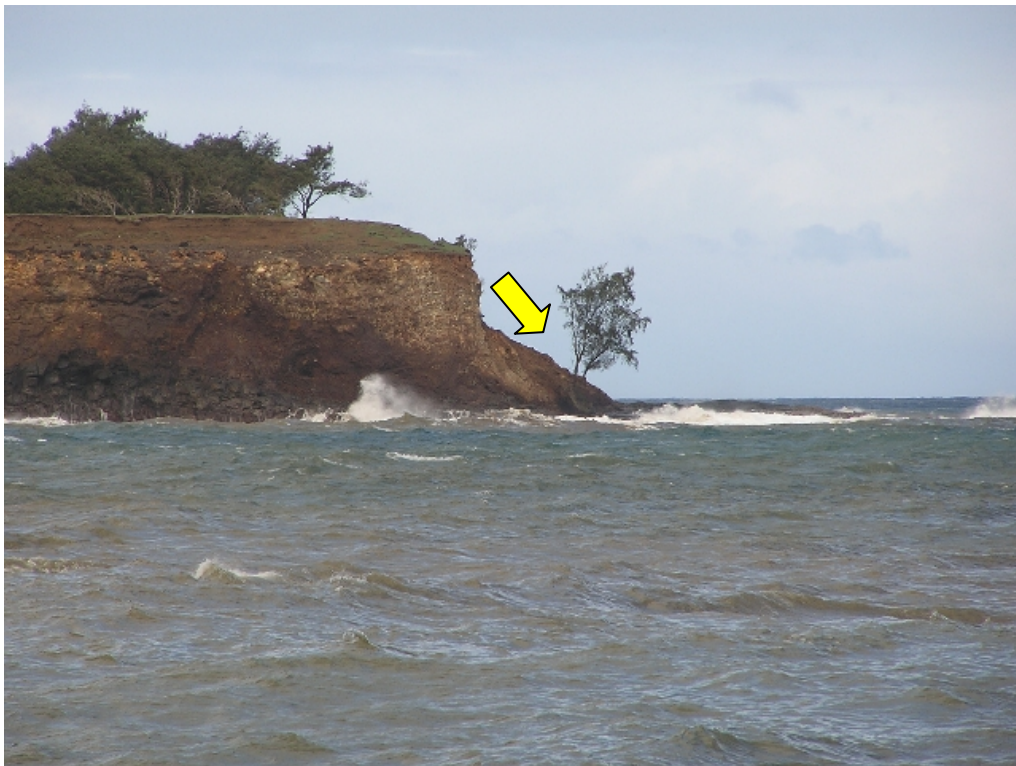
Figure 33. Headland to the northwest of Location 19, Kēōkea Bay. Cliff top slid into the ocean, indicated by the displaced tree and the mostly submerged toe debris.

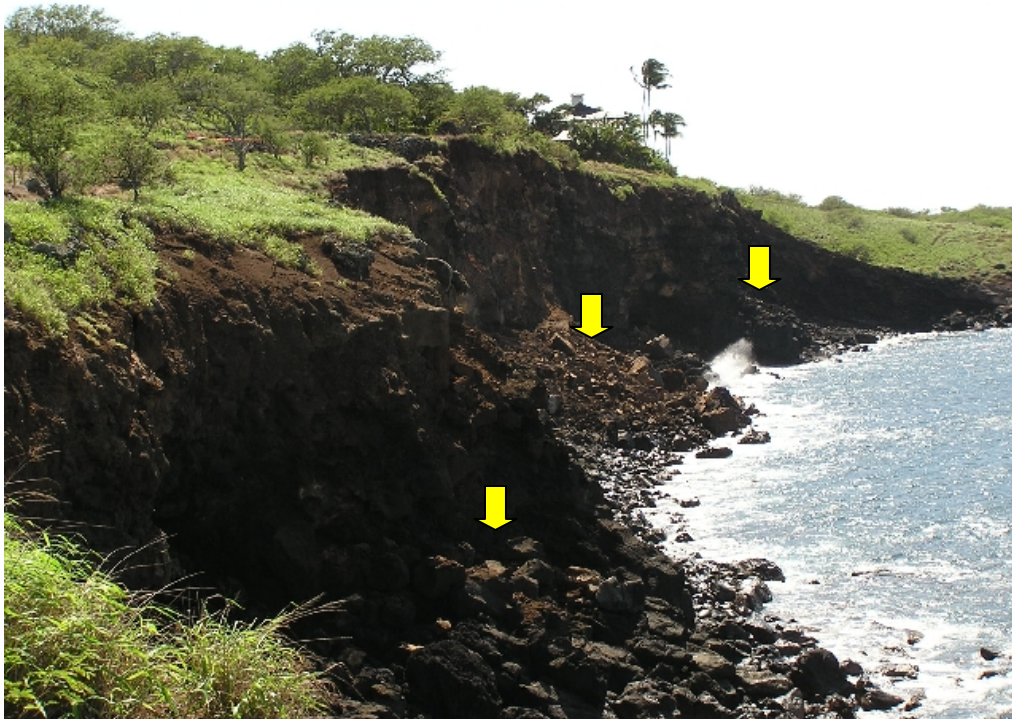
Figure 34. Location 23, failed cliffs (arrowed) south of Honoipu Landing (Ala Kuakini Trail).

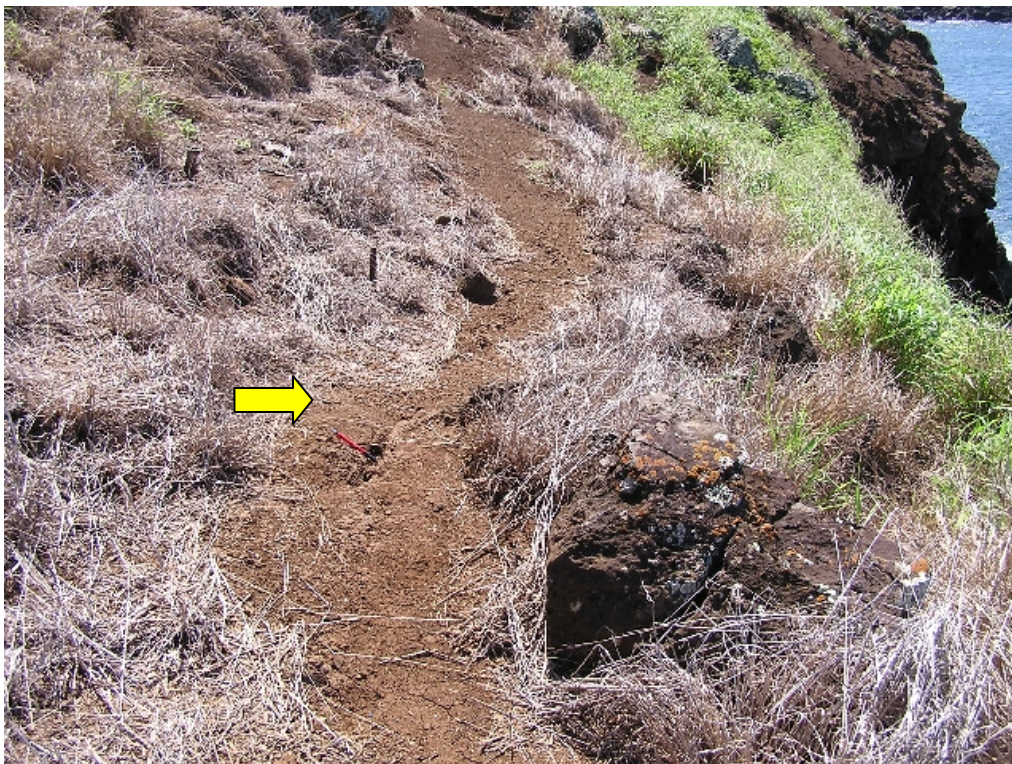
Figure 35. Location 23, Ala Kuakini Trail. Tension cracks behind cliff top (arrowed) in foreground.

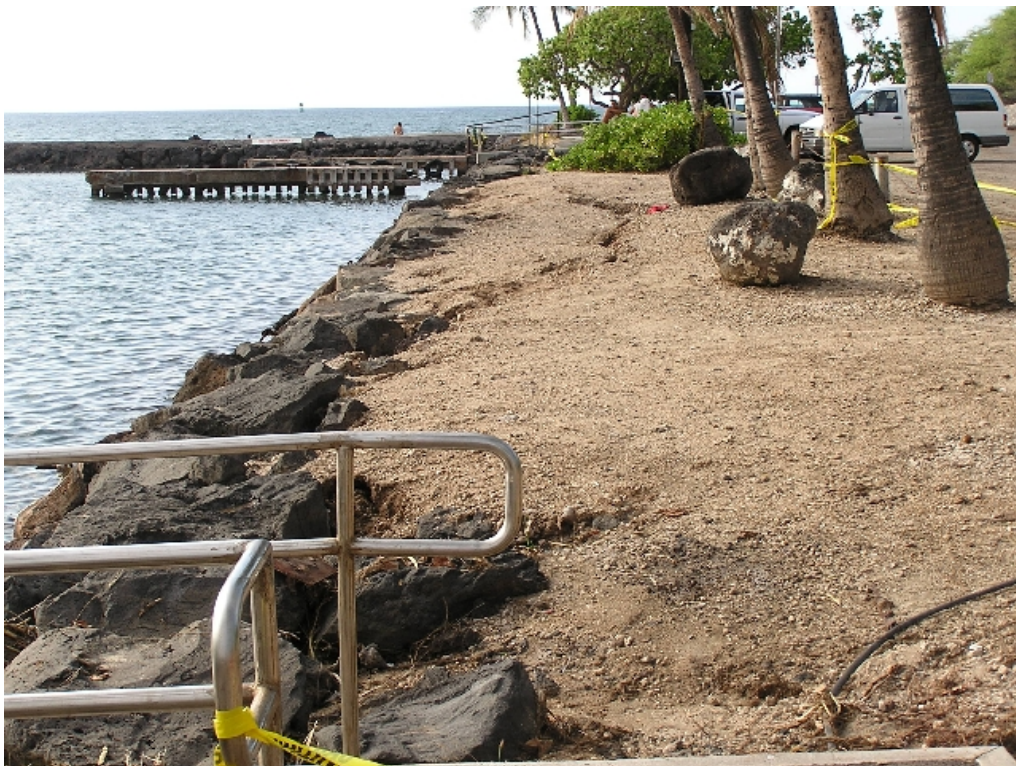
Figure 37. Location 27, Kawaihae Small Boat Harbor, showing arcuate ground crack resulting from lateral spreading.

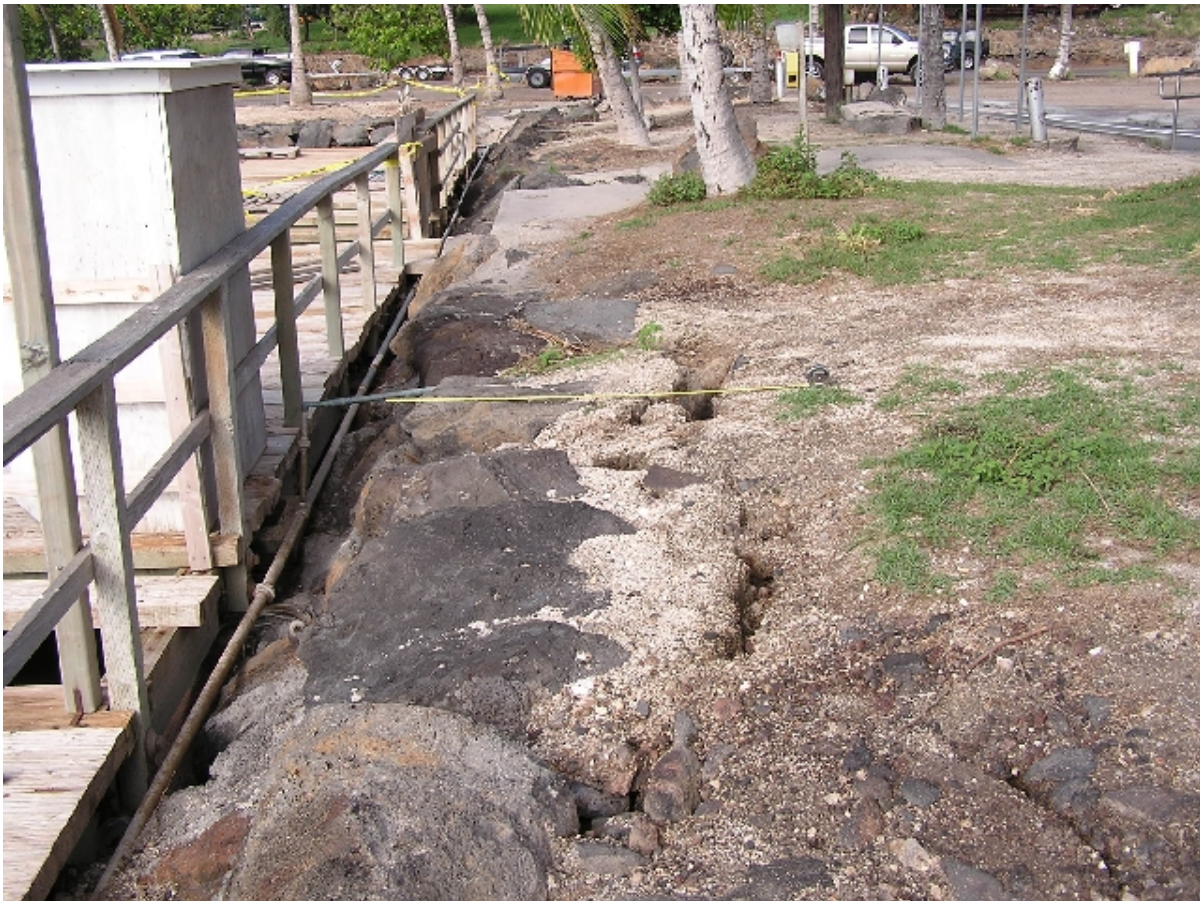
*Figure 38. Location 27, Kawaihae Small Boat Harbor. Lateral spreading, and damage to dock. Liquefied sand was ejected from the ground crack (white sand).*

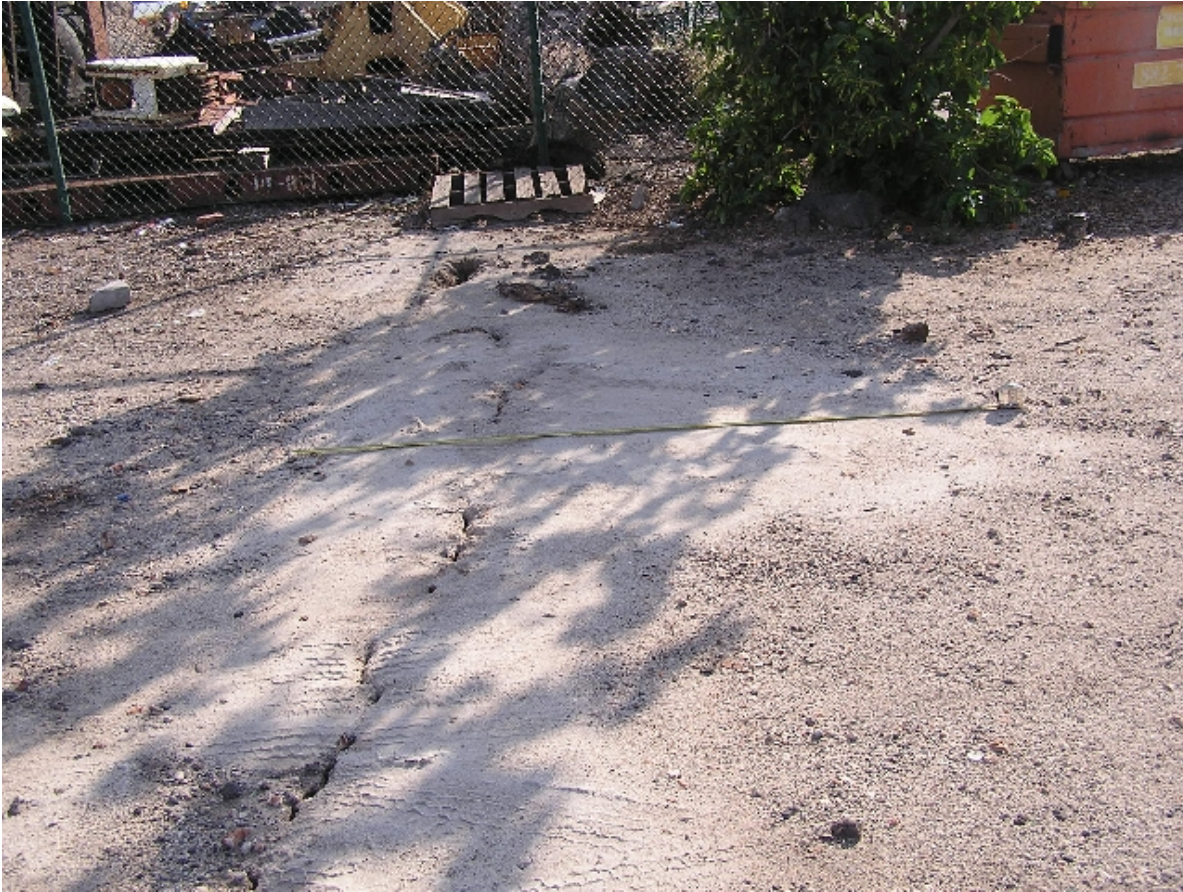
Figure 39. Location 27, Kawaihae Small Boat Harbor parking lot, adjacent boat yard at south side. Liquefied (white) sand was ejected from wide ground crack during the earthquake shaking.

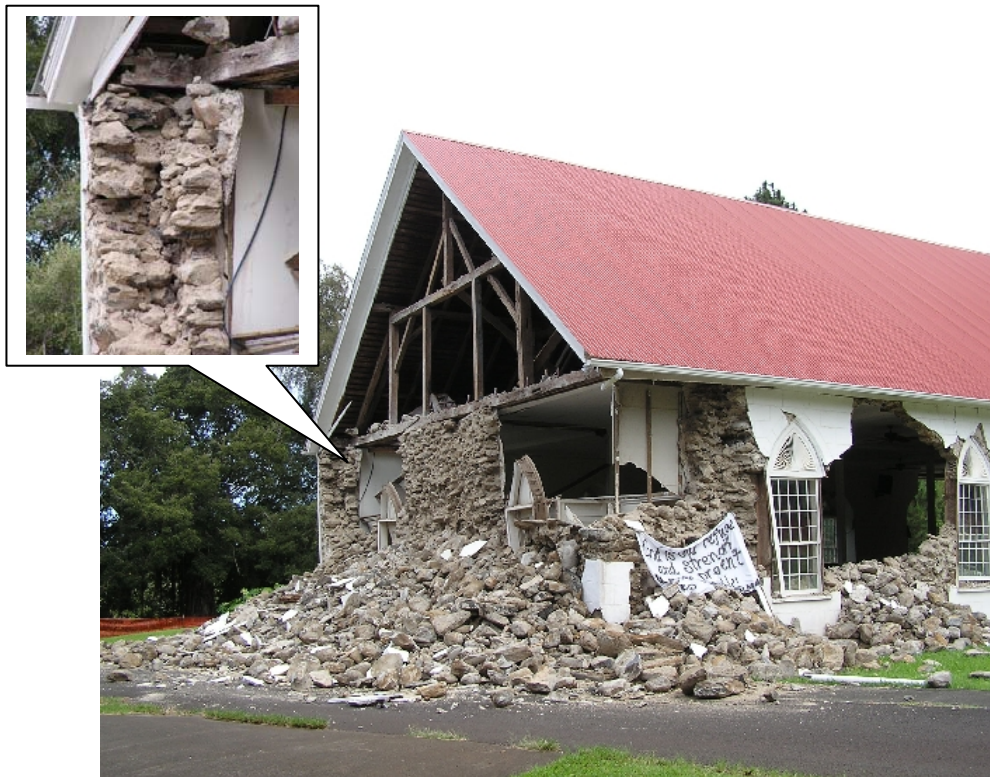
Figure 42. Location 21, Kalāhikiola Congregational Church, Kapa 'au. Weakly cemented stacked rock walls (inset) failed dramatically.

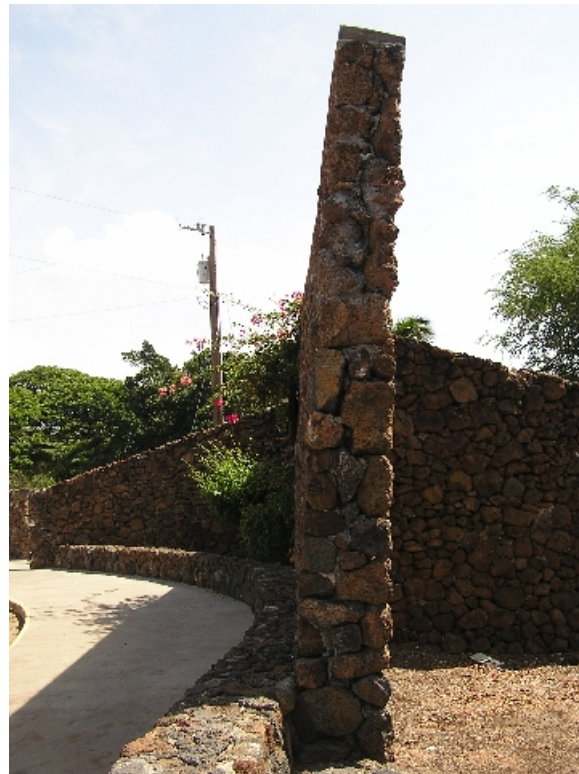
*Figure 43. Location 30, Spencer Beach Park, south of Kawaihae. Apparent earthquake damage of partially mortared rock wall: wall is bent.*

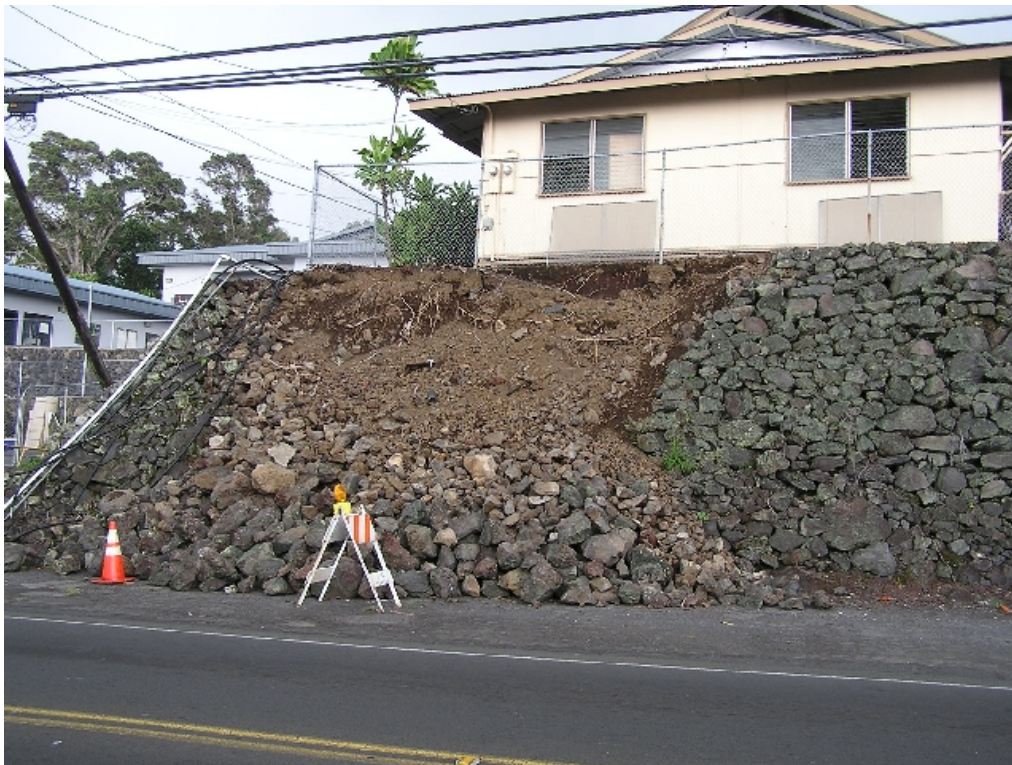
*Figure 44. Location 35, Captain Cook. Failed stacked rock retaining wall. 3*

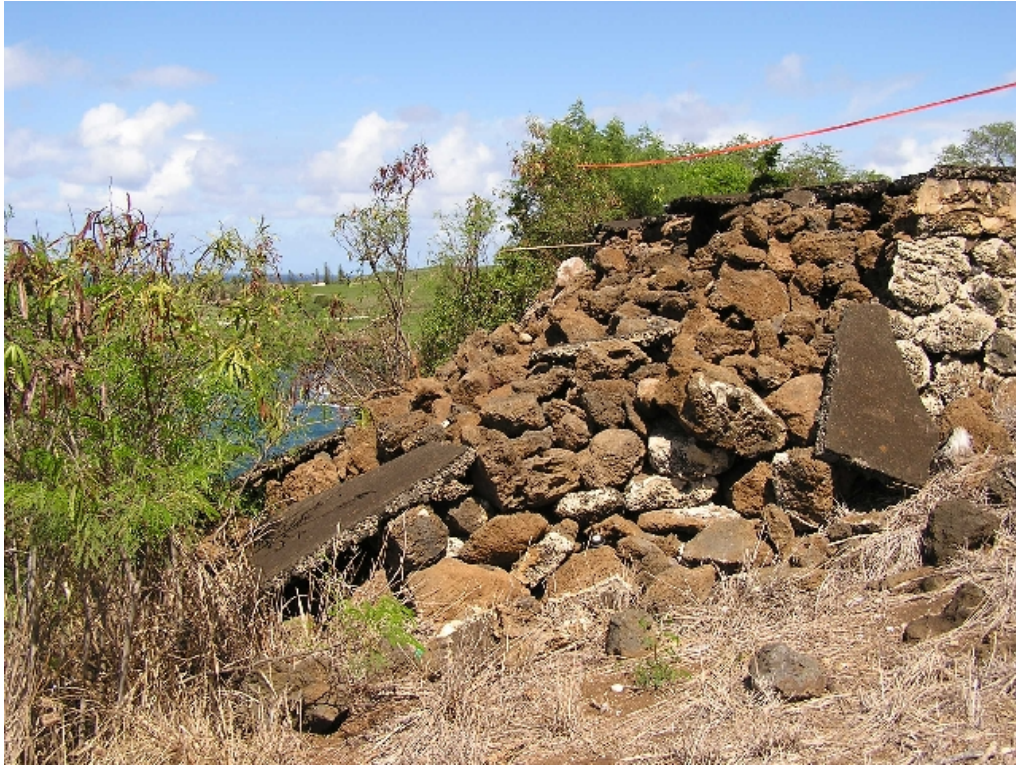
*Figure 45. Location 23. Collapse of dry stacked rock wall supporting paved parking area for shoreline access at Puakea Ranch end of trail to Honoipu Landing, due to cliff failures undermining wall foundation.*

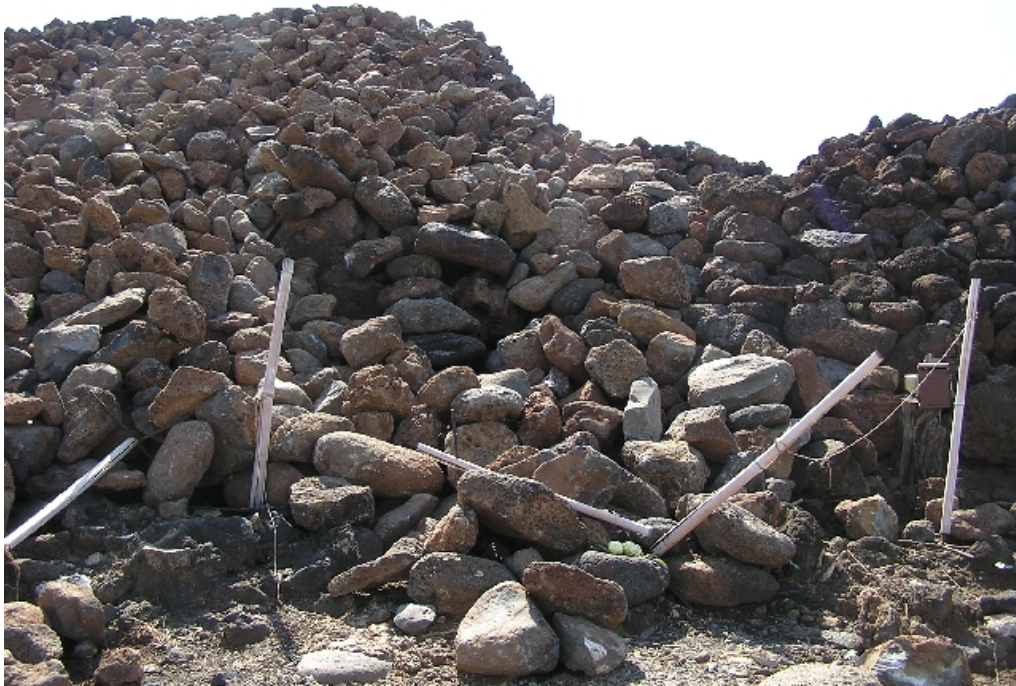
Figure 49. Location 29, Pu'ukoholā heiau, north side: Earthquake caused collapse of access step structure.

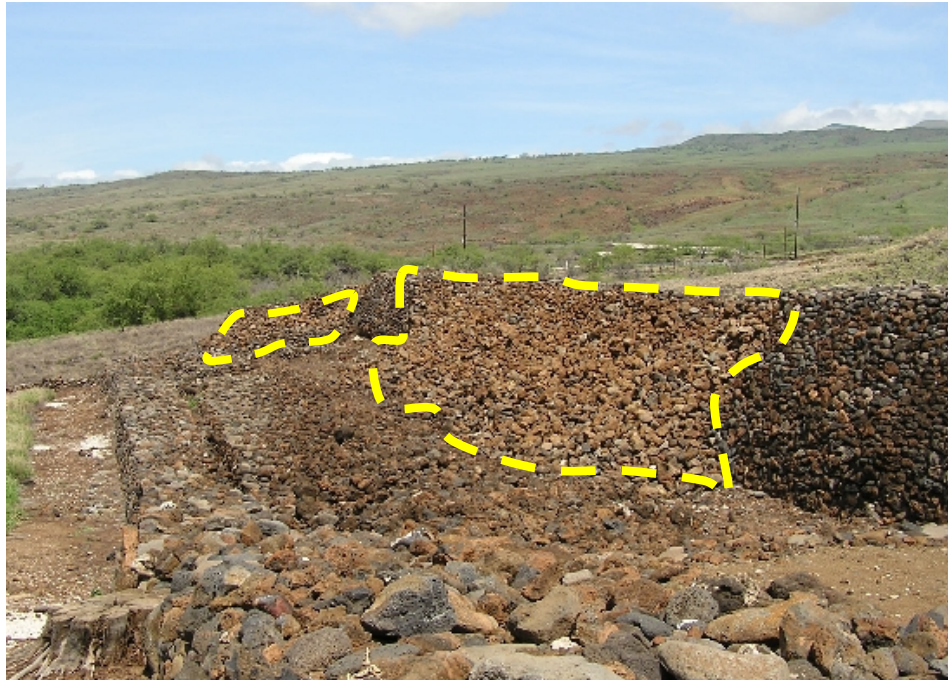
*Figure 51. Location 29, Mailekini heiau. Significant raveling and slumping of interior face of the eastern wall (outlined).*
