# Geological Engineering Reconnaissance of Damage Caused by the October 15, 2006 Hawaii Earthquakes

**Edmund W. Medley**, Senior Consultant, Geosyntec Consultants Inc., Oakland, CA, USA, Email: [emedley@geosyntec.com](mailto:emedley@geosyntec.com)

**ABSTRACT:** *Two strong earthquakes shook the Island of Hawaii, Hawaii on the morning of October 15, 2006. Peak Ground Accelerations reached 1.2g, and earthquake felt intensity of MMI VIII. Earthquake damage of public and private property totaled about \$200 million, with no fatalities. Geological engineering reconnaissance of earthquake damage resulting from the earthquakes focused on the apparent relationships between the observed geology and the damage. Some roadway embankments failed causing temporary closure of Island highways. Landslides were common at steep coastal cliffs. Liquefaction and lateral spreading occurred in coralline fill at Kawaihae Harbor. There were extensive road cut failures, in which the performance of road cuts in soil slopes was generally better than that of rock slopes. Where a'a clinker underlay massive a'a basalt blocks in road cut slopes, the loose clinker dislodged thereby undermining the blocks, and ca

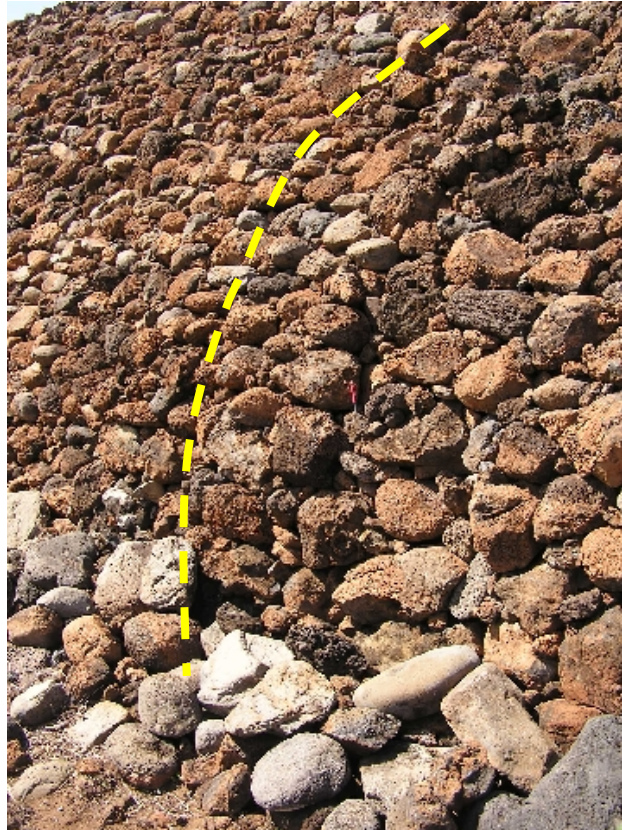
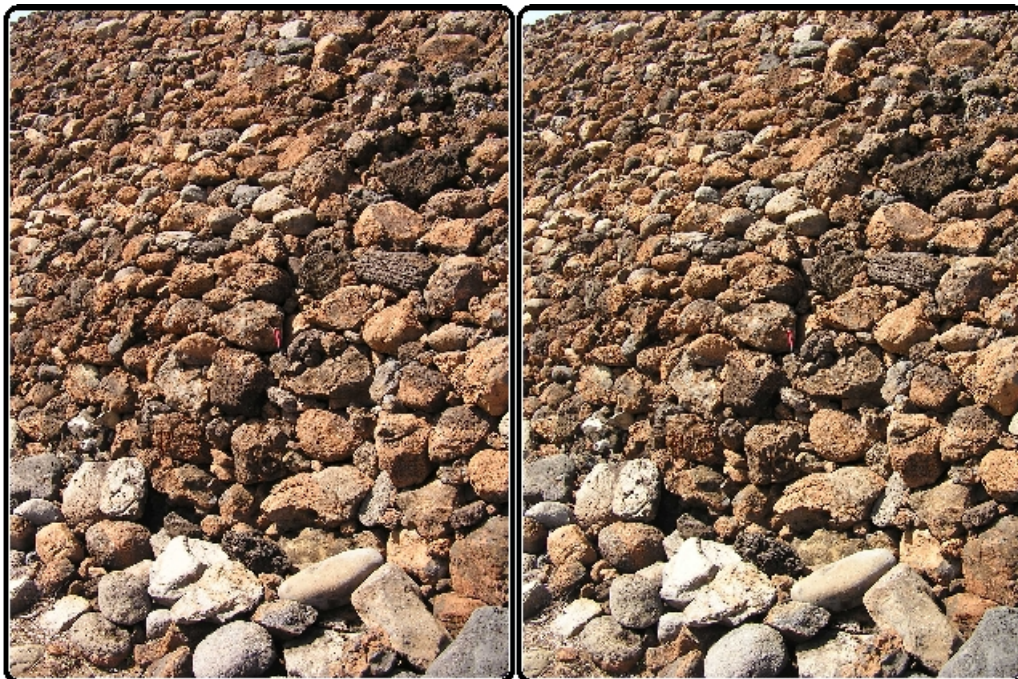
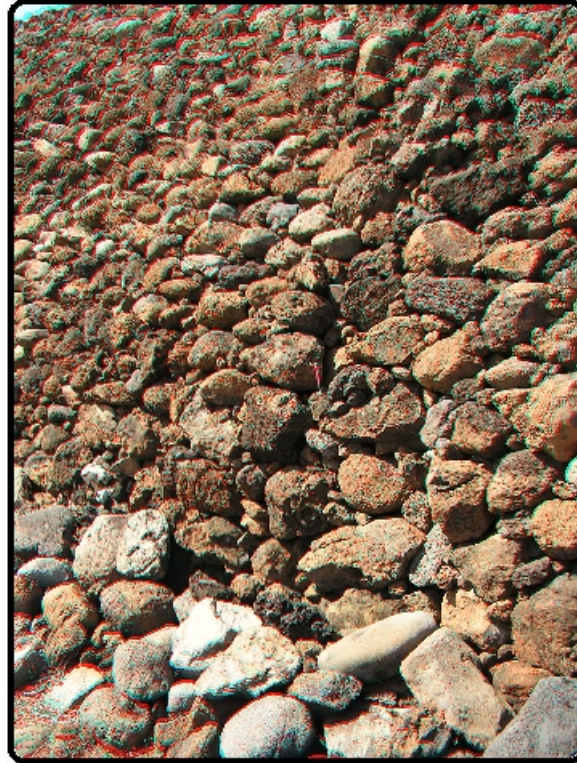
*Figure 53. Location 29, NE corner Pu'ukoholā Heiau. Bulging of rock face approaches 90 degree inclination as indicated by yellow line. Bulge is clearly seen in 3-D stereo versions of Figure 54 and Figure 55.*

*Figure 54. Location 29, bulge at NE corner of Pu'ukoholā heiau. 3-D stereo pair version of Figure 53.*

*Figure 55. Location 29, bulge at NE corner of Pu'ukoholā heiau. 3-D anaglyph stereo version of Figure 53.*

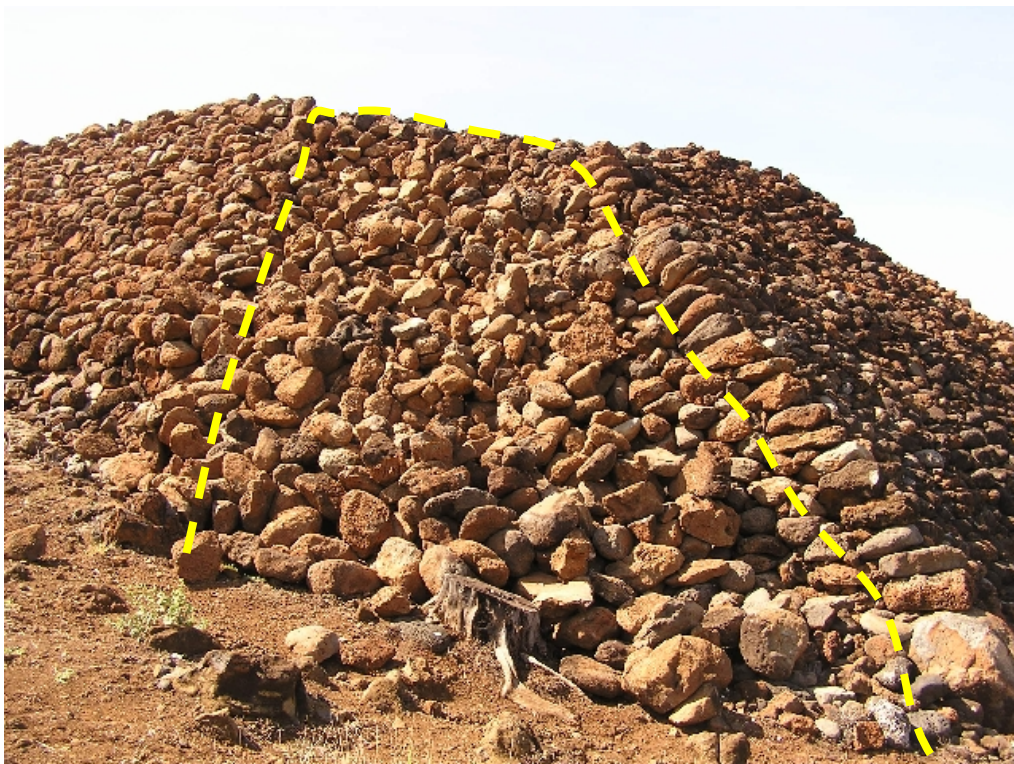
*Figure 56. Location 29, Pu'ukoholā heiau, northeast corner. Dashed lines indicate boundary of ravel zone.*

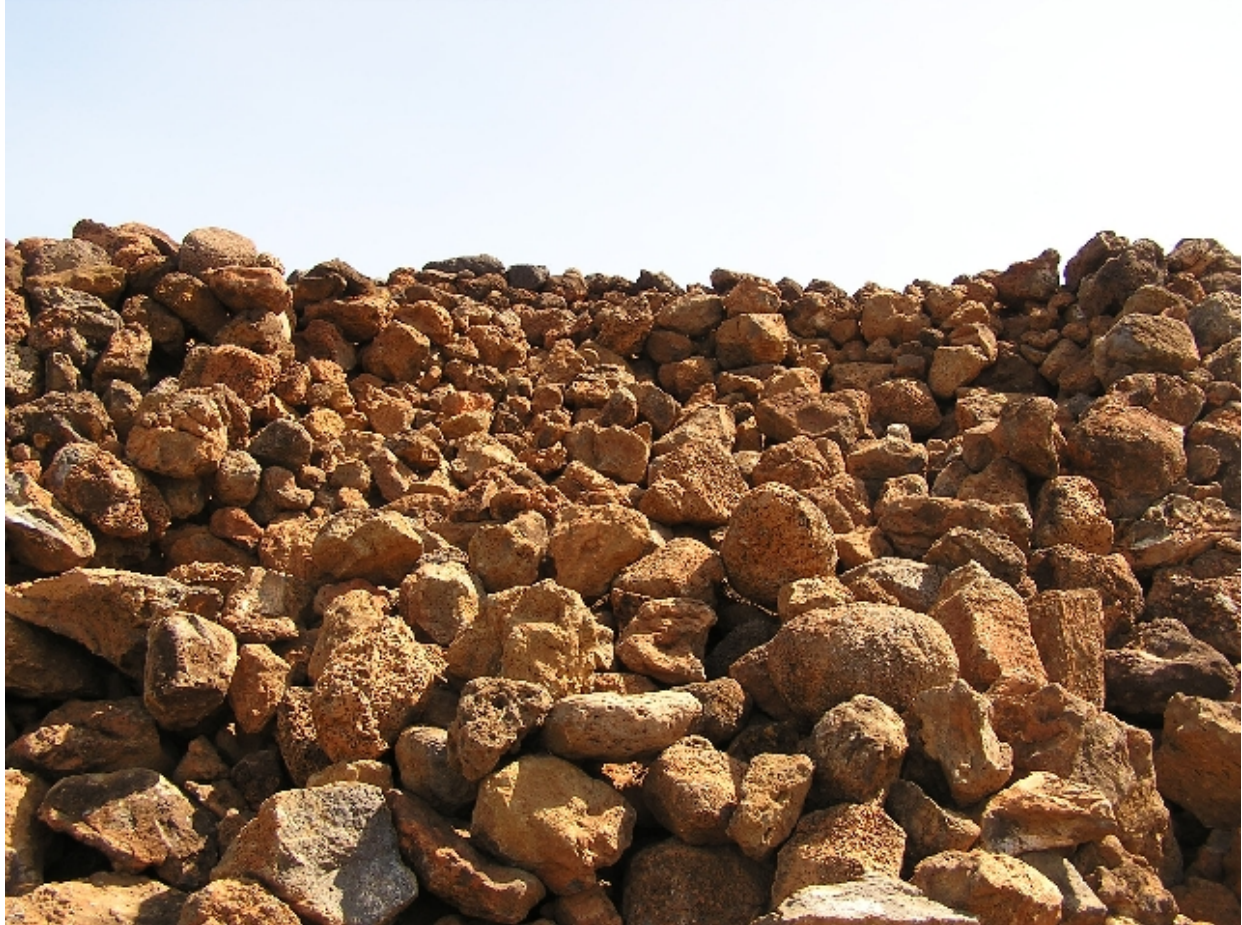
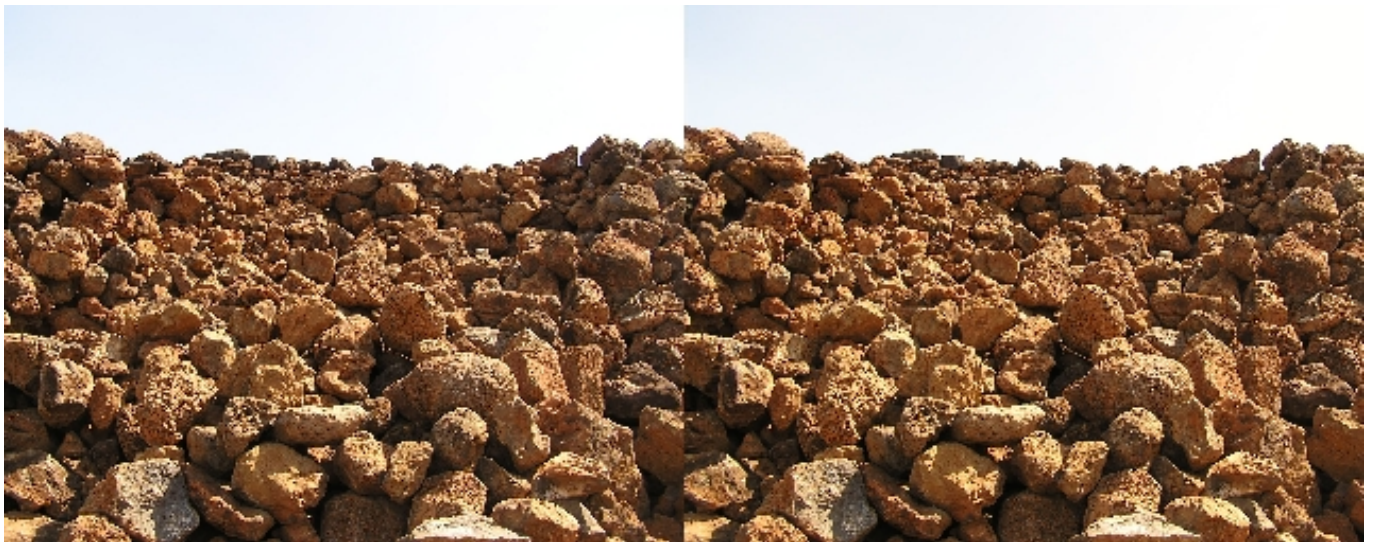
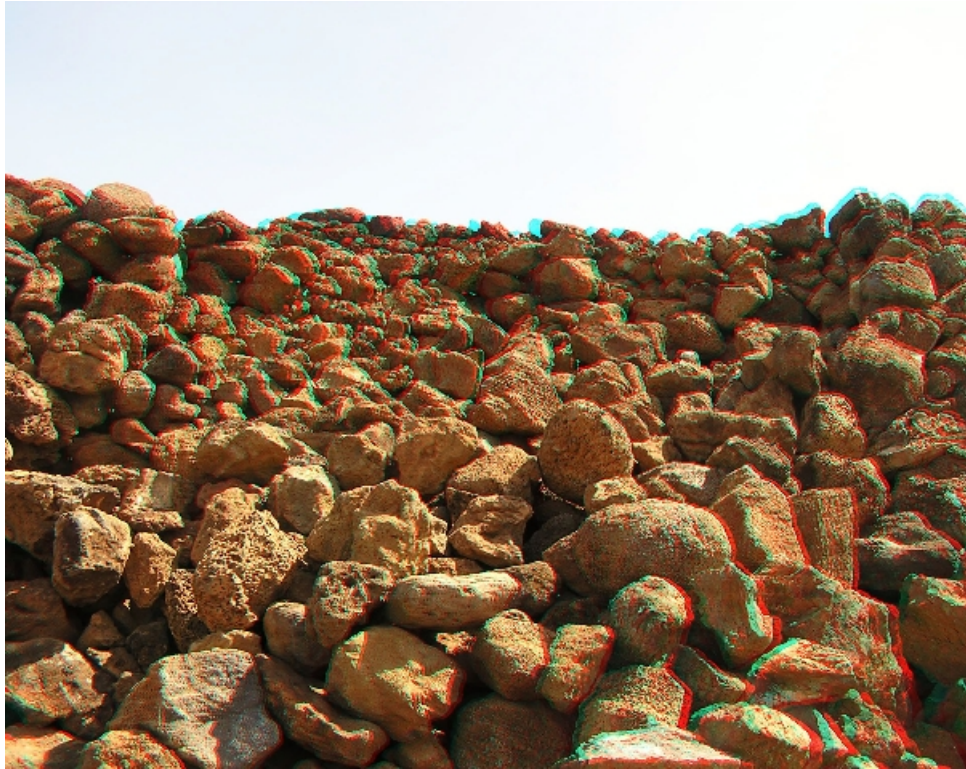
*Figure 57. Location 29, slump failure in high rock wall of Pu'ukoholā heiau, west side.  
See 3-D stereo images of Figure 58 and Figure 59.*

*Figure 58. Location 29, slump failure in high rock wall of Pu'ukoholā heiau, west side.  
Stereo pair 3-D version of Figure 57.*

Figure 59. Location 29, slump failure in high rock wall of Pu'ukoholā heiau, west side.  
3-D anaglyph stereo version of Figure 57.

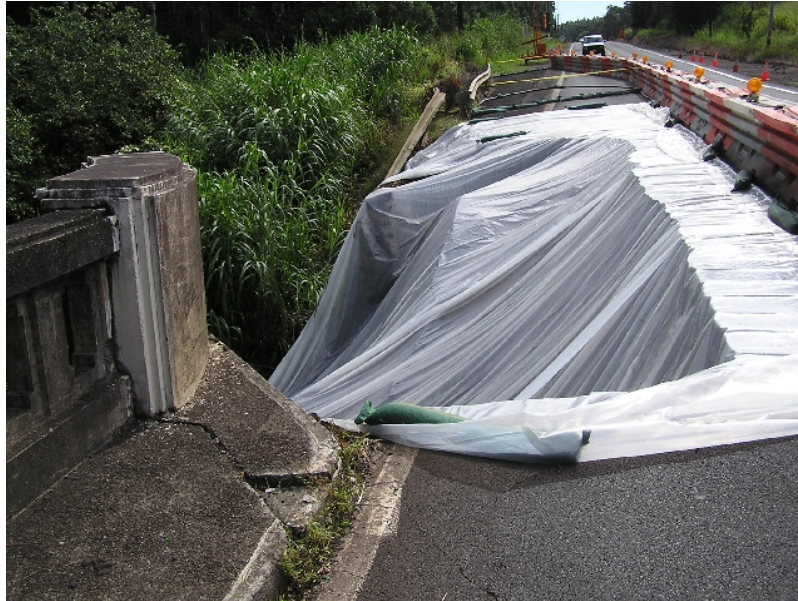
*Figure 61. Location 6, Mile Post 35, Hwy 11 near Pa’auilo.  
Failure of fill at east side of southern approach to bridge.*

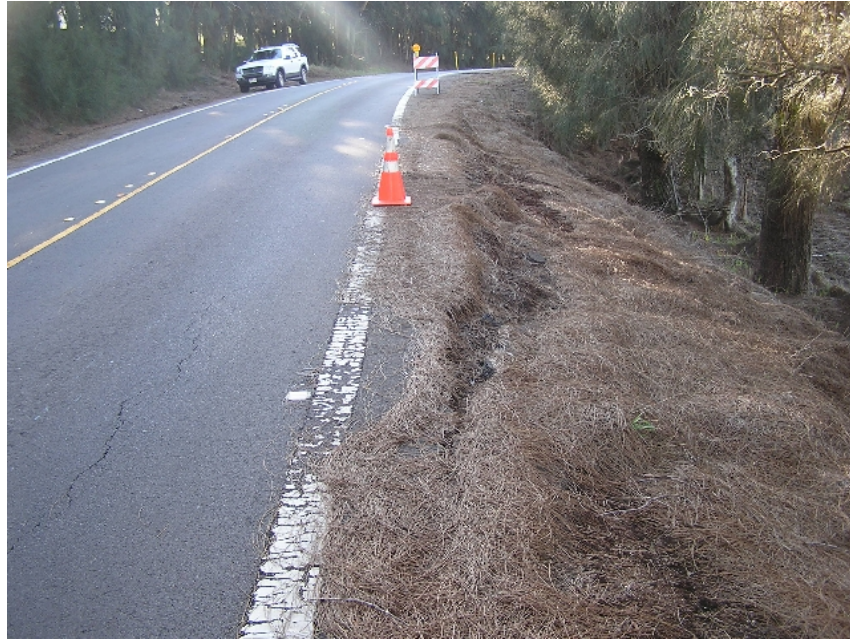
Figure 62. Location 15, north of Mile Post 9.4 Hwy 250. Slump failure of embankment on down slope side of road.

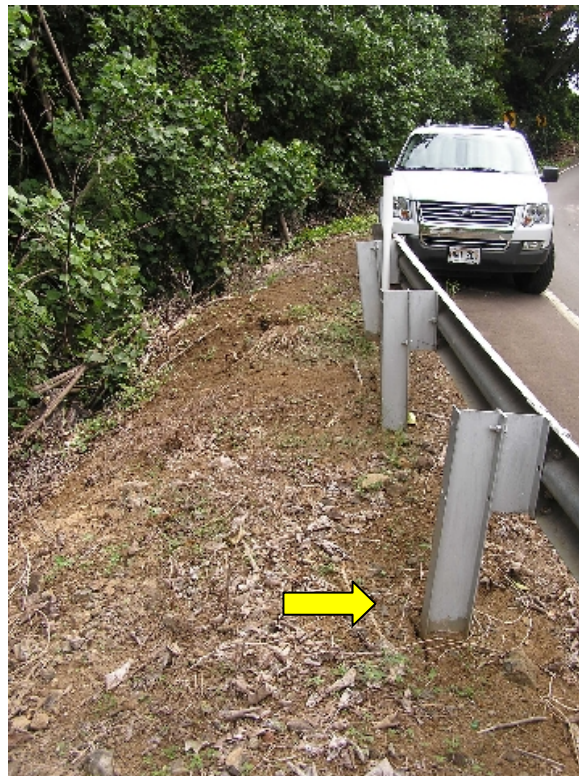
Figure 63. Location 18, Hwy 270 near Makapala, down slope side. Arrow indicates tension cracks and short head scarp 30 cm high at crest of steep and high fill slope.

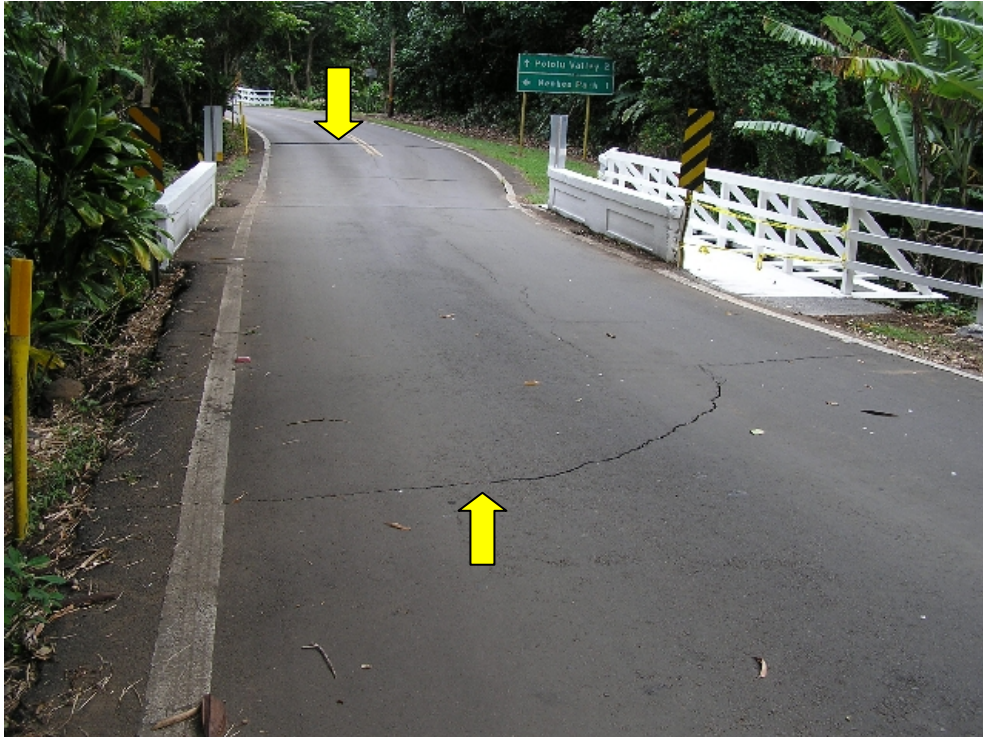
*Figure 64. Location 20, bridge at approximately Mile Post 28, Hwy 270. Asphalt pavement cracked at approximately the cut/fill transitions of underlying subgrade.*

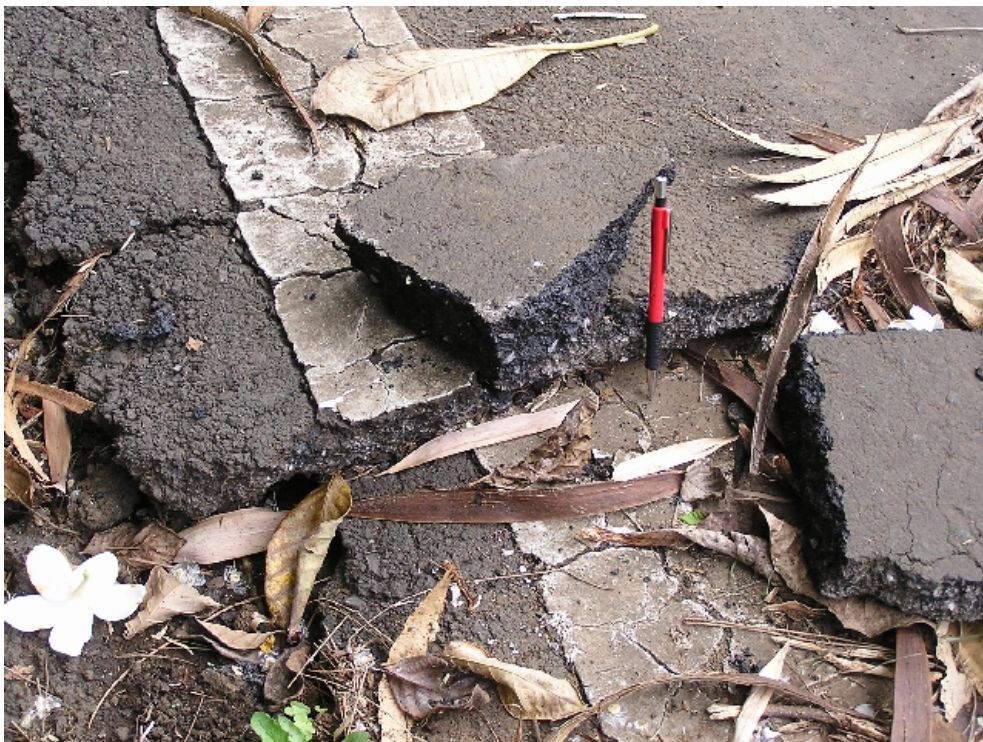
*Figure 65. Location 20, bridge at approximately Mile Post 28, Hwy 270. Thrusting of asphalt concrete pavement.*

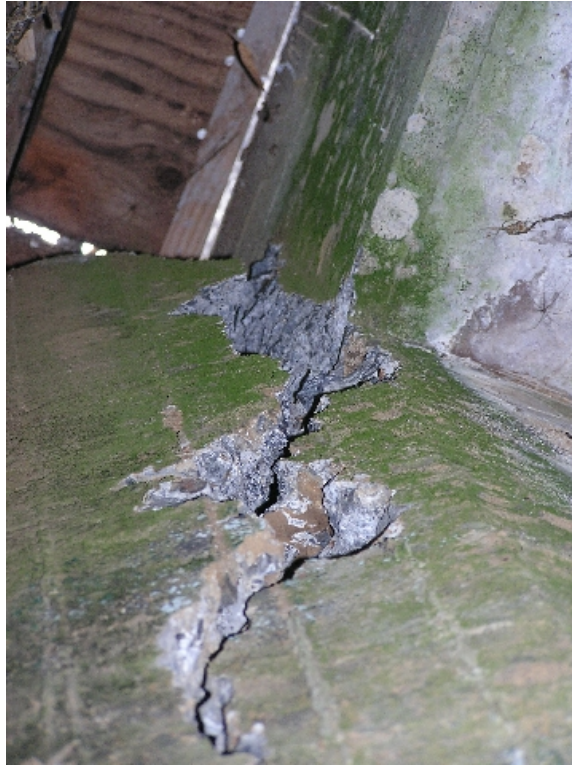
*Figure 66. Location 20, bridge at approximately Mile Post 28, Hwy 270. At SW corner of bridge, looking upward at wooden plank sidewalk above. Fresh spalling of bridge abutment headwall at old, pre-existing cracks.*

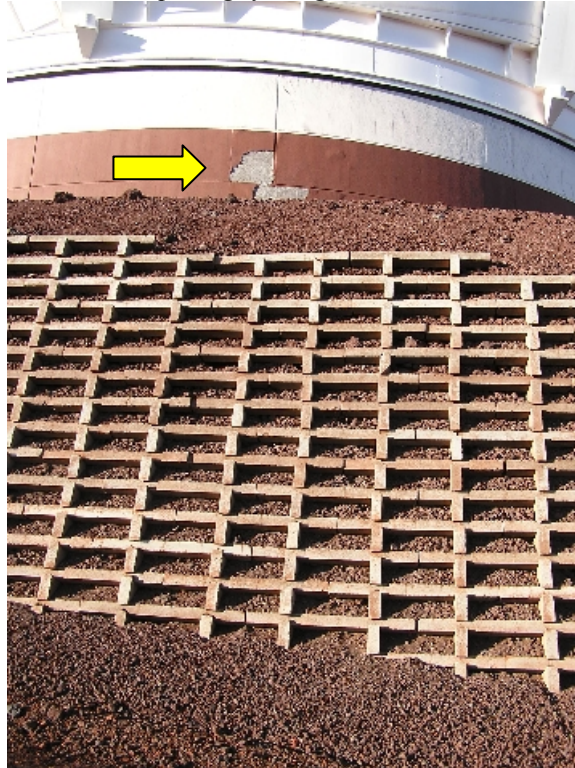
*Figure 67. Location 28, Keck Observatory, Mauna Kea summit. No apparent distress to high embankment beside the observatory. Spalled stucco evident at two places on the exterior wall of the building (one arrowed).*
