Geological Engineering Reconnaissance of Damage Caused by the October 15, 2006 Hawaii Earthquakes

Edmund W. Medley, Senior Consultant, Geosyntec Consultants Inc., Oakland, CA, USA, Email: emedley@geosyntec.com

KEYWORDS: Geological Engineering, Hawaii, Earthquake Damage, Rock Mass, Basalts, Rock Block Structures

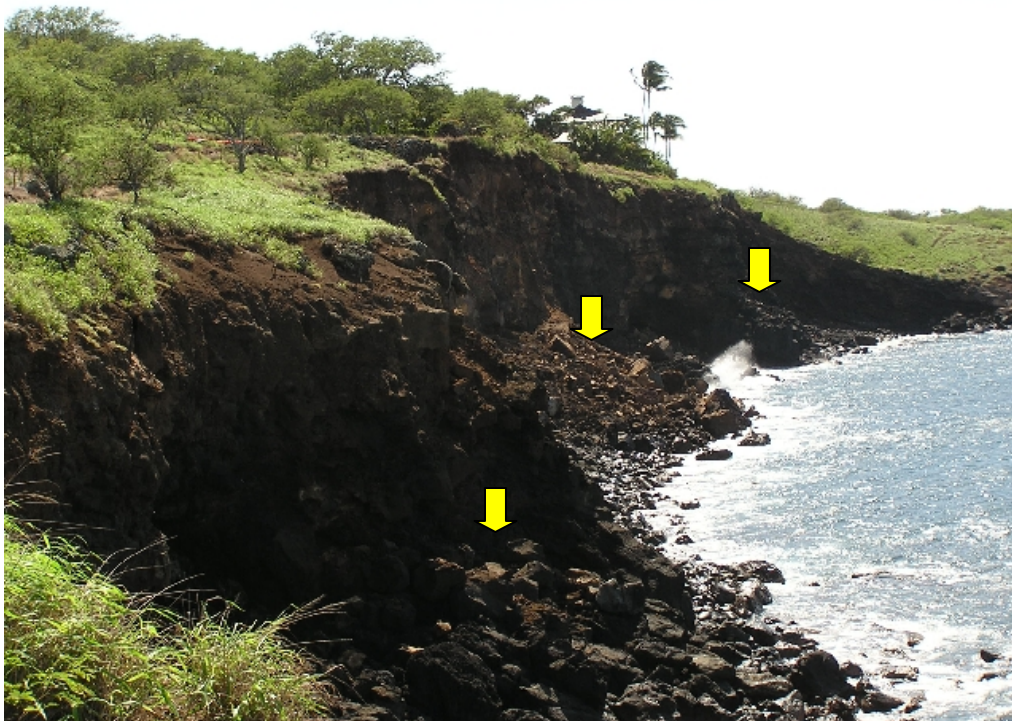
Figure 34. Location 23, failed cliffs (arrowed) south of Honoipu Landing (Ala Kuakini Trail).

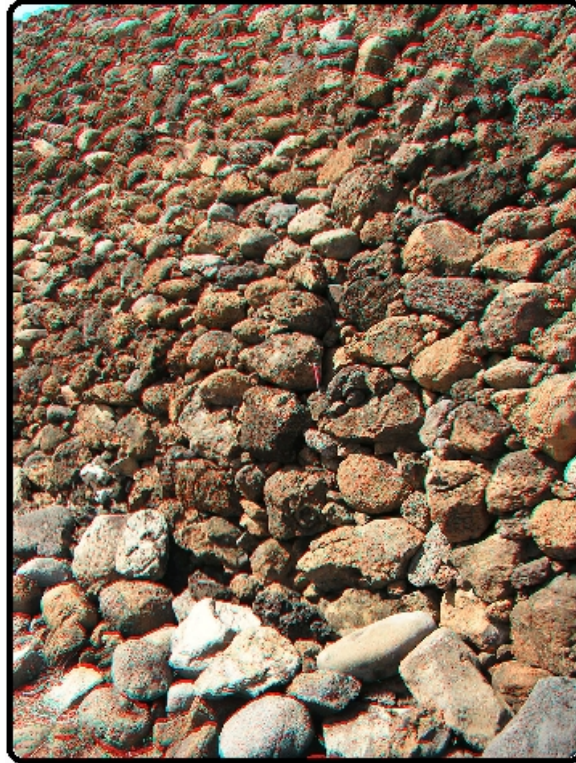
Figure 53. Location 29, NE corner Pu'ukoholā Heiau. Bulging of rock face approaches 90 degree inclination as indicated by yellow line. Bulge is clearly seen in 3-D stereo versions of Figure 54 and Figure 55.

Figure 54. Location 29, bulge at NE corner of Pu'ukoholā heiau. 3-D stereo pair version of Figure 53.

*Figure 55. Location 29, bulge at NE corner of Pu'ukoholā heiau.
3-D anaglyph stereo version of Figure 53.*
