Geological Engineering Reconnaissance of Damage Caused by the October 15, 2006 Hawaii Earthquakes

Edmund W. Medley, Senior Consultant, Geosyntec Consultants Inc., Oakland, CA, USA, Email: emedley@geosyntec.com

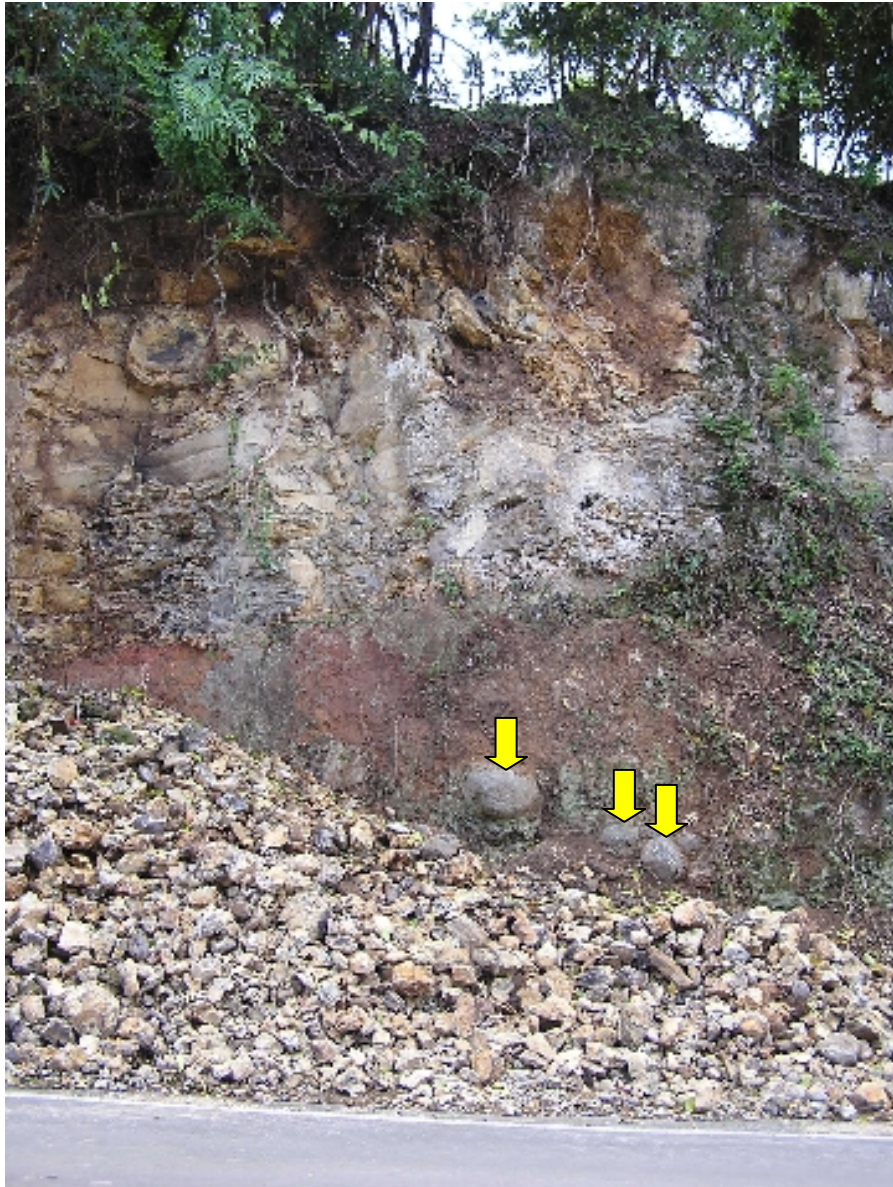
Figure 24. Location 18, Hwy 270 at Makapala. Failure (pile of rock fragments at front) of stronger rock underlain by baked zone soil, with weathered corestone boulders (arrowed).

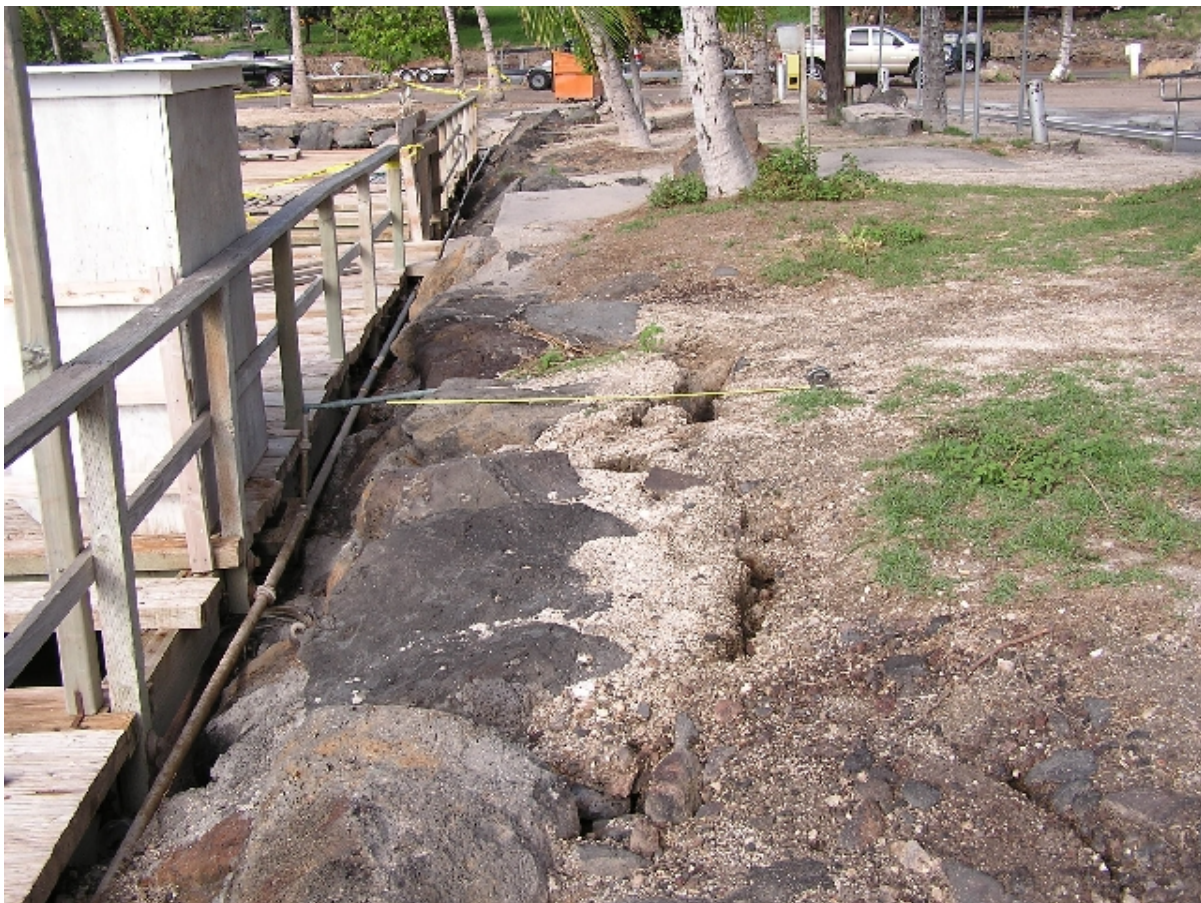
Figure 38. Location 27, Kawaihae Small Boat Harbor. Lateral spreading, and damage to dock. Liquefied sand was ejected from the ground crack (white sand).
