Geological Engineering Reconnaissance of Damage Caused by the October 15, 2006 Hawaii Earthquakes

Edmund W. Medley, Senior Consultant, Geosyntec Consultants Inc., Oakland, CA, USA, Email: emedley@geosyntec.com

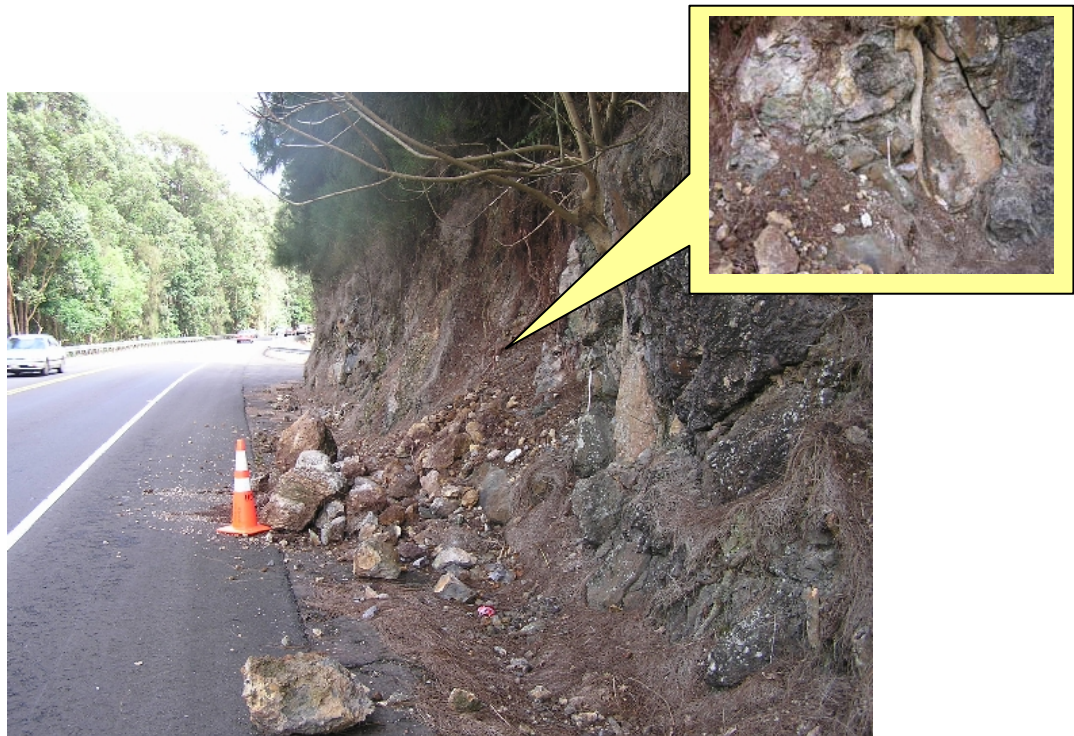
Figure 28. Location 9, Hwy 19 near Honoka'a. Weathered rock. Fractures occupied by tree roots, as shown in insert.

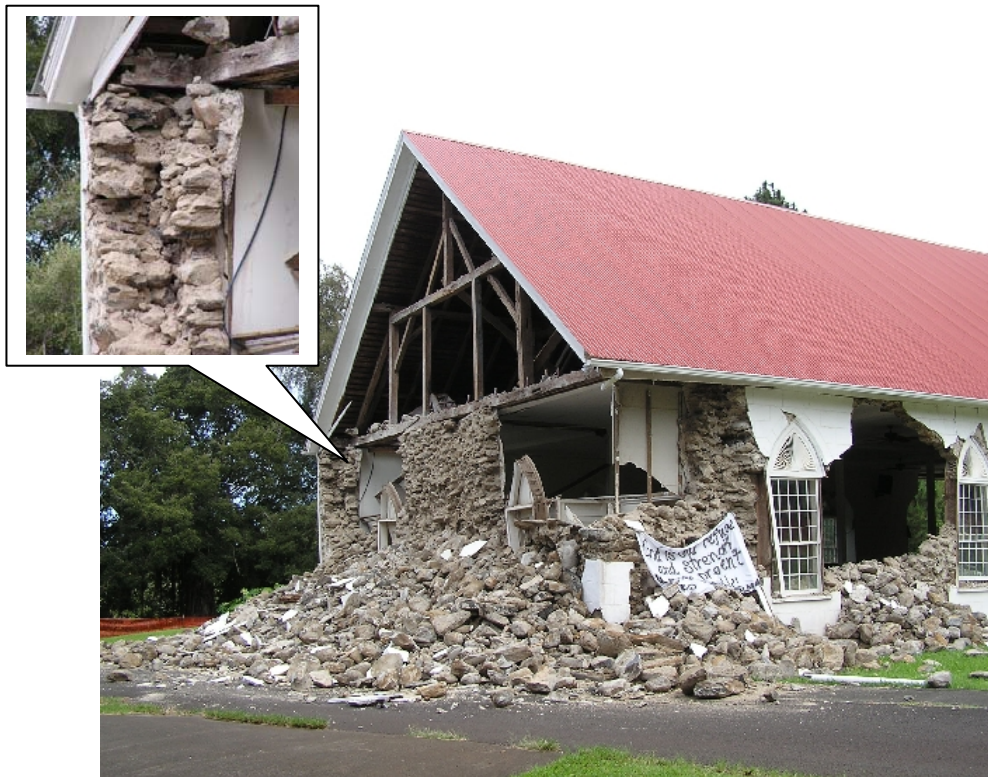
Figure 42. Location 21, Kalāhikiola Congregational Church, Kapa 'au. Weakly cemented stacked rock walls (inset) failed dramatically.
