Geological Engineering Reconnaissance of Damage Caused by the October 15, 2006 Hawaii Earthquakes

Edmund W. Medley, Senior Consultant, Geosyntec Consultants Inc., Oakland, CA, USA, Email: emedley@geosyntec.com

ABSTRACT: Two strong earthquakes shook the Island of Hawaii, Hawaii on the morning of October 15, 2006. Peak Ground Accelerations reached 1.2g, and earthquake felt intensity of MMI VIII. Earthquake damage of public and private property totaled about \$200 million, with no fatalities. Geological engineering reconnaissance of earthquake damage resulting from the earthquakes focused on the apparent relationships between the observed geology and the damage. Some roadway embankments failed causing temporary closure of Island highways. Landslides were common at steep coastal cliffs. Liquefaction and lateral spreading occurred in coralline fill at Kawaihae Harbor. There were extensive road cut failures, in which the performance of road cuts in soil slopes was generally better than that of rock slopes. Where a'a clinker underlay massive a'a basalt blocks in road cut slopes, the loose clinker dislodged thereby undermining the blocks, and causing failures that blocked important roads

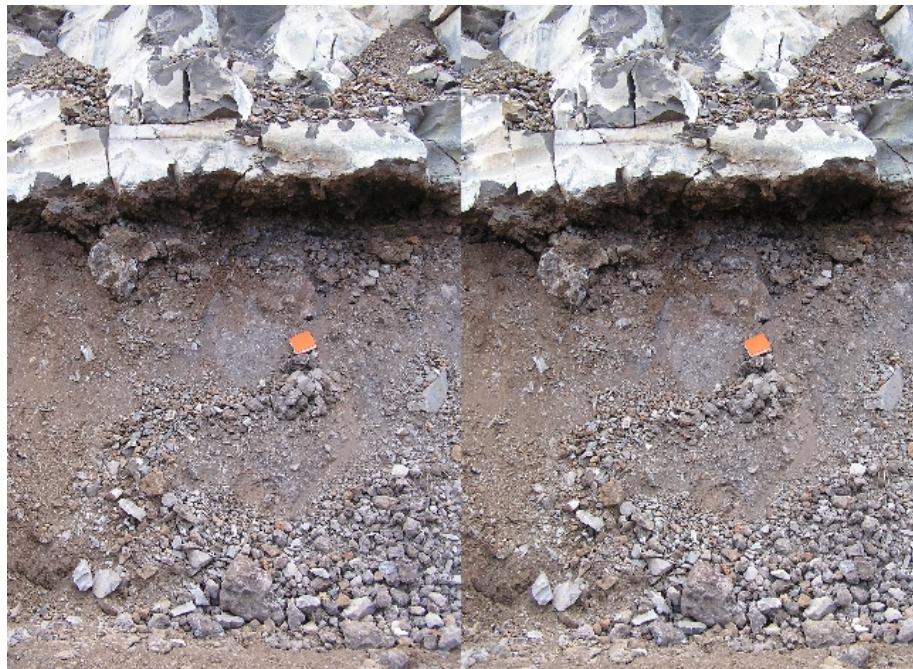
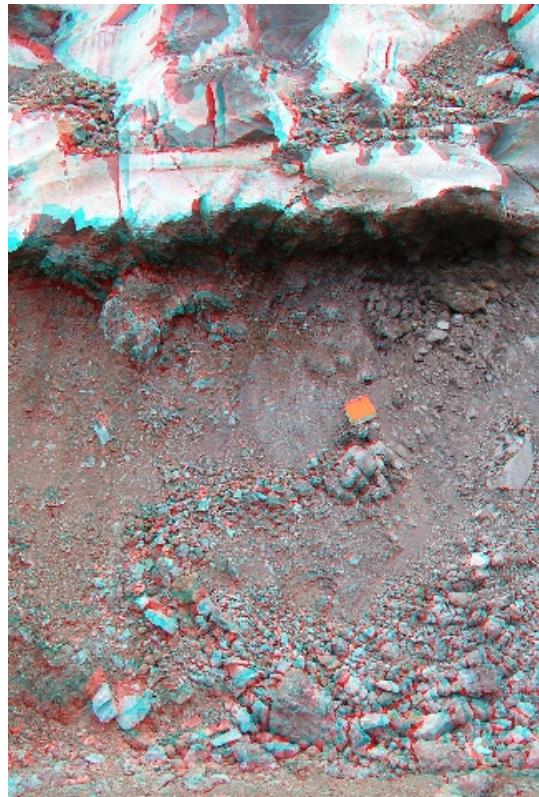
There is a considerable difference in the mechanical properties of the a'a clinker and massive basalt. During the earthquakes, loose a'a clinker raveled, removing support from the overlying massive blocks, some of which failed during the earthquakes as shown by Figures 9 through Figure 17 (includes 3-D stereo versions). It was the large and heavy blocks, rather than the soil-like clinker, that represented the greater hazard to traffic, and required greater effort to move. Consequently, where heavy equipment was not immediately available, fallen large rock blocks obstructed roads for longer periods than the finer debris.

Figure 15. Location 25, Hwy 270 north of Kawaihae. Cantilevered block of massive a'a basalt, undermined by clinker that raveled during the earthquakes. See 3-D stereo images of Figure 16 and Figure 17.

Figure 16. Location 25, Hwy 270 north of Kawaihae. 3-D stereo pair version of Figure 15. Cantilevered block of massive a'a basalt, undermined by clinker that raveled during the earthquakes.

Figure 17. Location 25, Hwy 270 north of Kawaihae. 3-D anaglyph stereo version of Figure 12. Cantilevered block of massive a'a basalt, undermined by clinker that raveled during the earthquakes.

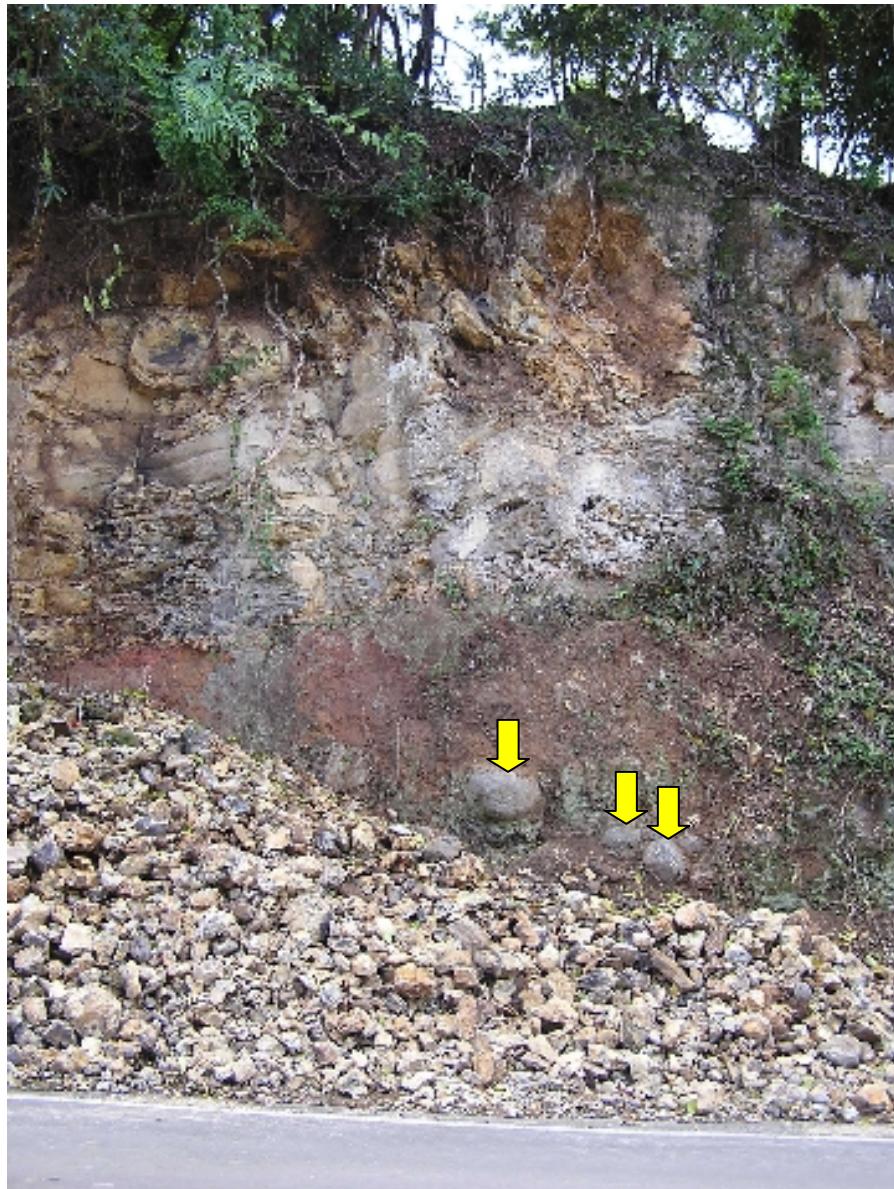
The baked contact between lava flows and pre-existing ground surfaces is often marked by a zone of red soil and highly weathered rock resulting from accelerated weathering. A number of road cut failures were observed where the weaker basal soils failed, undermining the stronger rock above (Figure 11 and Figure 24), in a fashion similar to that above described for a'a/massive basalt sequences.

Figure 24. Location 18, Hwy 270 at Makapala. Failure (pile of rock fragments at front) of stronger rock underlain by baked zone soil, with weathered corestone boulders (arrowed).

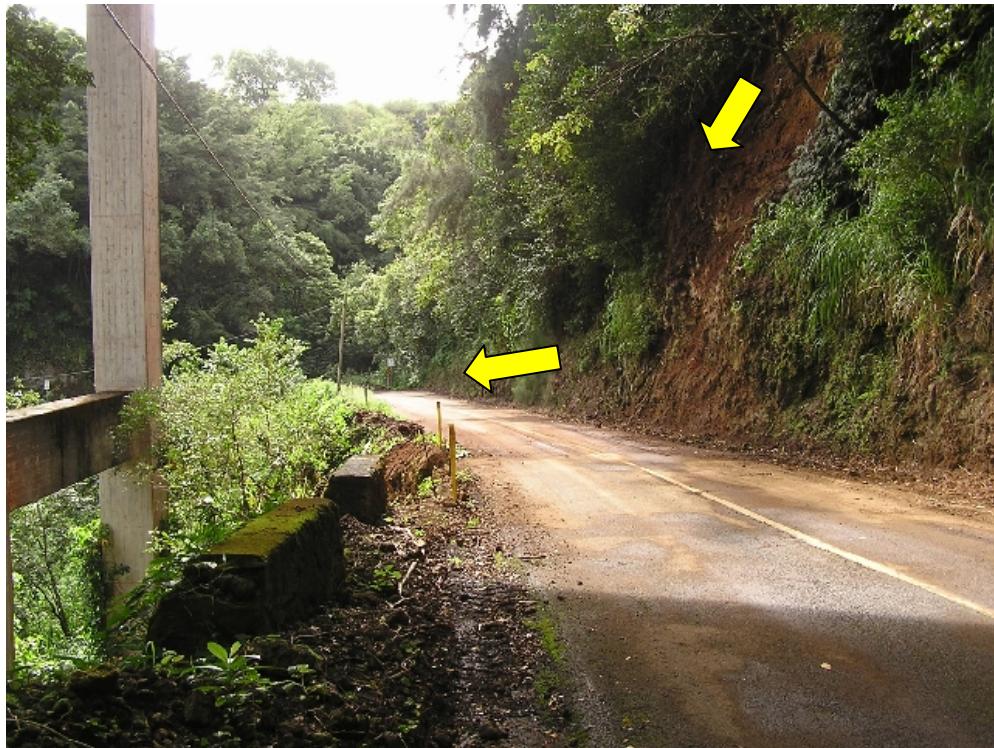
Many small slides of soil were observed during the reconnaissance, although the majority of these were generally of a few cubic meters in volume only. It is unknown what proportions of the observed failures were directly related to the earthquakes; subsequent common, and frequently heavy, tropical rainfall; and, the combination of these factors. Many road cut soil slides were observed to have occurred within larger and older failure features. As indicated above, soil slopes were generally inclined as steeply as rock cuts, greater than 45 degrees (Figure 25).

Figure 25. Location 4, old Hwy 11 near Oōkala, Modern Hwy 11 viaduct above. As evident from red stains in road, soil failed onto and across across Road (arrows) from very steep road cut; typical of many such slides along this road.

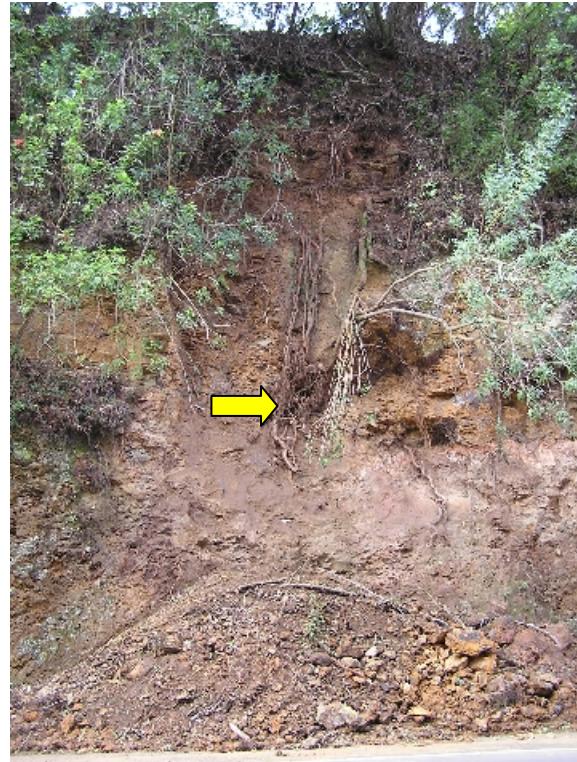
Weathered rock was often found to have failed along fractures occupied by tree roots. Where slopes had been stable long enough for tree roots to take hold in fractures, sections of the slopes peeled off to expose the roots (Figure 27, and Figure

Figure 27. Location 16, Near Kapa'au (Kohala), Hwy 270. Tree roots (arrowed) within relict rock mass fractures degraded the stability of road cuts in soil.

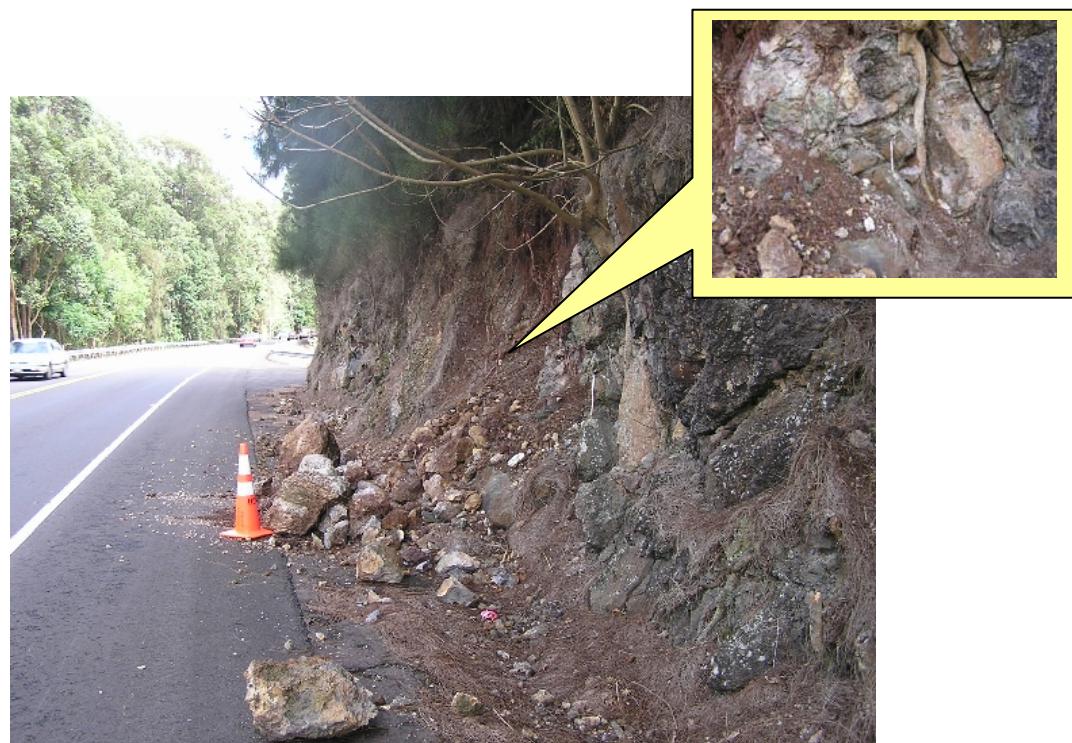
28). The waving of trees due to prolonged shaking may also have contributed lateral loading to the failed veneers. However, within less weathered rock the presence of tree roots within joints was less effective (Figure 29).

Figure 28. Location 9, Hwy 19 near Honoka'a. Weathered rock. Fractures occupied by tree roots, as shown in insert.

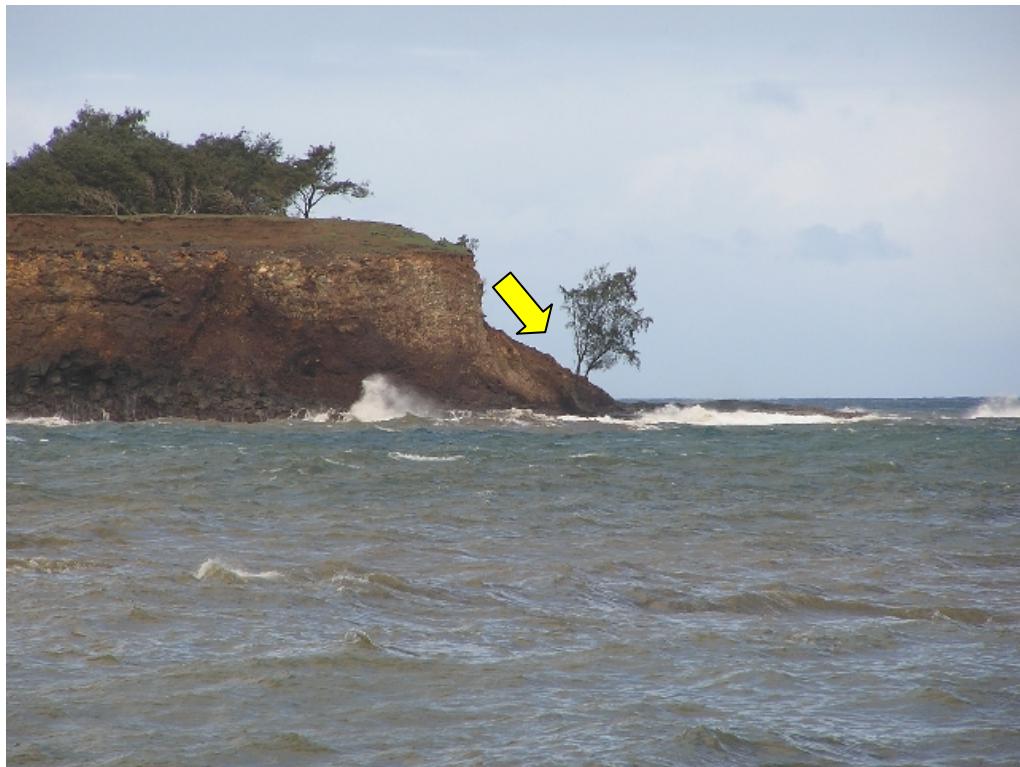
Figure 33. Headland to the northwest of Location 19, Kēōkea Bay. Cliff top slid into the ocean, indicated by the displaced tree and the mostly submerged toe debris.

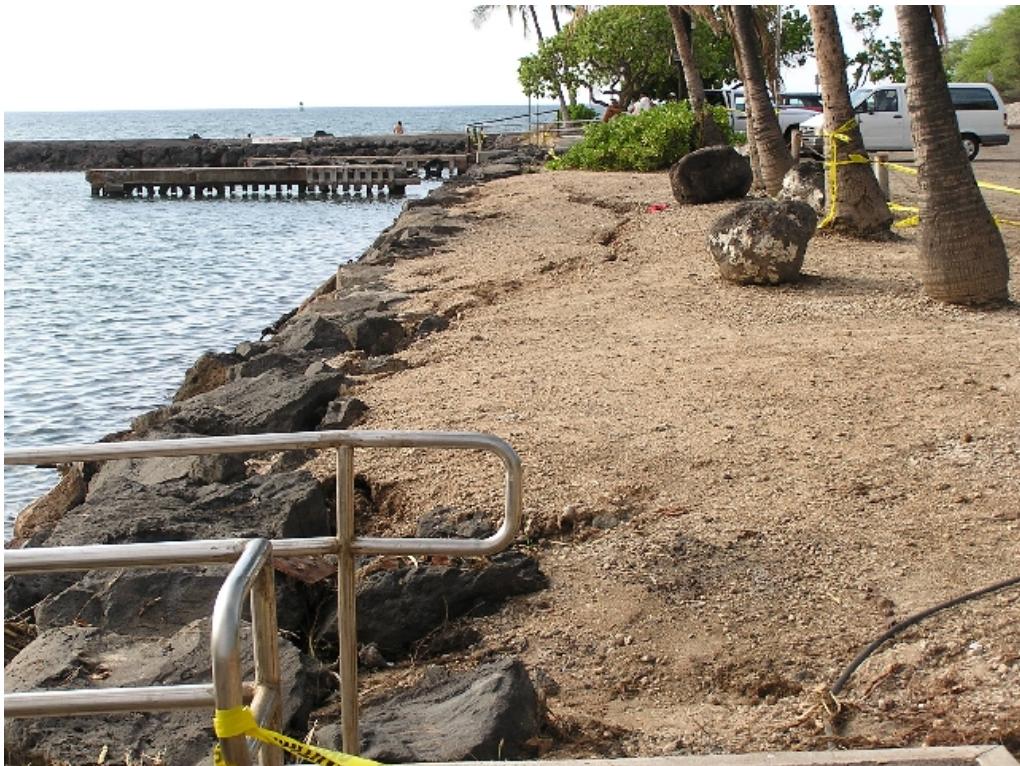
Figure 37. Location 27, Kawaihae Small Boat Harbor, showing arcuate ground crack resulting from lateral spreading.

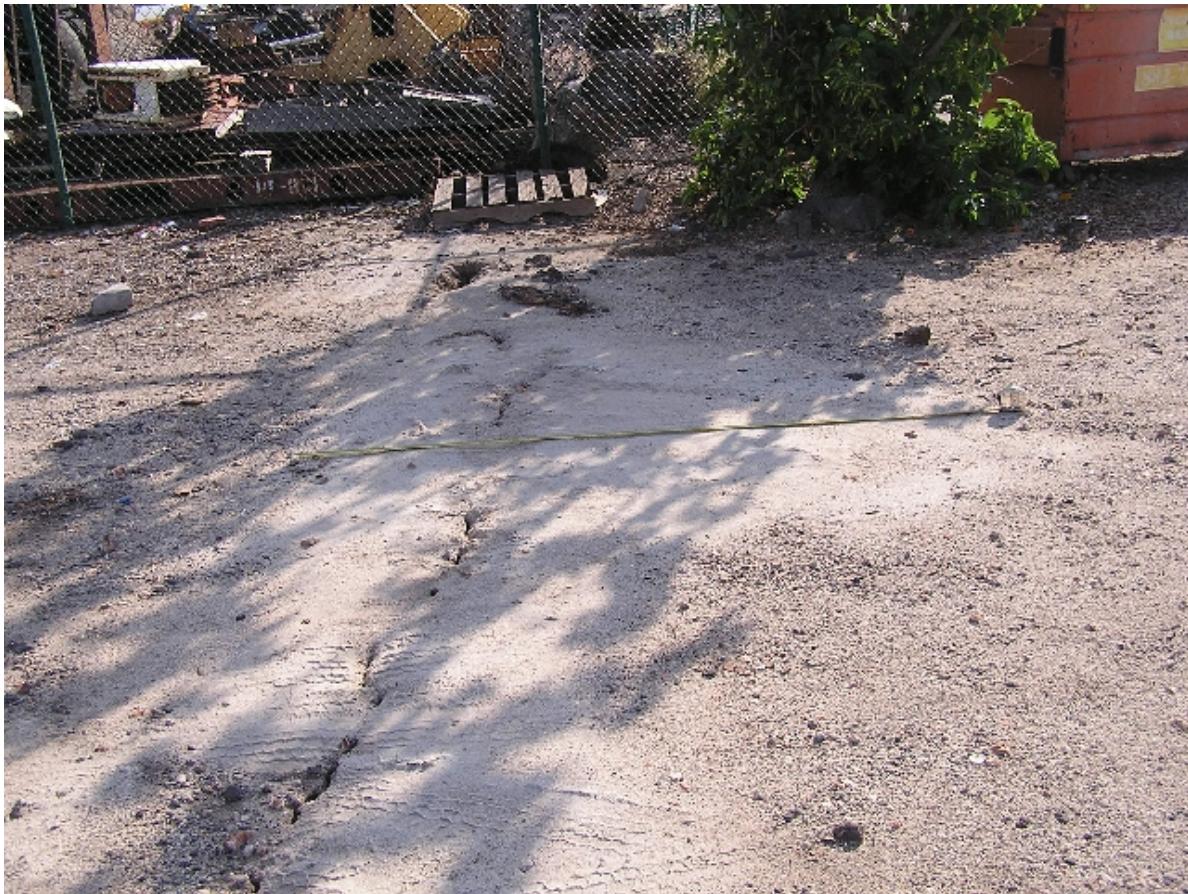
As reported by Robertson et al. (2006) and Chock (2006), sand boils were observed throughout the Harbor area, indicative of liquefaction of the underlying fill. The resulting lateral spreading of 15 to 30 cm caused up to 15 cm of settlement of the asphalt pavement at the shipping container area and lateral displacement of the pile supported concrete wharf.

Figure 39. Location 27, Kawaihae Small Boat Harbor parking lot, adjacent boat yard at south side. Liquefied (white) sand was ejected from wide ground crack during the earthquake shaking.

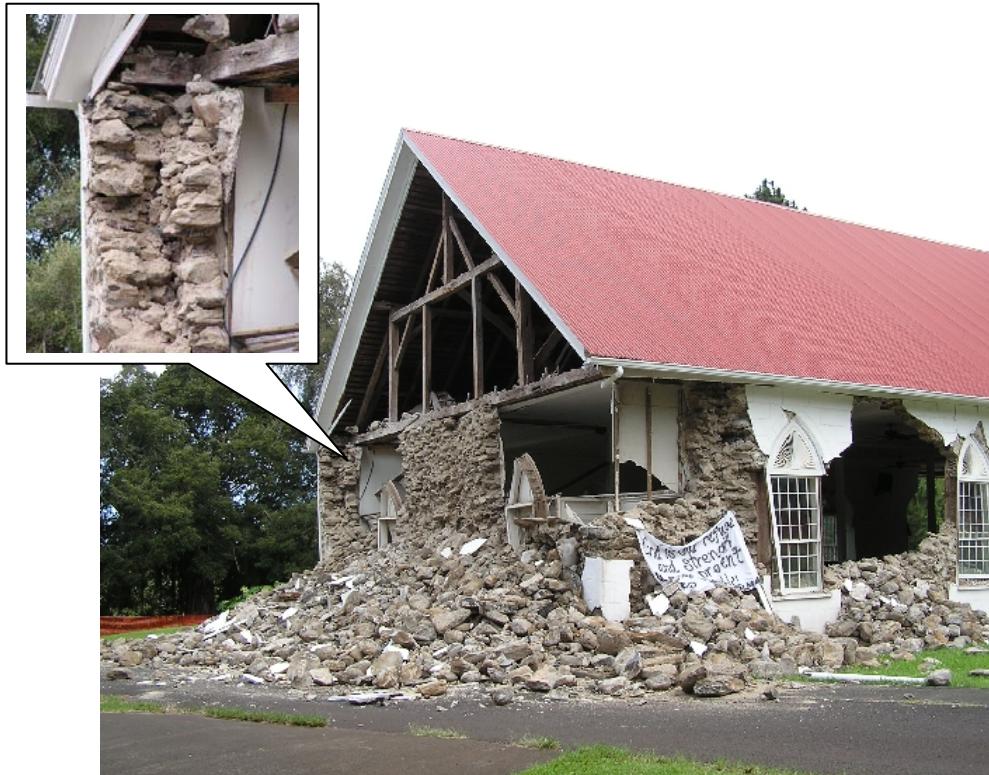
Figure 42. Location 21, Kalāhikiola Congregational Church, Kapa'au. Weakly cemented stacked rock walls (inset) failed dramatically.

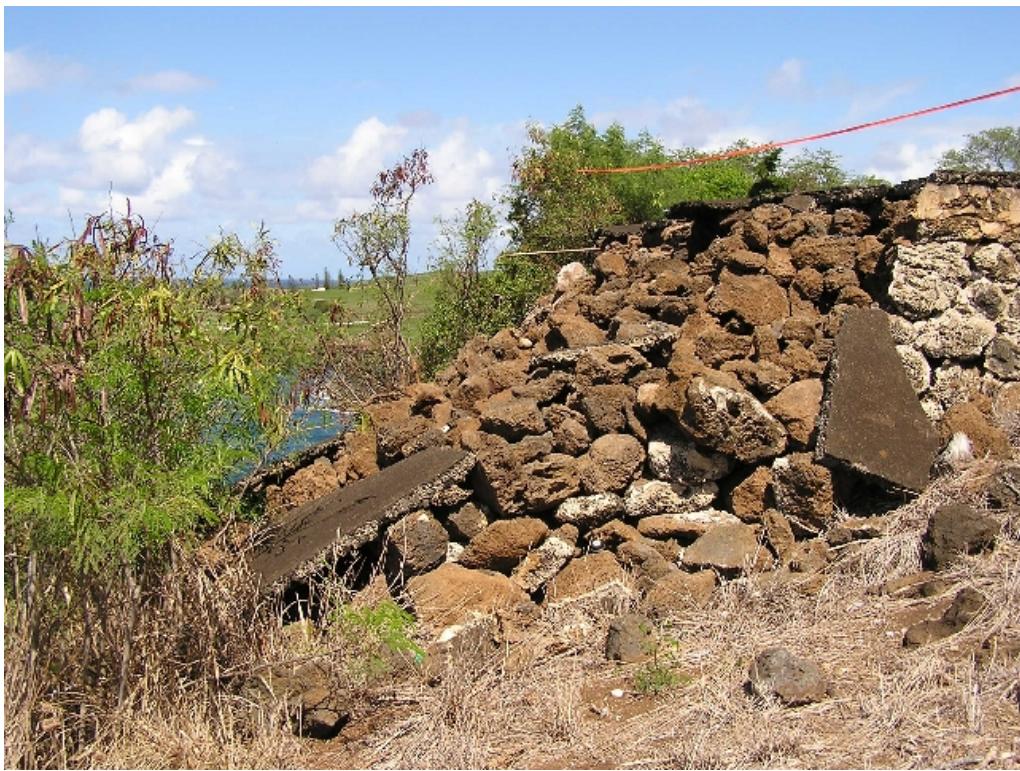
Figure 45. Location 23. Collapse of dry stacked rock wall supporting paved parking area for shoreline access at Puakea Ranch end of trail to Honoipu Landing, due to cliff failures undermining wall foundation.

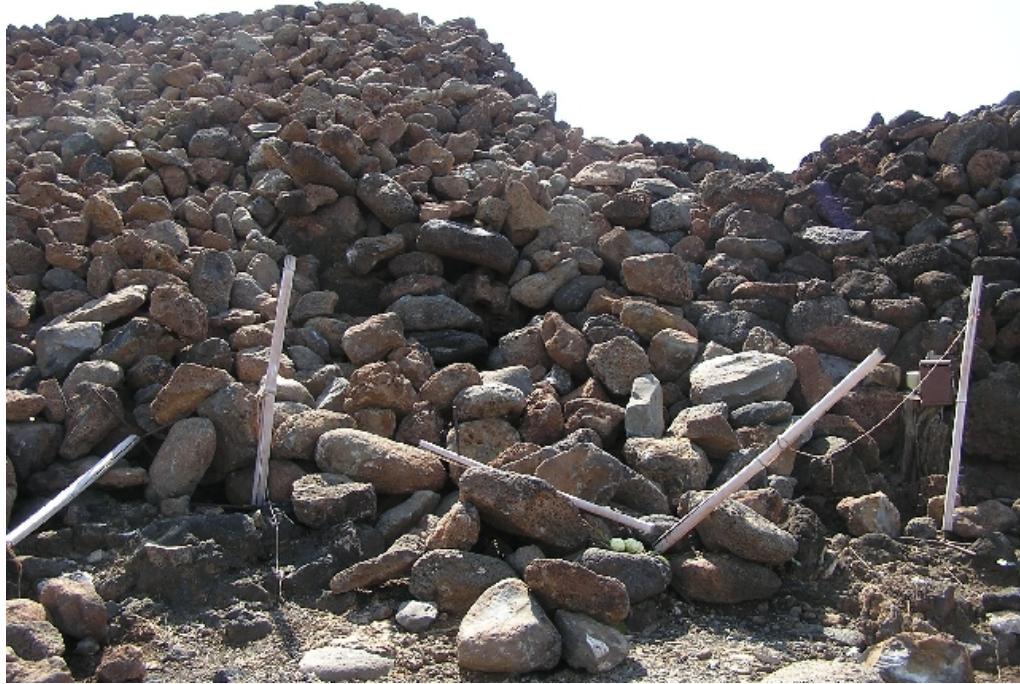
Sta.	Location	Lat. (N degs)	Long. (W degs)	Feature	Comments
29-3	Pu'ukoholā north side	20.0279	-155.8216	Failures of stacked rock block slopes	North side; most damage is to collapsed access stairs; see pre-EQ photo: http://www.pacificworlds.com/kawaihae/native/images/heiau3.jpg
29-4	Pu'ukoholā heiau west side heiau, SW and NW corners	20.0276	-155.8217	Failures of stacked rock block slopes	West side, SW and NW corners: slumping and bulging failures
29b (east)	Mailekini Heiau, Kawaihae, east side	20.0276	-155.8219	Failures of stacked rock block slopes	East wall exterior shows some bulging and slumping;
29b (west)	Mailekini Heiau west face, SW corner	20.0283 to 20.0275	-155.8222 to -155.8224	Failures of stacked rock block edifice	NW corner, west side and interior face east wall: extensive slumping failures. See pre-EQ appearance at: http://www.pacificworlds.com/kawaihae/native/images/mailekn3.jpg

Figure 49. Location 29, Pu'ukoholā heiau, north side: Earthquake caused collapse of access step structure.

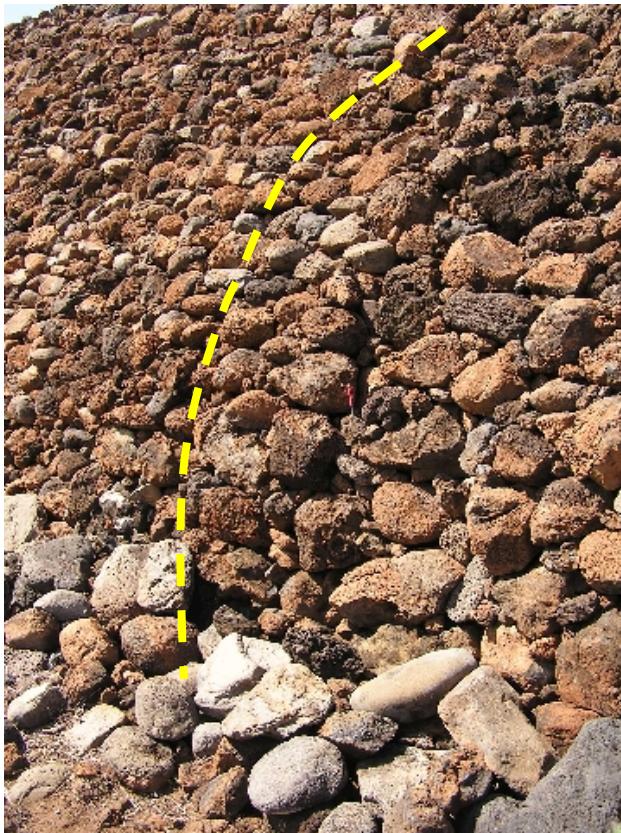
29-1	Pu'ukoholā heiau south side	20.0273	-155.8213	Stacked rock block slopes	South side relatively intact
29-2	Pu'ukoholā heiau: east side, NE corner	20.0279	-155.8213	Failures of stacked rock block slopes	East side and NE corner, major bulging, slumping and raveling failures

Figure 53. Location 29, NE corner Pu'ukoholā Heiau. Bulging of rock face approaches 90 degree inclination as indicated by yellow line. Bulge is clearly seen in 3-D stereo versions of Figure 54 and Figure 55.

Figure 54. Location 29, bulge at NE corner of Pu'ukoholā heiau. 3-D stereo pair version of Figure 53.

Figure 55. Location 29, bulge at NE corner of Pu'ukoholā heiau.
3-D anaglyph stereo version of Figure 53.
