Lack of Maintenance Compromises Tunnel Structural Safety

ABSTRACT: *The Chekka tunnels represent a critical section of the Northern Lebanon Highway. The approximately 350-m long twin tunnels are the most important tunnels in the country. They are used by regular and freight traffic and are a vital link to the capital, Beirut. The tunnels were completed in the early 1970s on the eve of the Lebanon civil war. Given the state of affairs in the country for about two decades of strife, the tunnels were not maintained nor did they undergo any regular inspection. This unique condition of near-abandonment continued up until recently, when the first signs of distress were documented. These consisted of severe and extensive cracking, particularly in the portal approach of the southbound tunnel, along with significant deterioration of the tunnel lining and radial section joints. The danger to traffic and, potentially, to the structure itself was evident. In this paper, the results of an extensive site inspection and evaluation program are presented. The underlying causes of the observed damage are analyzed and discussed using a modeling approach of the progressive loading conditions. Remedia

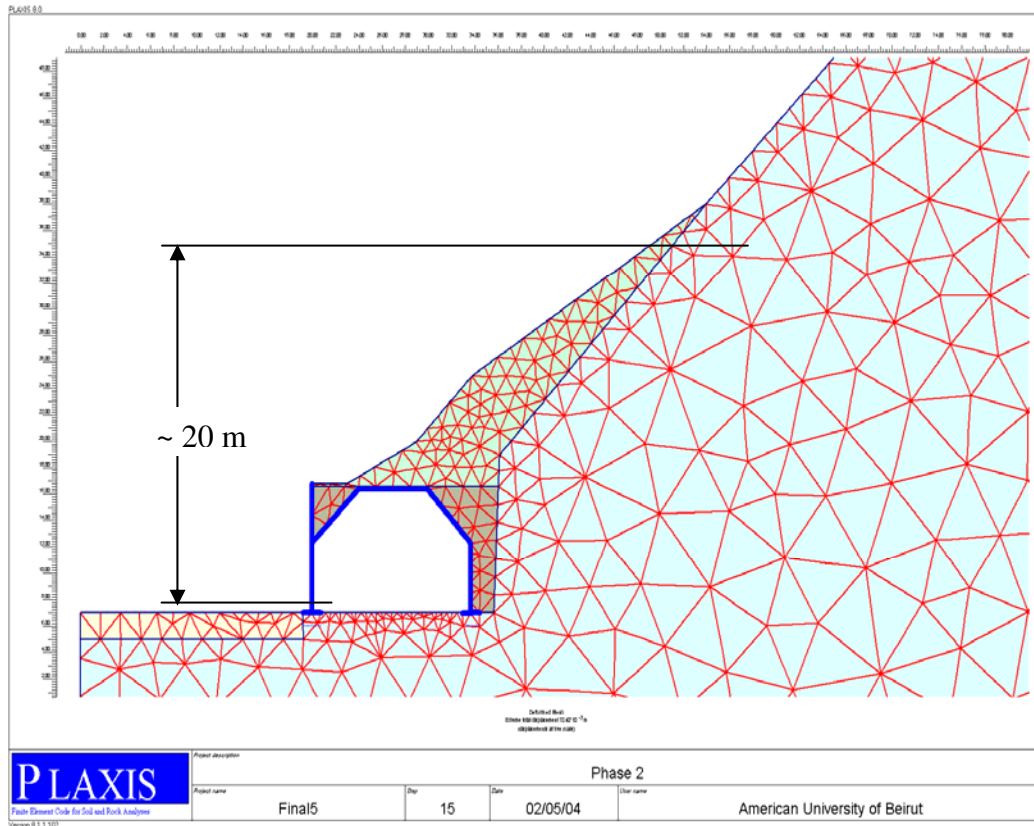
Fig.11 is a detail view of the finite element mesh near the tunnel portal, showing the soil and rock strata as described in Table 2. The intact rock is shown in light blue, while the slumping soil mass is green. The olive green color represents the engineered backfill soil at the end of construction. It is important to note here that the slumping soil mass was only activated for Stage 2.

Figure 11. Finite Element Model Showing the Various Strata and the Loading Sequences – Stages 1 and 2.
