Lack of Maintenance Compromises Tunnel Structural Safety

ABSTRACT: *The Chekka tunnels represent a critical section of the Northern Lebanon Highway. The approximately 350-m long twin tunnels are the most important tunnels in the country. They are used by regular and freight traffic and are a vital link to the capital, Beirut. The tunnels were completed in the early 1970s on the eve of the Lebanon civil war. Given the state of affairs in the country for about two decades of strife, the tunnels were not maintained nor did they undergo any regular inspection. This unique condition of near-abandonment continued up until recently, when the first signs of distress were documented. These consisted of severe and extensive cracking, particularly in the portal approach of the southbound tunnel, along with significant deterioration of the tunnel lining and radial section joints. The danger to traffic and, potentially, to the structure itself was evident. In this paper, the results of an extensive site inspection and evaluation program are presented. The underlying causes of the observed damage are analyzed and discussed using a modeling approach of the progressive loading conditions. Remedia

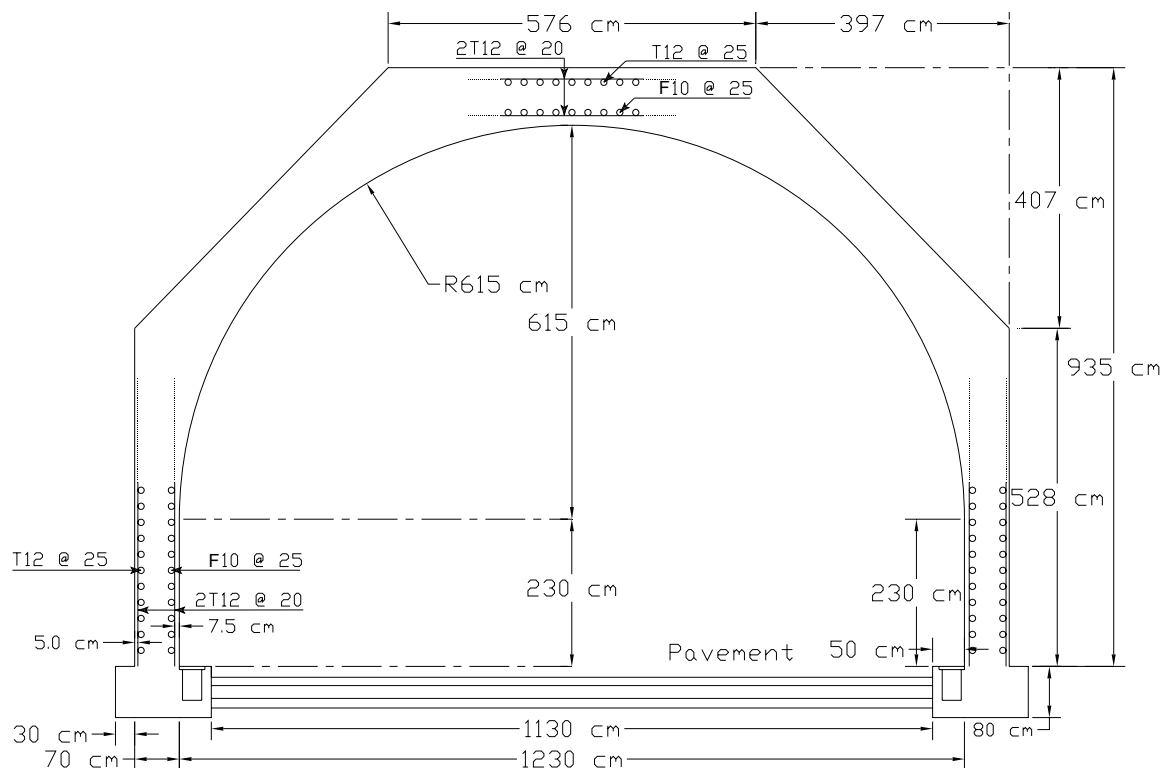
Figure 10. Geometry of the 35-m Long Extension of the Southbound Tunnel Portal.

Table 3 presents the bending moments calculated from the FE analyses and the ultimate moment section capacity at the position of the observed crack ~ 2.5 m above the footing level (Fig. 10).

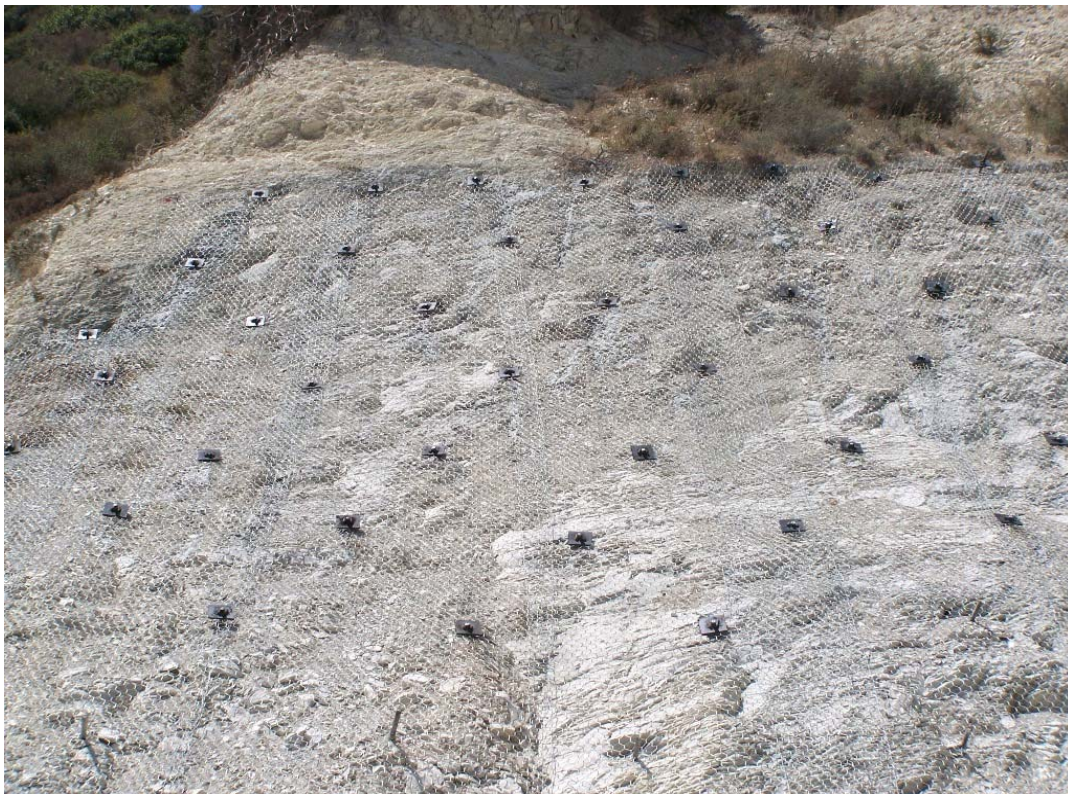
Figure 14. Completed Rock Bolts/nails and Wire Mesh Installation Along the Western Slope.

3. Repair and rehabilitation of the distressed structural elements including jacketing and repair of the eastern outer wall and the provision of passive nails/rock bolts on the western wall, tying into the parent intact rock, thus reducing pressures on the wall and lateral deformations.

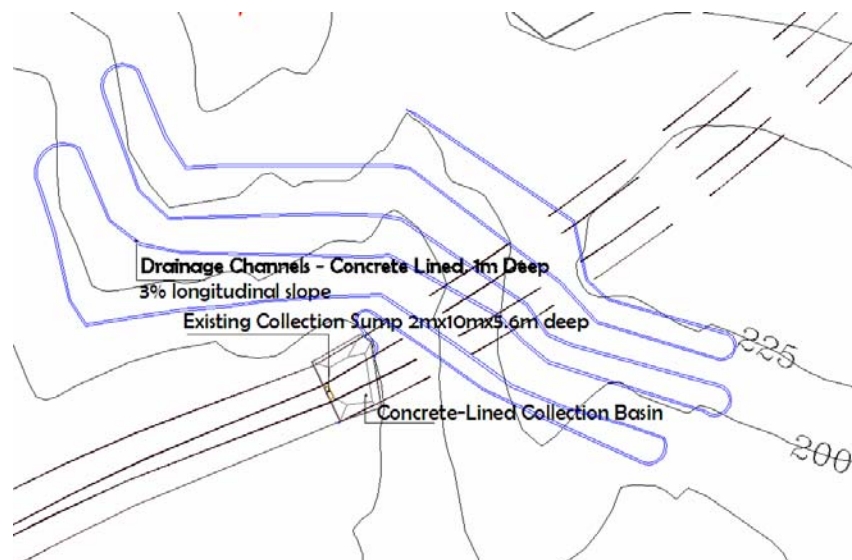
Figure 15. Schematic Plan of the Drainage/interception Channels (Trace of Tunnels Shown as Dashed Lines).

1. A water runoff interception scheme, with particular emphasis on the slopes contributing to the flow patterns towards the southbound tunnel exit. A schematic of the layout of the system is shown in Fig. 15. The interceptor trenches and drainage channels are concrete-lined and feed into controlled sumps and outlets, moving surface water away from the portals and vulnerable tunnel sections.

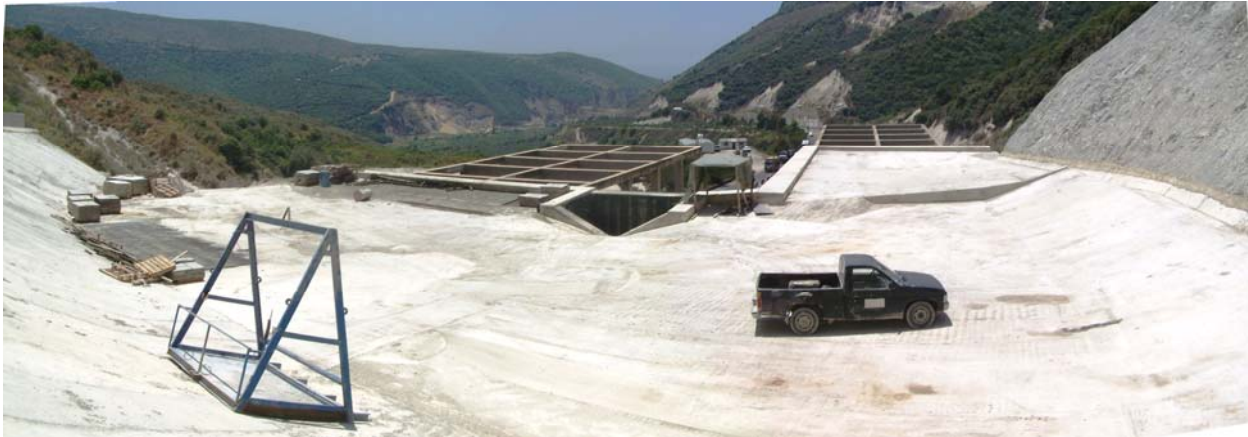
Figure 16. Regraded and Remediated Area Above the Portals and Southern Entrance/exit of Tunnels.

2. The surface water drainage provisions were re-designed to incorporate the already existing drainage structures that were not in service conditions. Surface run-off is collected by directing the rainwater by adequate leveling the area above the exit/entrance structures, into concrete-lined channels, which carry the water into the existing sump for storage and subsequent evacuation by gravity outside the project area. Fig. 16 shows the remediated area above the tunnels, with the v-notched entrance to the sump and peripheral drainage channels.

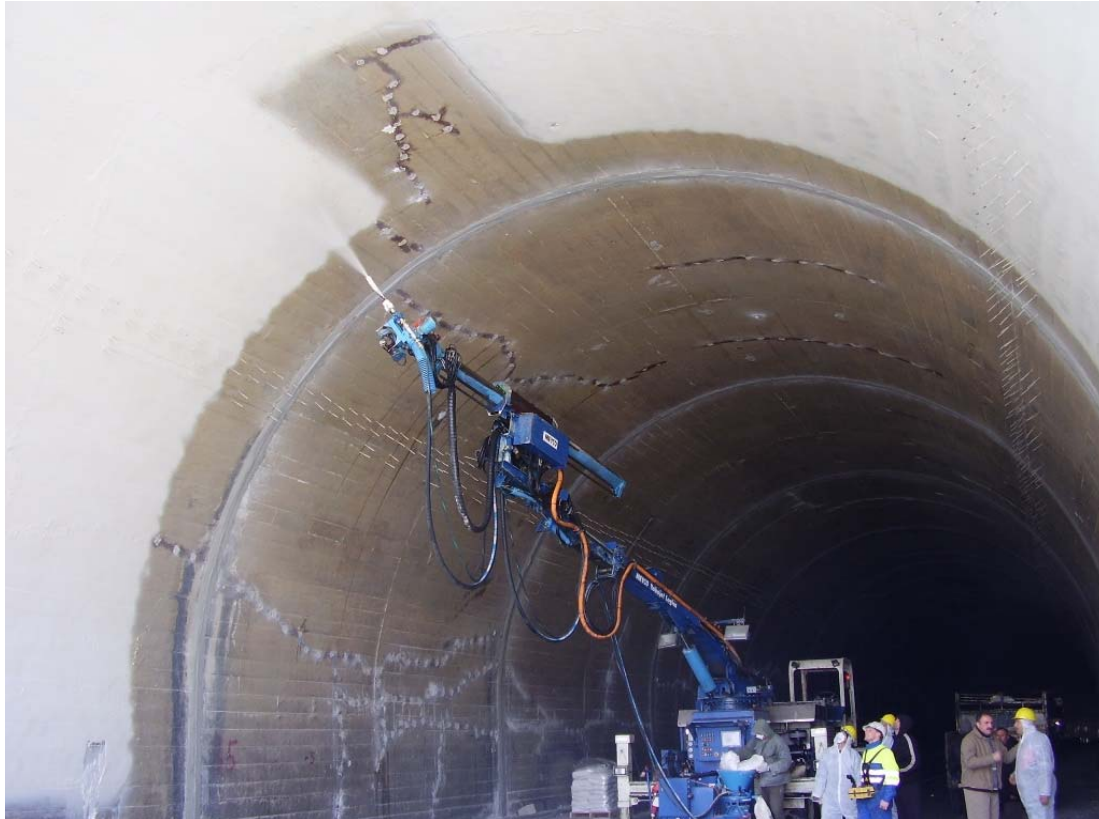
Figure 17. Installation of the Sprayed Membrane. Also Shown Are the Repaired Cracks in Original Lining.

4. Water proofing was provided through a projected/sprayed membrane. The sprayable membrane selected was a MASTERSEAL 345. The membrane was applied using an automated, computer controlled robotic arm, which insured thorough coverage/thickness and uniform application (Fig. 17).
