## Lack of Maintenance Compromises Tunnel Structural Safety

**ABSTRACT:** *The Chekka tunnels represent a critical section of the Northern Lebanon Highway. The approximately 350-m long twin tunnels are the most important tunnels in the country. They are used by regular and freight traffic and are a vital link to the capital, Beirut. The tunnels were completed in the early 1970s on the eve of the Lebanon civil war. Given the state of affairs in the country for about two decades of strife, the tunnels were not maintained nor did they undergo any regular inspection. This unique condition of near-abandonment continued up until recently, when the first signs of distress were documented. These consisted of severe and extensive cracking, particularly in the portal approach of the southbound tunnel, along with significant deterioration of the tunnel lining and radial section joints. The danger to traffic and, potentially, to the structure itself was evident. In this paper, the results of an extensive site inspection and evaluation program are presented. The underlying causes of the observed damage are analyzed and discussed using a modeling approach of the progressive loading conditions.

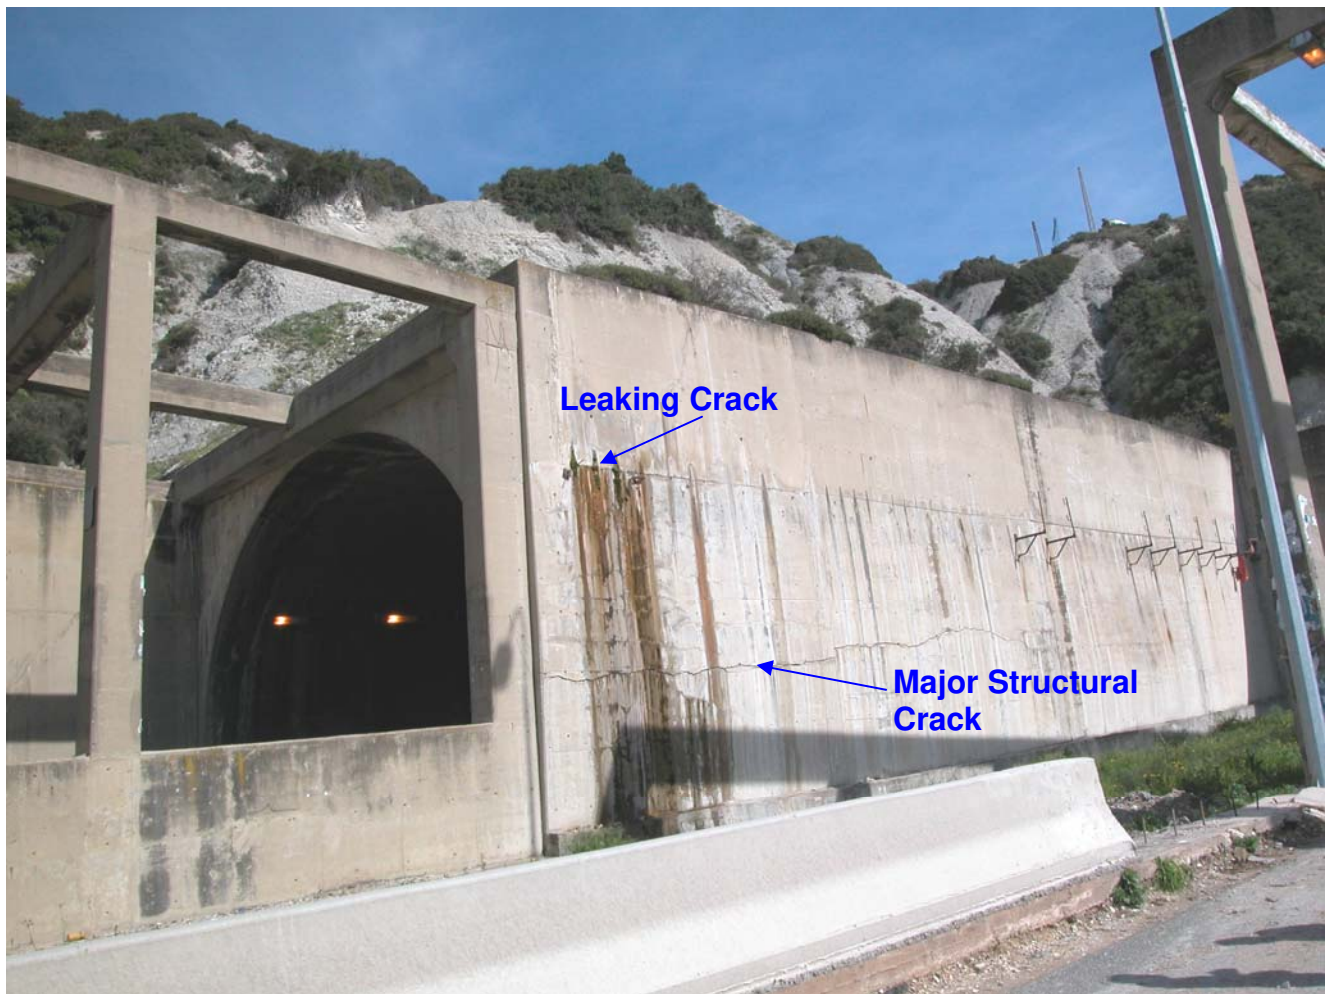
*Figure 1. Southbound Tunnel Portal - View of External Distress.*

The major crack along the 35-m long portal structure at the southbound tunnel exit (shown in Fig. 1 and Fig. 2) which initiated the engineering intervention, was attributed to increased differential loading. This possible cause for the structural damage was identified following the observation of a relatively large slumped mass of soil loading the western side of the portal structure of the southbound tunnel (Fig. 3). The slumped soil mass was due to weathering of the friable chalky limestone rock on the adjacent exposed slopes and subsequent instability and mass transport. The differential loading of one side of the portal frame structure by the slumped soil mass, along with other contributing factors, could have led to the observed cracking of the eastern wall of the portal along with the associated lateral deformations of up to 15 cm (Fig. 1 and Fig. 2). Additional pictures of this particular tunnel segment are provided in the online database that accompanies this paper.

1. A major longitudinal structural crack was clearly evident on the outside face of the eastern wall of the tunnel portal frame in the last 35 m span of the exit side of the southbound tunnel (Fig. 1). Signs of water leakage through a crack in the eastern wall were evident at the junction between the tunnel portal and the 4.72 m high retaining parapet. This pattern of damage was indicative of a number of problems with the tunnel portals, which are typically identified as potentially problematic areas in a number of situations (Rothfuss et al., 1995).

1. The major structural cracks on the outside face of the eastern wall of the portal frame were repaired by “crack-injection” using low viscosity, two-component epoxy resin. The injection was completed after thorough cleaning and preparation of the affected areas and the provision of injection ports to ensure thorough filling of the cracks. Similar treatments were applied to all cracks and damaged areas in the tunnel concrete lining (Fig. 15).

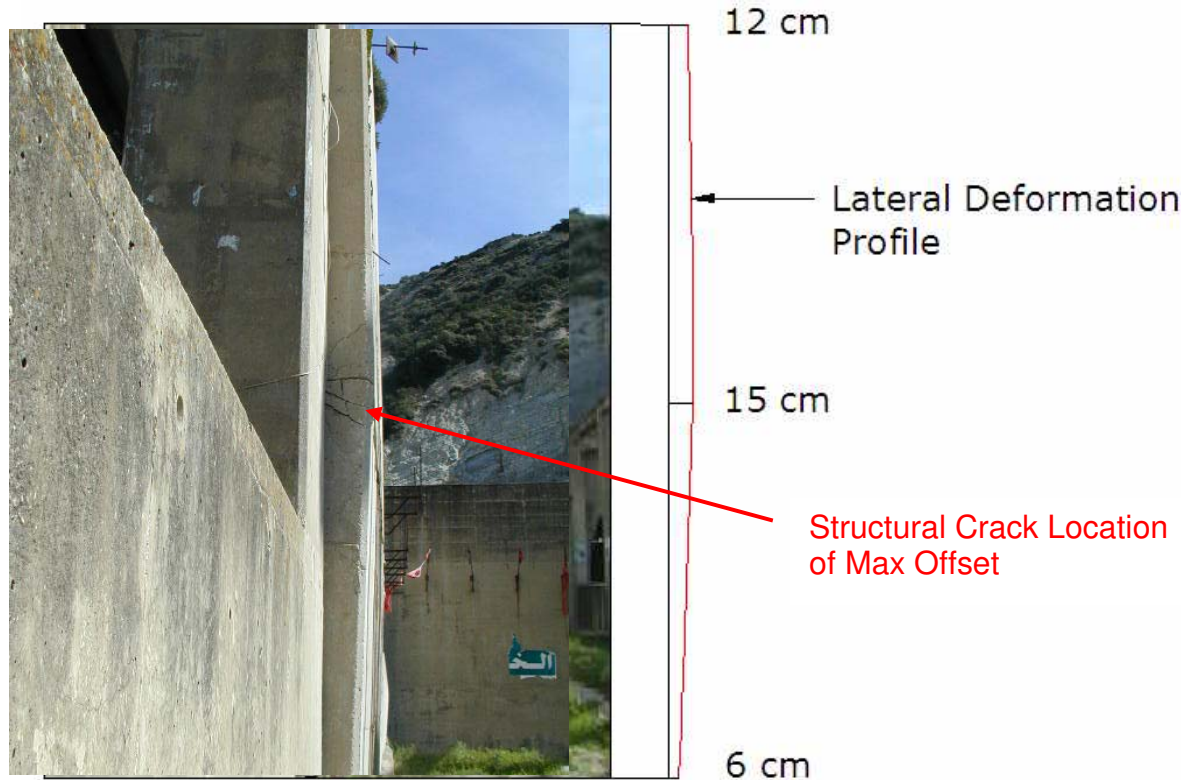
*Figure 2. Close-up View of the Outward Movement/bulging of the Eastern Portal Wall.*

2. The eastern wall of the southbound tunnel portal was further strengthened after the accumulated weathered material above it was removed and the crack treatment/repair completed. Strengthening was achieved by connecting a 15-cm reinforced concrete jacket to the existing wall.
3. Whereas the distress signs were evident along the eastern projecting portal wall only, the FEM analyses suggested that cracks could have developed along the inaccessible outside tension face of the backfilled western wall of the portal. As such, strengthening provisions for that element were taken. Jacketing was ruled out given that the outer surface is backfilled and cannot be exposed. Instead, the installation of passive nails/rock bolts at elevations of grade plus 2 m and grade plus 4 m was recommended, tying the wall to the intact rock and reducing the stresses on the wall itself.

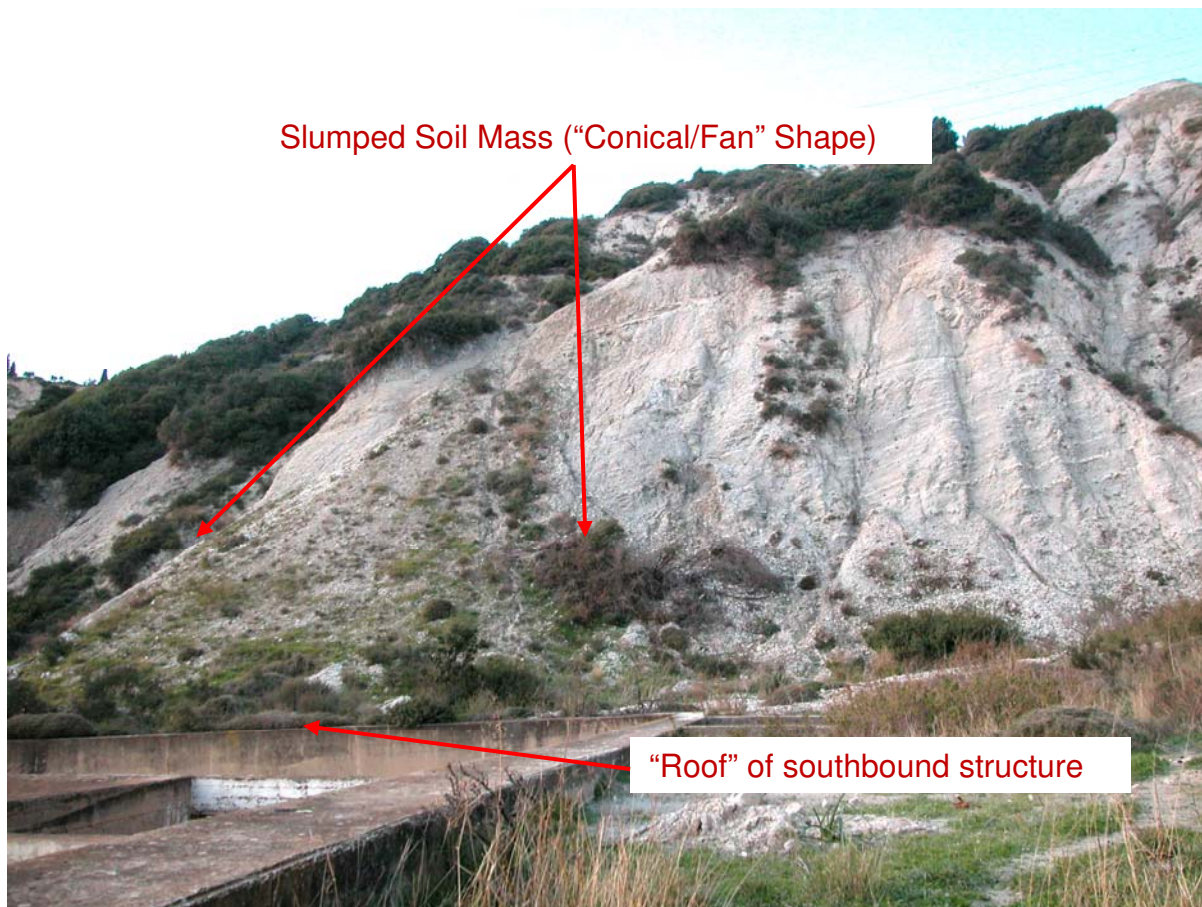
*Figure 3. Slumped Soil Mass Loading the Top of the Southbound Tunnel Exit Structure.*

1. “Soil 1”, is characteristic of the slumped mass above the southbound tunnel cross-section (Fig. 3). This soil type is characterized by relatively low values of the Menard modulus, dry density and unconfined compressive strength.
2. “Soil 2” is typical of the soft marlstone layers. This material is typical of materials in a band 4 to 6 m thick as evidenced in boreholes BH-1, BH-2, and BH-5.
3. Finally, the third type is the intact marly-limestone rock of the Chekka Formation.

1. Controlling surface water flow and improving drainage around structure area.
2. Removal of the slumped mass on top of the southbound tunnel exit structure and the provision of long-term stability and erosion control measures to eliminate the possibility of recurrence. These provisions included the installation of rock bolts/nails with a high strength steel wire mesh facing (Fig. 13 and Fig. 14). A program for regular inspection and maintenance of the structures was also developed.

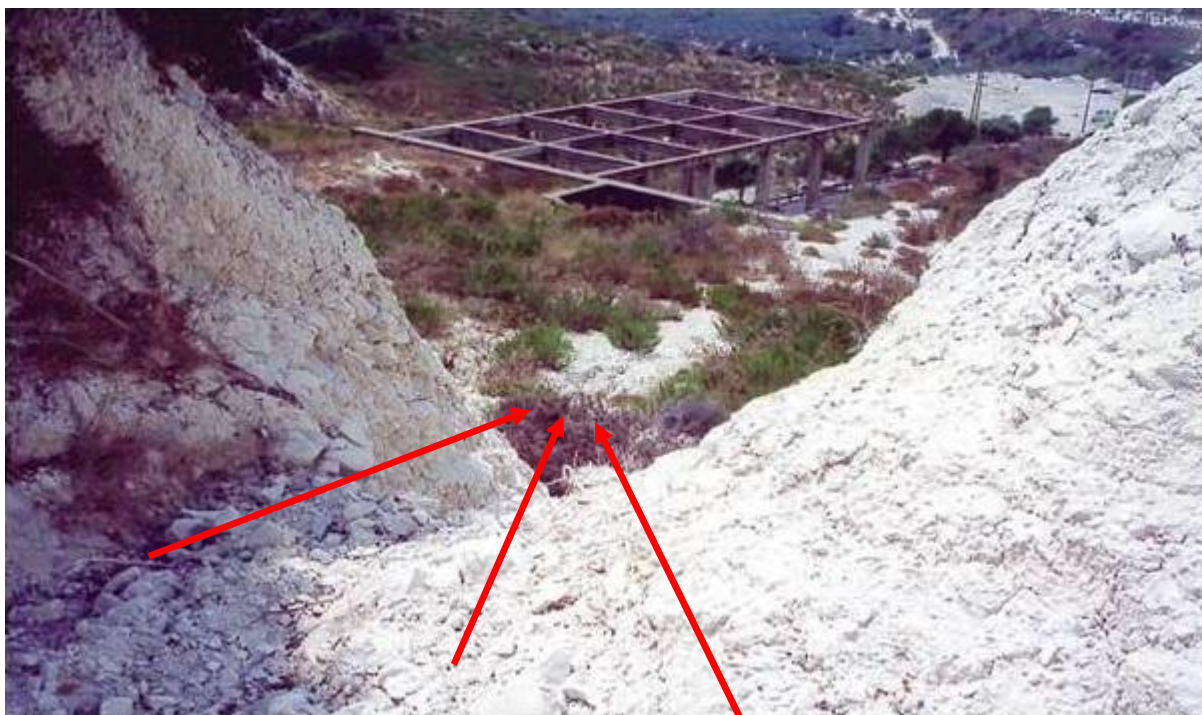
*Figure 4. Direct Surface Flow (arrows) Towards South Facing Tunnel Exit/entrance Structures -View From Top.*

1. A water runoff interception scheme, with particular emphasis on the slopes contributing to the flow patterns towards the southbound tunnel exit. A schematic of the layout of the system is shown in Fig. 15. The interceptor trenches and drainage channels are concrete-lined and feed into controlled sumps and outlets, moving surface water away from the portals and vulnerable tunnel sections.

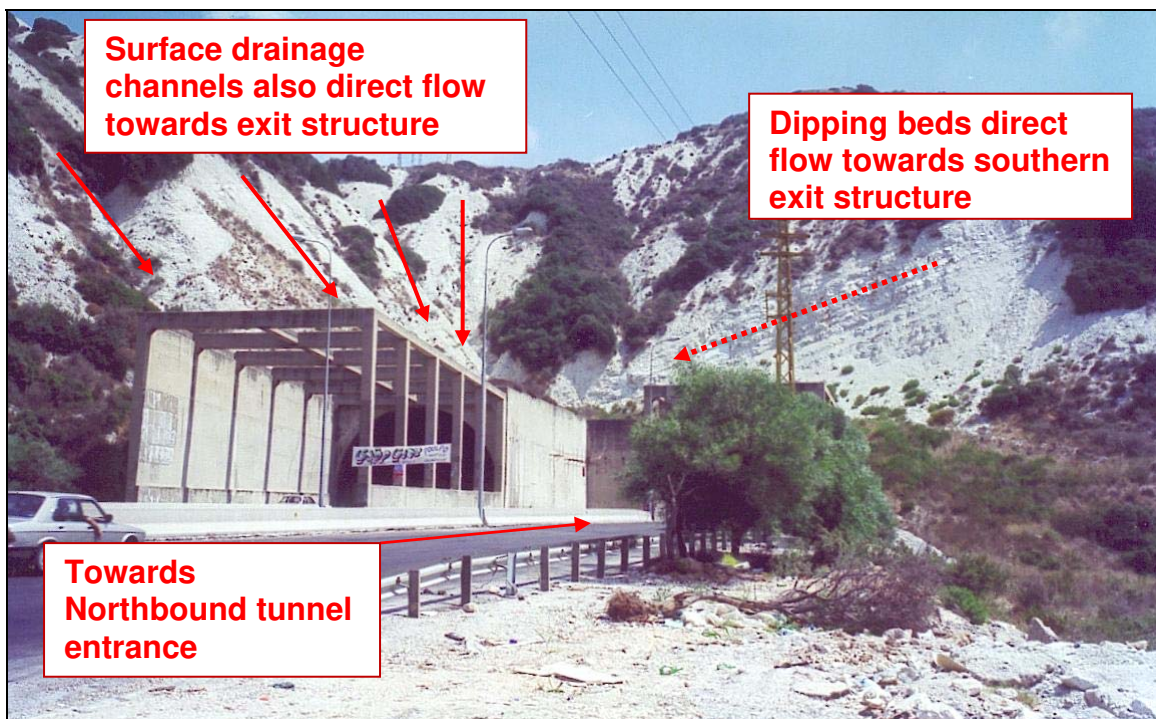
Figure 6. Dipping Beds and Surface Drainage Channels Increase Flow Towards Southbound Tunnel Exit Structure and “Sump” Area Above Tunnels.

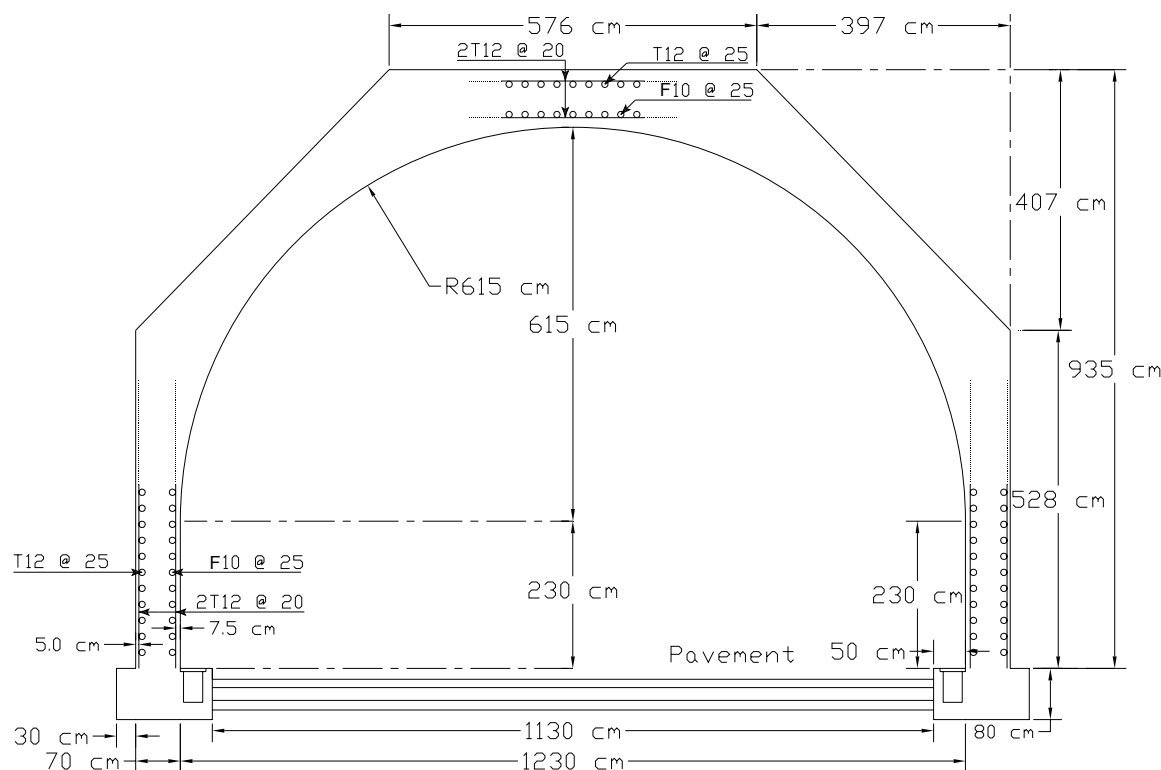
Figure 10. Geometry of the 35-m Long Extension of the Southbound Tunnel Portal.

Table 3 presents the bending moments calculated from the FE analyses and the ultimate moment section capacity at the position of the observed crack ~ 2.5 m above the footing level (Fig. 10).

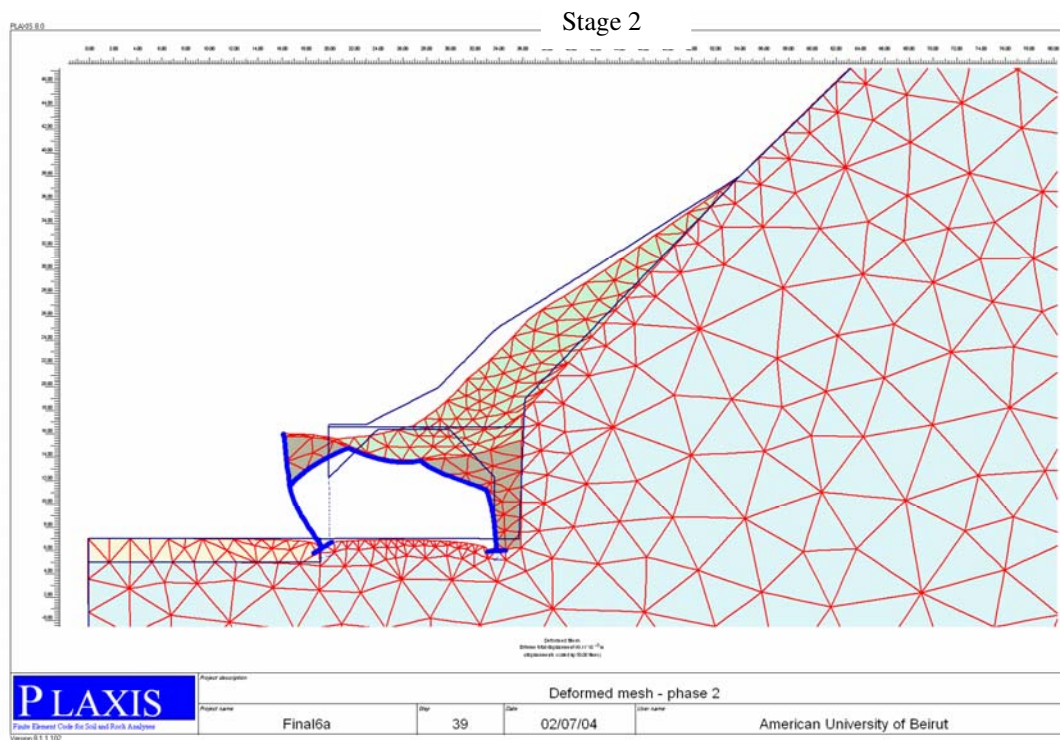
For conditions representing the current loading, Stage 2, the analyses yielded the deformed mesh shown in Fig. 12. The FE results for Stage 2 suggest the following:

1. The maximum bending moment values calculated are much larger than the ultimate moment capacity of the critical wall section. This implies that the additional loading due to the slumped soil accumulated on top of the tunnel section is indeed a major contributing cause of the observed failure of the portal wall section.
2. The values of the shear forces are within the section capacities.

Figure 12. Deformed Mesh for Stage-2 (Deformations Are Scaled up 50 times).

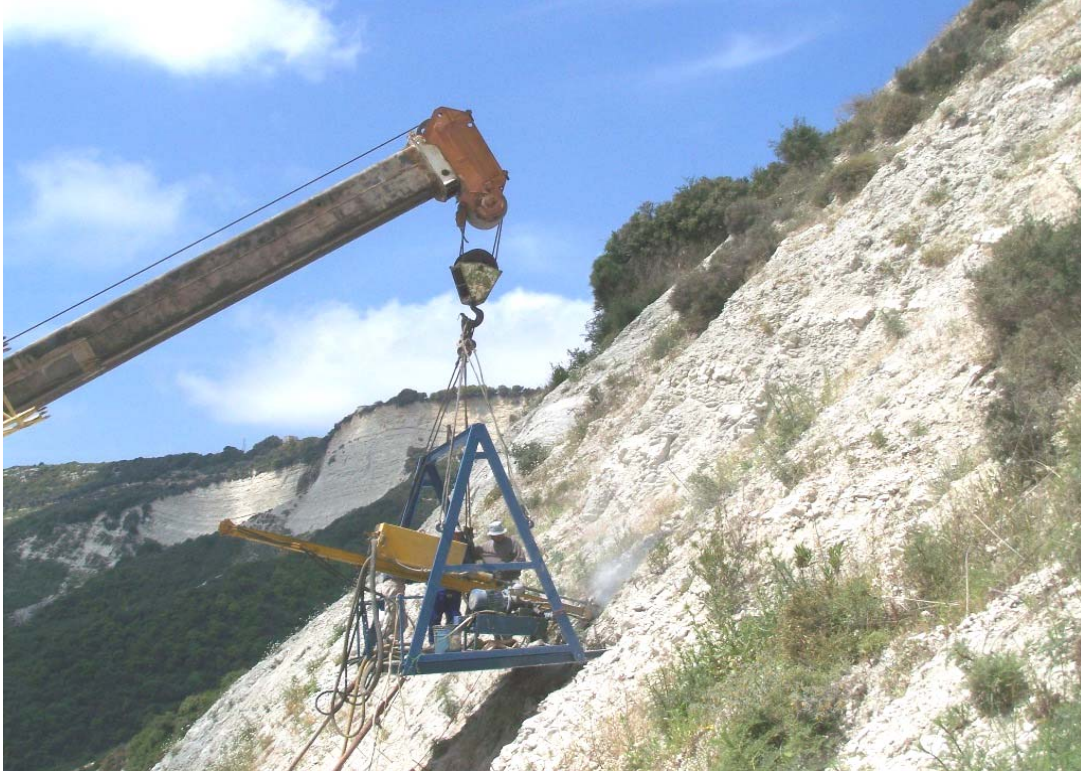
*Figure- 13. Installation of the Nails/bolts Along the Western Slopes.*

3. Repair and rehabilitation of the distressed structural elements including jacketing and repair of the eastern outer wall and the provision of passive nails/rock bolts on the western wall, tying into the parent intact rock, thus reducing pressures on the wall and lateral deformations.

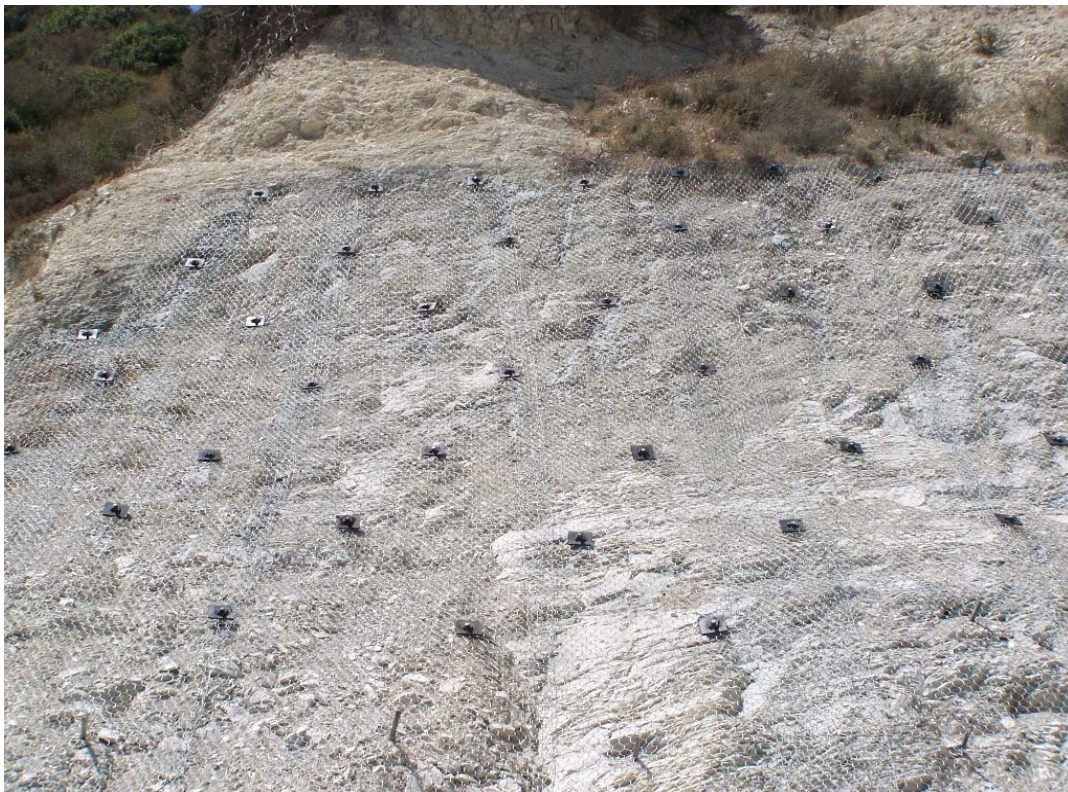
*Figure 14. Completed Rock Bolts/nails and Wire Mesh Installation Along the Western Slope.*

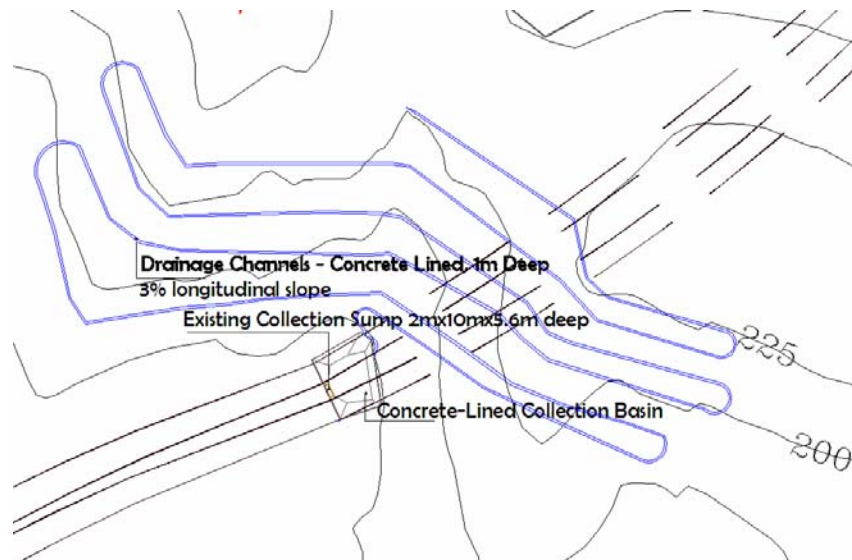
Figure 15. Schematic Plan of the Drainage/interception Channels (Trace of Tunnels Shown as Dashed Lines).
