Lack of Maintenance Compromises Tunnel Structural Safety

ABSTRACT: *The Chekka tunnels represent a critical section of the Northern Lebanon Highway. The approximately 350-m long twin tunnels are the most important tunnels in the country. They are used by regular and freight traffic and are a vital link to the capital, Beirut. The tunnels were completed in the early 1970s on the eve of the Lebanon civil war. Given the state of affairs in the country for about two decades of strife, the tunnels were not maintained nor did they undergo any regular inspection. This unique condition of near-abandonment continued up until recently, when the first signs of distress were documented. These consisted of severe and extensive cracking, particularly in the portal approach of the southbound tunnel, along with significant deterioration of the tunnel lining and radial section joints. The danger to traffic and, potentially, to the structure itself was evident. In this paper, the results of an extensive site inspection and evaluation program are presented. The underlying causes of the observed damage are analyzed and discussed using a modeling approach of the progressive loading conditions. Remedia

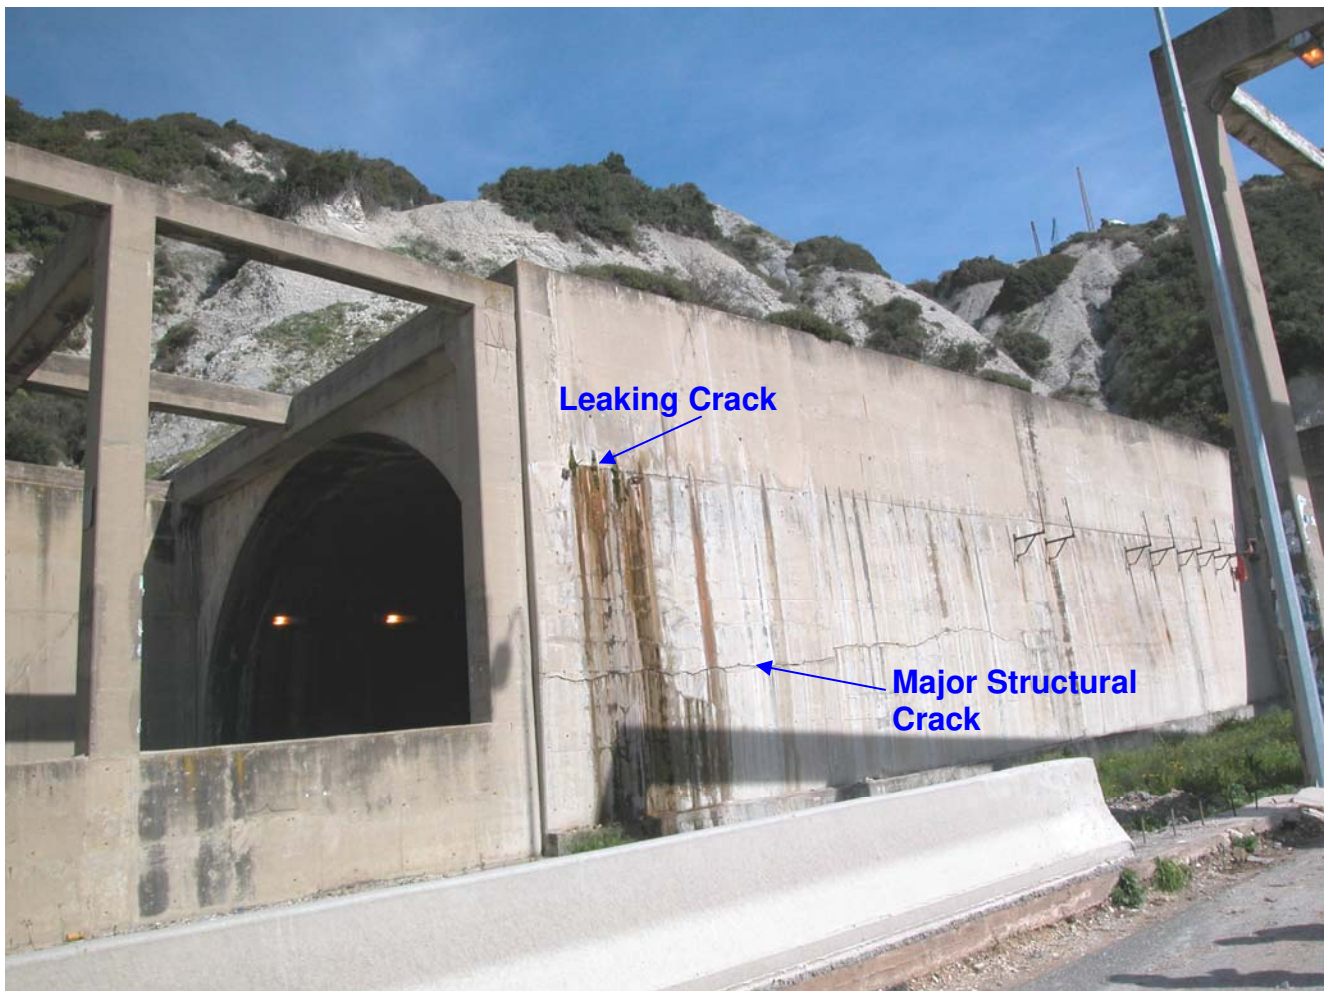
Figure 1. Southbound Tunnel Portal - View of External Distress.

The major crack along the 35-m long portal structure at the southbound tunnel exit (shown in Fig. 1 and Fig. 2) which initiated the engineering intervention, was attributed to increased differential loading. This possible cause for the structural damage was identified following the observation of a relatively large slumped mass of soil loading the western side of the portal structure of the southbound tunnel (Fig. 3). The slumped soil mass was due to weathering of the friable chalky limestone rock on the adjacent exposed slopes and subsequent instability and mass transport. The differential loading of one side of the portal frame structure by the slumped soil mass, along with other contributing factors, could have led to the observed cracking of the eastern wall of the portal along with the associated lateral deformations of up to 15 cm (Fig. 1 and Fig. 2). Additional pictures of this particular tunnel segment are provided in the online database that accompanies this paper.

1. A major longitudinal structural crack was clearly evident on the outside face of the eastern wall of the tunnel portal frame in the last 35 m span of the exit side of the southbound tunnel (Fig. 1). Signs of water leakage through a crack in the eastern wall were evident at the junction between the tunnel portal and the 4.72 m high retaining parapet. This pattern of damage was indicative of a number of problems with the tunnel portals, which are typically identified as potentially problematic areas in a number of situations (Rothfuss et al., 1995).

1. The major structural cracks on the outside face of the eastern wall of the portal frame were repaired by “crack-injection” using low viscosity, two-component epoxy resin. The injection was completed after thorough cleaning and preparation of the affected areas and the provision of injection ports to ensure thorough filling of the cracks. Similar treatments were applied to all cracks and damaged areas in the tunnel concrete lining (Fig. 15).

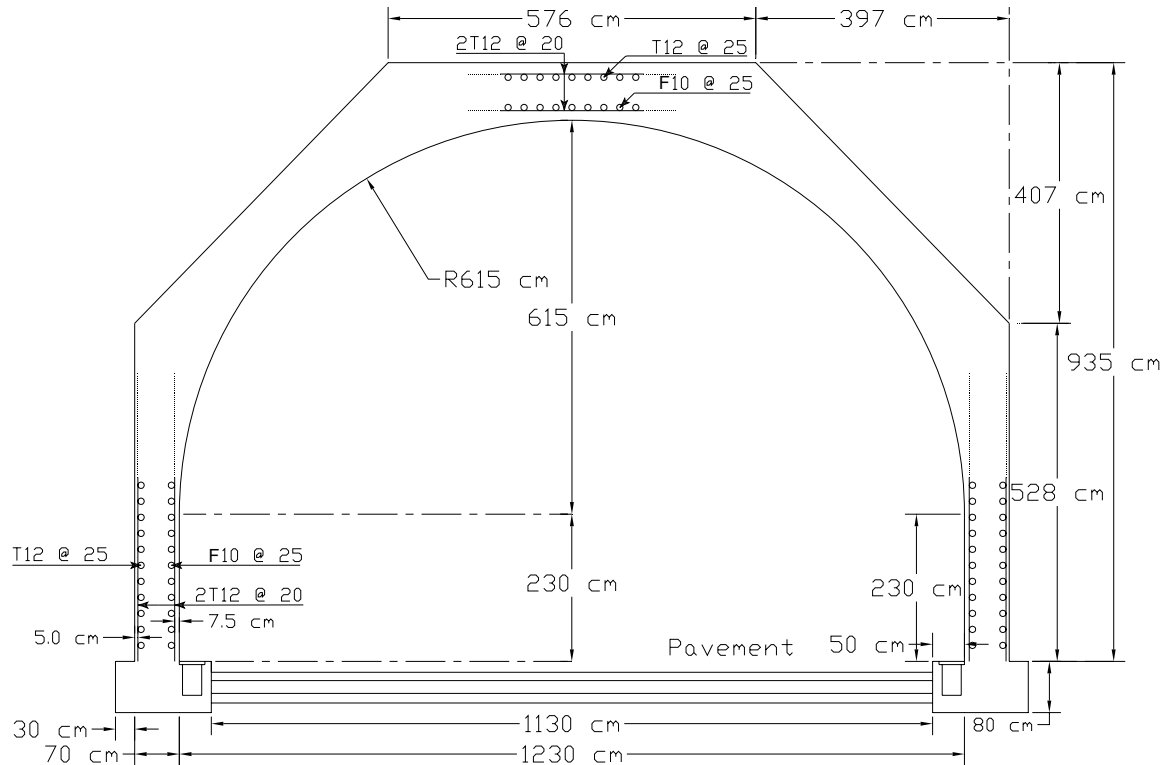
Figure 10. Geometry of the 35-m Long Extension of the Southbound Tunnel Portal.

Table 3 presents the bending moments calculated from the FE analyses and the ultimate moment section capacity at the position of the observed crack ~ 2.5 m above the footing level (Fig. 10).
