Lack of Maintenance Compromises Tunnel Structural Safety

KEYWORDS: Tunnels, maintenance, structural failure, finite element analysis

Sadek S., Hamad B. (2007). *Lack of Maintenance Compromises Tunnel Structural Safety*. International Journal of Geoenvironmental Engineering Case histories, <http://casehistories.geoengineer.org>, Vol.1, Issue 2, p. 136-153.

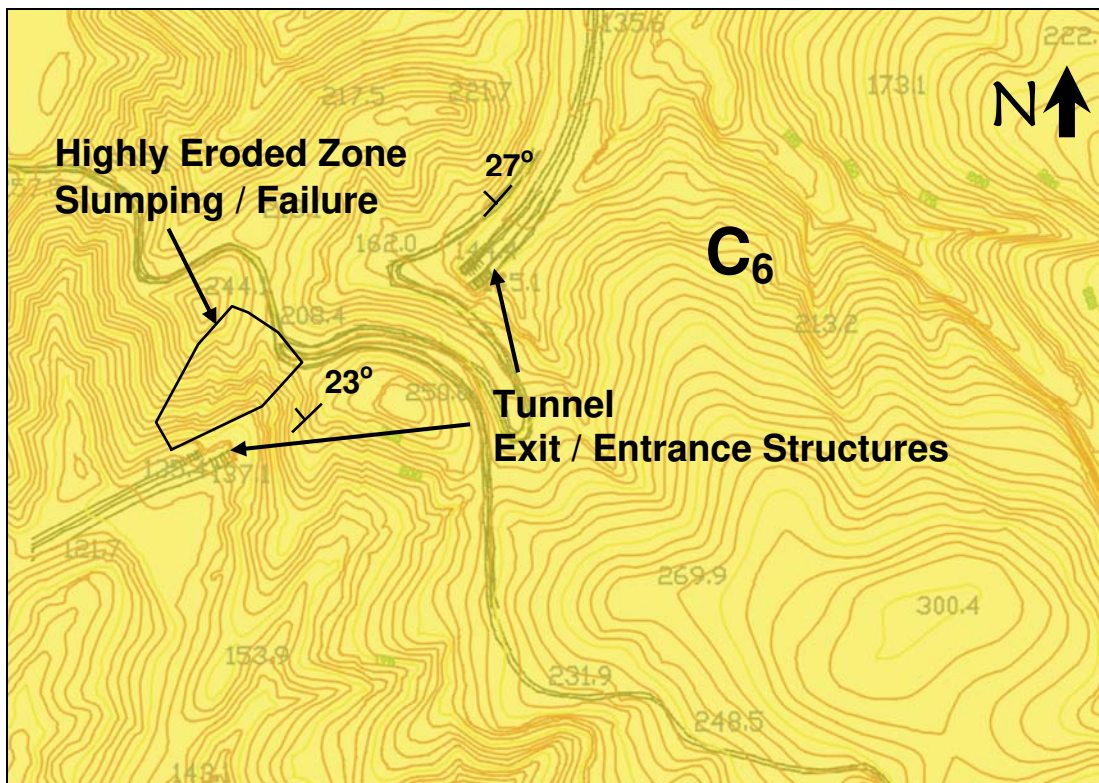
Figure 5. Geology of Area: The Only Outcropping Unit is the Chekka Formation C6.

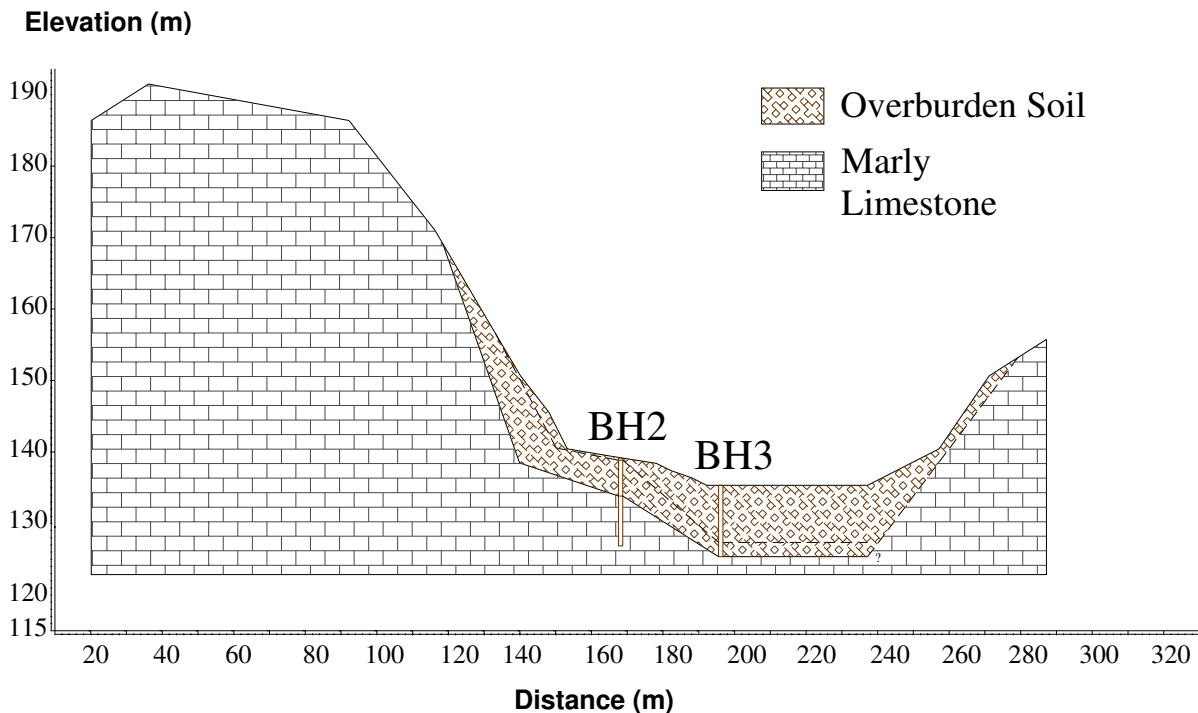
Figure 8. Transverse Section Across South tunnel (A-A in Fig. 7). Tunnel Portal Between Two Hills.

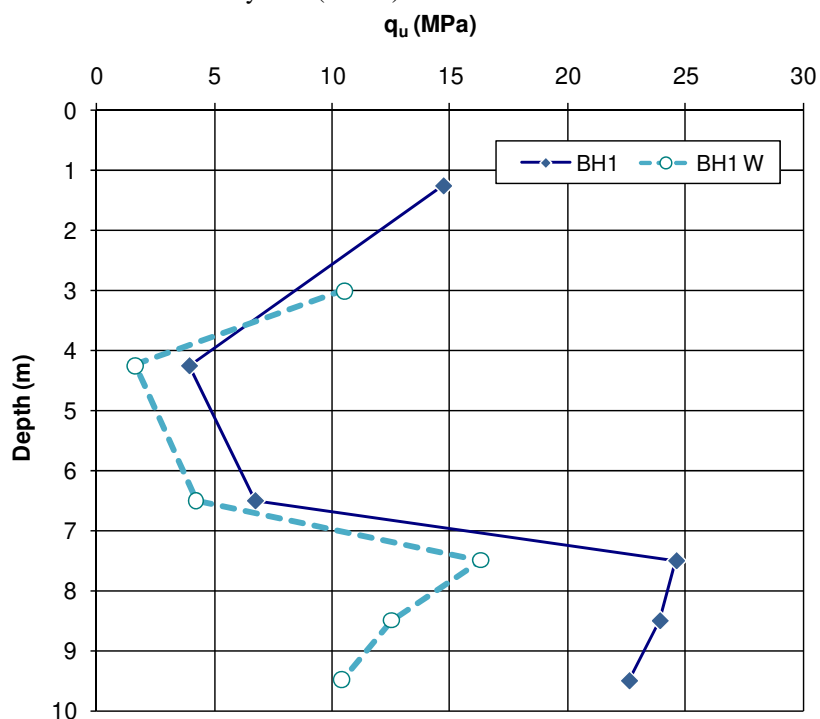
Unconfined compression tests were conducted on rock cores according to ASTM D2166. Some of the samples were submerged in water for 48 hours prior to testing in order to explore the effect of increased water content on the strength of the marlstone/rock samples. The elastic deformation modulus values obtained from the laboratory tests on the cores extracted from the material above the southbound tunnel cross-section are relatively low (from about 5800 to 15000 kPa), which was expected given their higher degree of weathering. The results of the unconfined compression tests showed a significant decrease in strength for the wetted samples. The average unconfined compression strength values from samples from BH-1 and BH-5 for the marly limestone layers are shown in Table 1. The unconfined compressive strengths above the southbound tunnel cross-section suggested an average value of $q_u \sim 19.5$ MPa for the natural condition samples, and a value of $q_u \sim 7.0$ MPa for the wetted samples. Typical results from BH1 samples are presented in Fig. 9.

Figure 9. Unconfined Compressive Strength Results From BH1: Natural Water Content and Wetted Samples (w).
