# Reconstruction of Konstantinovsky Palace in a Suburb of Saint Petersburg

**ABSTRACT:** *This article describes a complex approach to the condition survey and design executed as part of the remedial works on Konstantinovsky palace in the suburb of Strelna (Saint Petersburg)--one of the most beautiful historic monuments of 18th century Russia. The palace was almost completely destroyed in the 1940s. In 2000 the decision was made to reconstruct the palace, and the project for palace reconstruction was developed. The project was completed in 2003. The following important stages of the project are discussed in this paper: palace condition survey and site investigations, analyses of the palace retaining structures, design project of palace reconstruction, and phases of the remedial works.*

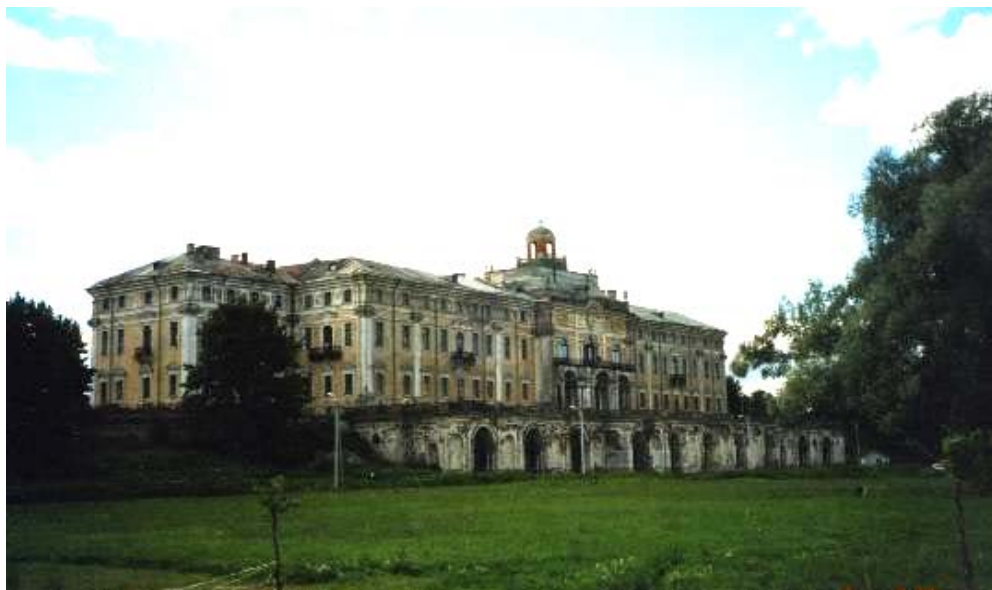
*Figure 6. A photograph of Konstantinovsky Palace taken in 2000 before reconstruction.*

The condition survey results were as follows (see Fig. 6, 7, 9, 10):

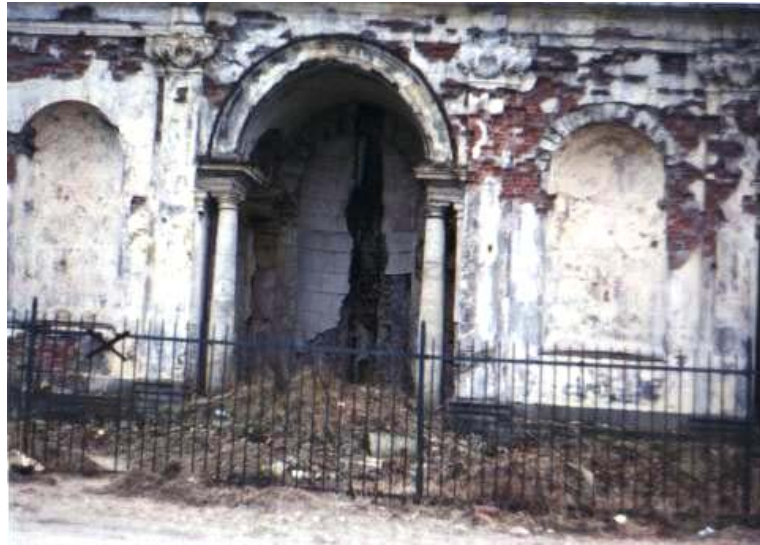
*Figure 7a. Dilapidated structures of the palace: grotto.*

1. Foundations of the dilapidated retaining walls were constructed of bricks. The foundations were no longer capable of being classified as a structure. There was imminent danger of crushed brickwork movement with formation of local bulges.

2. The entire brickwork structure was soaked in water, causing dilapidation through cycles of freezing and thawing.
3. There were no foundations of the transverse walls of the cellars. Footing was level with the cellar's floor. Decomposed timber pile heads supported the transverse walls.

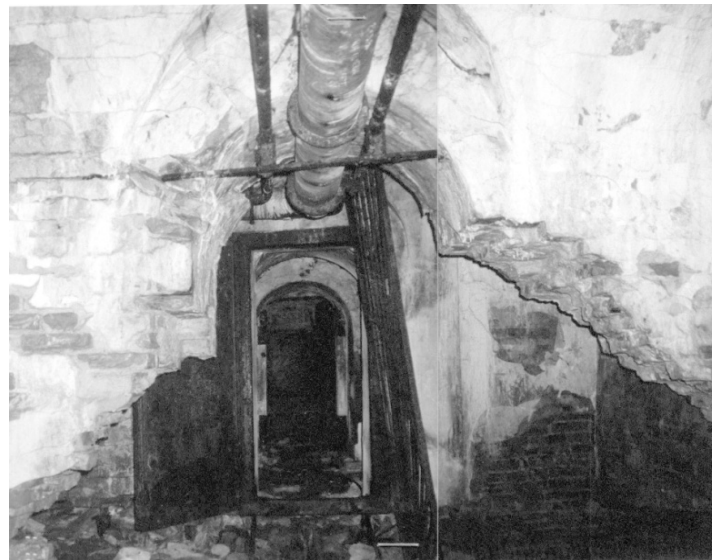
*Figure 7b. Dilapidated structures of the palace: transverse walls.*

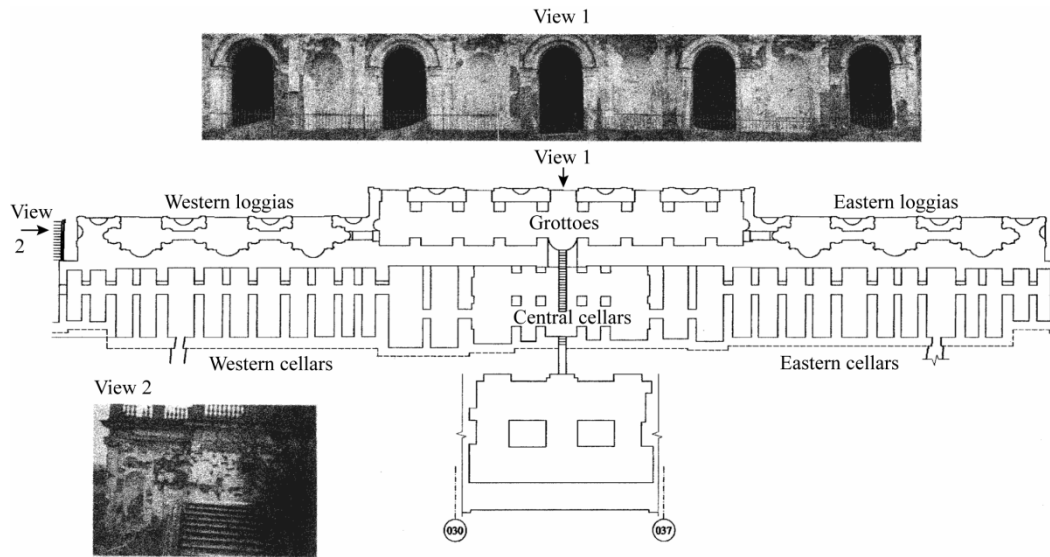
4. Dilapidated terrace gutters had caused weakening of some retaining wall sections adjacent to niches of the loggias and grottoes.
5. The precipitation sewer consisted of three straight courses underneath the retaining structures, designed to divert precipitation and groundwater from the palace. There was water flow through the ground underneath the cellar walls, and through dilapidated retaining wall sections.

6. Most structural damage (fallouts) was associated with the destroyed drainage sections underlying the retaining structures.

Figure 9. Dilapidated cellars, grottoes, and loggias of Konstantinovsky Palace.

The dilapidation mechanism can be presented as follows. The damaged precipitation sewer caused water discharge from the precipitation water collector adjacent to the gable end of the cellars chamber through the ground underneath the floor and the transverse cellar walls, towards the retaining wall. The drainage pipe under the floor alongside the retaining wall stopped functioning, increasing hydraulic pressure to the retaining wall, and over-dampening the brickwork. Because of the damage to the horizontal waterproofing of the terrace floor, percolating water sufficiently increased, and all cellar structures were finally soaked.

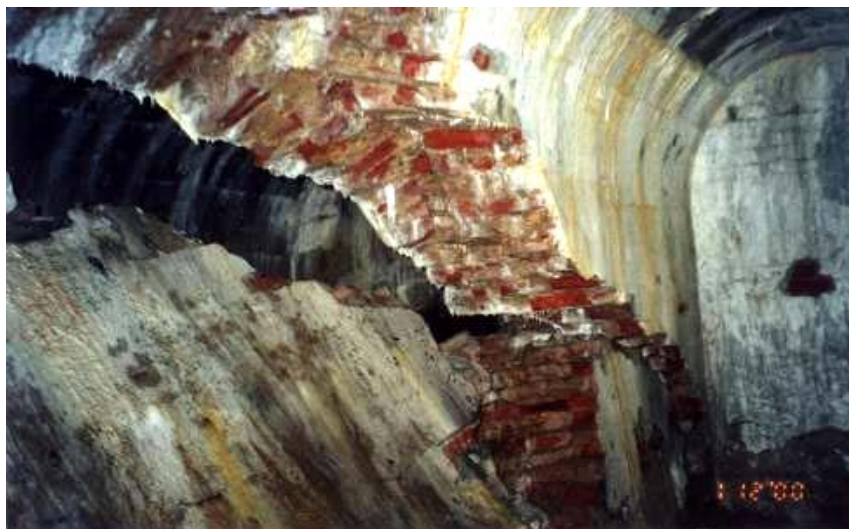
Frost penetration brought about the process of brickwork corrosion accompanied by frost heaving pressure on the retaining wall. At the same time, the vertical terrace drains started malfunctioning, thus thinning and weakening the bearing section of the retaining wall. Cycles of frost penetration into damp brickwork caused destruction thereof by low temperatures. Countless traces of such destruction were observed throughout. Intermittent water discharge into the ground in front of the retaining wall resulted in degradation of the timber pile heads supporting the transverse cellar walls, bringing about their settlement.

Figure 10. Collapsing cellar wall behind east loggias.

Seepage of water through the retaining wall in the weakened section caused suffusion of mortar, formation of seepage passages, and crumbling of brickwork around such passages during frost penetration. Movement of water through the wall caused a flow velocity increase, as well as higher than critical pressure gradients in the subsoil of the transverse walls, washing out of fines from under the transverse cellar walls with corresponding piping, and formation of cavities underneath the walls and the floors.

Piping from under the walls led to their uneven settlement. It also resulted in the subsoil surcharge and generation of additional horizontal pressure on the retaining wall. Gradual dilapidation of the retaining wall brickwork finally resulted in the palace's partial collapse in locations where its bearing section was most weakened by the formation of gaping holes and fallouts (ground and dilapidated brickwork suffusion cones) in the loggia niches. The above description of the dilapidation mechanism was verified by means of detailed geotechnical analyses.

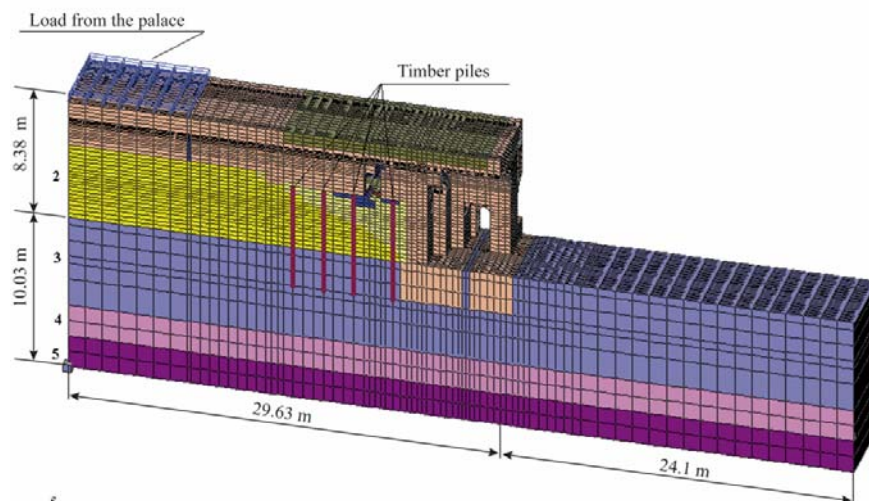
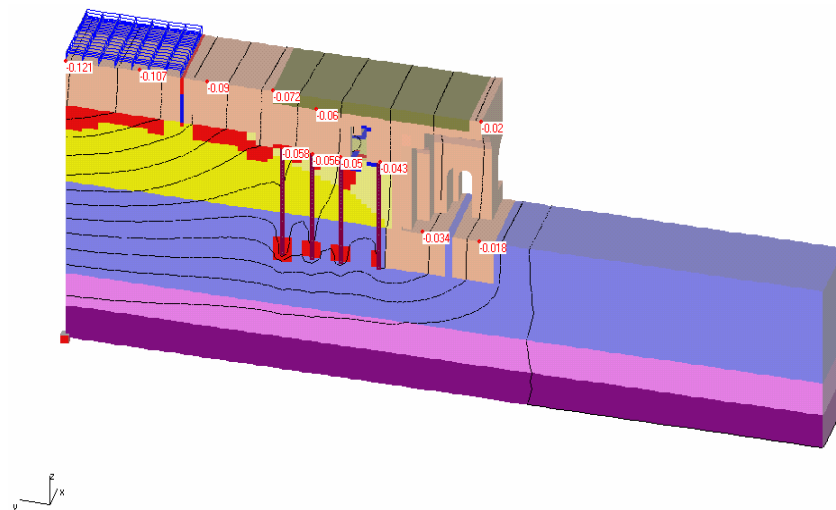
1. Provided that the piled foundation is kept intact underneath the cellar walls (Fig. 11, 12) and the loggia structures remain in stable condition, with settlement of exterior loggia structures not exceeding 3.4 cm, and the settlement of the cellar walls not exceeding 5.8 cm, the building would be stable.
2. In the case of the decomposed timber piles, if the cellar wall settlement reached 7.7 cm it would cause the transverse wall's dilapidation. Due to decomposition, the piles were considered inadequate to support the required loads and thus were not included in the analyses.
3. In the case of ground piping and foundation brickwork loosening, if the settlement reached 8.3 cm and the deformation profile resembled that shown in Fig. 13, then the brickwork material would be dilapidated. Observed brickwork dilapidation suggested that this mechanism was actually occurring at the site.

Figure 11. Calculation profile of the cellars' and loggias' deformation with account of intact timber piles.

Figure 12. Contours of settlements of the cellars and loggias (m) with account of intact timber piles. Dark red color denotes soil regions reaching the limit state by Mohr-Coulomb criteria.

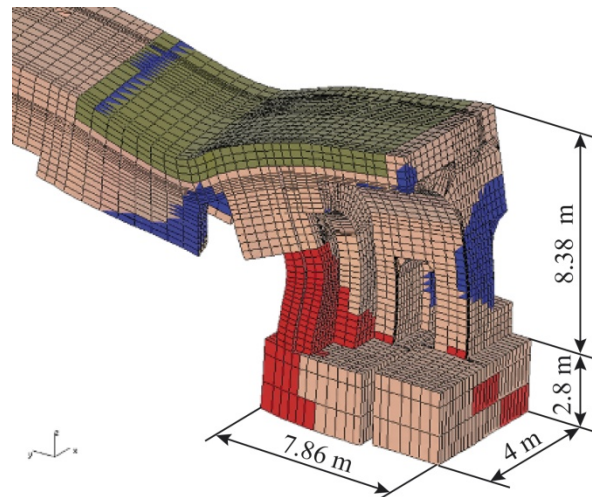
Therefore, the conclusion was that the retaining structure was critically damaged and it would be necessary to carry out complex remedial works.

Figure 13. Deformation scheme (scale of deformations enlarged 500 times) and limit state areas in brickwork (defined by Mohr-Coulomb criteria) accounting for subsoil ground wash-out and decomposed timber piles. Shaded sections denote limit state areas generated by compressive and tensile stresses.

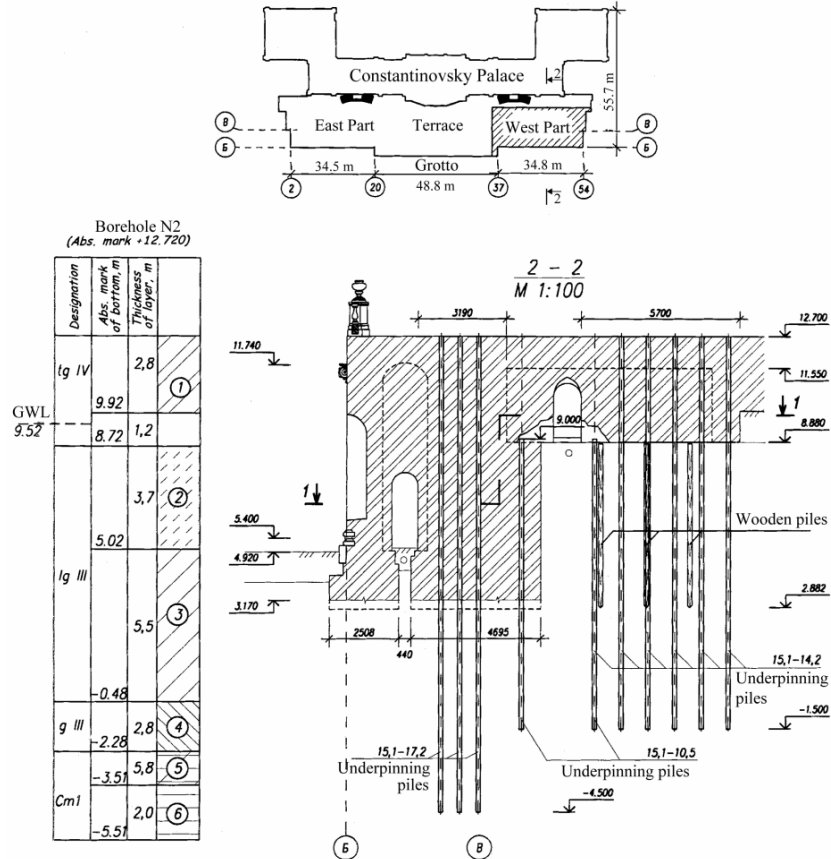
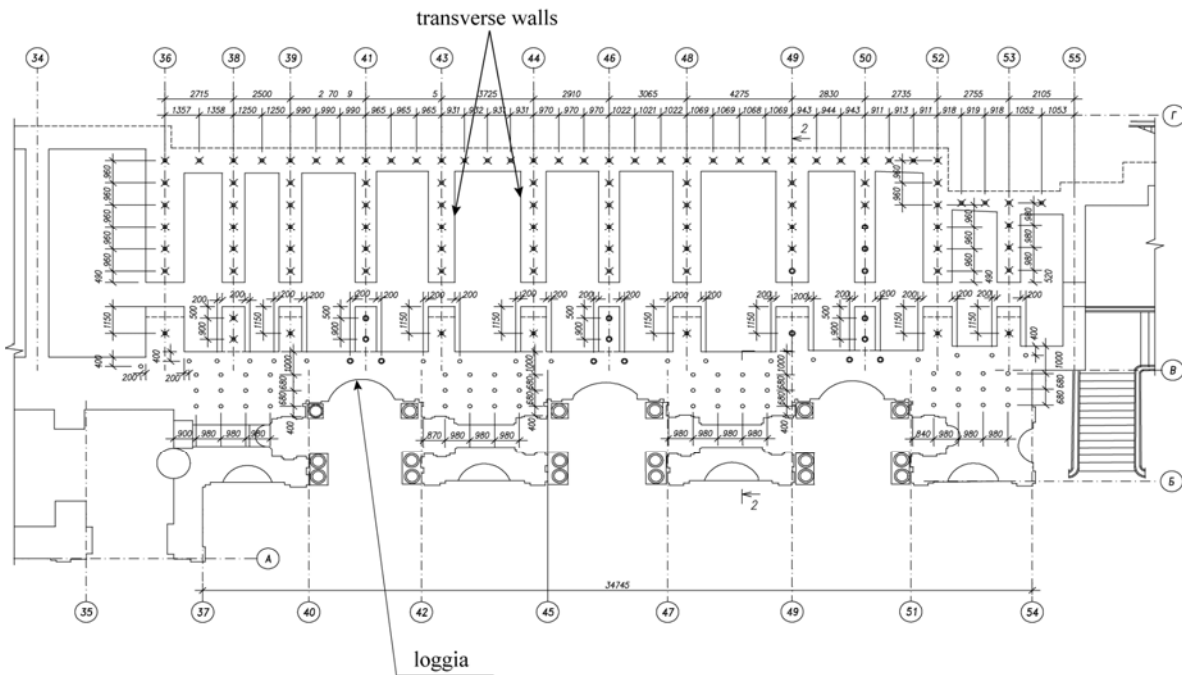
Figure 14. Palace layout in plan - Underpinning of the retaining structure. See Fig. 8 for soil stratification.

Figure 15. Location of underpinning piles in plan: o, x - underpinning piles.

In light of the overall surface dilapidation and general weakening of the brickwork, the option of bandages, confining frames, or other structural reinforcement was considered impractical for providing safe retaining structures and would damage the appearance of the historical building. Therefore, the only option that would address all the issues listed previously appeared to be pressure grouting and strengthening of brickwork, with underpinning of all retaining structures with piles embedded into stiff stratum (Fig. 14, 15).

Based on the above, the foundations underpinning of the retaining structures was carried out in the following sequence (see Fig. 14, 15).

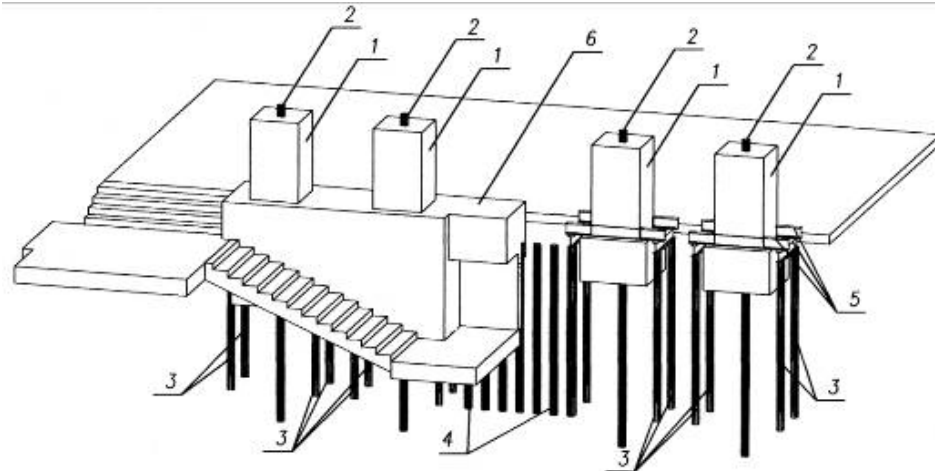
Figure 16. Provision of celebrity entrance overlooking the Lower Park (deepening of the basement down to 5.0 m):  
1. existing brickwork pillar, 2. underpinning piles constructed from terrace surface, 3. pile supports for propping brickwork pillars, 4. pile wall, 5. steel waling transmitting loads form pillars onto piles, 6. retaining wall constructed of reinforced concrete.

3. The constructed strengthening option was successful even when faced with an unexpected challenge. The architects suddenly decided to provide front access to the palace from the Lower Park and furnish a vestibule underneath the terrace. To do this, all cellars had to be deepened by 1.0-1.5 m and the transverse brick walls were temporarily suspended on the thin underpinning piles (Fig. 16, 17, 18). Quality of the strengthening was attested by the fact that not one section of the brickwork was in any way displaced. It was therefore ascertained that the strengthening was successful.

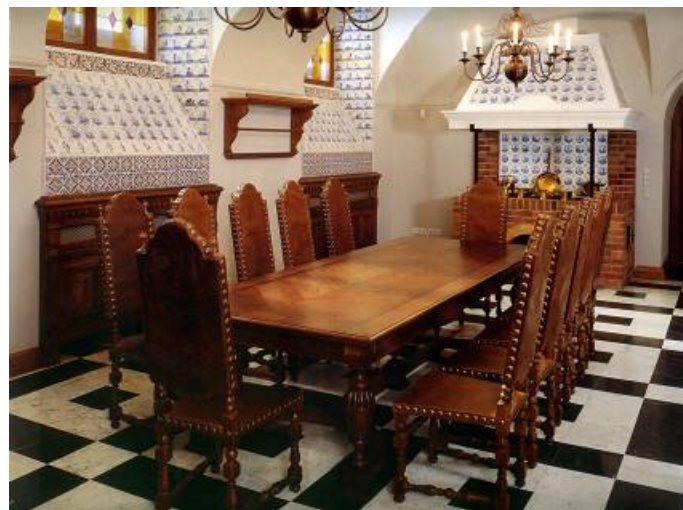
*Figure 20. Cellars of Konstantinovsky Palace, 2004 (at the location of reconstructed retaining cellar wall, see Fig. 10).*
