Reconstruction of Konstantinovsky Palace in a Suburb of Saint Petersburg

ABSTRACT: *This article describes a complex approach to the condition survey and design executed as part of the remedial works on Konstantinovsky palace in the suburb of Strelna (Saint Petersburg)--one of the most beautiful historic monuments of 18th century Russia. The palace was almost completely destroyed in the 1940s. In 2000 the decision was made to reconstruct the palace, and the project for palace reconstruction was developed. The project was completed in 2003. The following important stages of the project are discussed in this paper: palace condition survey and site investigations, analyses of the palace retaining structures, design project of palace reconstruction, and phases of the remedial works.*

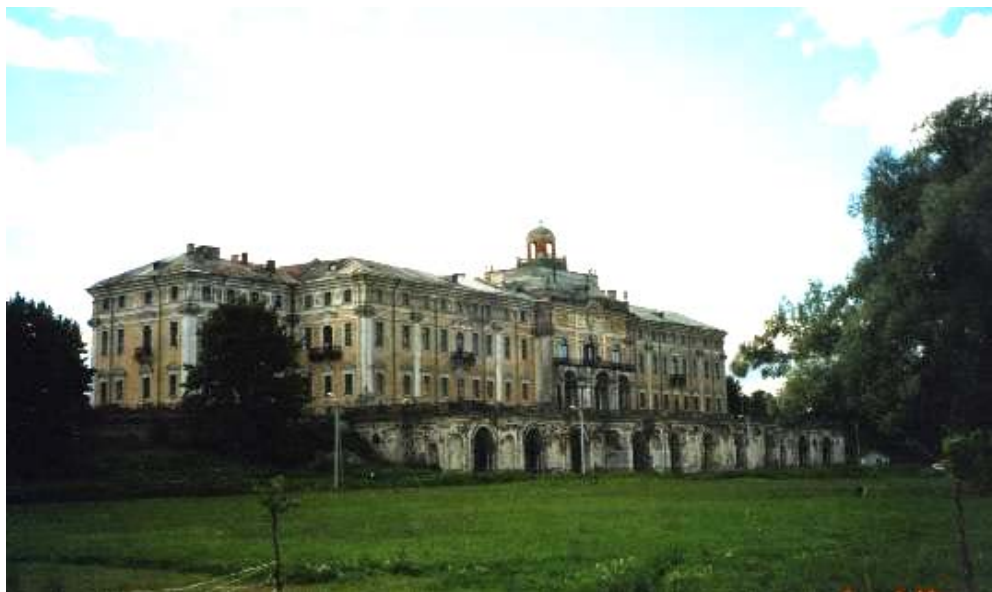
Figure 6. A photograph of Konstantinovsky Palace taken in 2000 before reconstruction.

The condition survey results were as follows (see Fig. 6, 7, 9, 10):

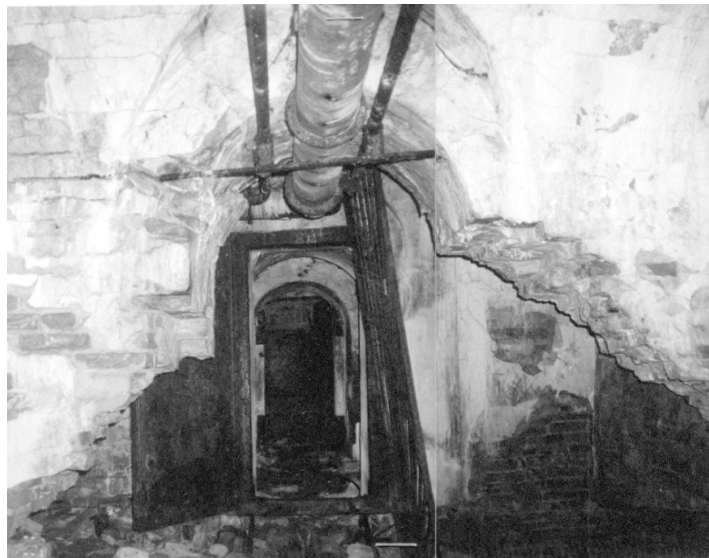
Figure 7b. Dilapidated structures of the palace: transverse walls.

2. The entire brickwork structure was soaked in water, causing dilapidation through cycles of freezing and thawing.
3. There were no foundations of the transverse walls of the cellars. Footing was level with the cellar's floor. Decomposed timber pile heads supported the transverse walls.

Frost penetration brought about the process of brickwork corrosion accompanied by frost heaving pressure on the retaining wall. At the same time, the vertical terrace drains started malfunctioning, thus thinning and weakening the bearing section of the retaining wall. Cycles of frost penetration into damp brickwork caused destruction thereof by low temperatures. Countless traces of such destruction were observed throughout. Intermittent water discharge into the ground in front of the retaining wall resulted in degradation of the timber pile heads supporting the transverse cellar walls, bringing about their settlement.

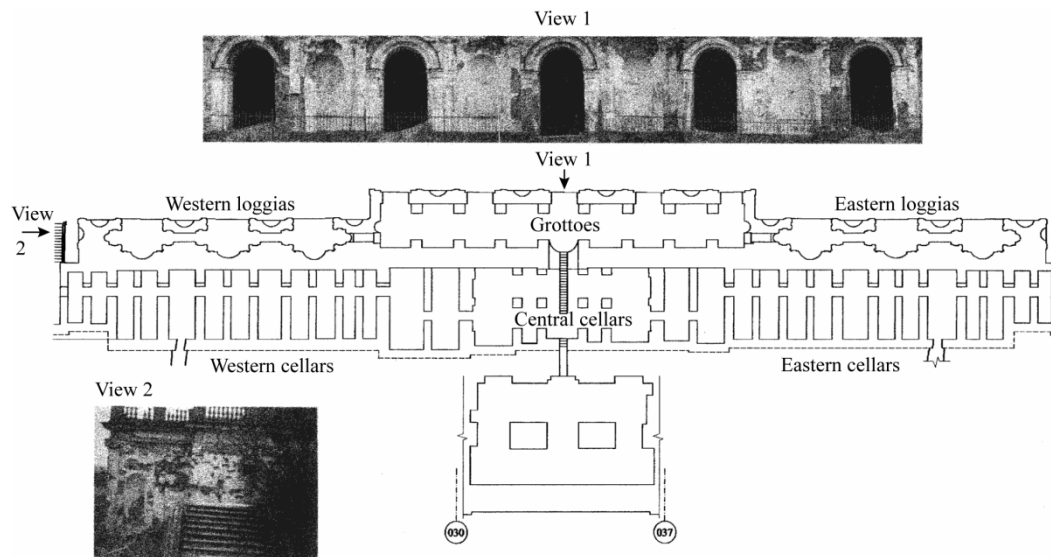
4. Dilapidated terrace gutters had caused weakening of some retaining wall sections adjacent to niches of the loggias and grottoes.
5. The precipitation sewer consisted of three straight courses underneath the retaining structures, designed to divert precipitation and groundwater from the palace. There was water flow through the ground underneath the cellar walls, and through dilapidated retaining wall sections.

6. Most structural damage (fallouts) was associated with the destroyed drainage sections underlying the retaining structures.

Figure 9. Dilapidated cellars, grottoes, and loggias of Konstantinovsky Palace.

The dilapidation mechanism can be presented as follows. The damaged precipitation sewer caused water discharge from the precipitation water collector adjacent to the gable end of the cellars chamber through the ground underneath the floor and the transverse cellar walls, towards the retaining wall. The drainage pipe under the floor alongside the retaining wall stopped functioning, increasing hydraulic pressure to the retaining wall, and over-dampening the brickwork. Because of the damage to the horizontal waterproofing of the terrace floor, percolating water sufficiently increased, and all cellar structures were finally soaked.

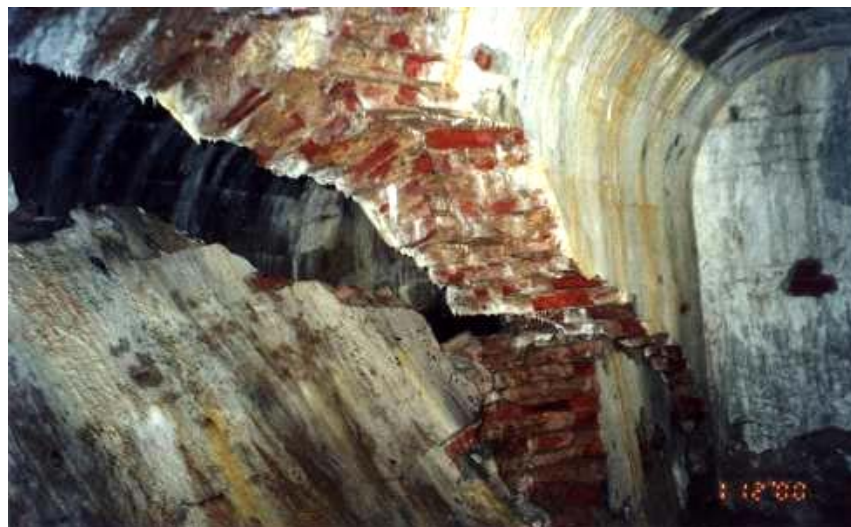
Figure 10. Collapsing cellar wall behind east loggias.

Seepage of water through the retaining wall in the weakened section caused suffusion of mortar, formation of seepage passages, and crumbling of brickwork around such passages during frost penetration. Movement of water through the wall caused a flow velocity increase, as well as higher than critical pressure gradients in the subsoil of the transverse walls, washing out of fines from under the transverse cellar walls with corresponding piping, and formation of cavities underneath the walls and the floors.

Piping from under the walls led to their uneven settlement. It also resulted in the subsoil surcharge and generation of additional horizontal pressure on the retaining wall. Gradual dilapidation of the retaining wall brickwork finally resulted in the palace's partial collapse in locations where its bearing section was most weakened by the formation of gaping holes and fallouts (ground and dilapidated brickwork suffusion cones) in the loggia niches. The above description of the dilapidation mechanism was verified by means of detailed geotechnical analyses.

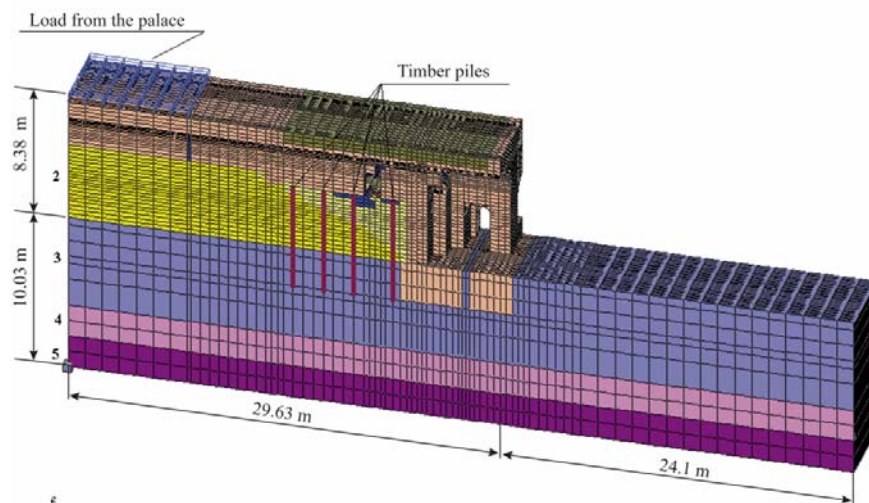
1. Provided that the piled foundation is kept intact underneath the cellar walls (Fig. 11, 12) and the loggia structures remain in stable condition, with settlement of exterior loggia structures not exceeding 3.4 cm, and the settlement of the cellar walls not exceeding 5.8 cm, the building would be stable.
2. In the case of the decomposed timber piles, if the cellar wall settlement reached 7.7 cm it would cause the transverse wall's dilapidation. Due to decomposition, the piles were considered inadequate to support the required loads and thus were not included in the analyses.
3. In the case of ground piping and foundation brickwork loosening, if the settlement reached 8.3 cm and the deformation profile resembled that shown in Fig. 13, then the brickwork material would be dilapidated. Observed brickwork dilapidation suggested that this mechanism was actually occurring at the site.

Figure 11. Calculation profile of the cellars' and loggias' deformation with account of intact timber piles.

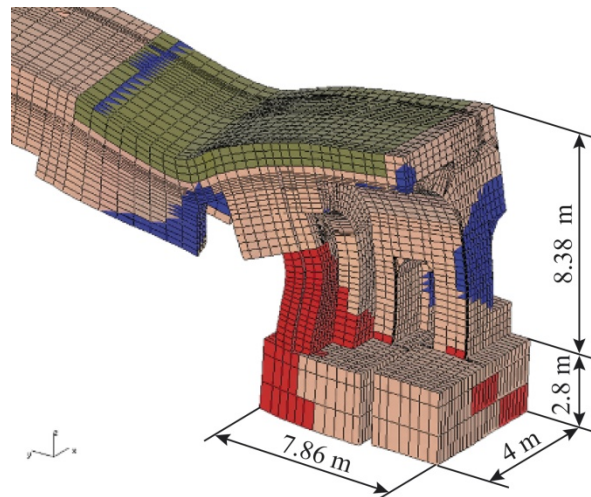
Therefore, the conclusion was that the retaining structure was critically damaged and it would be necessary to carry out complex remedial works.

Figure 13. Deformation scheme (scale of deformations enlarged 500 times) and limit state areas in brickwork (defined by Mohr-Coulomb criteria) accounting for subsoil ground wash-out and decomposed timber piles. Shaded sections denote limit state areas generated by compressive and tensile stresses.

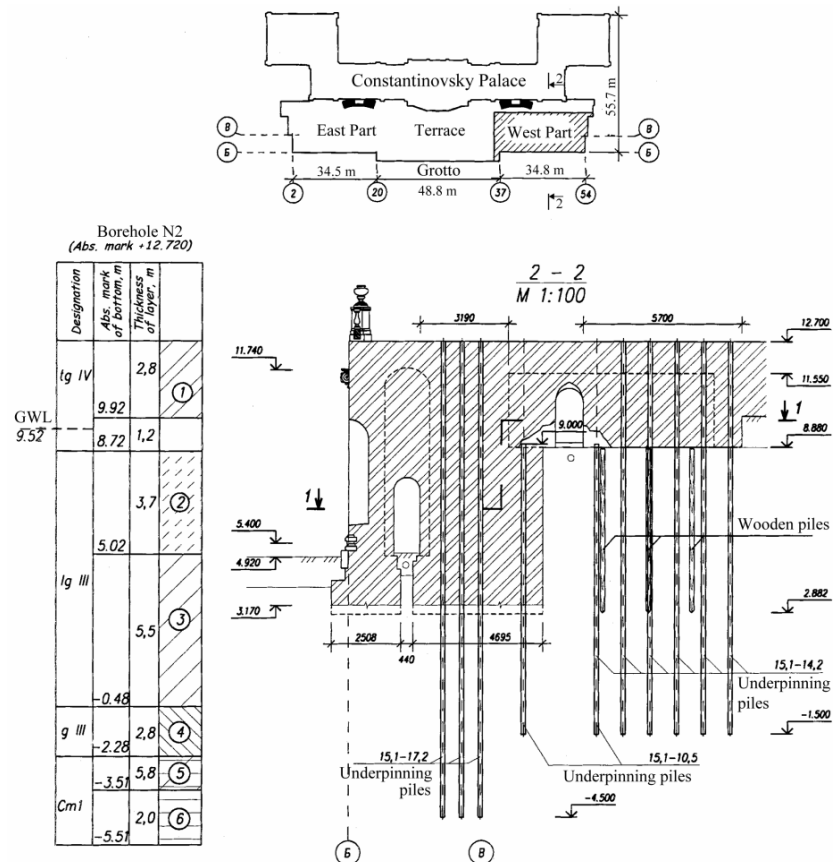
Figure 14. Palace layout in plan - Underpinning of the retaining structure. See Fig. 8 for soil stratification.

In light of the overall surface dilapidation and general weakening of the brickwork, the option of bandages, confining frames, or other structural reinforcement was considered impractical for providing safe retaining structures and would damage the appearance of the historical building. Therefore, the only option that would address all the issues listed previously appeared to be pressure grouting and strengthening of brickwork, with underpinning of all retaining structures with piles embedded into stiff stratum (Fig. 14, 15).

Based on the above, the foundations underpinning of the retaining structures was carried out in the following sequence (see Fig. 14, 15).

1. Strengthening of the critically dilapidated structures (3 left and 3 right loggias).
2. Provision of temporary propping scaffolding in cellar chambers installed on wedges in the cellar floors. Wedging of the scaffolding was regularly inspected. The unsupported spans in locations of the brickwork fallouts were likewise propped.

3. Drilling of 42 mm vertical bores above the partitions of the retaining wall from the terrace in front of the palace down to the brick-wall footing level. Subsequently, the brickwork was grouted by intervals with packing lime mortar until completely permeated.

4. Redrilling of the bores by 151-mm core bores down to the top of the firm Cambrian stratum following 70% setting of the mortar. Drilling below foundation footing was either carried out using thixotropic grout or was casing protected. Cement grout with added plasticizing and shrink-proofing agents was pumped into the subsoil and brickwork at 0.2 and 0.1 MPa respectively, followed by a stain-proof reinforcement casing tube being oscillated into the grout mix. The resulting pile was thus constructed with its toe against the stiff Cambrian stratum reinforcing and underpinning the entire retaining brickwork section. The tube was required to ensure both longer pile life and subsequent possible of deepening of the cellars. Toe levels and bearing of the piles had been previously confirmed based on the static loading tests.

5. Drilling of 42 mm vertical bores paced at approximately 1.0 m from the terrace in front of the palace along each transverse wall down to the brick-wall footing level (absolute level 8.9 m BD) in order to reinforce the transverse walls and rear longitudinal wall of the cellars. This was followed by interval grouting and subsequent redrilling of the bores by 151-mm augers, used in the bored piles construction, down to absolute level of 1.5 m BD. Those piles were likewise reinforced through their entire length.

6. Construction of pile heads in the dilapidated areas of the transverse walls at the level of the brickwork footing (absolute level 8.8 m BD), with subsequent construction of the pile caps and masonry courses within the original scope.

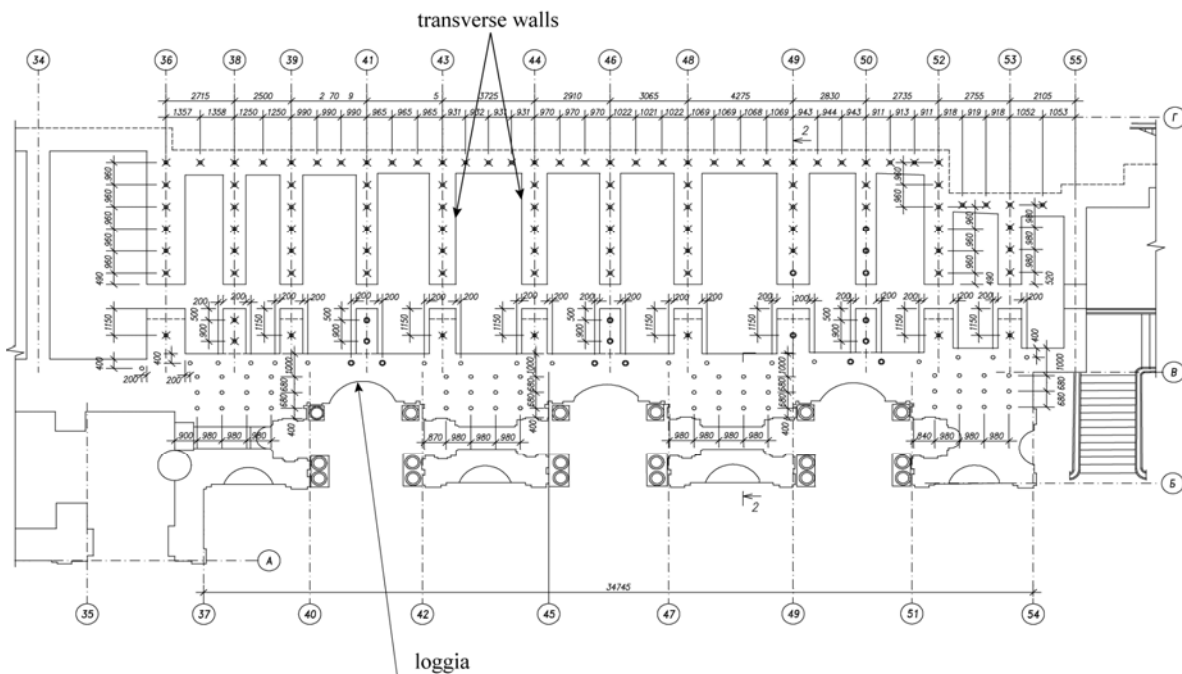
Figure 15. Location of underpinning piles in plan: o, x - underpinning piles.

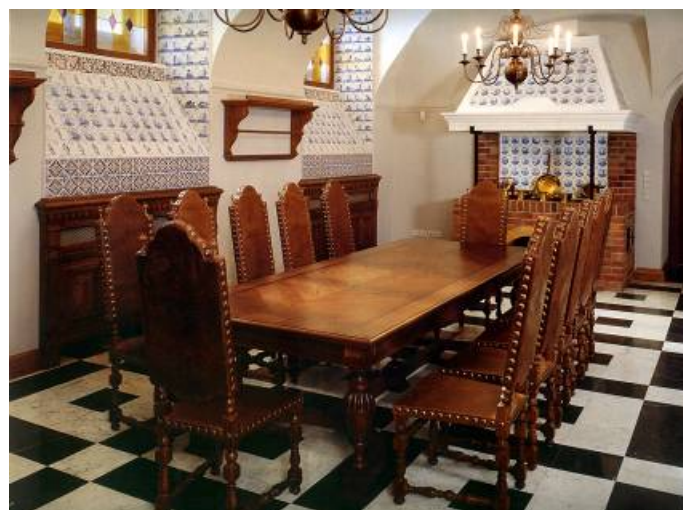
Figure 20. Cellars of Konstantinovsky Palace, 2004 (at the location of reconstructed retaining cellar wall, see Fig. 10).
