Reconstruction of Konstantinovsky Palace in a Suburb of Saint Petersburg

ABSTRACT: *This article describes a complex approach to the condition survey and design executed as part of the remedial works on Konstantinovsky palace in the suburb of Strelna (Saint Petersburg)--one of the most beautiful historic monuments of 18th century Russia. The palace was almost completely destroyed in the 1940s. In 2000 the decision was made to reconstruct the palace, and the project for palace reconstruction was developed. The project was completed in 2003. The following important stages of the project are discussed in this paper: palace condition survey and site investigations, analyses of the palace retaining structures, design project of palace reconstruction, and phases of the remedial works.*

Reconstruction of Konstantinovsky Palace in a Suburb of Saint Petersburg. International Journal of Geoengineering Case histories, <http://casehistories.geoengineer.org>, Vol.1, Issue 3, p.189-205.

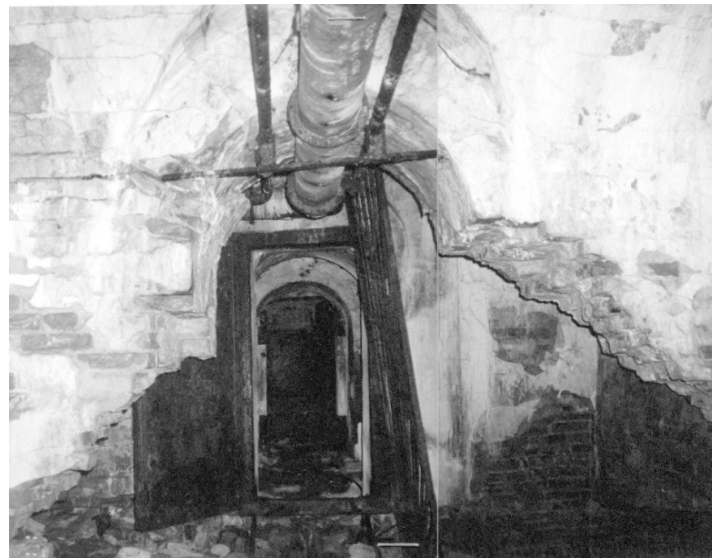
Figure 7b. Dilapidated structures of the palace: transverse walls.

2. The entire brickwork structure was soaked in water, causing dilapidation through cycles of freezing and thawing.
3. There were no foundations of the transverse walls of the cellars. Footing was level with the cellar's floor. Decomposed timber pile heads supported the transverse walls.

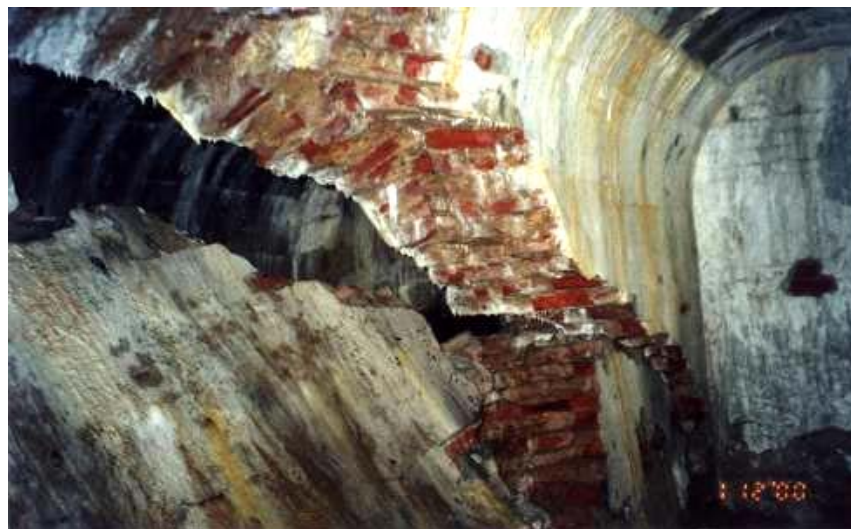
Figure 10. Collapsing cellar wall behind east loggias.

Seepage of water through the retaining wall in the weakened section caused suffusion of mortar, formation of seepage passages, and crumbling of brickwork around such passages during frost penetration. Movement of water through the wall caused a flow velocity increase, as well as higher than critical pressure gradients in the subsoil of the transverse walls, washing out of fines from under the transverse cellar walls with corresponding piping, and formation of cavities underneath the walls and the floors.

Piping from under the walls led to their uneven settlement. It also resulted in the subsoil surcharge and generation of additional horizontal pressure on the retaining wall. Gradual dilapidation of the retaining wall brickwork finally resulted in the palace's partial collapse in locations where its bearing section was most weakened by the formation of gaping holes and fallouts (ground and dilapidated brickwork suffusion cones) in the loggia niches. The above description of the dilapidation mechanism was verified by means of detailed geotechnical analyses.

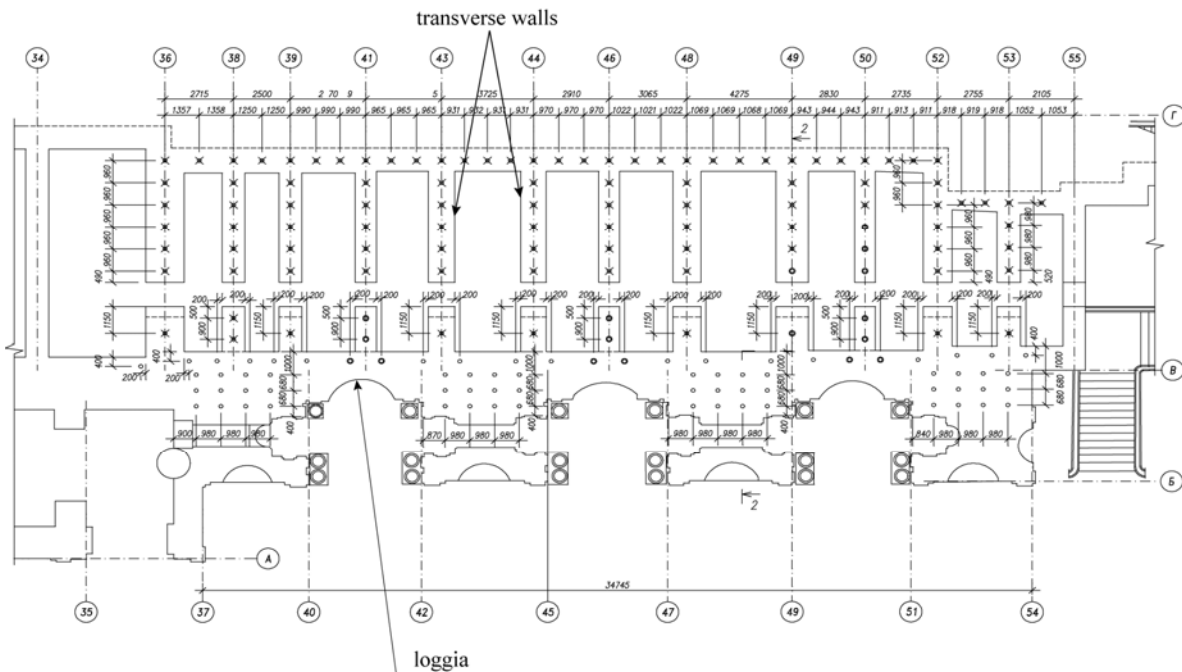
Figure 15. Location of underpinning piles in plan: o, x - underpinning piles.

In light of the overall surface dilapidation and general weakening of the brickwork, the option of bandages, confining frames, or other structural reinforcement was considered impractical for providing safe retaining structures and would damage the appearance of the historical building. Therefore, the only option that would address all the issues listed previously appeared to be pressure grouting and strengthening of brickwork, with underpinning of all retaining structures with piles embedded into stiff stratum (Fig. 14, 15).

Based on the above, the foundations underpinning of the retaining structures was carried out in the following sequence (see Fig. 14, 15).

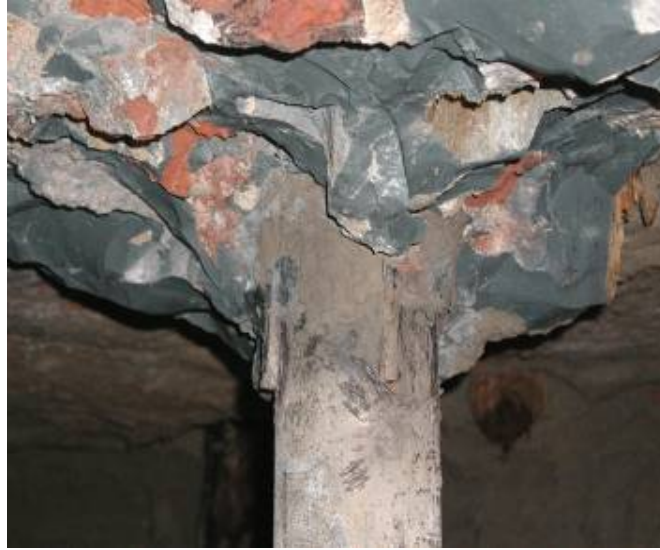
Figure 18. Bored pile with tube reinforcement viewed from underneath foundation.

4. Redrilling of the bores by 151-mm core bores down to the top of the firm Cambrian stratum following 70% setting of the mortar. Drilling below foundation footing was either carried out using thixotropic grout or was casing protected. Cement grout with added plasticizing and shrink-proofing agents was pumped into the subsoil and brickwork at 0.2 and 0.1 MPa respectively, followed by a stain-proof reinforcement casing tube being oscillated into the grout mix. The resulting pile was thus constructed with its toe against the stiff Cambrian stratum reinforcing and underpinning the entire retaining brickwork section. The tube was required to ensure both longer pile life and subsequent possible of deepening of the cellars. Toe levels and bearing of the piles had been previously confirmed based on the static loading tests.

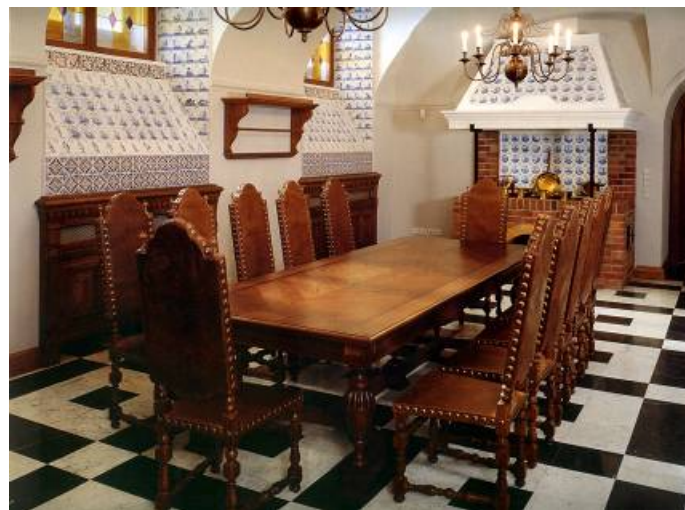
Figure 20. Cellars of Konstantinovsky Palace, 2004 (at the location of reconstructed retaining cellar wall, see Fig. 10).
