# Reconstruction of Konstantinovsky Palace in a Suburb of Saint Petersburg

ABSTRACT: This article describes a complex approach to the condition survey and design executed as part of the remedial works on Konstantinovsky palace in the suburb of Strelna (Saint Petersburg)--one of the most beautiful historic monuments of 18th century Russia. The palace was almost completely destroyed in the 1940s. In 2000 the decision was made to reconstruct the palace, and the project for palace reconstruction was developed. The project was completed in 2003. The following important stages of the project are discussed in this paper: palace condition survey and site investigations, analyses of the palace retaining structures, design project of palace reconstruction, and phases of the remedial works.

Reconstruction of Konstantinovsky Palace in a Suburb of Saint Petersburg. International Journal of Geoengineering Case histories, http://casehistories.geoengineer.org, Vol.1, Issue 3, p.189-205.

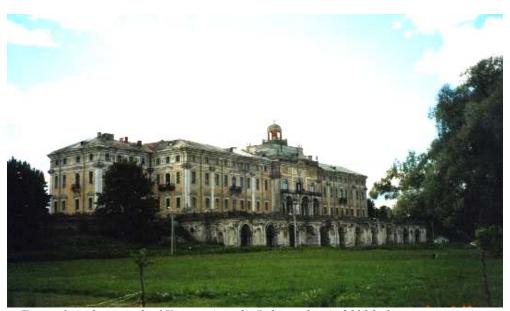
Figure 6. A photograph of Konstantinovsky Palace taken in 2000 before reconstruction.

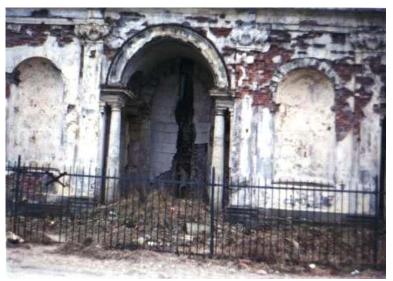
Figure 7a. Dilapidated structures of the palace: grotto.

- 2. The entire brickwork structure was soaked in water, causing dilapidation through cycles of freezing and thawing.
- 3. There were no foundations of the transverse walls of the cellars. Footing was level with the cellar's floor. Decomposed timber pile heads supported the transverse walls.

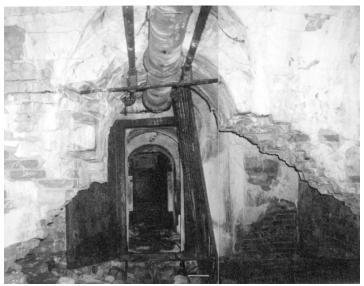
Figure 7b. Dilapidated structures of the palace: transverse walls.

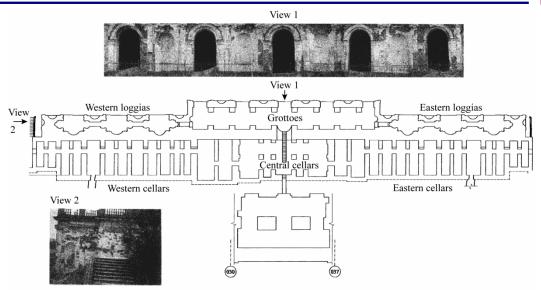
- 1. Foundations of the dilapidated retaining walls were constructed of bricks. The foundations were no longer capable of being classified as a structure. There was imminent danger of crushed brickwork movement with formation of local bulges.

- 4. Dilapidated terrace gutters had caused weakening of some retaining wall sections adjacent to niches of the loggias and grottoes.
- 5. The precipitation sewer consisted of three straight courses underneath the retaining structures, designed to divert precipitation and groundwater from the palace. There was water flow through the ground underneath the cellar walls, and through dilapidated retaining wall sections.

Figure 9. Dilapidated cellars, grottoes, and loggias of Konstantinovsky Palace.

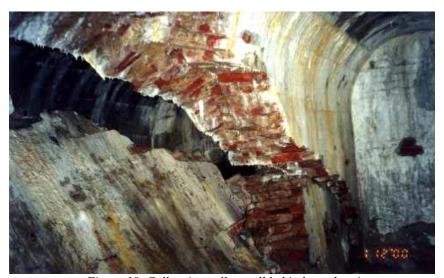
Figure 10. Collapsing cellar wall behind east loggias.

Seepage of water through the retaining wall in the weakened section caused suffusion of mortar, formation of seepage passages, and crumbling of brickwork around such passages during frost penetration. Movement of water through the wall caused a flow velocity increase, as well as higher than critical pressure gradients in the subsoil of the transverse walls, washing out of fines from under the transverse cellar walls with corresponding piping, and formation of cavities underneath the walls and the floors.

Piping from under the walls led to their uneven settlement. It also resulted in the subsoil surcharge and generation of additional horizontal pressure on the retaining wall. Gradual dilapidation of the retaining wall brickwork finally resulted in the palace's partial collapse in locations where its bearing section was most weakened by the formation of gaping holes and fallouts (ground and dilapidated brickwork suffusion cones) in the loggia niches. The above description of the dilapidation mechanism was verified by means of detailed geotechnical analyses.

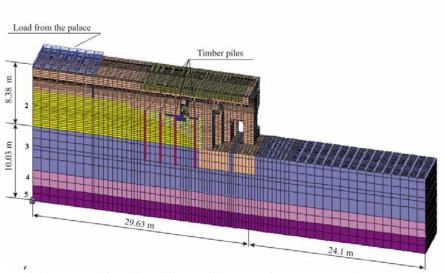
- 1. Provided that the piled foundation is kept intact underneath the cellar walls (Fig. 11, 12) and the loggia structures remain in stable condition, with settlement of exterior loggia structures not exceeding 3.4 cm, and the settlement of the cellar walls not exceeding 5.8 cm, the building would be stable.
- 2. In the case of the decomposed timber piles, if the cellar wall settlement reached 7.7 cm it would cause the transverse wall's dilapidation. Due to decomposition, the piles were considered inadequate to support the required loads and thus were not included in the analyses.
- 3. In the case of ground piping and foundation brickwork loosening, if the settlement reached 8.3 cm and the deformation profile resembled that shown in Fig. 13, then the brickwork material would be dilapidated. Observed brickwork dilapidation suggested that this mechanism was actually occurring at the site.

Figure 11. Calculation profile of the cellars' and loggias' deformation with account of intact timber piles.

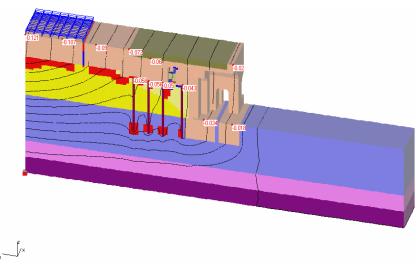
Figure 12. Contours of settlements of the cellars and loggias (m) with account of intact timber piles. Dark red color denotes soil regions reaching the limit state by Mohr-Coulomb criteria.

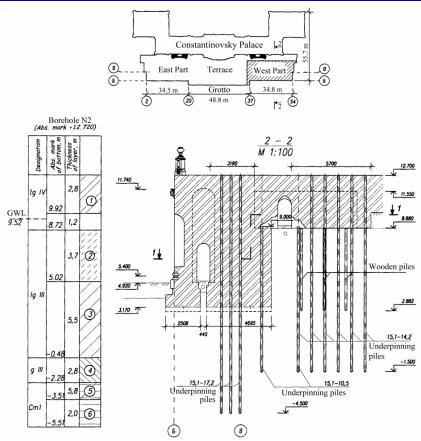
Figure 14. Palace layout in plan - Underpinning of the retaining structure. See Fig. 8 for soil stratification.

Based on the above, the foundations underpinning of the retaining structures was carried out in the following sequence (see Fig. 14, 15).

- 3. Drilling of 42 mm vertical bores above the partitions of the retaining wall from the terrace in front of the palace down to the brick-wall footing level. Subsequently, the brickwork was grouted by intervals with packing lime mortar until completely permeated.

- 4. Redrilling of the bores by 151-mm core bores down to the top of the firm Cambrian stratum following 70% setting of the mortar. Drilling below foundation footing was either carried out using thixotropic grout or was casing protected. Cement grout with added plasticizing and shrink-proofing agents was pumped into the subsoil and brickwork at 0.2 and 0.1 MPa respectively, followed by a stain-proof reinforcement casing tube being oscillated into the grout mix. The resulting pile was thus constructed with its toe against the stiff Cambrian stratum reinforcing and underpinning the entire retaining brickwork section. The tube was required to ensure both longer pile life and subsequent possible of deepening of the cellars. Toe levels and bearing of the piles had been previously confirmed based on the static loading tests.

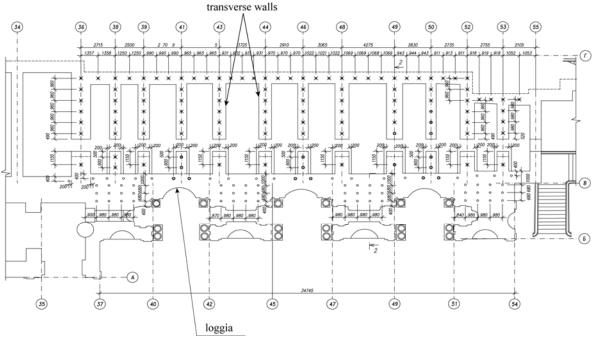
Figure 15. Location of underpinning piles in plan: o, x - underpinning piles.

- 5. Drilling of 42 mm vertical bores paced at approximately 1.0 m from the terrace in front of the palace along each transverse wall down to the brick-wall footing level (absolute level 8.9 m BD) in order to reinforce the transverse walls and rear longitudinal wall of the cellars. This was followed by interval grouting and subsequent redrilling of the bores by 151-mm augers, used in the bored piles construction, down to absolute level of 1.5 m BD. Those piles were likewise reinforced through their entire length.

- 6. Construction of pile heads in the dilapidated areas of the transverse walls at the level of the brickwork footing (absolute level 8.8 m BD), with subsequent construction of the pile caps and masonry courses within the original scope.

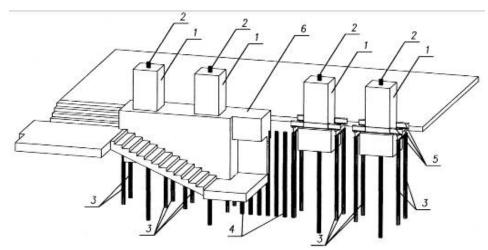
Figure 16. Provision of celebrity entrance overlooking the Lower Park (deepening of the basement down to 5.0 m):
1. existing brickwork pillar, 2. underpinning piles constructed from terrace surface, 3. pile supports for propping brickwork pillars, 4. pile wall, 5. steel waling transmitting loads form pillars onto piles, 6. retaining wall constructed of reinforced concrete.

- 3. The constructed strengthening option was successful even when faced with an unexpected challenge. The architects suddenly decided to provide front access to the palace from the Lower Park and furnish a vestibule underneath the terrace. To do this, all cellars had to be deepened by 1.0-1.5 m and the transverse brick walls were temporarily suspended on the thin underpinning piles (Fig. 16, 17, 18). Quality of the strengthening was attested by the fact that not one section of the brickwork was in any way displaced. It was therefore ascertained that the strengthening was successful.

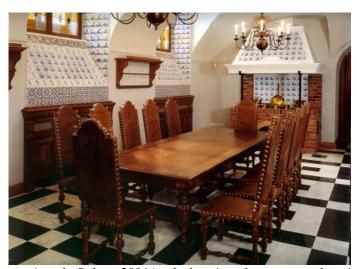
Figure 20. Cellars of Konstantinovsky Palace, 2004 (at the location of reconstructed retaining cellar wall, see Fig. 10).
