# Reconstruction of Konstantinovsky Palace in a Suburb of Saint Petersburg

**ABSTRACT:** *This article describes a complex approach to the condition survey and design executed as part of the remedial works on Konstantinovsky palace in the suburb of Strelna (Saint Petersburg)--one of the most beautiful historic monuments of 18th century Russia. The palace was almost completely destroyed in the 1940s. In 2000 the decision was made to reconstruct the palace, and the project for palace reconstruction was developed. The project was completed in 2003. The following important stages of the project are discussed in this paper: palace condition survey and site investigations, analyses of the palace retaining structures, design project of palace reconstruction, and phases of the remedial works.*

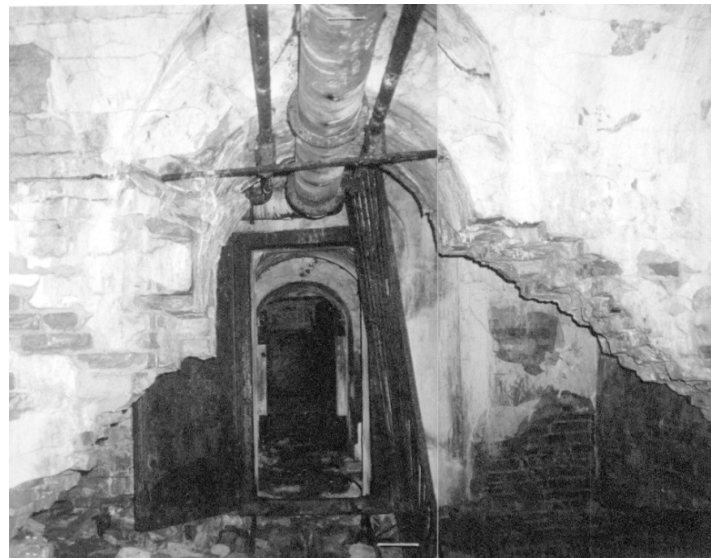
*Figure 7b. Dilapidated structures of the palace: transverse walls.*

2. The entire brickwork structure was soaked in water, causing dilapidation through cycles of freezing and thawing.
3. There were no foundations of the transverse walls of the cellars. Footing was level with the cellar's floor. Decomposed timber pile heads supported the transverse walls.

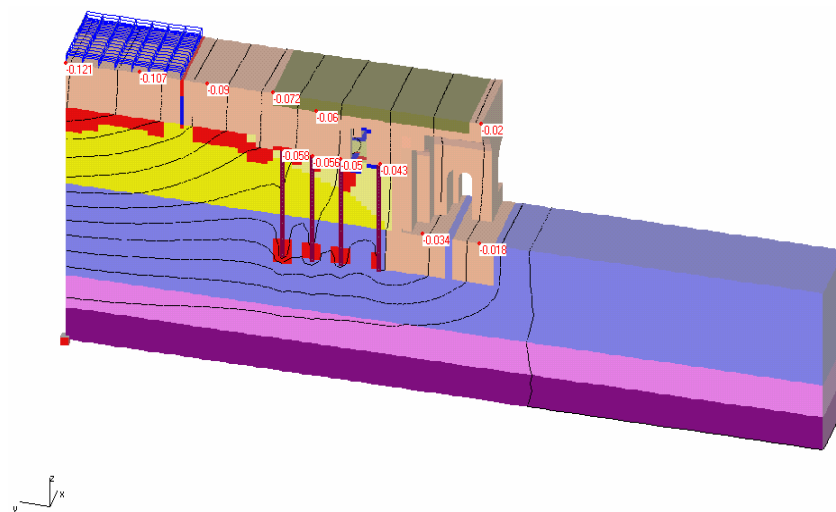
1. Provided that the piled foundation is kept intact underneath the cellar walls (Fig. 11, 12) and the loggia structures remain in stable condition, with settlement of exterior loggia structures not exceeding 3.4 cm, and the settlement of the cellar walls not exceeding 5.8 cm, the building would be stable.
2. In the case of the decomposed timber piles, if the cellar wall settlement reached 7.7 cm it would cause the transverse wall's dilapidation. Due to decomposition, the piles were considered inadequate to support the required loads and thus were not included in the analyses.
3. In the case of ground piping and foundation brickwork loosening, if the settlement reached 8.3 cm and the deformation profile resembled that shown in Fig. 13, then the brickwork material would be dilapidated. Observed brickwork dilapidation suggested that this mechanism was actually occurring at the site.

Figure 12. Contours of settlements of the cellars and loggias (m) with account of intact timber piles. Dark red color denotes soil regions reaching the limit state by Mohr-Coulomb criteria.

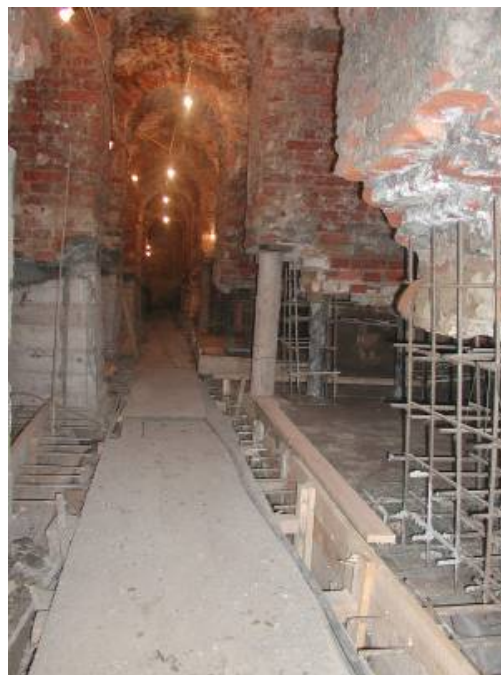
Figure 17. Deepening of the basements by 1.0-1.5 m.

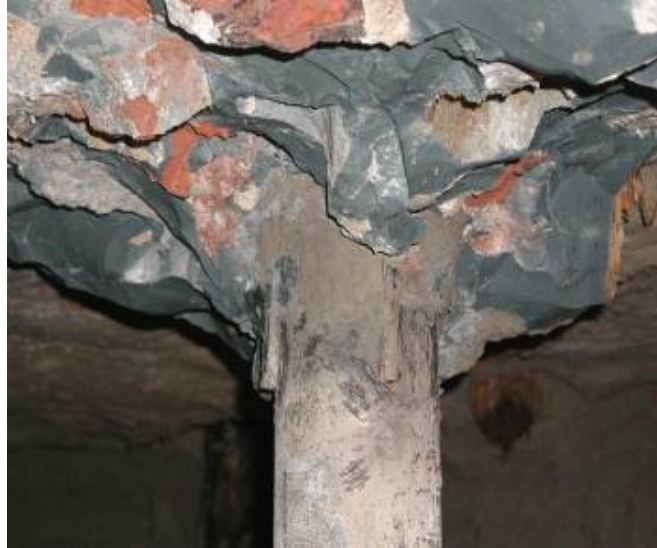
*Figure 18. Bored pile with tube reinforcement viewed from underneath foundation.*

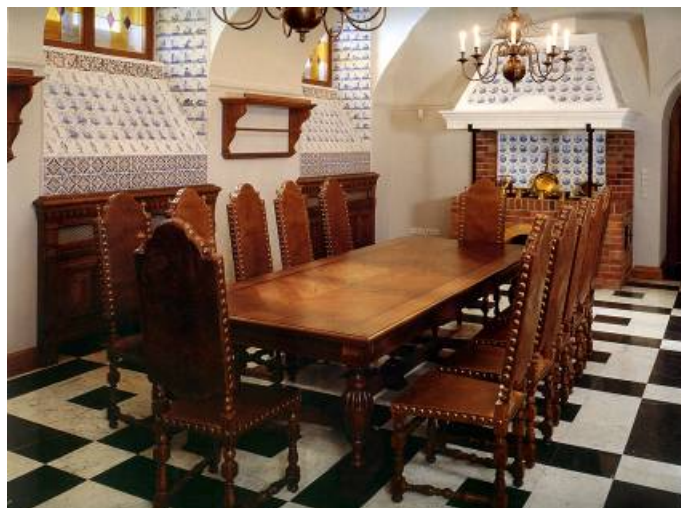
*Figure 20. Cellars of Konstantinovsky Palace, 2004 (at the location of reconstructed retaining cellar wall, see Fig. 10).*
