Rockfall and Subsidence on Mumbai-Pune Expressway

Reference: Kumar, K., Prasad, P.S., Mathur, S., Kimothi, S., (2010). Rockfall and Subsidence on Mumbai -Pune Expressway. *International Journal of Geoengineering Case Histories*, <http://casehistories.geoengineer.org>, Vol. 2, Issue 1, p.24-39. doi: 10.4417/IJGCH-02-01-02.

investigations carried out to assess the probable causes and the remedial measures recommended in order to control the rockfall and subsidence at km 41 on the Mumbai-Pune Expressway.

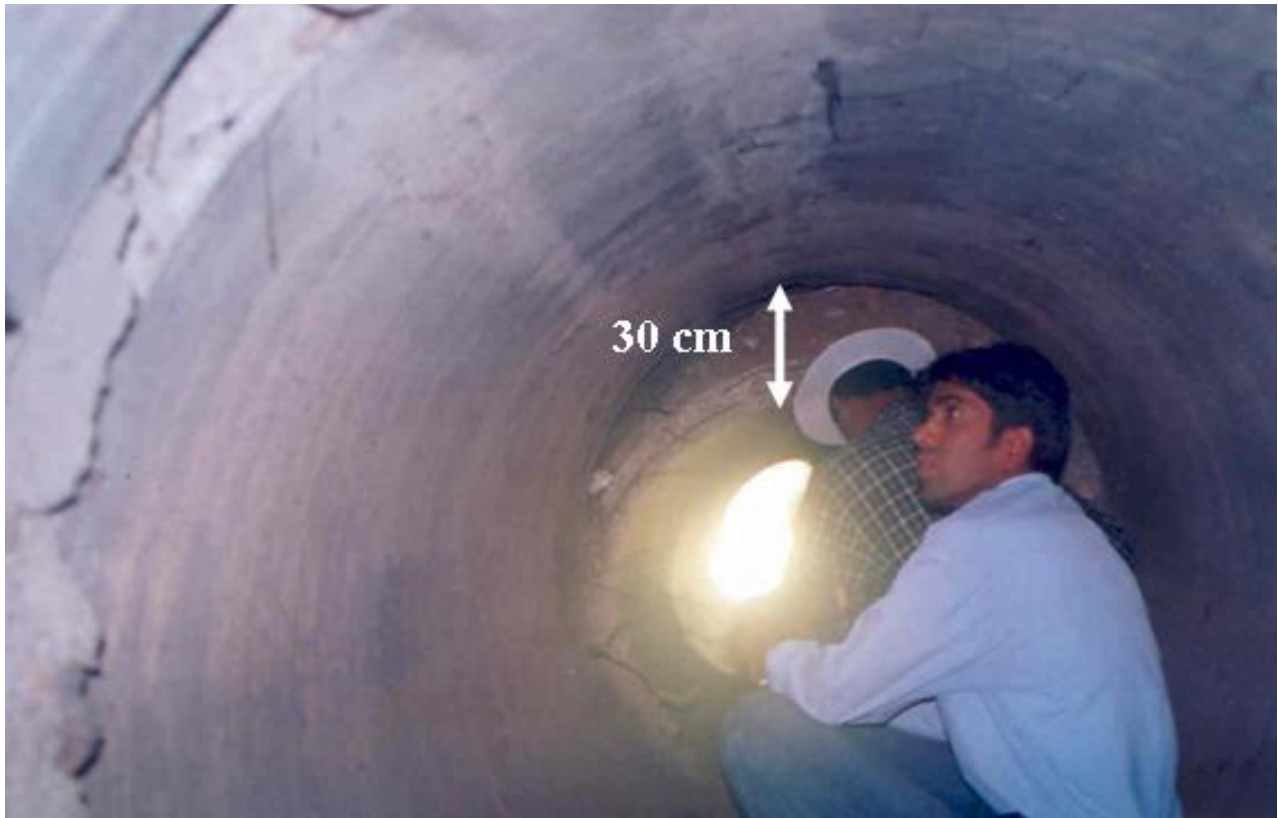
Figure 11. Dislodged pipe culvert.

- The broken culvert was repaired by providing uniform-sized pipe sections, and the joints were properly sealed.
- On the shoulder portion and below the crash barrier, the cracks were sealed with cement grouting and monitored for three years. The portion stabilized and no further cracks were observed in this area.
- After the crash barrier, the embankment was excavated up to 3 m and recompacted to 95% of maximum dry density and moisture content.
- Longitudinal and transverse drains were provided at frequent intervals.
- To prevent erosion and to stabilize the embankment, the slope has been protected with stone pitching/turfing.

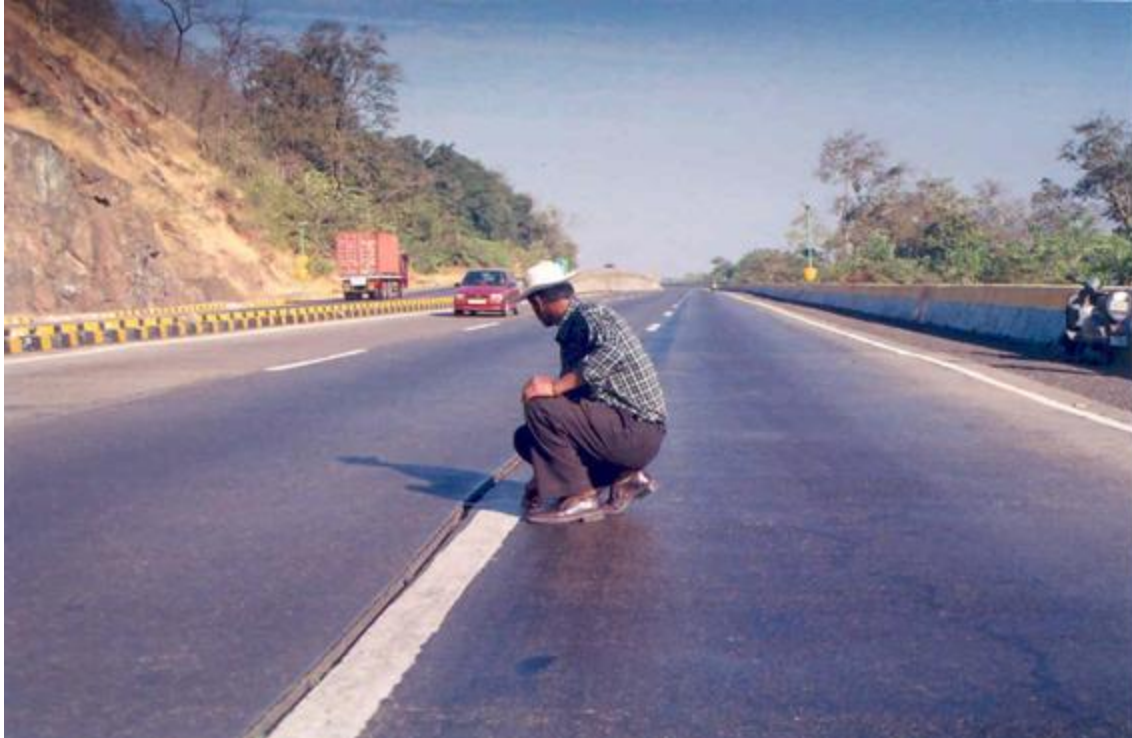
Figure 13. Dislodged rigid pavement.
