Rockfall and Subsidence on Mumbai-Pune Expressway

ABSTRACT: Mumbai-Pune, India's first expressway, which crosses the mountainous and rugged Deccan Trap Province, suffered from a large amount of rockfall and major landslides in 2003 and 2004. A significant number of accidents and fatalities have occurred on the expressway as a result of such events. On the basis of frequency and magnitude of the recorded incidences of rockfall, seventeen critical areas of the road have been deemed in need of investigations and mitigation. One of the problematic areas that suffered from rockfall and subsidence is at km 41 on the expressway, adjacent to a tunnel (Adoshi). This location has been chosen for detailed study. This area extends for 500 m along the expressway, and the embankment has subsided by 2 to 3 m along the entire length. Based on the geological, geomorphologic and geotechnical investigations, causative factors for rockfall and subsidence at this location have been established. This paper presents the field investigations, probable causes, stability analysis and remedial measures for controlling the subsidence and rock fall.

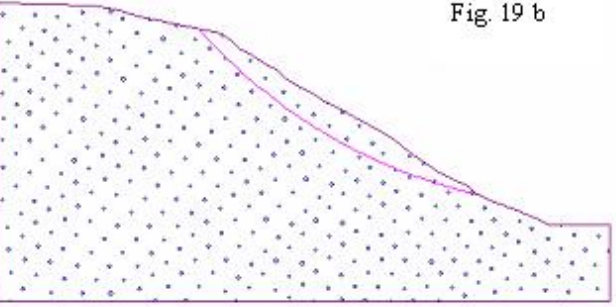
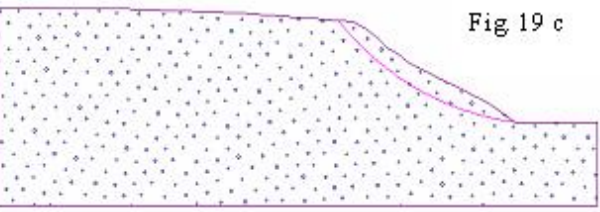
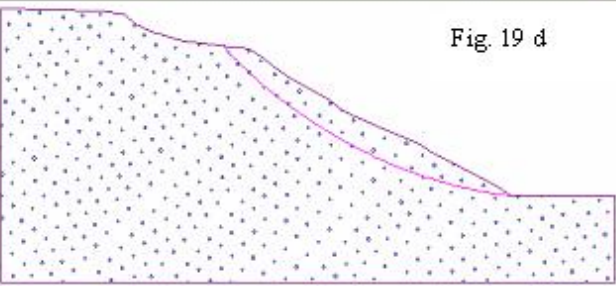
Figure19. Slope stability of subsidence portion.

S.No	Cross Section	Factor of Safety	
		Bishop Method	Peterson Method
1	A - A	1.17	1.14
2	B - B	1.14	1.11
3	C - C	1.38	1.34
4	D - D	1.46	1.42
