## Rockfall and Subsidence on Mumbai-Pune Expressway

**ABSTRACT:** Mumbai-Pune, India's first expressway, which crosses the mountainous and rugged Deccan Trap Province, suffered from a large amount of rockfall and major landslides in 2003 and 2004. A significant number of accidents and fatalities have occurred on the expressway as a result of such events. On the basis of frequency and magnitude of the recorded incidences of rockfall, seventeen critical areas of the road have been deemed in need of investigations and mitigation. One of the problematic areas that suffered from rockfall and subsidence is at km 41 on the expressway, adjacent to a tunnel (Adoshi). This location has been chosen for detailed study. This area extends for 500 m along the expressway, and the embankment has subsided by 2 to 3 m along the entire length. Based on the geological, geomorphologic and geotechnical investigations, causative factors for rockfall and subsidence at this location have been established. This paper presents the field investigations, probable causes, stability analysis and remedial measures for controlling the subsidence and rock fall.

Reference: Kumar, K., Prasad, P.S., Mathur, S., Kimo

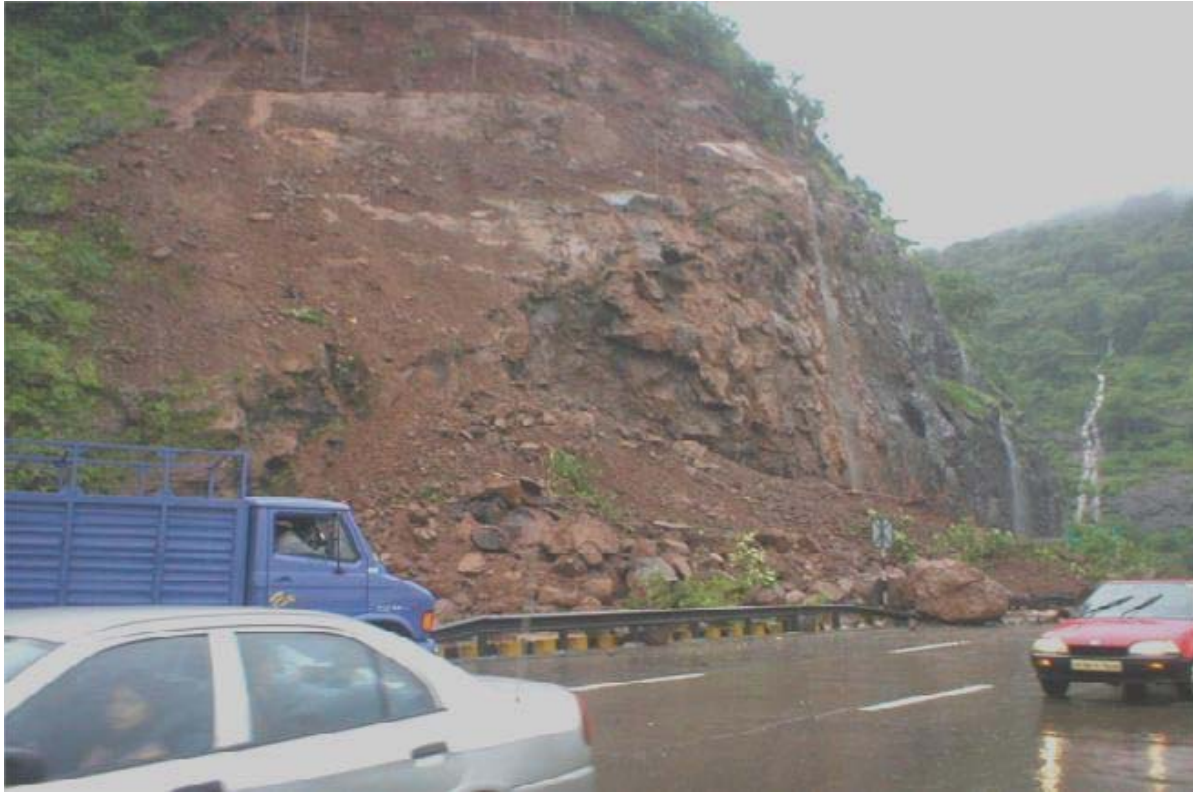
*Figure 3. Rockfall and debris in 2004.*

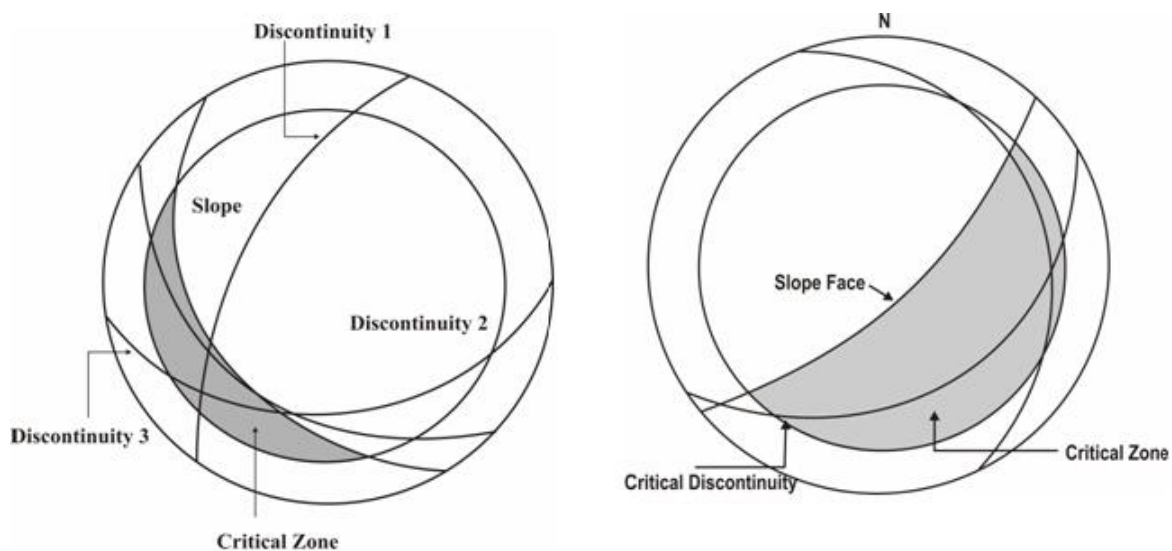
Figure 4. Markland test for planar failure on two sites showing critical zone for potential failure.

planes. The fractures on the rocks, which are normally confused with joints, have prominent attitudes. There are mainly three major joints, but one of the most prominent planes of weakness is the vertical joint (typical of basaltic layer, i.e. columnar joint). This prominent joint is repeated at regular intervals. The stereographic projection diagram, using the field data of joints, revealed the formation of a prominent wedge at the slope face. The vertical joints intersect to form wedges on the slope independently as well as when they intersect other steeply dipping fractures and other horizontal and subhorizontal fractures, as shown in Figure 4. In most cases, the plunge of the intersection of these two joint sets lies toward NNW in the direction of the slope. Additionally, the plunge of the intersection of the joints is more than the angle of the slope most of the time. The Markland Test was used to define the critical zone of planar and wedge failure in the stereographic projection. In the case of planar failure, the dip of the discontinuity exceeds the angle of friction of the rock; the discontinuity daylight in the slope face and dips less than the slope. In the case of wedge failure, the plunge of the line of intersection of two joints is considered (Figure 4) (Markland, 1972).

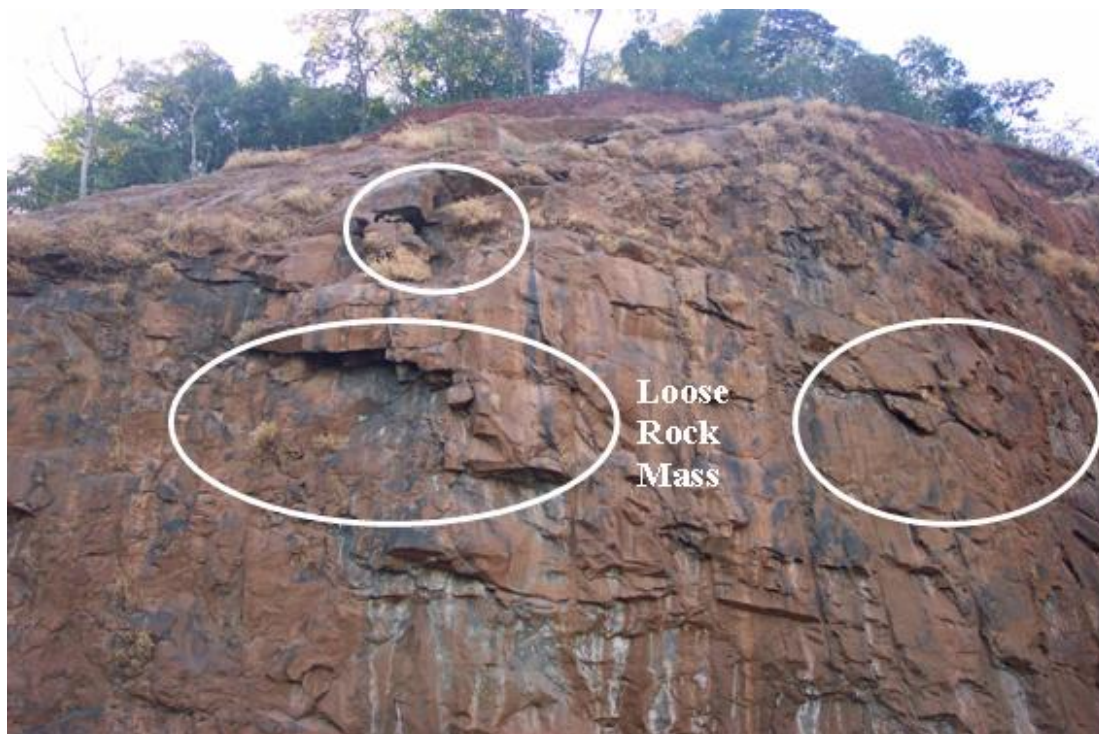
Figure 5. Vertical joints and formation of wedge along slope face.

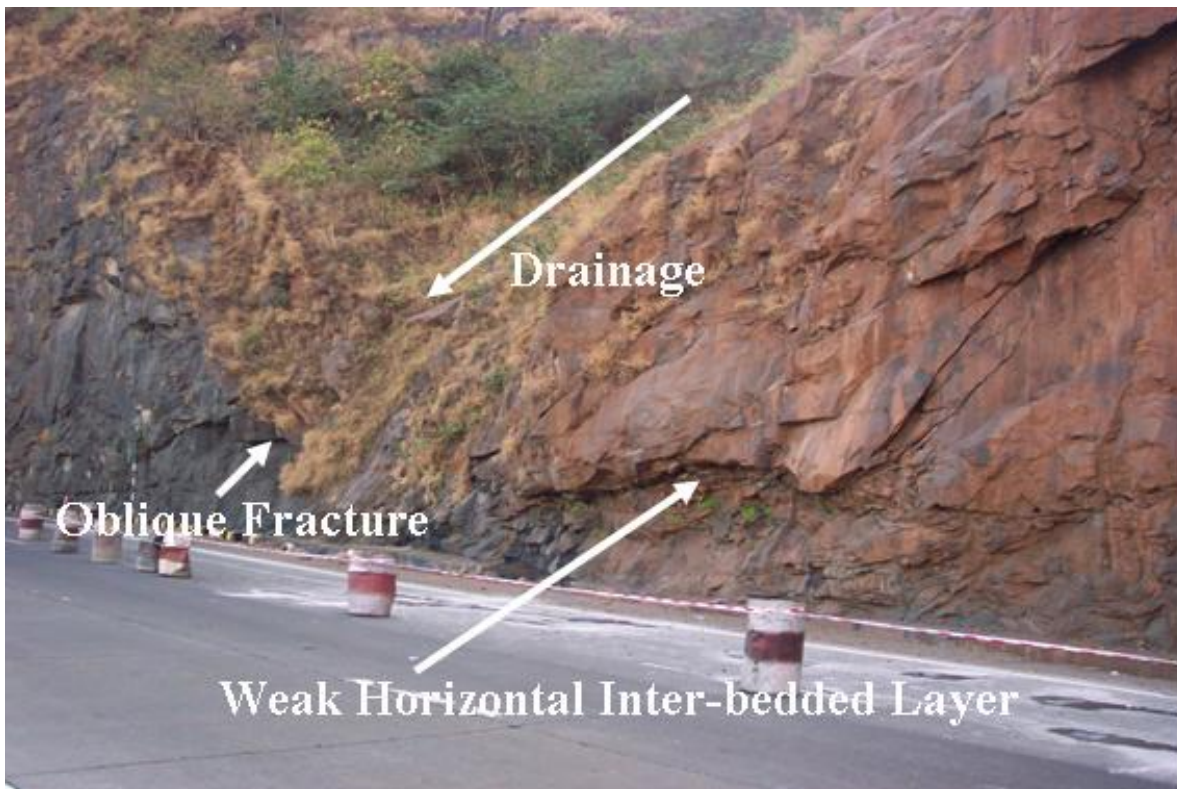
*Figure 6. Intersection of oblique and sub-horizontal fractures.*

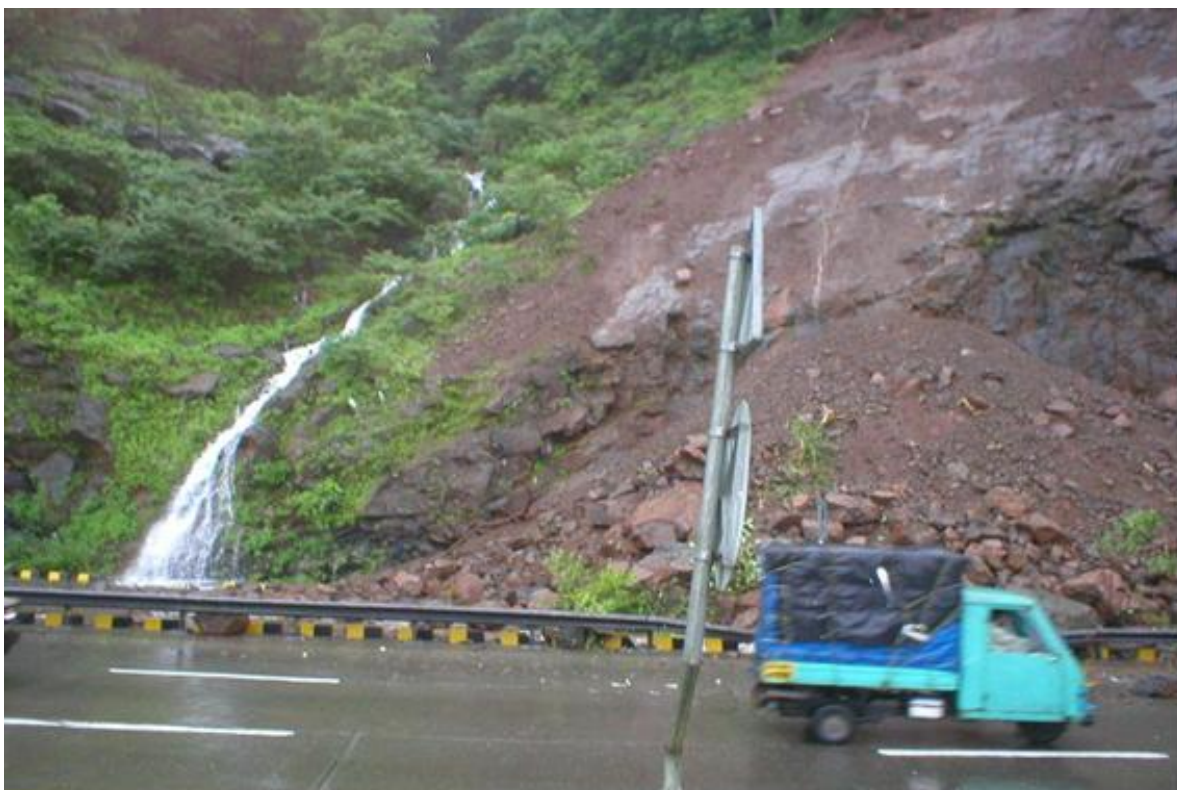
The slope is well covered by trees. The uphill slope has good catchment, and the rainwater generally drains out through the natural streams on both flanks of the slide. A considerable quantity of water also flows down the middle of the slope, above the affected portion. Near the crown there are a number of loose stone blocks, which rest on the slope. These may facilitate blocking and infiltration of more water into the slope during rains. The crown consists of a thin soil cover of a few centimeters to about one-third of a meter in thickness, below which lies 1–2-meter thick weathered and jointed basalt. This layer of weathered and jointed basalt, along with the thin overburden, fails along a smooth sheet joint surface and falls on the expressway through the adjoining vertical cut slope (Figure 2). This vertical cut of about 40 m in height has many joint intersections separating the blocks of the basaltic layer (Figure 5). A stream, guided by the intersection of one of the oblique and sub-horizontal fractures (Figure 6), remains dry except during the monsoon months when it serves as one of the main draining streams (Figure 7). A significant amount of water drains from the above catchment area.

*Figure 7. Significant water drainage during a monsoon.*

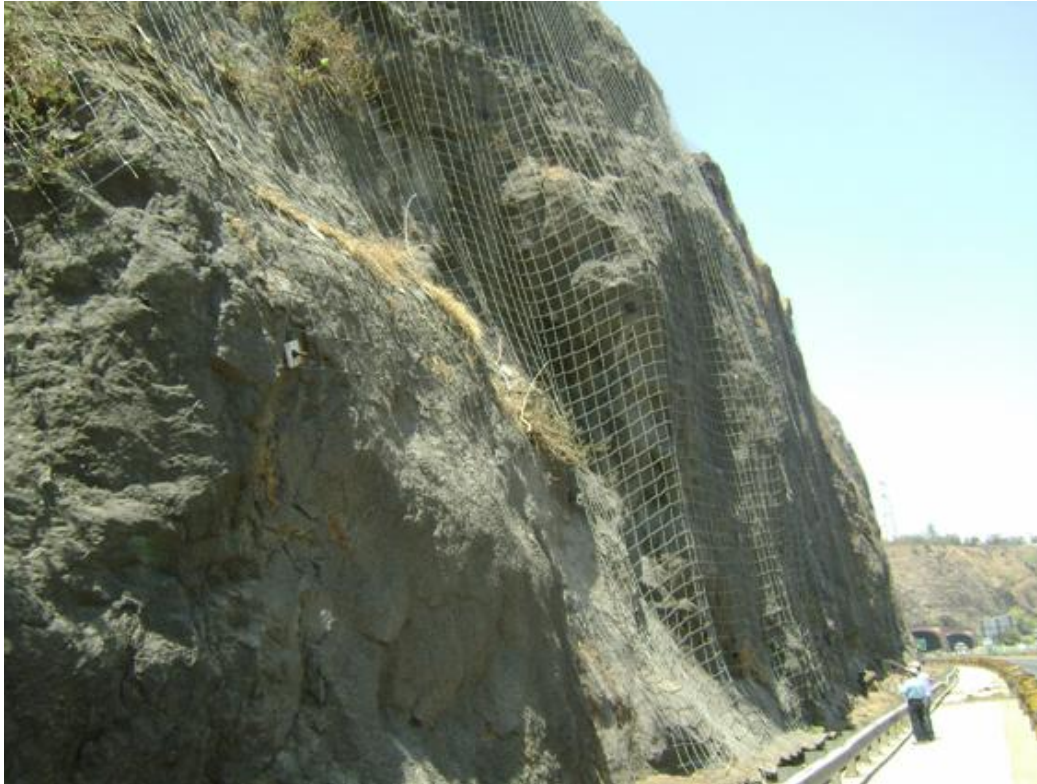
*Figure 8. Remedial measures implemented on vertical slope (shotcrete and wire mesh).*

The vertical face, which is vulnerable to sudden detachment of rocks, was mitigated to prevent dislodged rock from falling off the vertical cliff. The steep vertical cuts with loose overhanging blocks were leveled and the loose rock was removed. Since the rocks have multiple open joints and are likely to widen over time, the application of steel fiber reinforced shotcrete (SFERS) of 70 mm thickness was suggested along with covering the entire sledge with a steel cable net of aperture size (300 mm x 300 mm) in order to stabilize the rock slopes. Steel fibers are very efficient compared to other material fibers such as asbestos, nylon or polypropylene and glass due to their high tensile strength and adherence to concrete. The SFERS provides measures to prevent the rock blocks from moving off the slope and also will prevent the weathering of the rock slope. This kind of stabilization is not intended to prevent the movement of blocks but rather to control rockfall from bouncing onto or blocking the expressway. For installing the steel cable net on the slope, a trench of 30 cm x 50 cm at a distance of 1.5 m from the top of the cliff was excavated. Iron rods were inserted 0.5 m from the bed of the trench. After inserting the rods, the holes were grouted with cement concrete. Subsequently, the steel rope net was laid and the trench was filled with cement concrete for anchorage. The steel cable was spread across the vertical face of the slope up to the toe. The cable net was anchored on the surface of the slope with expansion bolts/grouted bolts of 0.50 m length.

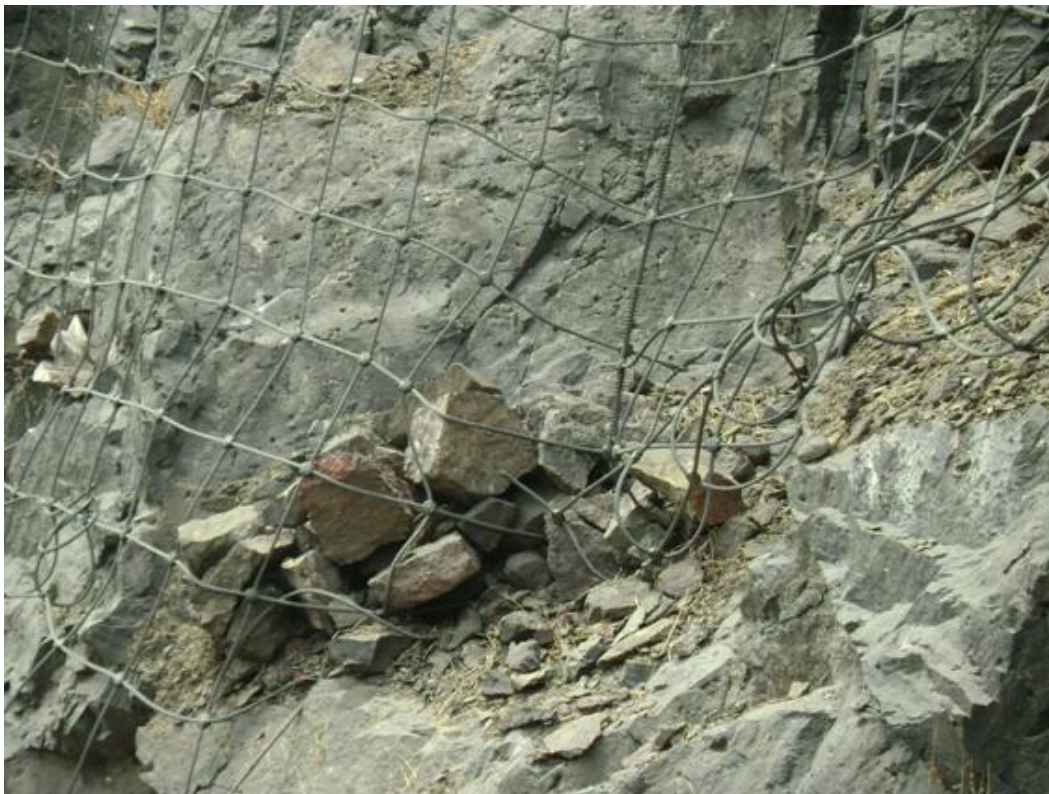
The remedial measures suggested were implemented in 2006 on some of the highway's stretches. In a few locations, the slopes were stabilized with SFERS and steel cable net; at others, the slopes were treated only with steel cable net. The slopes are being physically monitored by the Central Road Research Institute (CRRI) till September 2010. Figures 8 and 9 show the remedial measures that were implemented on the rock slope. The rocks were detached from the sloping surface where the slope is treated with steel cable net. Some rocks are trapped in the net and some were falling at the toe of the slope.

*Figure 9. Trapped rock blocks at the toe of the slope.*

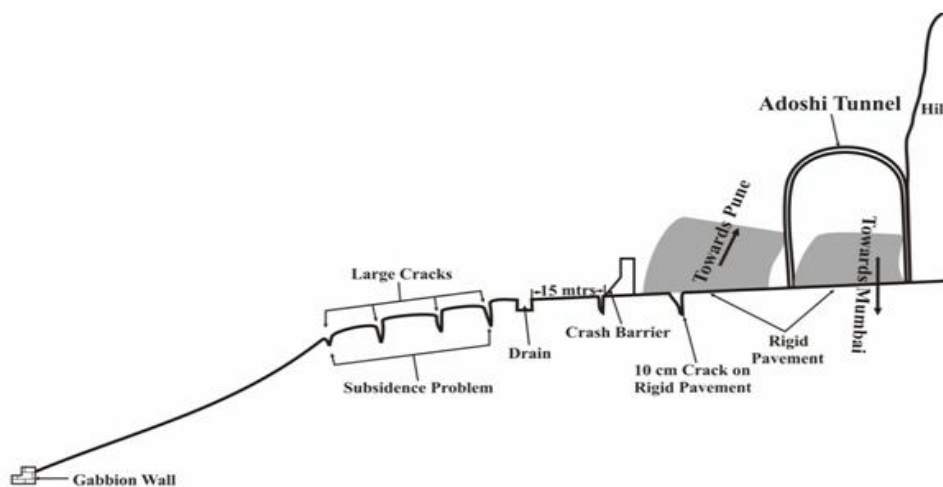
The subsidence portion (Figure 1) is located at km 41 on the downhill side of the expressway, adjacent to Adoshi tunnel (which extends for 500 m along the expressway). Figure 10 shows the schematic diagram of the subsidence problem on the expressway. The annual rainfall in this area is 200–300 cm, and the present drainage measures are not sufficient to drain this amount of water effectively. During the rainy season, water causes significant damage to this road at four locations in the form of a waterfall. One is in the curved portion, the second one is in between the curve and entrance of the tunnel, the third one is above the tunnel and the fourth one is after the tunnel exit. Pipe culverts were provided to help drain out the water on this stretch of the road, but the gradient of these culverts is not proper. However, it was observed that the internal diameter of the pipes varies from 1 to 1.2 m. In the pipe culvert, two pipe sections 1.0 m in internal diameter are provided, and the remaining pipes are 1.20 m in internal diameter. Two 1.0 m diameter pipe sections are installed in between the 1.20 m pipe sections. The joint between the 1.0 m diameter pipe and the 1.2 m diameter pipe is not proper, and the gap between the two pipes is 30 cm (Figure 11). Remaining pipes are also not joined properly. During periods of heavy rain, water seeps through the joints and saturates the surrounding soil mass, thereby causing cracking between lanes (i.e., flexible and rigid pavement). The runoff from the pipe culvert and cross drains is draining directly onto the embankment surface (Figure 12). The rainwater scours the embankment soil, thereby causing the instability of the embankment. After the exit of the Adoshi tunnel, the gradient of the drain is not proper. As a result, water may stagnate and seep into the pavement through the existing weep holes. The rigid pavement (on the outermost side lane) subsided by 5 to 6 cm, and subsidence also has occurred in between the joint of fast track lane (middle lane) and the truck lane. The average width of a crack is 5 cm and the average length of a crack is 85 m (Figure 13). The surface between the crash barrier and the rigid portion has been paved with bitumen. The flexible portion or shoulder (bituminous surface) has separated from the rigid pavement; the depth of the crack is 50 cm (Figure 14).

Figure 10. Schematic diagram showing subsidence problem on the Mumbai-Pune expressway.

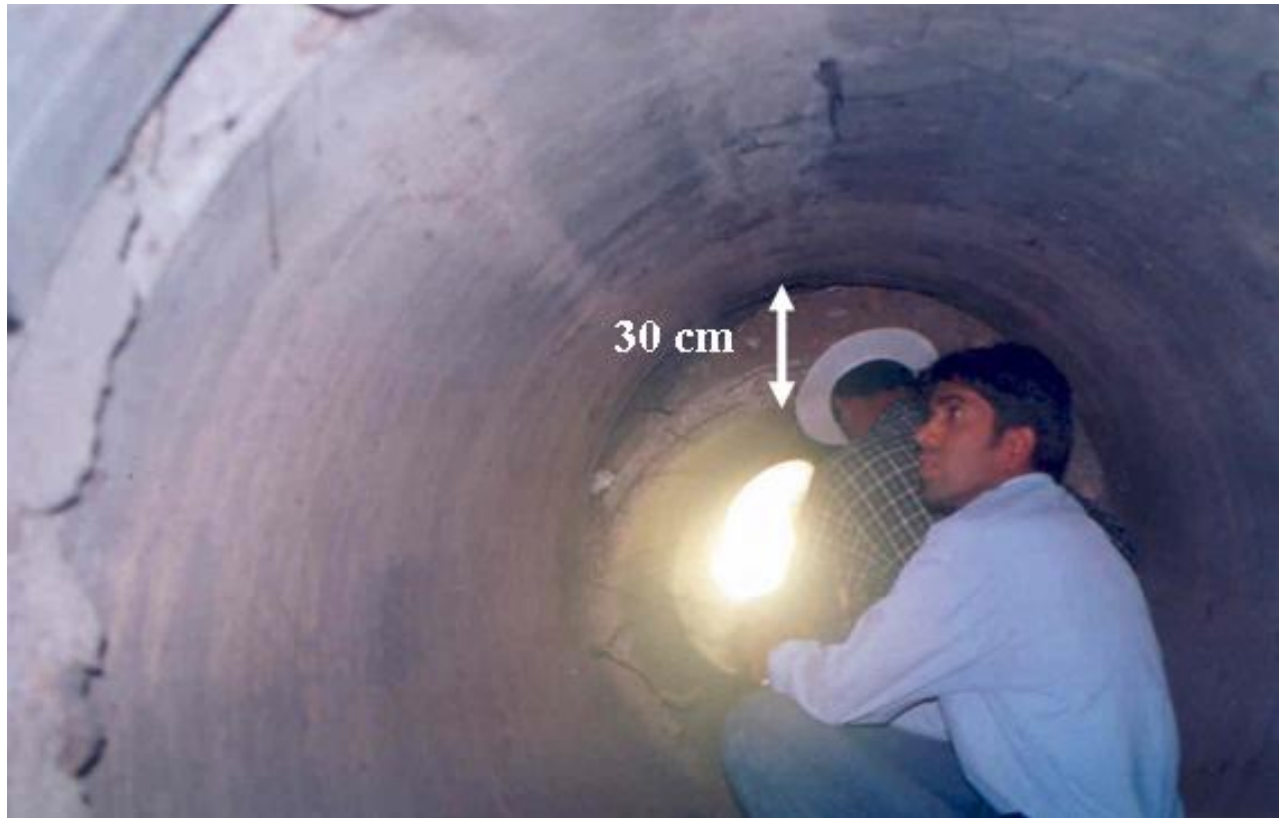
*Figure 11. Dislodged pipe culvert.*

- The broken culvert was repaired by providing uniform-sized pipe sections, and the joints were properly sealed.
- On the shoulder portion and below the crash barrier, the cracks were sealed with cement grouting and monitored for three years. The portion stabilized and no further cracks were observed in this area.
- After the crash barrier, the embankment was excavated up to 3 m and recompacted to 95% of maximum dry density and moisture content.
- Longitudinal and transverse drains were provided at frequent intervals.
- To prevent erosion and to stabilize the embankment, the slope has been protected with stone pitching/turfing.

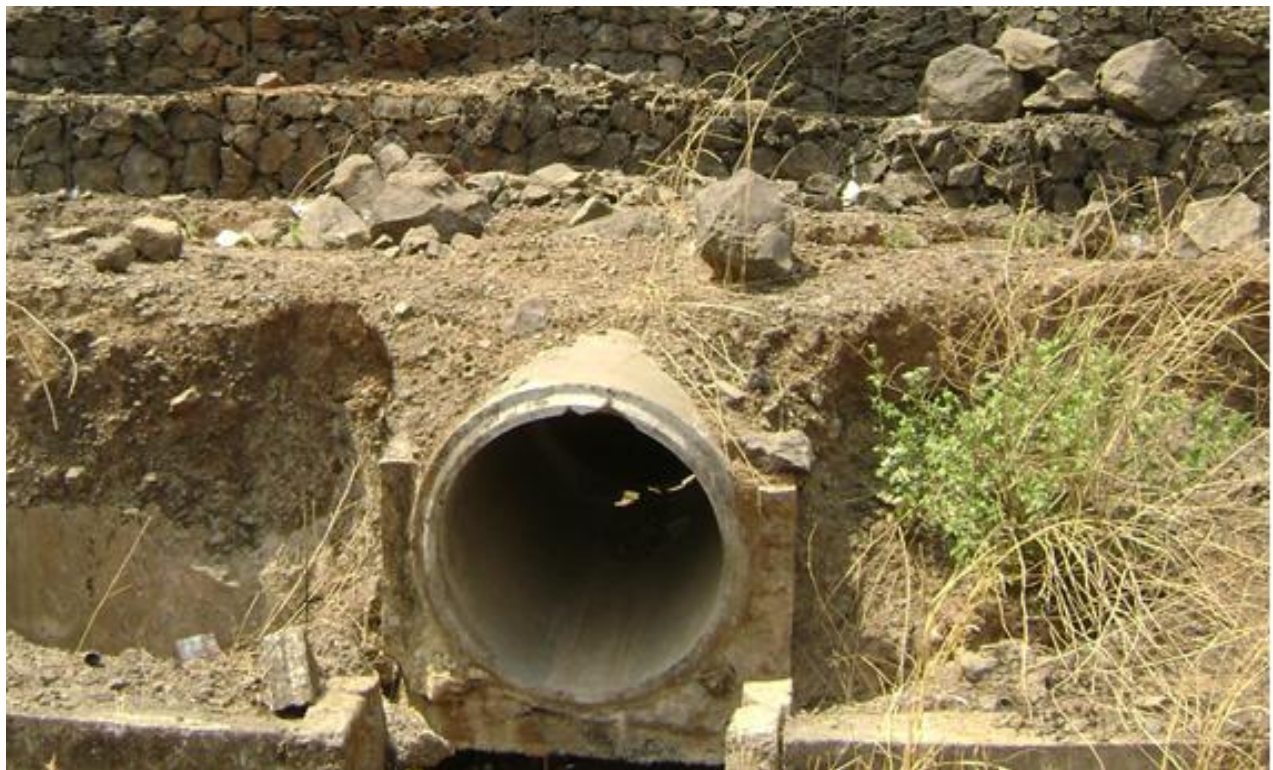
*Figure 12. Pipe culvert without stepped chute.*

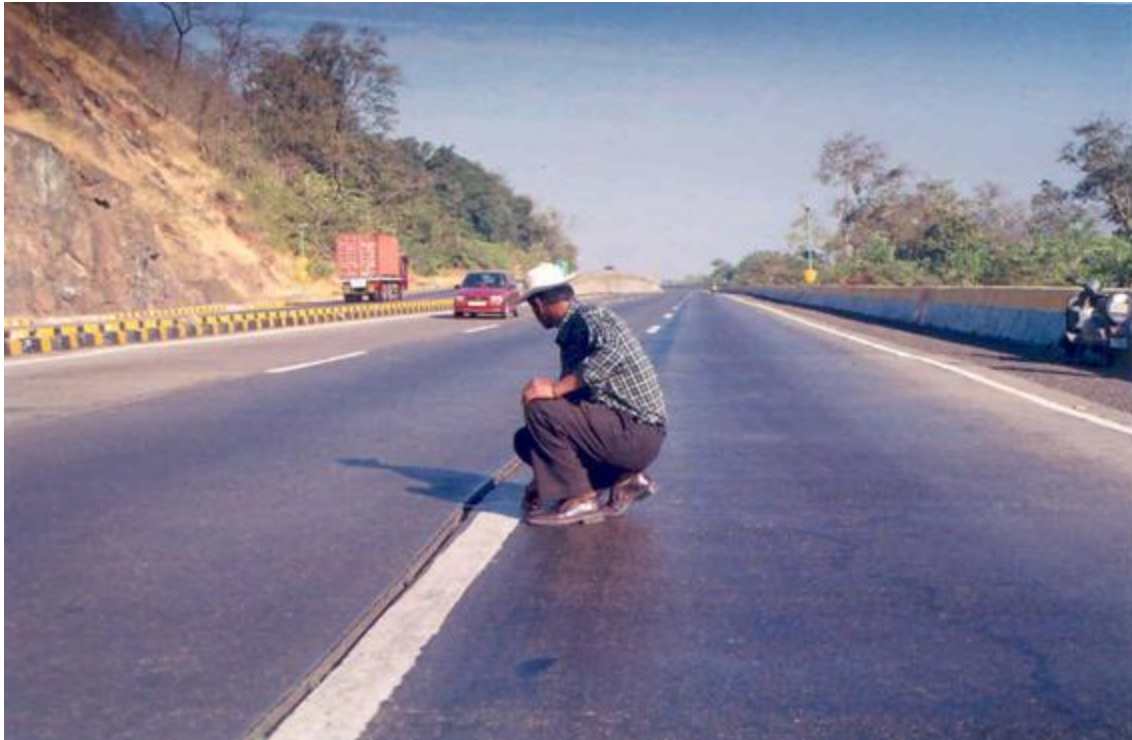
*Figure 13. Dislodged rigid pavement.*

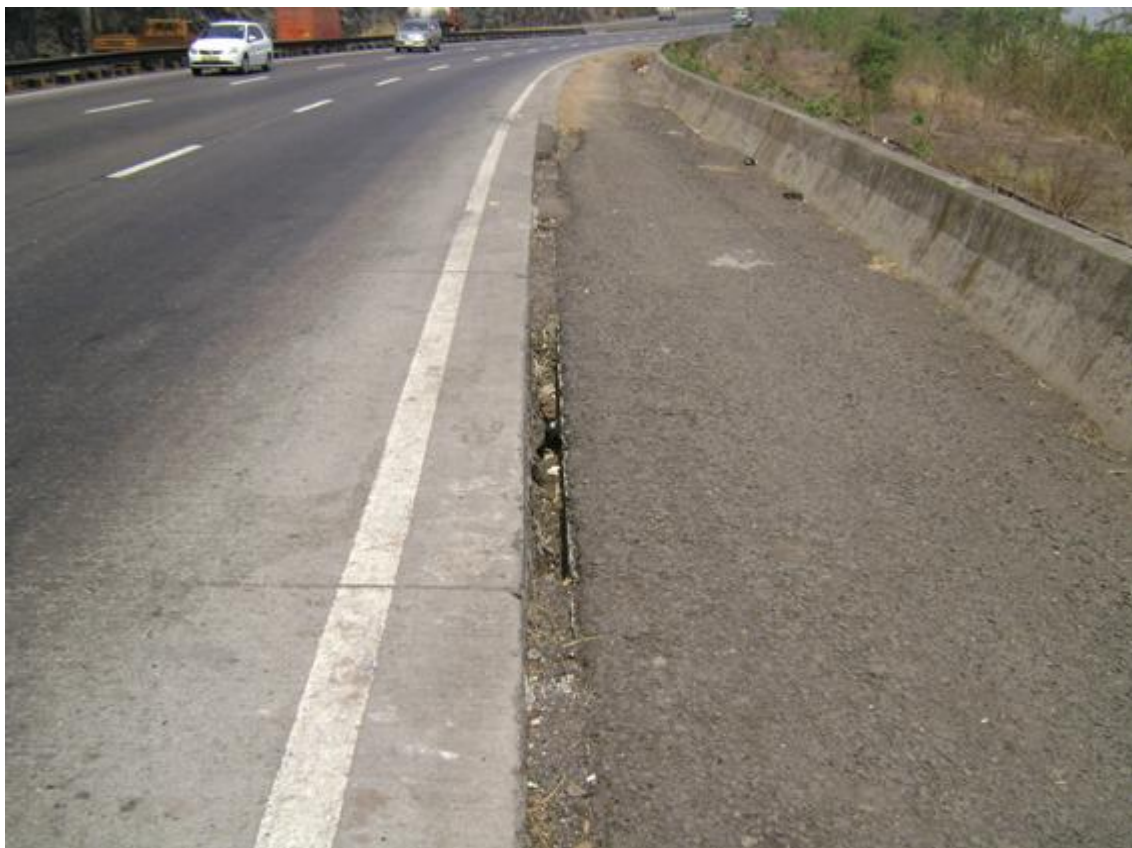
*Figure 14. Crack between rigid and bituminous pavement.*

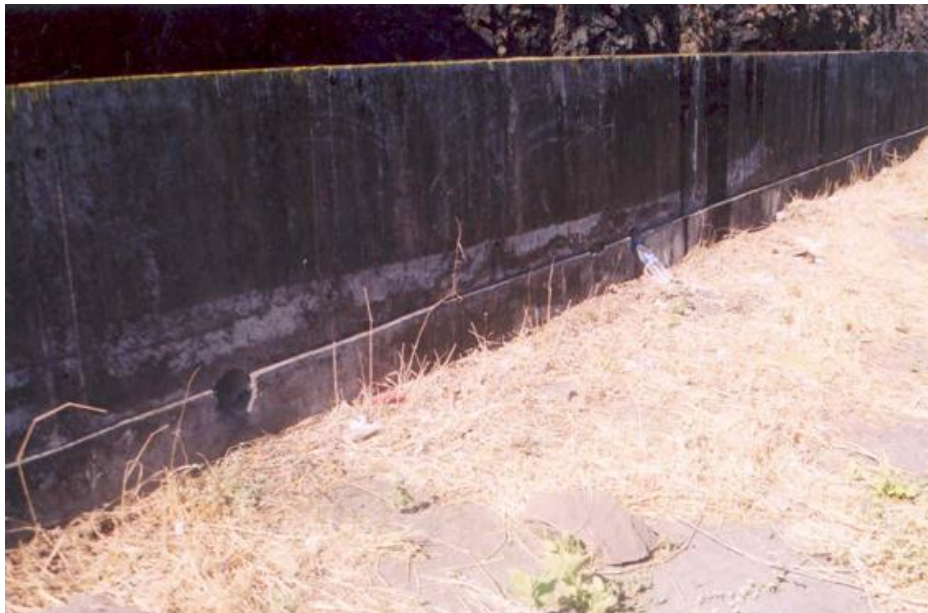
A crash barrier has been provided along the slope. Beyond the crash barrier, the average width of the embankment on the downhill extends downhill another 12 m. Drainage holes (Figure 15) are provided in the crash barrier at frequent intervals, but the holes are left open directly on the embankment surface. The considerable quantity of water passing through these drainage holes is causing saturation of the embankment fill beyond the parapet and is weakening the foundation of the crash barrier as well as the scouring below the crash barrier and pavement (Figure 16). A longitudinal drain is provided after a certain distance from the crash barrier on the embankment. From the crash barrier to the longitudinal drain, the surface is not lined and scouring was observed below the crash barrier. The crash barrier is also tilted, and below the crash barrier, the embankment slope has experienced scouring up to a depth of 1 m. The embankment has subsided by 2 to 3 m in steps, and each step has an average height of 1 m (Figure 17).

*Figure 15. Drainage holes left open on embankment surface.*

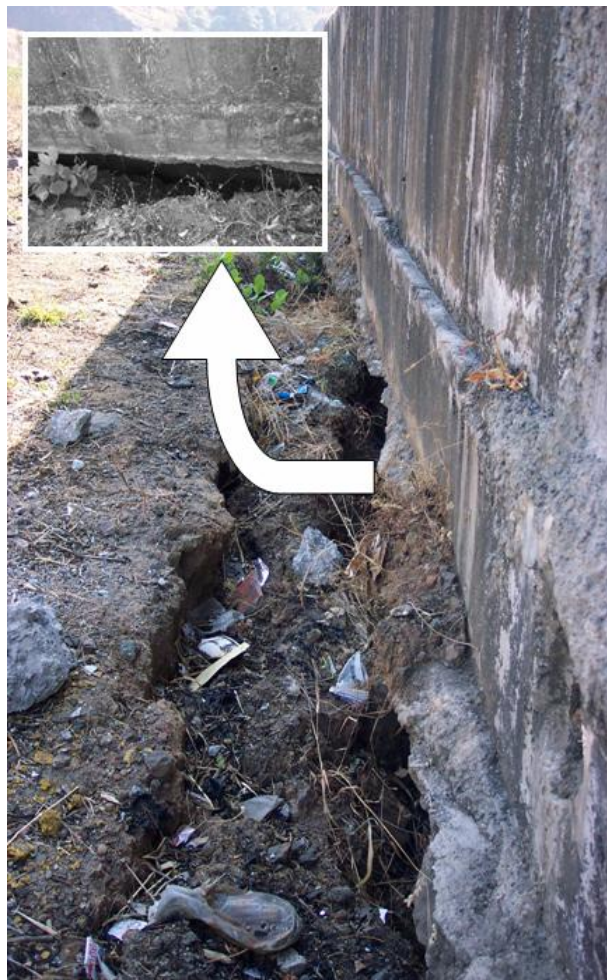
*Figure 16. Embankment scoured below the crash barrier.*

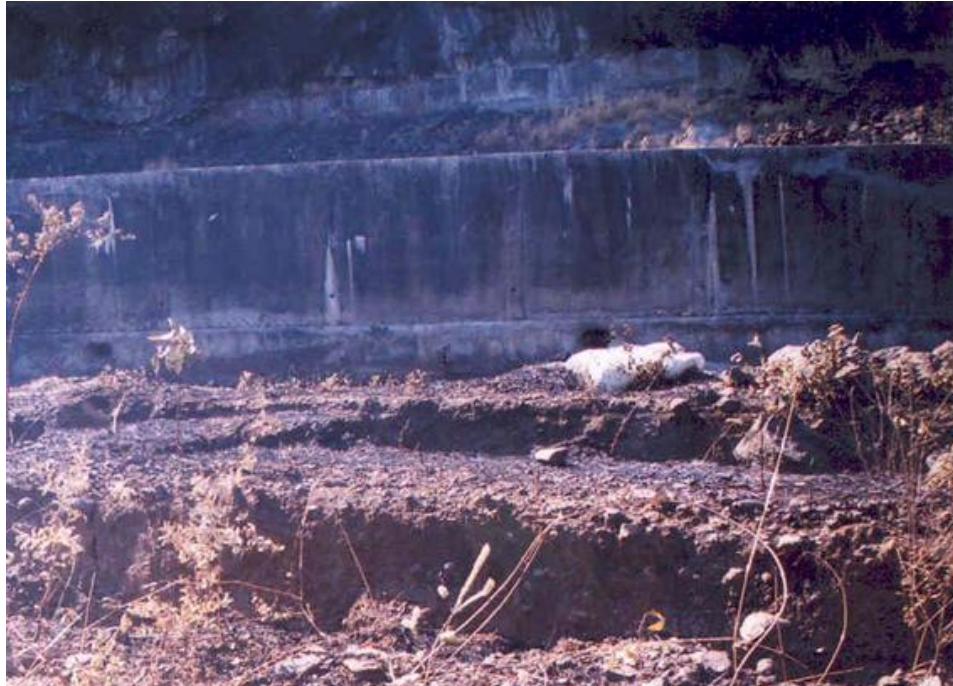
Figure 17. Subsidence of the embankment.

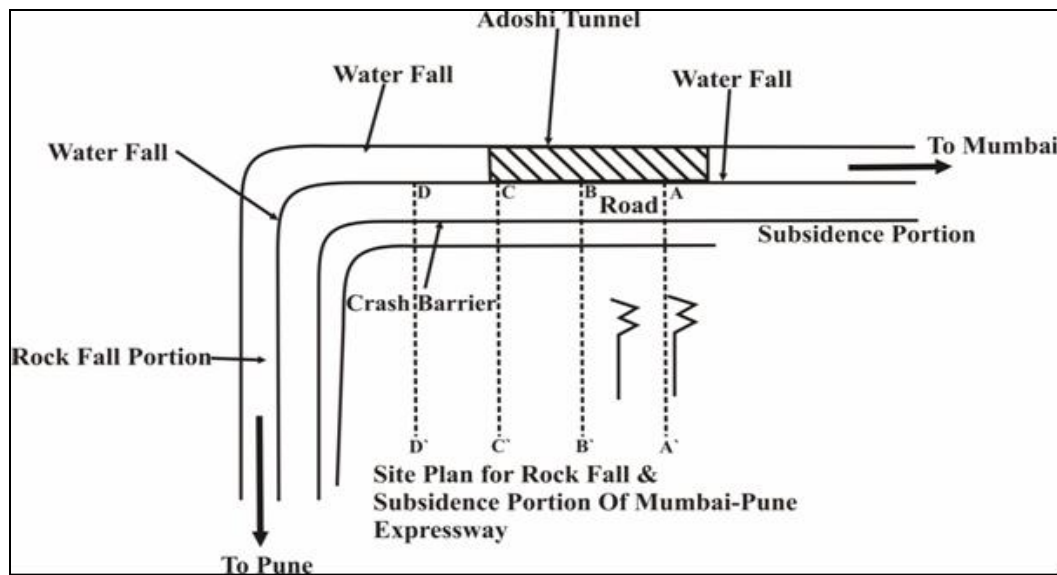
Figure 18. Location of cross sections for stability analysis.

Cross section	Stability analysis	Factor of Safety	
		Bishop method	Peterson Method
A - A	  <p>Fig. 19 a</p>	1.17	1.14
B - B	  <p>Fig 19 b</p>	1.14	1.11
C - C	  <p>Fig 19 c</p>	1.38	1.34
D - D	  <p>Fig 19 d</p>	1.46	1.42
