Rockfall and Subsidence on Mumbai-Pune Expressway

Reference: Kumar, K., Prasad, P.S., Mathur, S., Kimothi, S., (2010). Rockfall and Subsidence on Mumbai -Pune Expressway. *International Journal of Geoengineering Case Histories*, <http://casehistories.geoengineer.org>, Vol. 2, Issue 1, p.24-39. doi: 10.4417/IJGCH-02-01-02.

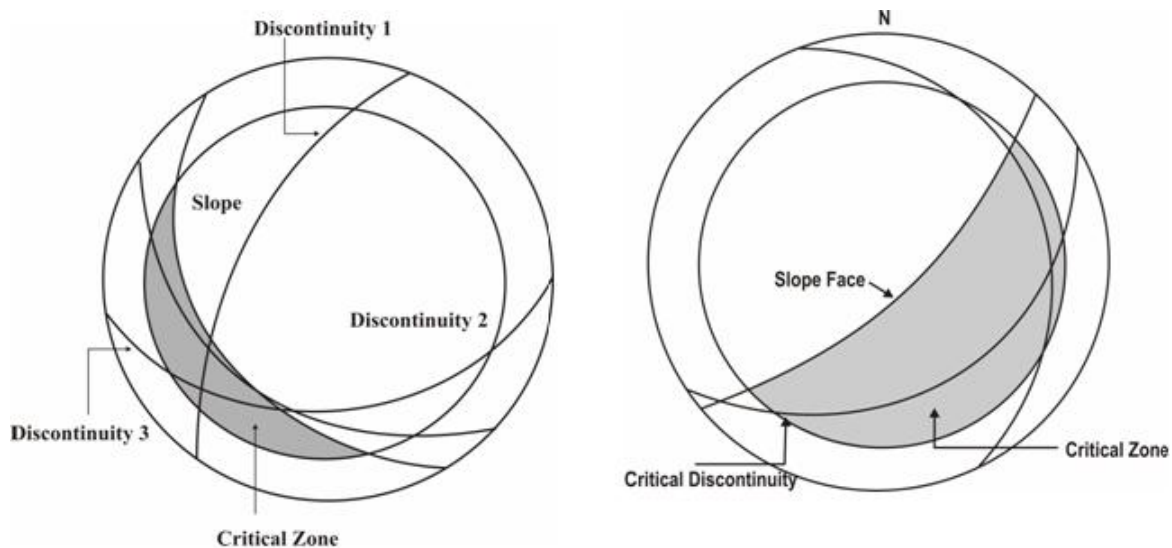
Figure 4. Markland test for planar failure on two sites showing critical zone for potential failure.
