Rockfall and Subsidence on Mumbai-Pune Expressway

ABSTRACT: Mumbai-Pune, India's first expressway, which crosses the mountainous and rugged Deccan Trap Province, suffered from a large amount of rockfall and major landslides in 2003 and 2004. A significant number of accidents and fatalities have occurred on the expressway as a result of such events. On the basis of frequency and magnitude of the recorded incidences of rockfall, seventeen critical areas of the road have been deemed in need of investigations and mitigation. One of the problematic areas that suffered from rockfall and subsidence is at km 41 on the expressway, adjacent to a tunnel (Adoshi). This location has been chosen for detailed study. This area extends for 500 m along the expressway, and the embankment has subsided by 2 to 3 m along the entire length. Based on the geological, geomorphologic and geotechnical investigations, causative factors for rockfall and subsidence at this location have been established. This paper presents the field investigations, probable causes, stability analysis and remedial measures for controlling the subsidence and rock fall.

Reference: Kumar, K., Prasad, P.S., Mathur, S., Kimothi, S.

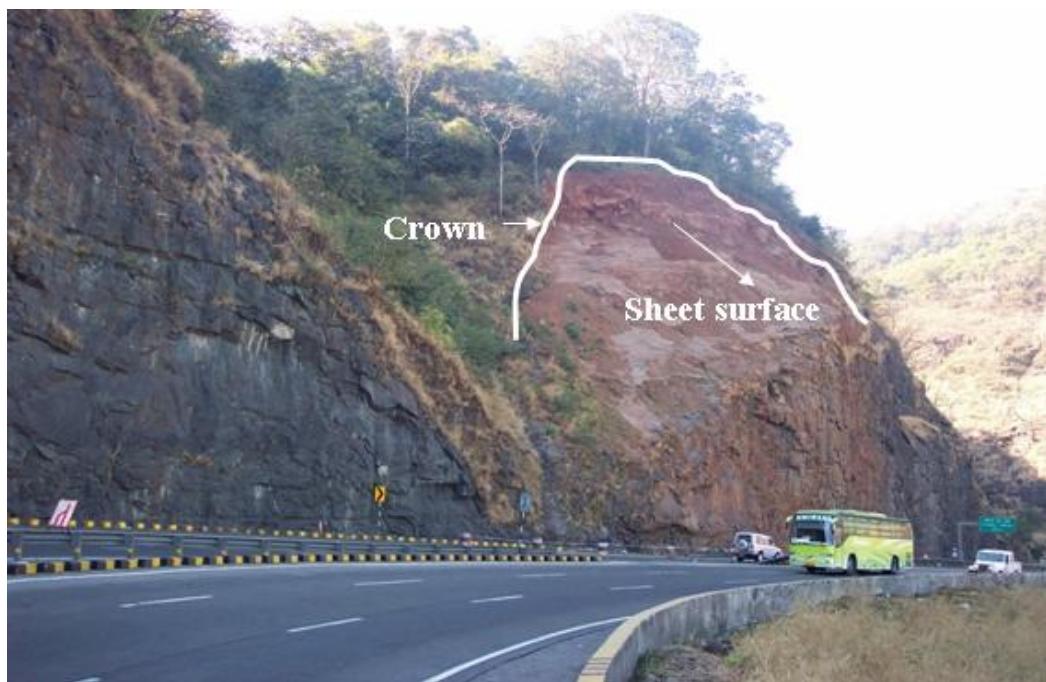
Figure 1 shows the location of the Adoshi site. Rockfall and debris flow are the predominant problems at this location. The first incident of rockfall and debris flow (Figure 2) reportedly occurred in 2003–2004, during the monsoon. Since then, rock blocks have been intermittently falling from the face and top of the slope, damaging the side drains as well as the middle of the expressway. The size of the rock blocks varies from a few centimeters to a meter—and sometimes even larger—in diameter (Figure 3). The hill slope geometry at this location is such that rock blocks fall directly onto the expressway. There is no space or slope bench on the side of the expressway and the hill; as a result, there is no reduction in the momentum of the detached rock when it plummets toward the expressway at this location. This direct fall makes the impact more dangerous and more potentially fatal when rock blocks impact a running vehicle. Such incidences are particularly frequent during the rainy season. Rockfall can be caused by a variety of reasons such as unfavorable jointing, freeze-thaw cycles, water effects, earthquake loading, etc. (Topal et al., 2007; Dorren, 2003). In the present case, on the basis of field observations and the records of failures, the jointing and the effect of water are expected to be major contributors to the failure. Rockfall can be studied using various techniques such as empirical, experimental and modeling procedures (Giani, 1992; Okura et al., 2000; Evans and Hungr, 1993).

Figure 2. General view of rockfall and debris.

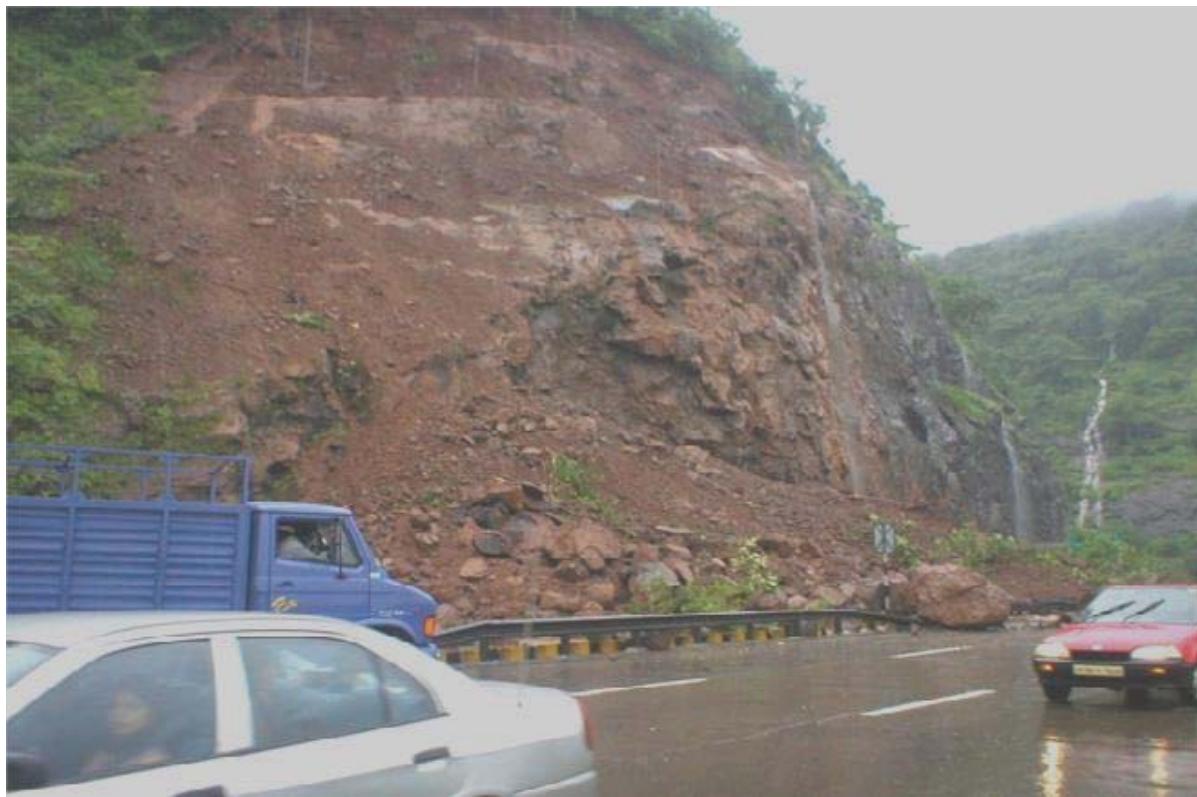
Figure 3. Rockfall and debris in 2004.

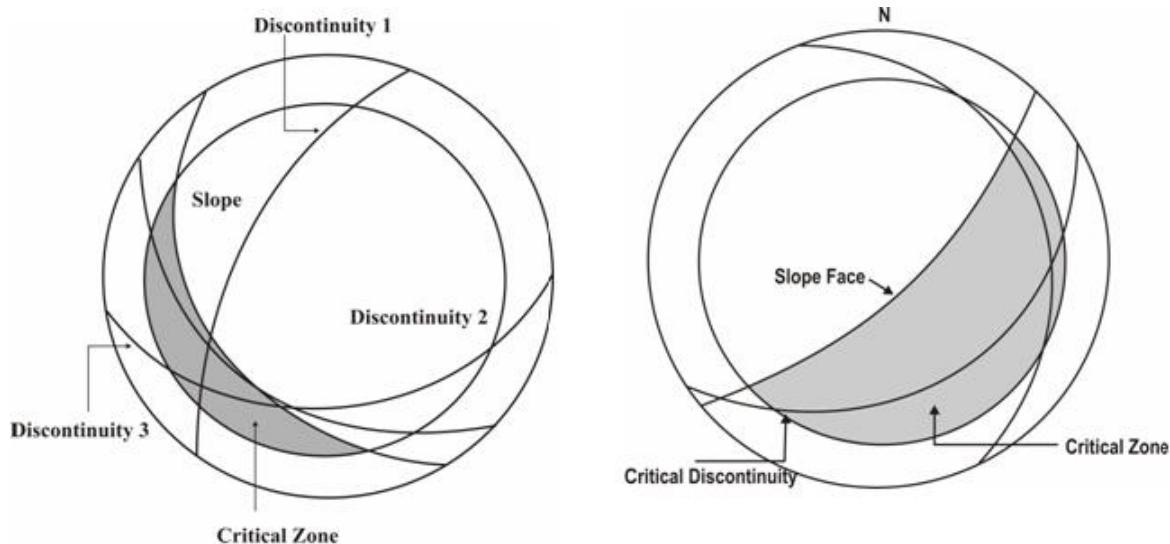
Figure 4. Markland test for planar failure on two sites showing critical zone for potential failure.

planes. The fractures on the rocks, which are normally confused with joints, have prominent attitudes. There are mainly three major joints, but one of the most prominent planes of weakness is the vertical joint (typical of basaltic layer, i.e. columnar joint). This prominent joint is repeated at regular intervals. The stereographic projection diagram, using the field data of joints, revealed the formation of a prominent wedge at the slope face. The vertical joints intersect to form wedges on the slope independently as well as when they intersect other steeply dipping fractures and other horizontal and subhorizontal fractures, as shown in Figure 4. In most cases, the plunge of the intersection of these two joint sets lies toward NNW in the direction of the slope. Additionally, the plunge of the intersection of the joints is more than the angle of the slope most of the time. The Markland Test was used to define the critical zone of planar and wedge failure in the stereographic projection. In the case of planar failure, the dip of the discontinuity exceeds the angle of friction of the rock; the discontinuity daylights in the slope face and dips less than the slope. In the case of wedge failure, the plunge of the line of intersection of two joints is considered (Figure 4) (Markland, 1972).

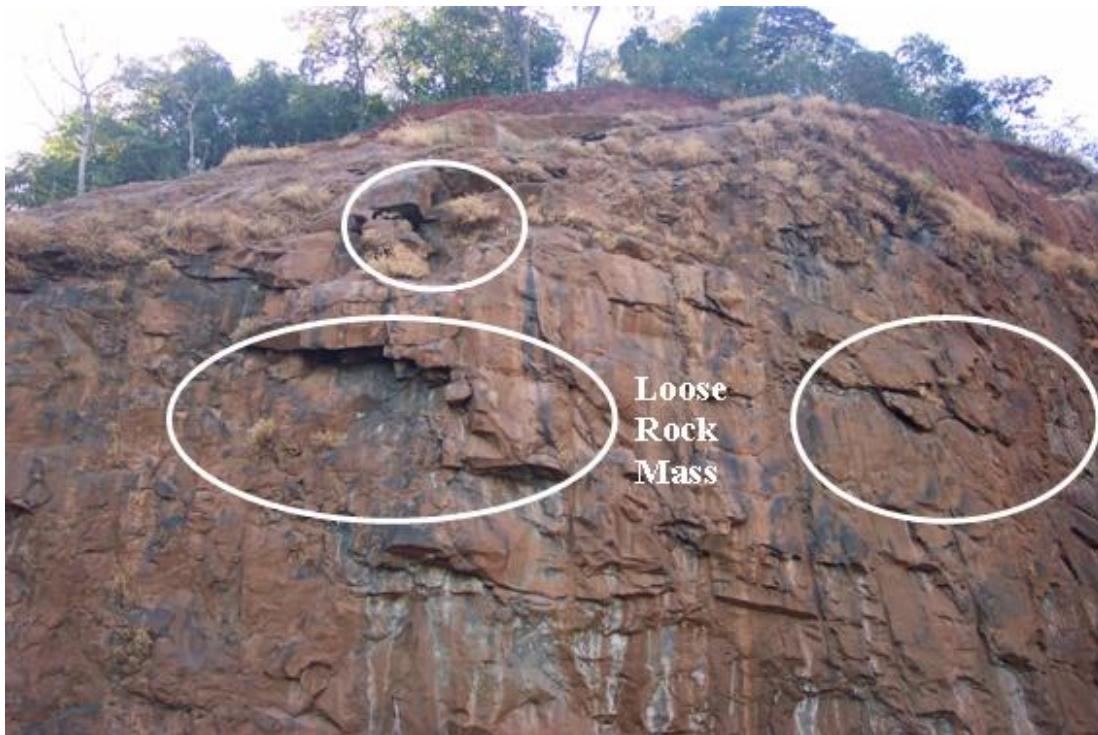
Figure 5. Vertical joints and formation of wedge along slope face.

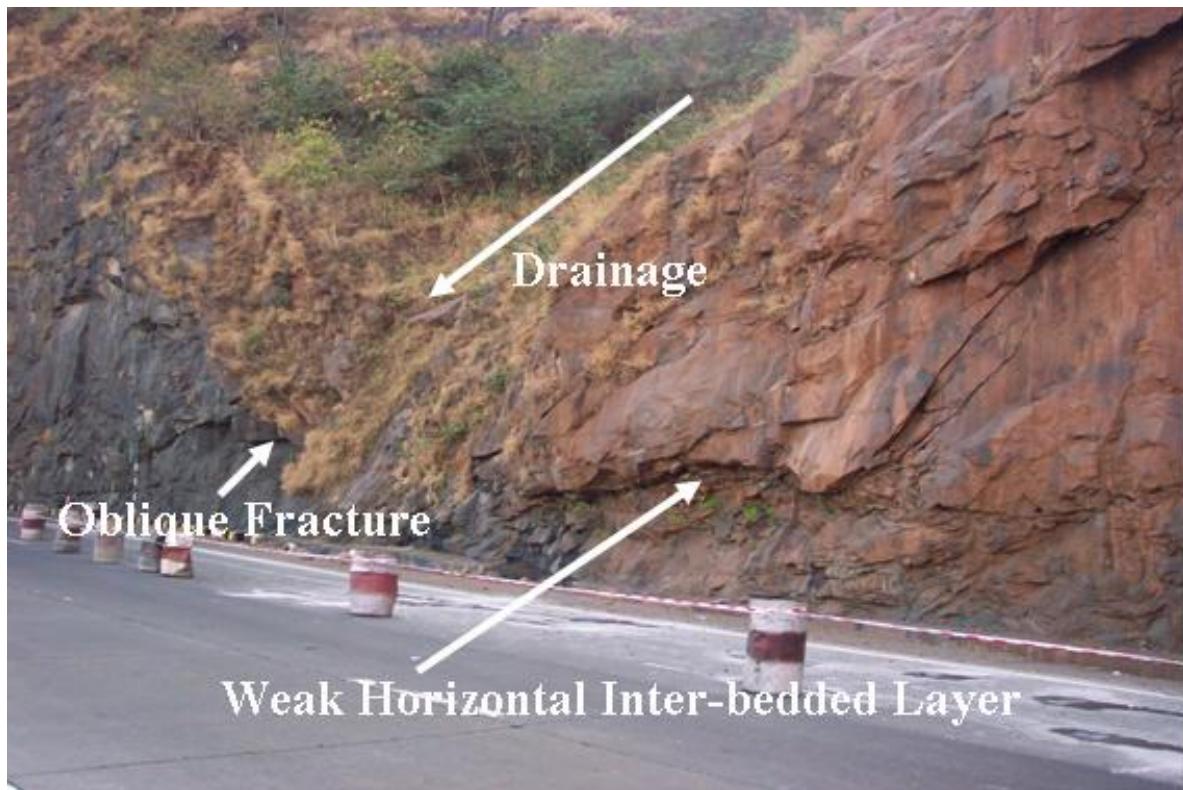
Figure 6. Intersection of oblique and sub-horizontal fractures.

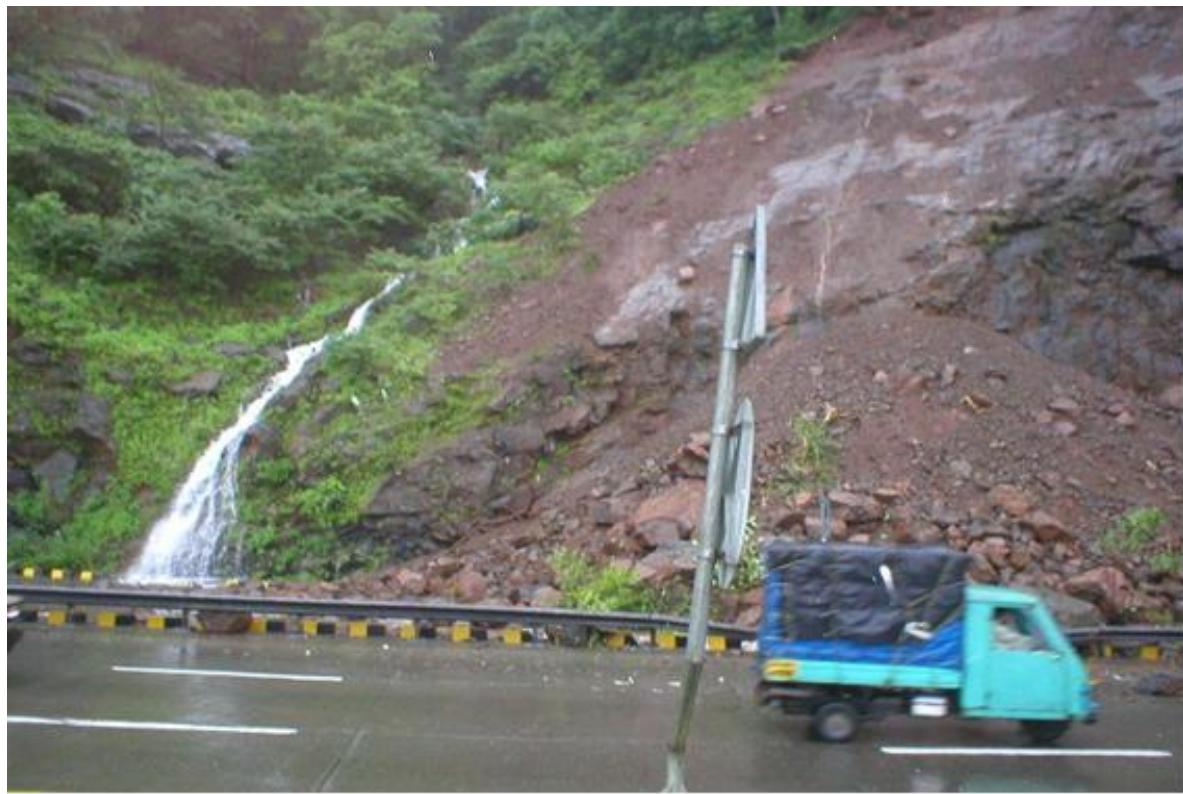
The slope is well covered by trees. The uphill slope has good catchment, and the rainwater generally drains out through the natural streams on both flanks of the slide. A considerable quantity of water also flows down the middle of the slope, above the affected portion. Near the crown there are a number of loose stone blocks, which rest on the slope. These may facilitate blocking and infiltration of more water into the slope during rains. The crown consists of a thin soil cover of a few centimeters to about one-third of a meter in thickness, below which lies 1–2-meter thick weathered and jointed basalt. This layer of weathered and jointed basalt, along with the thin overburden, fails along a smooth sheet joint surface and falls on the expressway through the adjoining vertical cut slope (Figure 2). This vertical cut of about 40 m in height has many joint intersections separating the blocks of the basaltic layer (Figure 5). A stream, guided by the intersection of one of the oblique and sub-horizontal fractures (Figure 6), remains dry except during the monsoon months when it serves as one of the main draining streams (Figure 7). A significant amount of water drains from the above catchment area.

Figure 7. Significant water drainage during a monsoon.

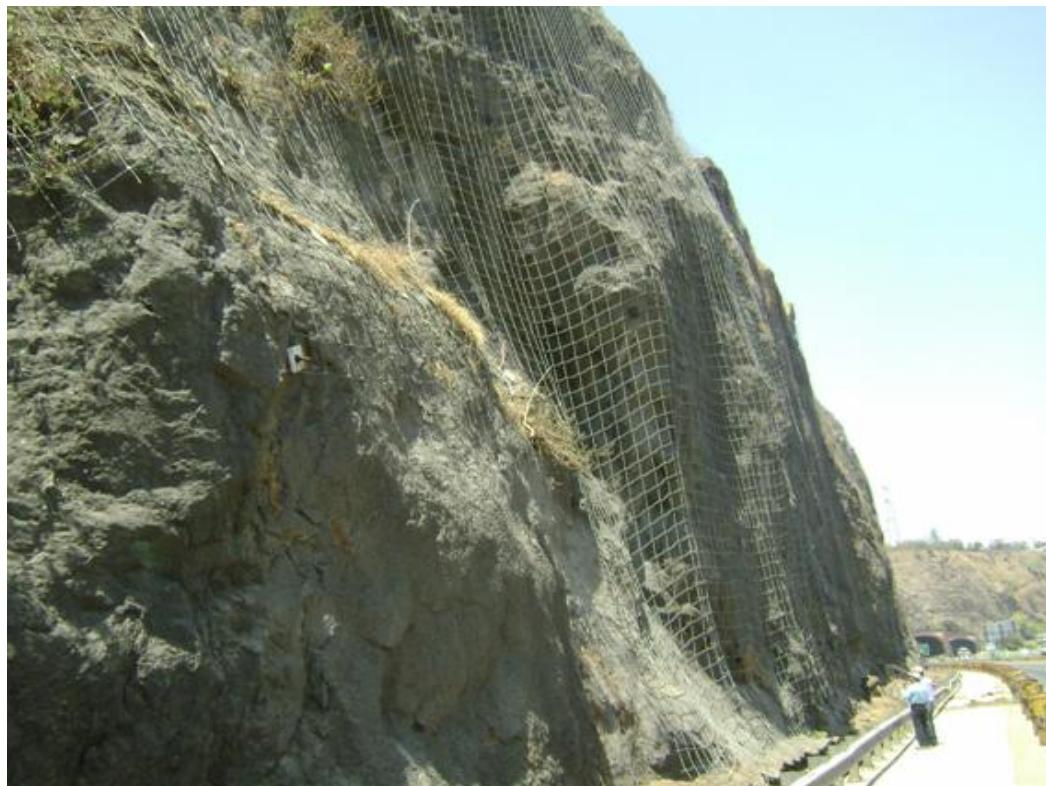
Figure 8. Remedial measures implemented on vertical slope (shotcrete and wire mesh).

The vertical face, which is vulnerable to sudden detachment of rocks, was mitigated to prevent dislodged rock from falling off the vertical cliff. The steep vertical cuts with loose overhanging blocks were leveled and the loose rock was removed. Since the rocks have multiple open joints and are likely to widen over time, the application of steel fiber reinforced shotcrete (SFRS) of 70 mm thickness was suggested along with covering the entire slope with a steel cable net of aperture size (300 mm x 300 mm) in order to stabilize the rock slopes. Steel fibers are very efficient compared to other material fibers such as asbestos, nylon or polypropylene and glass due to their high tensile strength and adherence to concrete. The SFRS provides measures to prevent the rock blocks from moving off the slope and also will prevent the weathering of the rock slope. This kind of stabilization is not intended to prevent the movement of blocks but rather to control rockfall from bouncing onto or blocking the expressway. For installing the steel cable net on the slope, a trench of 30 cm x 50 cm at a distance of 1.5 m from the top of the cliff was excavated. Iron rods were inserted 0.5 m from the bed of the trench. After inserting the rods, the holes were grouted with cement concrete. Subsequently, the steel rope net was laid and the trench was filled with cement concrete for anchorage. The steel cable was spread across the vertical face of the slope up to the toe. The cable net was anchored on the surface of the slope with expansion bolts/grouted bolts of 0.50 m length.

The remedial measures suggested were implemented in 2006 on some of the highway's stretches. In a few locations, the slopes were stabilized with SFRS and steel cable net; at others, the slopes were treated only with steel cable net. The slopes are being physically monitored by the Central Road Research Institute (CRRI) till September 2010. Figures 8 and 9 show the remedial measures that were implemented on the rock slope. The rocks were detached from the sloping surface where the slope is treated with steel cable net. Some rocks are trapped in the net and some were falling at the toe of the slope.

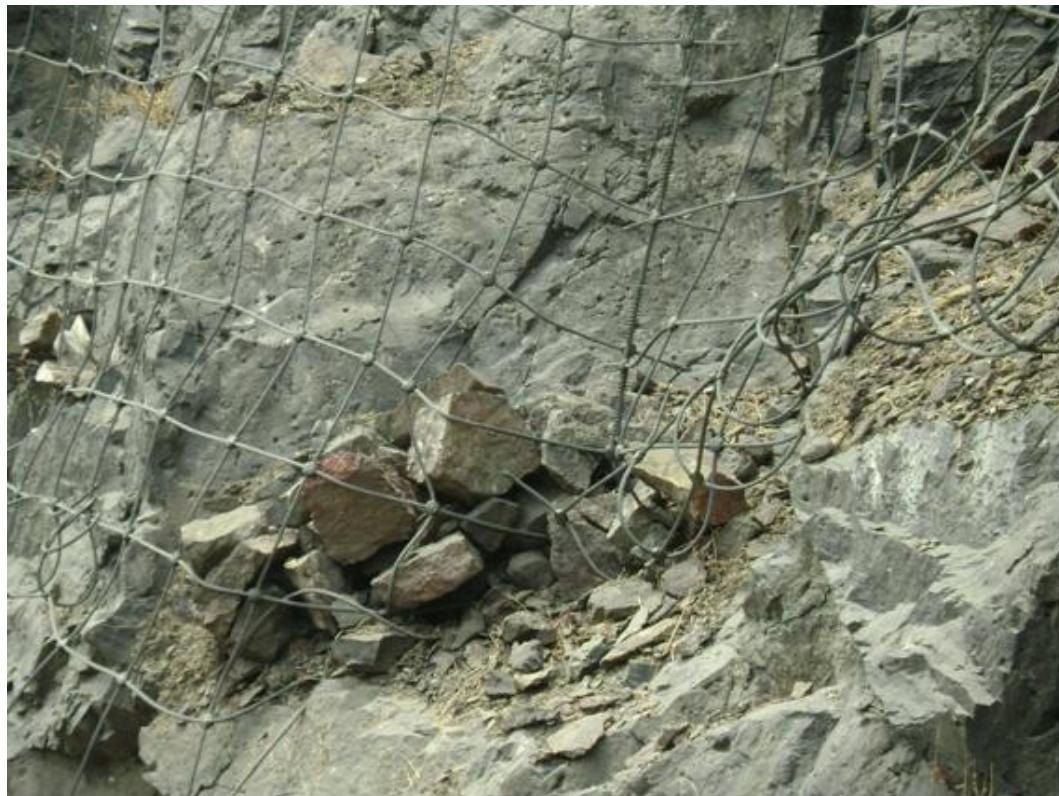
Figure 9. Trapped rock blocks at the toe of the slope.

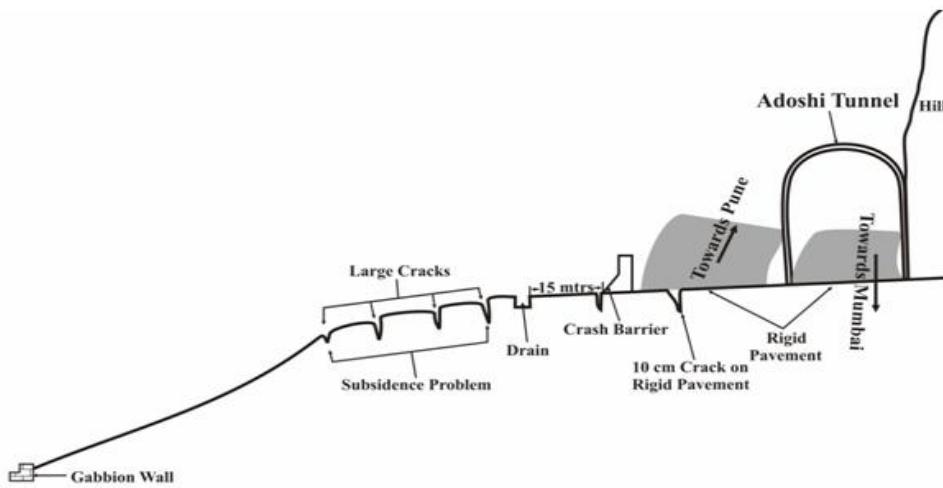
The subsidence portion (Figure 1) is located at km 41 on the downhill side of the expressway, adjacent to Adoshi tunnel (which extends for 500 m along the expressway). Figure 10 shows the schematic diagram of the subsidence problem on the expressway. The annual rainfall in this area is 200–300 cm, and the present drainage measures are not sufficient to drain this amount of water effectively. During the rainy season, water causes significant damage to this road at four locations in the form of a waterfall. One is in the curved portion, the second one is in between the curve and entrance of the tunnel, the third one is above the tunnel and the fourth one is after the tunnel exit. Pipe culverts were provided to help drain out the water on this stretch of the road, but the gradient of these culverts is not proper. However, it was observed that the internal diameter of the pipes varies from 1 to 1.2 m. In the pipe culvert, two pipe sections 1.0 m in internal diameter are provided, and the remaining pipes are 1.20 m in internal diameter. Two 1.0 m diameter pipe sections are installed in between the 1.20 m pipe sections. The joint between the 1.0 m diameter pipe and the 1.2 m diameter pipe is not proper, and the gap between the two pipes is 30 cm (Figure 11). Remaining pipes are also not joined properly. During periods of heavy rain, water seeps through the joints and saturates the surrounding soil mass, thereby causing cracking between lanes (i.e., flexible and rigid pavement). The runoff from the pipe culvert and cross drains is draining directly onto the embankment surface (Figure 12). The rainwater scours the embankment soil, thereby causing the instability of the embankment. After the exit of the Adoshi tunnel, the gradient of the drain is not proper. As a result, water may stagnate and seep into the pavement through the existing weep holes. The rigid pavement (on the outermost side lane) subsided by 5 to 6 cm, and subsidence also has occurred in between the joint of fast track lane (middle lane) and the truck lane. The average width of a crack is 5 cm and the average length of a crack is 85 m (Figure 13). The surface between the crash barrier and the rigid portion has been paved with bitumen. The flexible portion or shoulder (bituminous surface) has separated from the rigid pavement; the depth of the crack is 50 cm (Figure 14).

Figure 10. Schematic diagram showing subsidence problem on the Mumbai-Pune expressway.

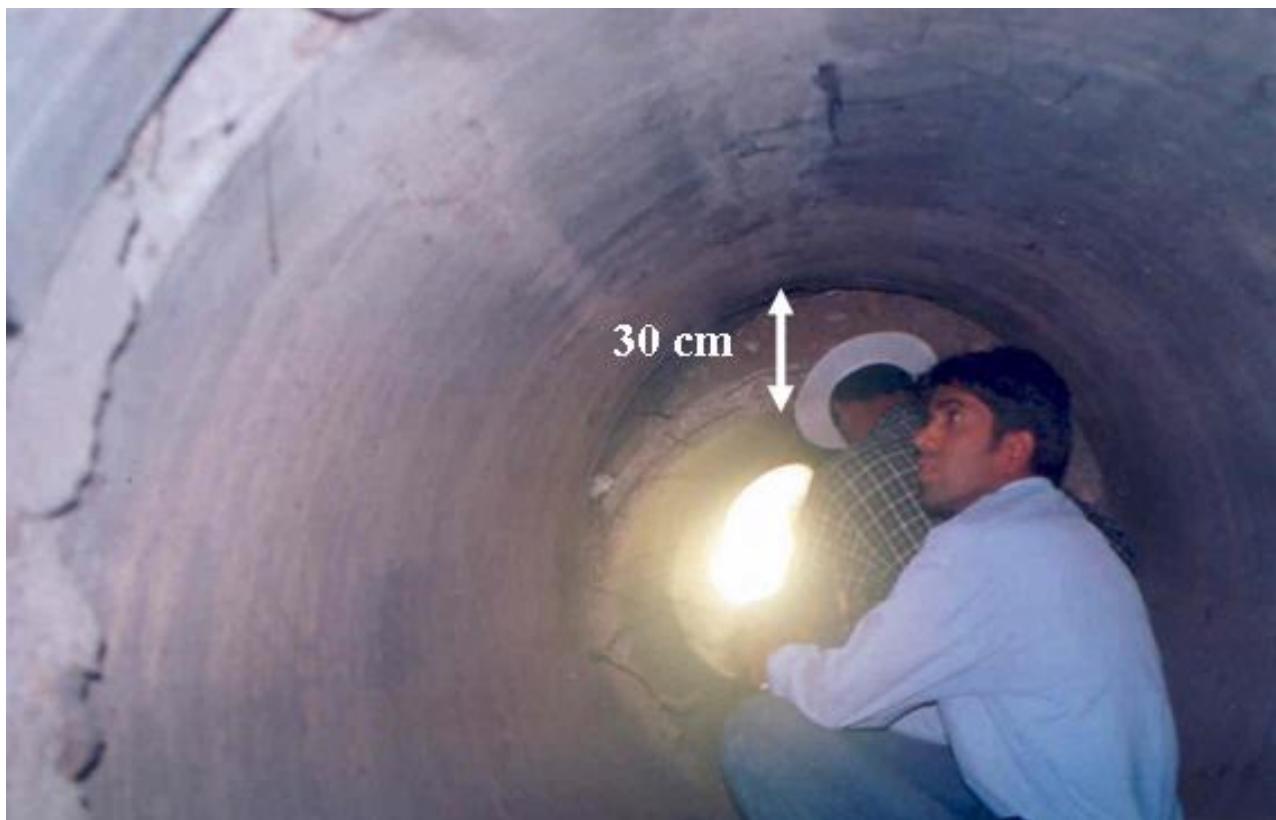
Figure 11. Dislodged pipe culvert.

- The broken culvert was repaired by providing uniform-sized pipe sections, and the joints were properly sealed.
- On the shoulder portion and below the crash barrier, the cracks were sealed with cement grouting and monitored for three years. The portion stabilized and no further cracks were observed in this area.
- After the crash barrier, the embankment was excavated up to 3 m and recompacted to 95% of maximum dry density and moisture content.
- Longitudinal and transverse drains were provided at frequent intervals.
- To prevent erosion and to stabilize the embankment, the slope has been protected with stone pitching/turffing.

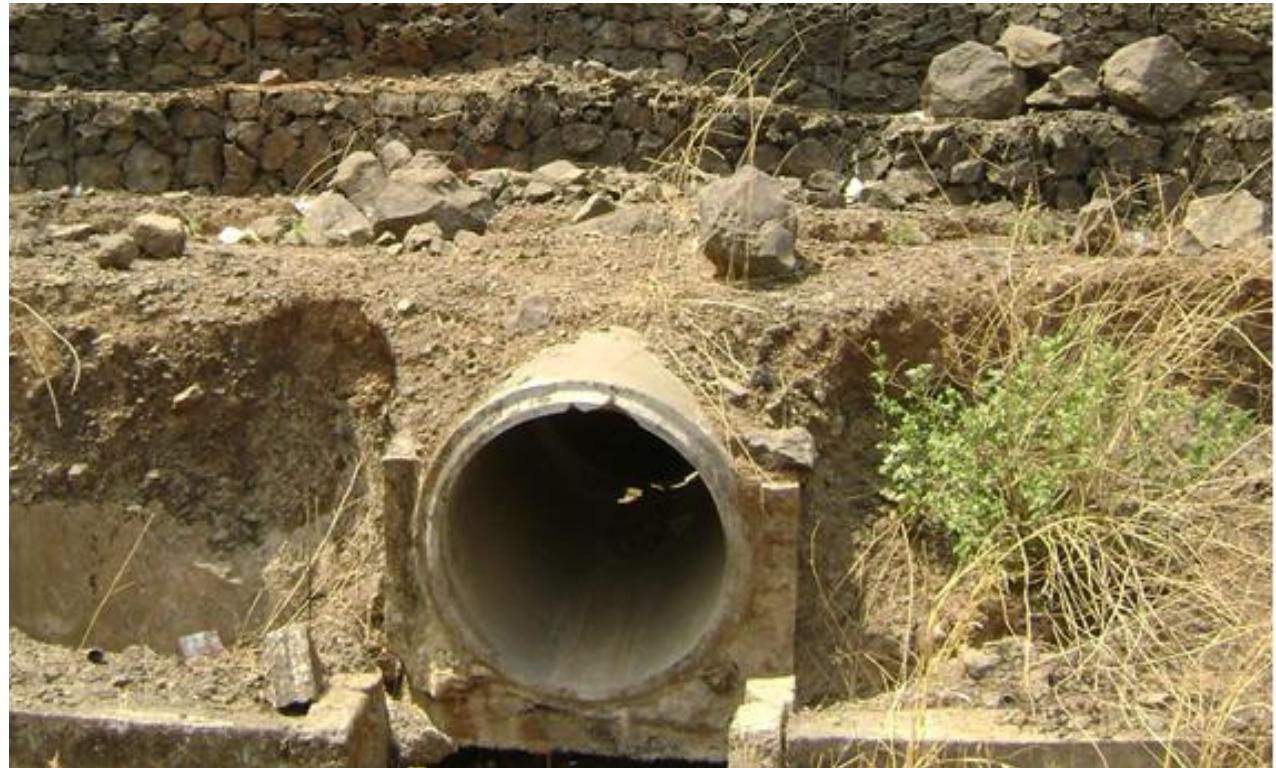
Figure 12. Pipe culvert without stepped chute.

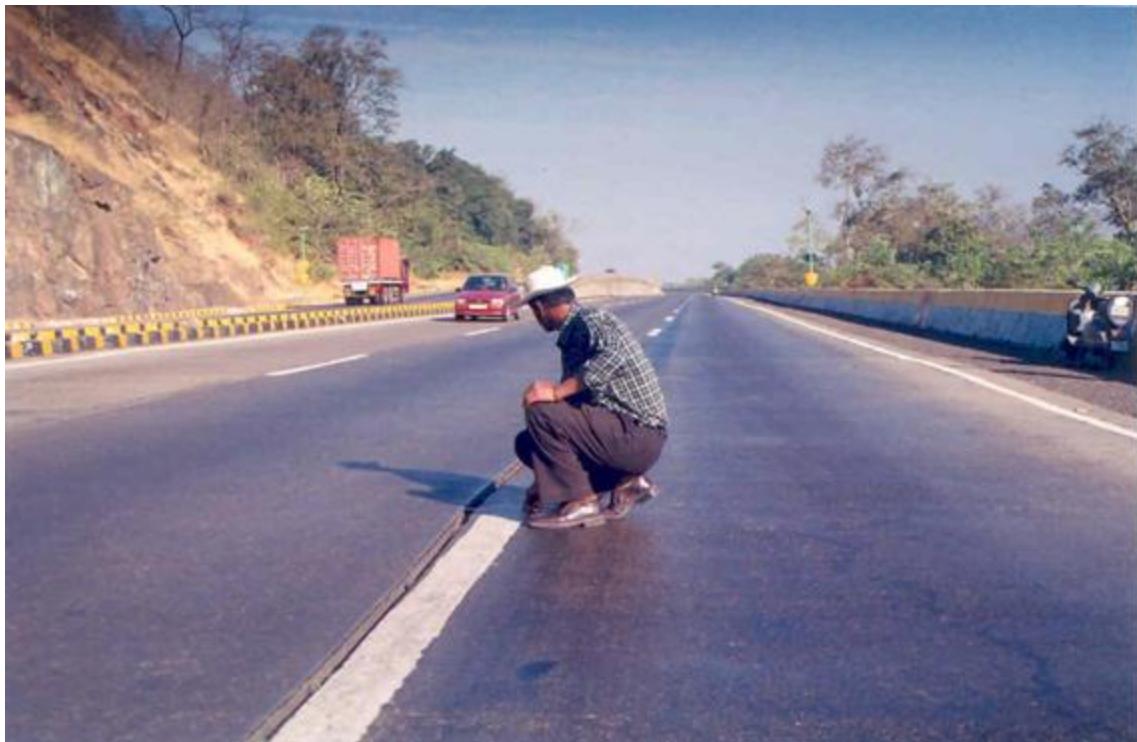
Figure 13. Dislodged rigid pavement.

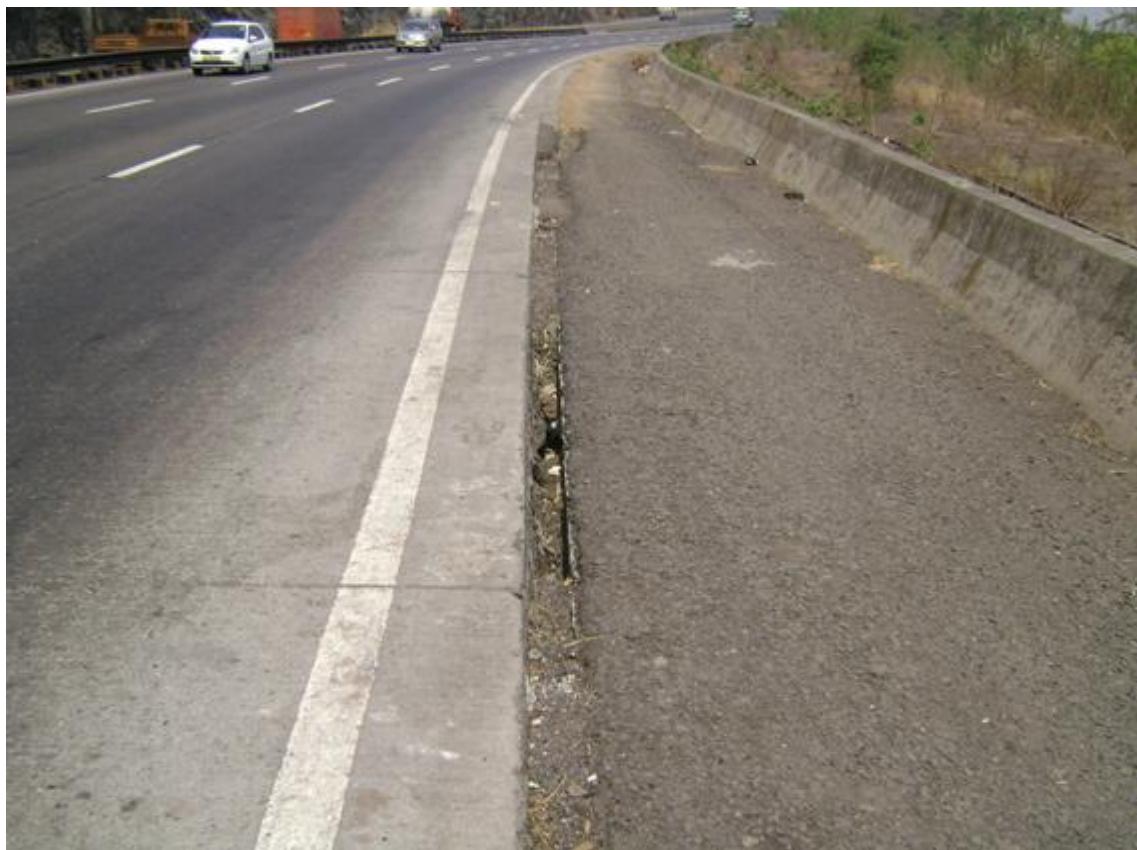
Figure 14. Crack between rigid and bituminous pavement.

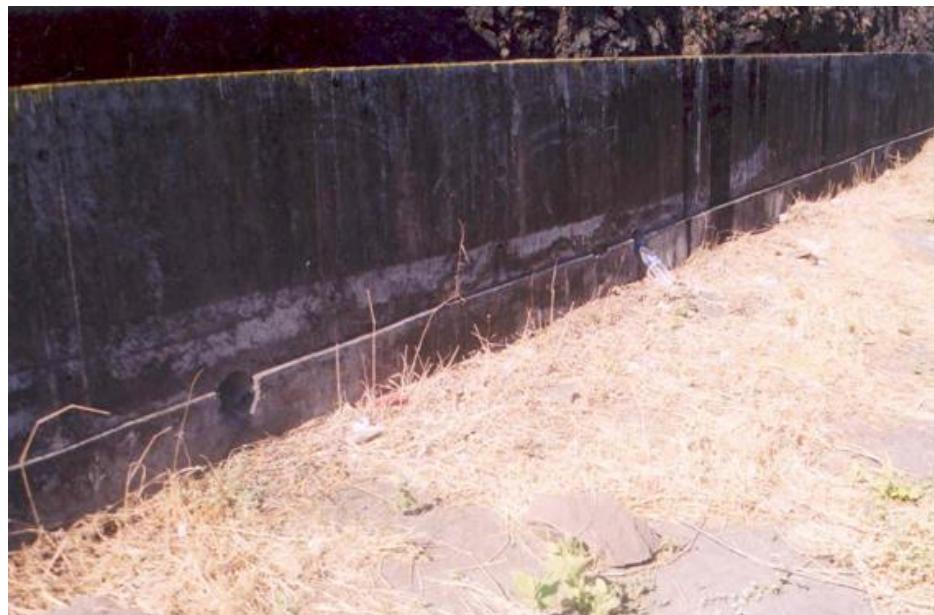
A crash barrier has been provided along the slope. Beyond the crash barrier, the average width of the embankment on the downhill extends downhill another 12 m. Drainage holes (Figure 15) are provided in the crash barrier at frequent intervals, but the holes are left open directly on the embankment surface. The considerable quantity of water passing through these drainage holes is causing saturation of the embankment fill beyond the parapet and is weakening the foundation of the crash barrier as well as the scouring below the crash barrier and pavement (Figure 16). A longitudinal drain is provided after a certain distance from the crash barrier on the embankment. From the crash barrier to the longitudinal drain, the surface is not lined and scouring was observed below the crash barrier. The crash barrier is also tilted, and below the crash barrier, the embankment slope has experienced scouring up to a depth of 1 m. The embankment has subsided by 2 to 3 m in steps, and each step has an average height of 1 m (Figure 17).

Figure 15. Drainage holes left open on embankment surface.

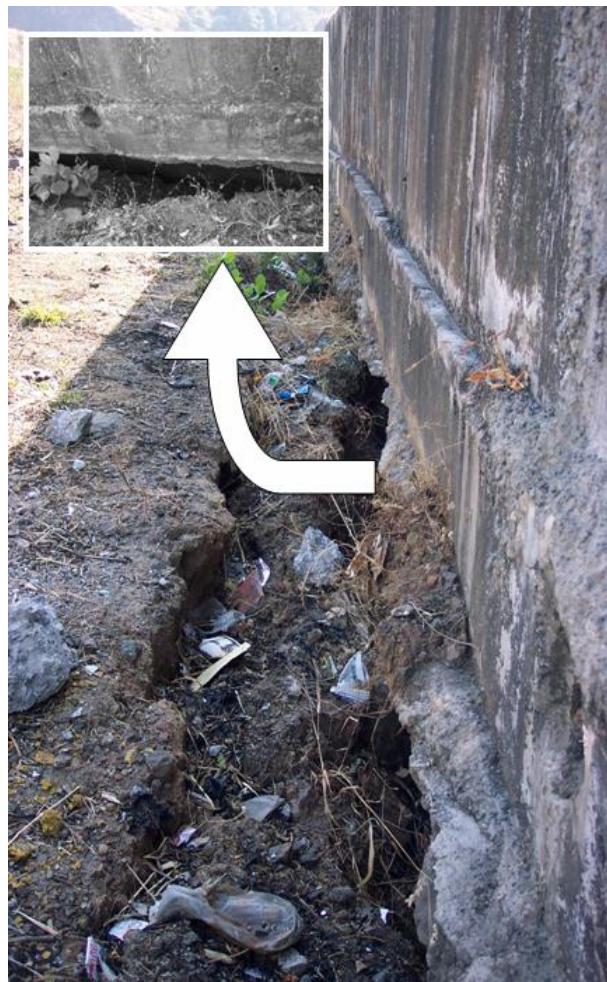
Figure 16. Embankment scoured below the crash barrier.

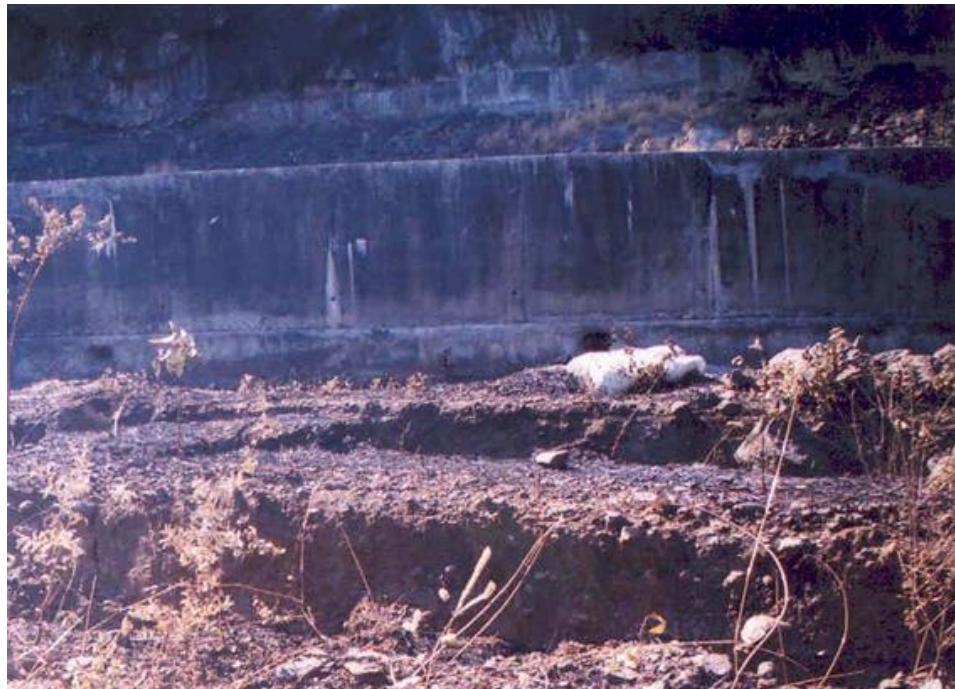
Figure 17. Subsidence of the embankment.

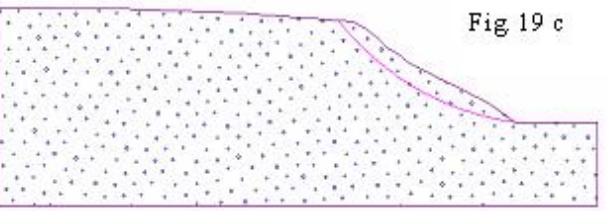
Fig. 19 c	1.38	1.34
D - D

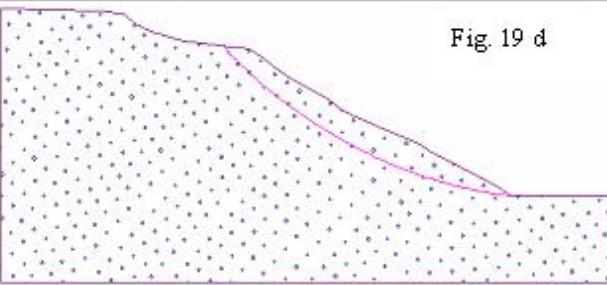
Fig. 19 d	1.46	1.42
