Mississippi River Levee Failures: June 2008 Flood

ABSTRACT: *During the spring and summer of 2008, record rainfall in the Midwest United States led to severe flooding as water overtopped the levees bordering the Mississippi River and its tributaries. The erosion associated with the overtopping resulted in levee breaches in many places. After the flooding, a field reconnaissance team was sent to collect time-sensitive data and provide a comprehensive overview of the performance of the levees during the flooding.*

Reference: Bernhardt, M., Briaud, J.L., Kim, D., Leclair, M., Storesund, R., Lim, S.G., Bea, R.G., Rogers, J.D., (2011). *Mississippi River Levee Failures: June 2008 Flood*. International Journal of Geoengineering Case Histories, <http://casehistories.geoengineer.org>, Vol.2, Issue 3, p. 127-162. doi: 10.4417/IJGCH-02-02-03.

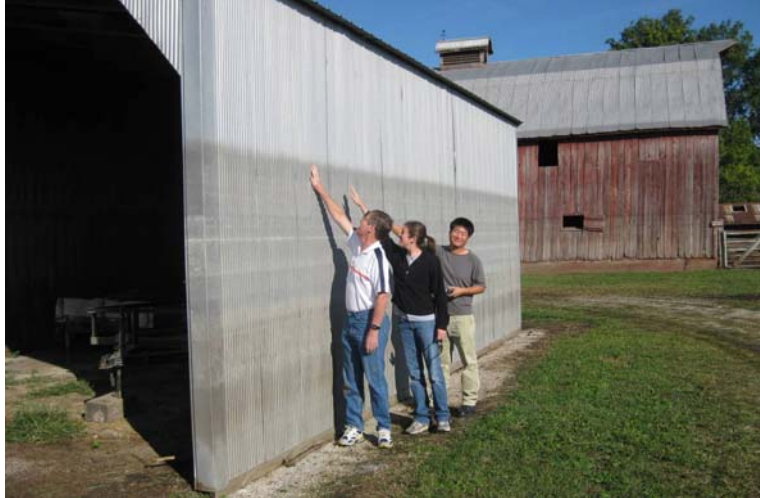
While the levees did not breach, there was still a large amount of damage to homes and equipment on the dry side of the levee due to the overtopping waters. The area enclosed by the levees at this site was much smaller compared to the other sites, so the overtopping water began to fill the internal area like a swimming pool. Figure 21 shows the high water marks on a barn located within the area surrounded by the levees. As the water on the dry side of the levee rose, the difference in elevation between the two sides decreased thereby decreasing the erosion potential. Substantial damage occurred within the internal area even though the levee performed well.

Figure 21. High water marks on barn within the Brevator levee system.
