Mississippi River Levee Failures: June 2008 Flood

ABSTRACT: *During the spring and summer of 2008, record rainfall in the Midwest United States led to severe flooding as water overtopped the levees bordering the Mississippi River and its tributaries. The erosion associated with the overtopping resulted in levee breaches in many places. After the flooding, a field reconnaissance team was sent to collect time-sensitive data and provide a comprehensive overview of the performance of the levees during the flooding.*

Reference: Bernhardt, M., Briaud, J.L., Kim, D., Leclair, M., Storesund, R., Lim, S.G., Bea, R.G., Rogers, J.D., (2011). *Mississippi River Levee Failures: June 2008 Flood*. International Journal of Geoengineering Case Histories, <http://casehistories.geoengineer.org>, Vol.2, Issue 3, p. 127-162. doi: 10.4417/IJGCH-02-02-03.

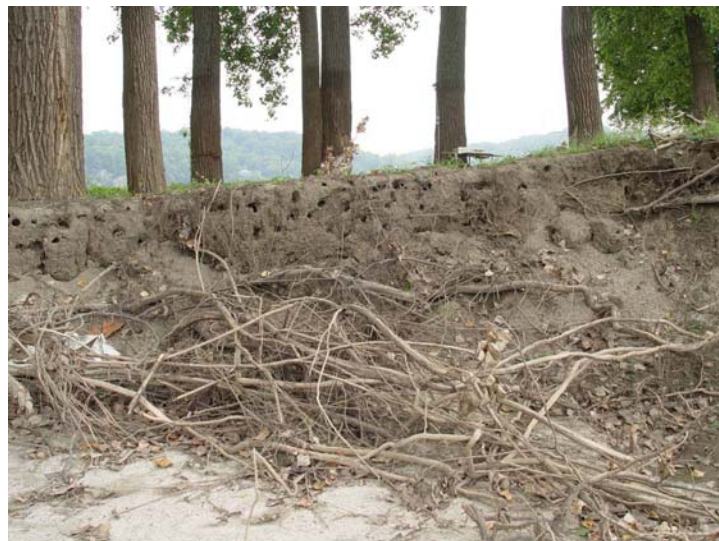
Extensive root networks and crayfish tunnels were present throughout the existing levee and breached area (Figure 17). These encroachments often encourage the formation of seepage paths through embankments.

Figure 17. Root networks and crayfish tunnels throughout the levee.

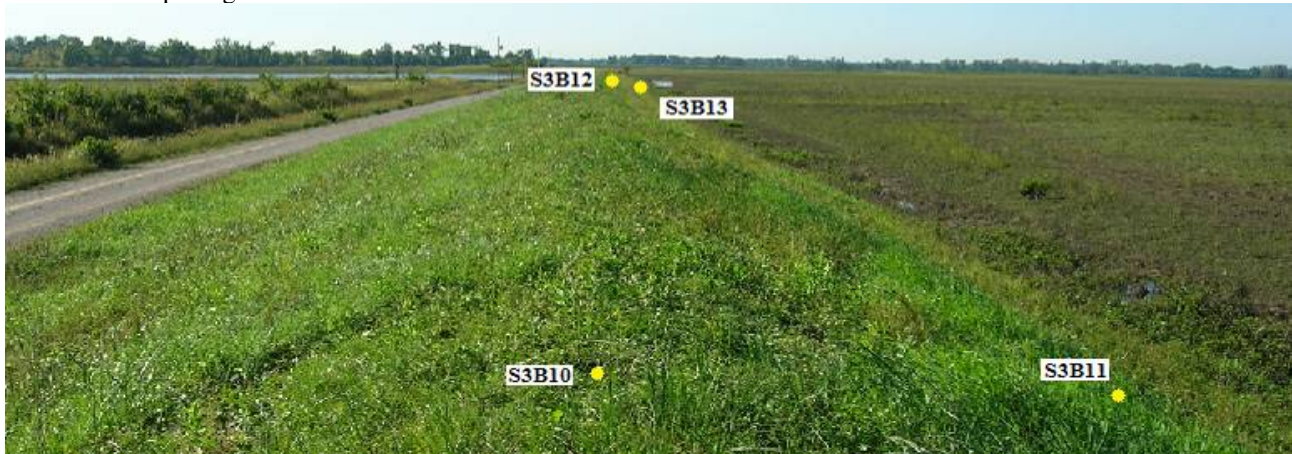
Figure 20. Brevator boring locations.

This site was unique in the fact that there was no breach in 2008. The only sign of erosion was at a box culvert that was cracked allowing water and soil to seep through. A local resident (Mr. James Pieper) informed the team that the levee was overtopped by nearly 1 m of water for three days and never failed. Four samples were collected from various locations along the levee. Because there was no actual breach, only surficial samples were taken. These samples were much harder to obtain and the soil seemed to be much stiffer than at the previous sites as can be seen by the higher Pocket Penetrometer values (Table 6) obtained at this site compared to the Winfield site. Figure 20 shows the boring locations and Table 6 presents the sample logs for this site.
