Mississippi River Levee Failures: June 2008 Flood

ABSTRACT: *During the spring and summer of 2008, record rainfall in the Midwest United States led to severe flooding as water overtopped the levees bordering the Mississippi River and its tributaries. The erosion associated with the overtopping resulted in levee breaches in many places. After the flooding, a field reconnaissance team was sent to collect time-sensitive data and provide a comprehensive overview of the performance of the levees during the flooding.*

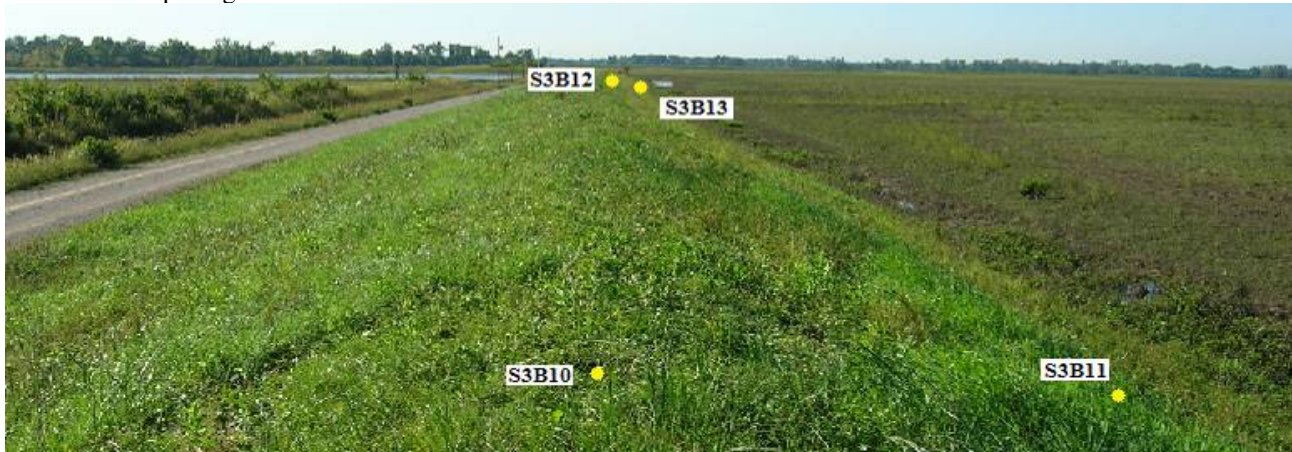
Figure 20. Brevator boring locations.

This site was unique in the fact that there was no breach in 2008. The only sign of erosion was at a box culvert that was cracked allowing water and soil to seep through. A local resident (Mr. James Pieper) informed the team that the levee was overtopped by nearly 1 m of water for three days and never failed. Four samples were collected from various locations along the levee. Because there was no actual breach, only surficial samples were taken. These samples were much harder to obtain and the soil seemed to be much stiffer than at the previous sites as can be seen by the higher Pocket Penetrometer values (Table 6) obtained at this site compared to the Winfield site. Figure 20 shows the boring locations and Table 6 presents the sample logs for this site.
