Quarry-Induced Slope Instability at a Broadcasting Transmission Plant near Valcava, Lombardia, Italy

Monica Barbero, Assistant professor, Politecnico di Torino (Torino, Italy); email: monica.barbero@polito.it
Fabrizio Barpi, Assistant professor, Politecnico di Torino (Torino, Italy); email: fabrizio.barpi@polito.it

ABSTRACT: *Since 2006, a broadcasting tower and ancillary buildings on the top of a hill adjacent to a large, active limestone quarry, in northern Italy near the village of Valcava, has been heavily damaged by ground deformation due to slope instability. In 2005, the quarry began to work the slope toward the broadcasting plant, releasing bedding planes that affected the tower site: a number of fractures occurred in the warehouse and in the ground around it, that grew particularly during significant rainfalls. In October 2006 a landslide occurred in the quarry area, close to the broadcasting site. In order to understand what induced the fracture process in the buildings and define a support system to stabilize the broadcasting site, a detailed geotechnical survey and a number of numerical slope stability analyses were carried out. One of the main goals of the paper is t

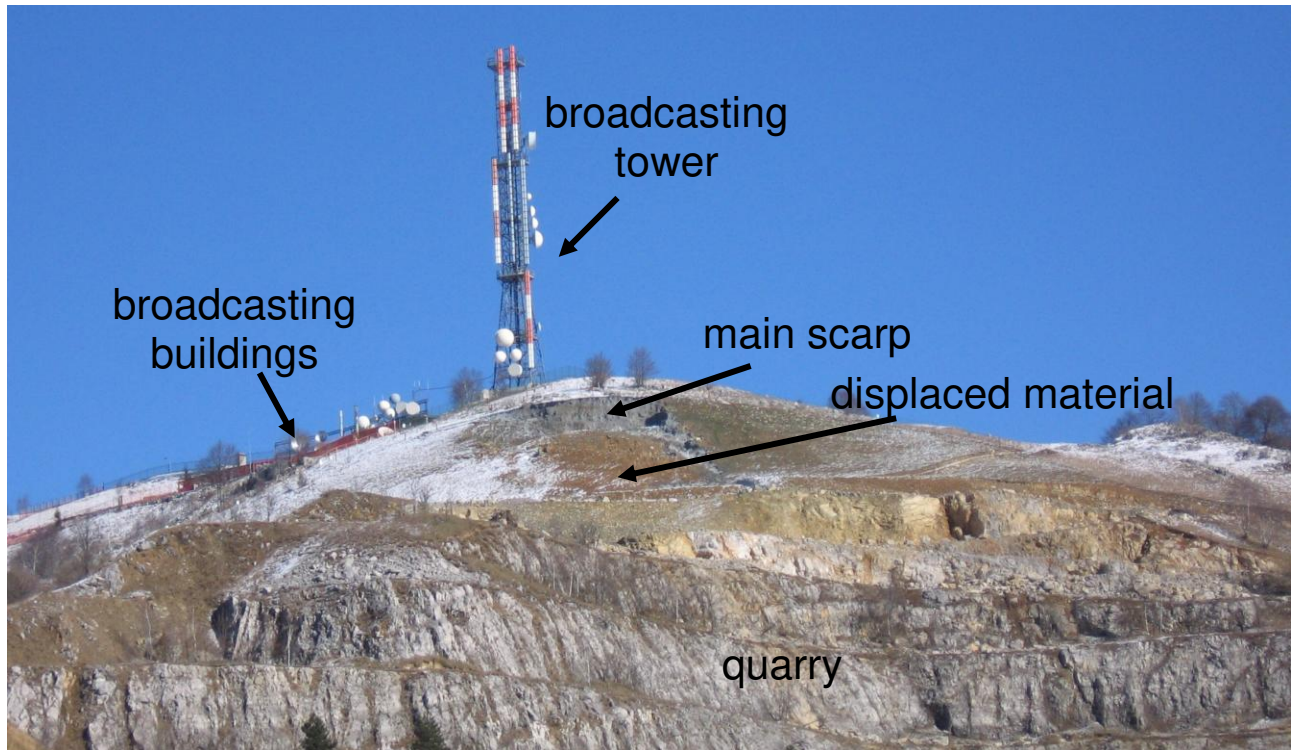
Figure 4. The landslide in the pit area.

3. Fault A marks the eastern boundary of the landslide in the pit area. This involves a 30 m slope height and has a crown length of about 35 m;
4. In the west side of the edge and in the toe of the landslide, many opened cracks were observed, suggesting that the instability phenomenon is not completed yet and potential landslide progression toward the plant is possible;

5. After the event, the landslide was entirely covered by a layer of sprayed-on concrete. In the edge of the landslide, many tension cracks developed with openings of a few centimeters in width. These confirmed that the slope is still moving.

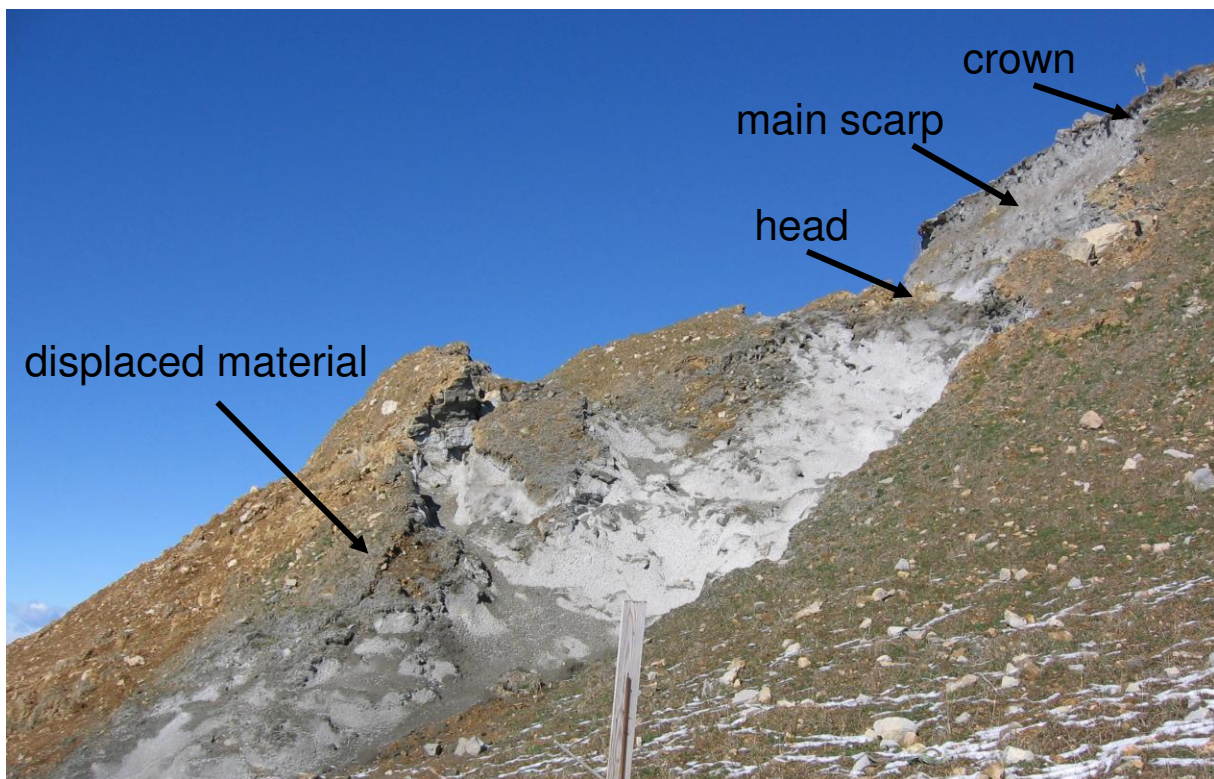
Figure 5. Top of the landslide.

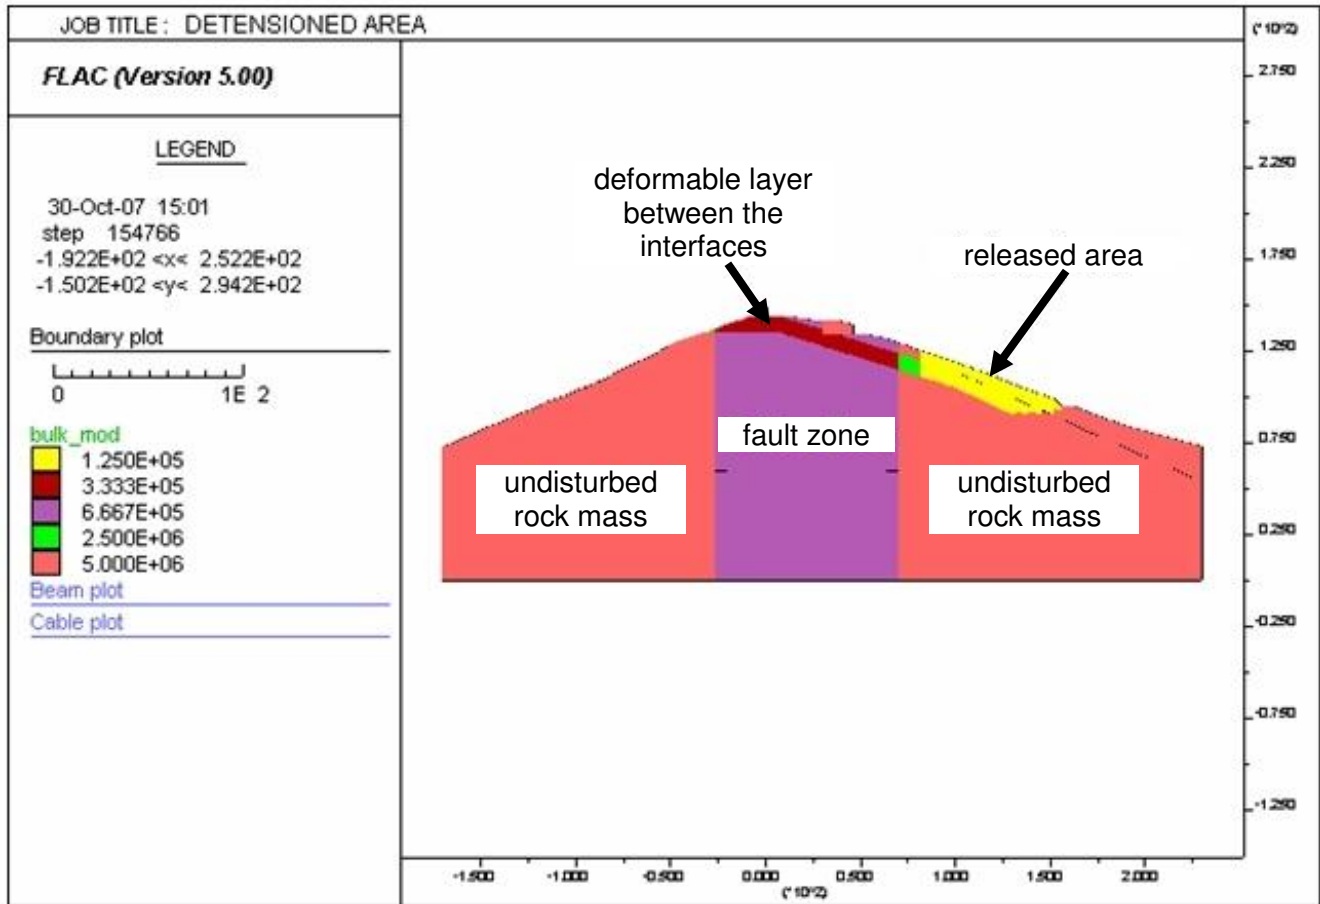
The slope behavior after the landslide in the pit area was simulated. It was assumed that the landslide induced a stress release in the slope beside it, between 1345 m and 1375 m above sea level with down slope displacements. For this purpose, a 20 m thick layer of the rock mass (equal to the estimated depth of the landslide) has been relieved between 1345 m and 1375 m above sea level. In order to simulate the progressive failure along the critical layer, the deformability and strength properties of the corresponding elements were progressively reduced (Table 6 and Figure 12).

The results show an important displacement increase in the upper part of the slope. The displacements in the warehouse area are appreciable only in the case of water table at 5 m from the level of site (Figure 13). A wide area in the disturbed rock mass reaches the plastic boundary for every hydraulic scenarios. From this, it is possible to reconstruct the slope's stress-strain history. The cuts in the pit area induced a progressive instability in the area immediately below the broadcasting plant, with downwards displacements that started in the pit cut and spread towards the warehouse. The landslide in the pit area quickened the instability phenomenon that worsened with heavy rain falls, leading to considerable displacements in the warehouse area.

Figure 12. Model with released area to simulate the landslide in the pit (FLAC).

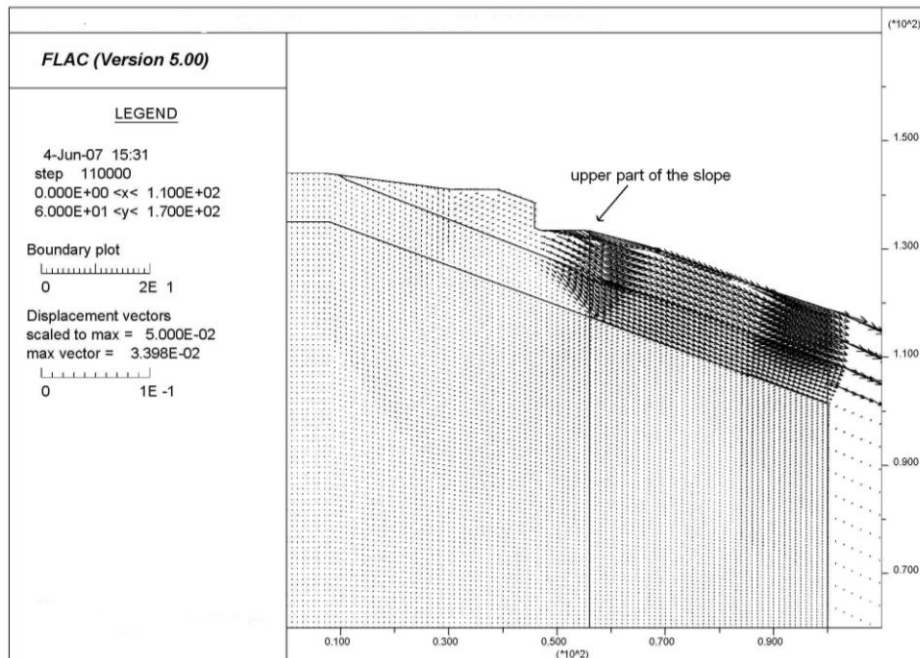
Figure 13. Numerical results: displacements in the upper part of the slope.

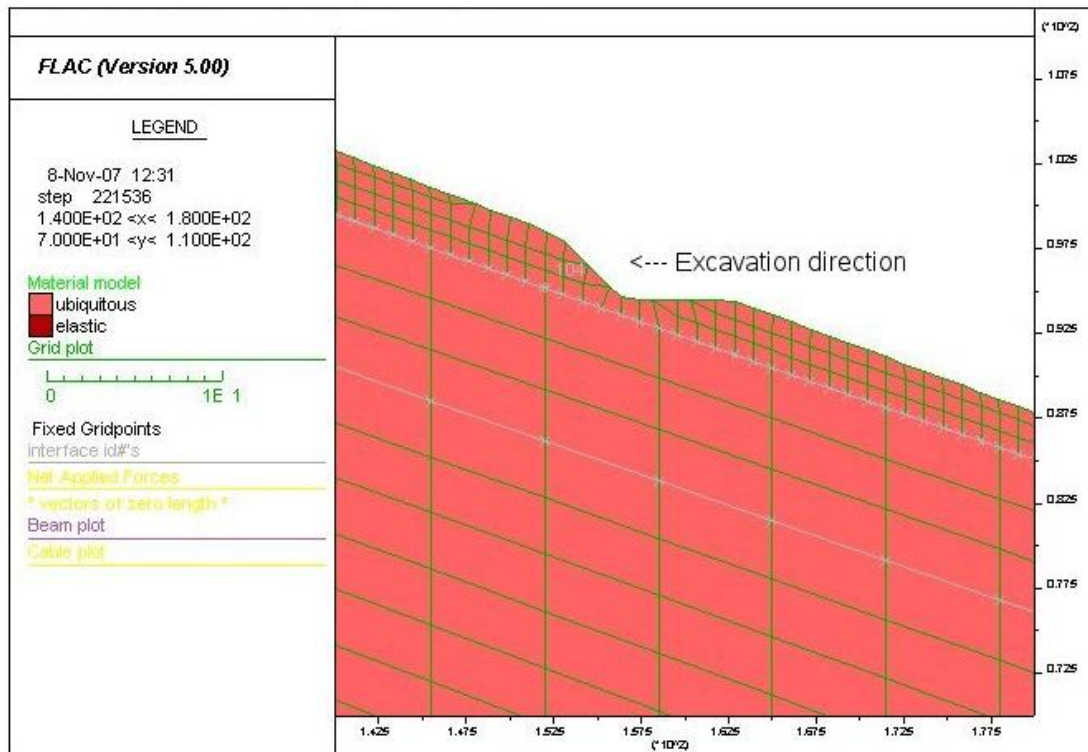
The obtained results pointed out that, with the extension of the pit area, the displacements in the upper part of the slope increase. Close to the warehouse they become in the order of a few centimeters. In particular, the displacements become considerable when the excavation involves the deformable layer.

The results allow to assert that a progression of the mining activity toward the broadcasting plant would induce its instability. For this reason, it can be considered as a triggering cause of the slope movement. As such, it should not to be authorized.

Figure 14. Model for the progression of the mining activities analysis.

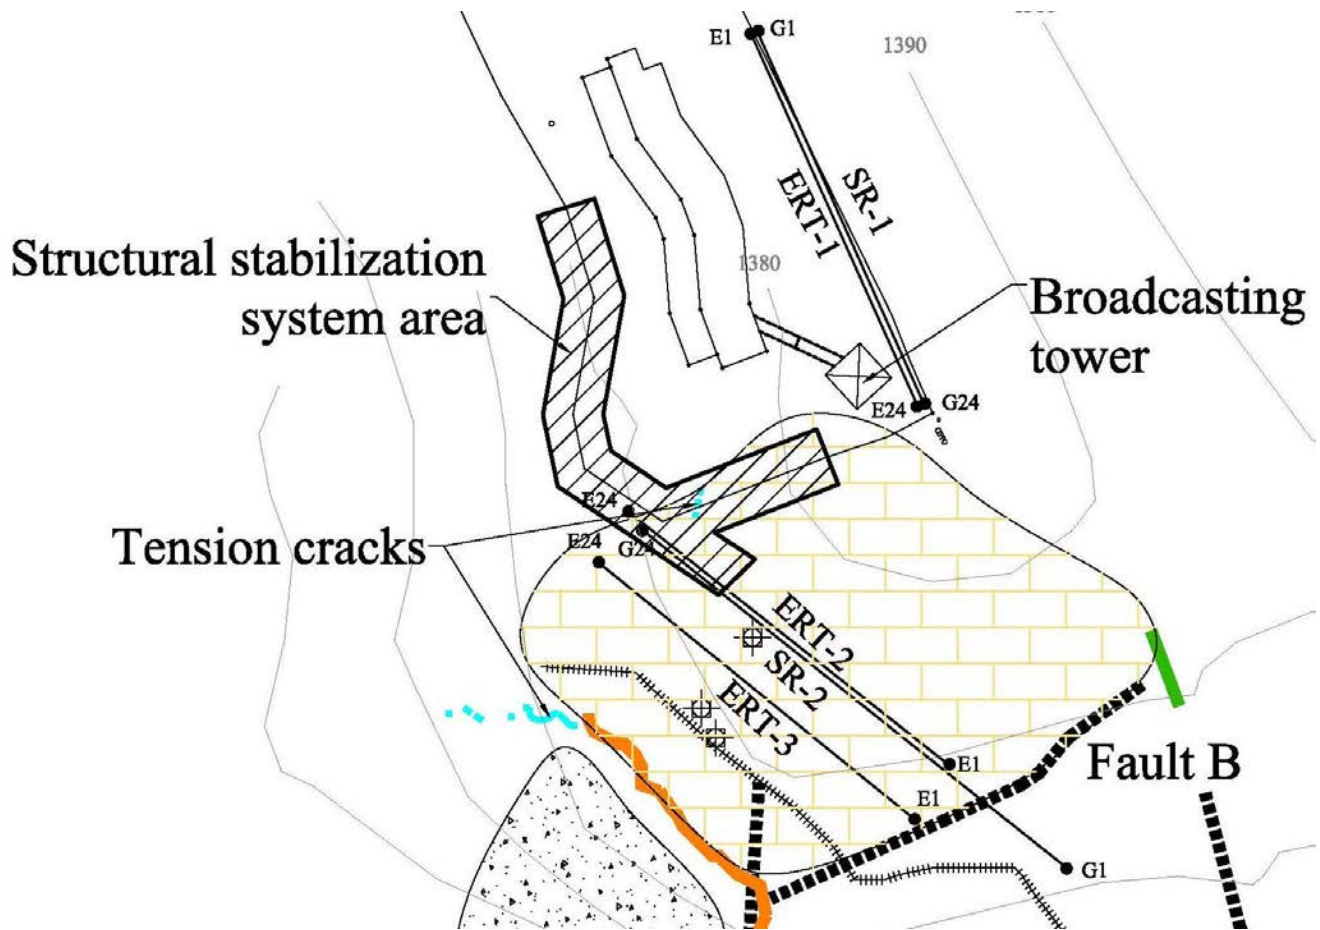
Figure 15. Map of the site with the location of the stabilization system.

In order to confine the strain effects of the stress release induced by the landslide, the broadcasting site has to be isolated from the unstable slope. For this purpose, a structural stabilization system in the warehouse square was suggested (Figure

15 and 17). It was conceived to be a bulkhead consisting of 27 m long micropiles reinforced with steel pipes, 139.7 mm of diameter and 10 mm thick. The micropiles are connected at their head level by a reinforced concrete beam. The bulkhead extends as shown in Figure 15 and is anchored in the head to the undamaged rock mass by means of 28 m long four strands steel anchors, at center distance of 3 m and with a down dipping of 25°. During the construction of the bulkhead, any karst cavities will be filled.

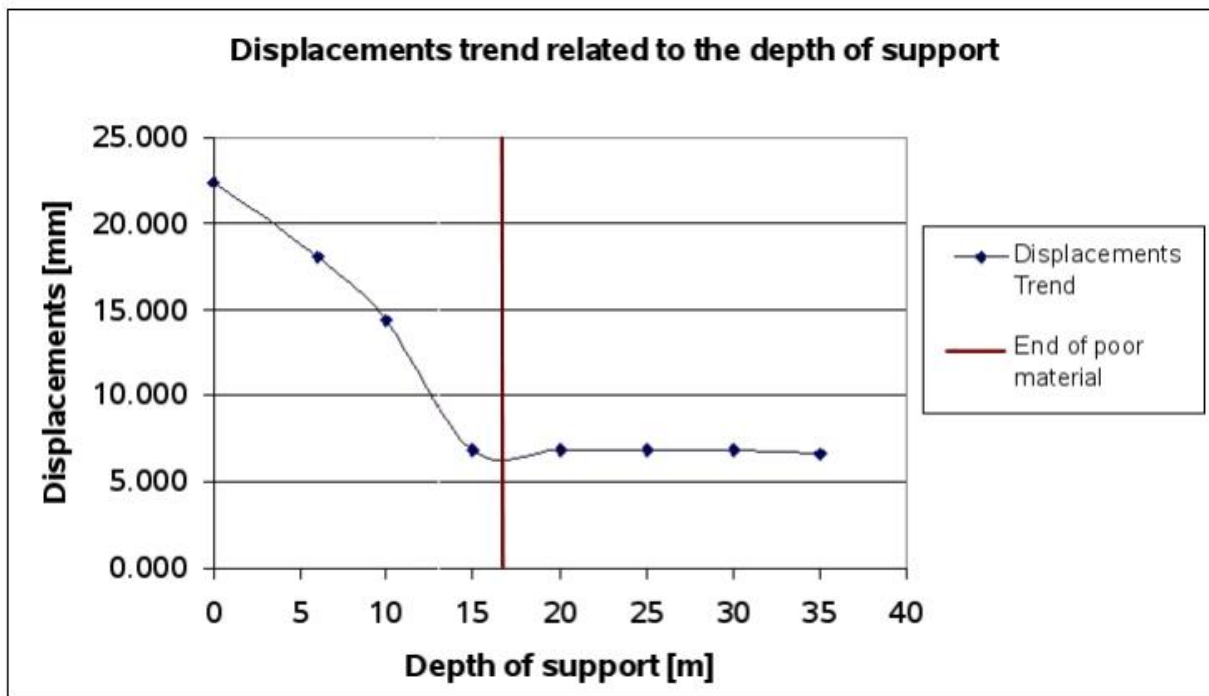
The results (Figure 16) confirm that the minimum length for the micropiles is about 16 m (the depth at which the boundary between the weaker layer and the undisturbed rock mass is located). On the other hand micropile lengths greater than 20 m don't provide further benefit to the plant stability. It is possible to conclude that 27 m is a good estimate of the length for the micropiles.

Figure 16. Model displacements in the area upstream the bulkhead, related to the length of the micropiles (assuming that in-situ bedrock is at 16 m depth).
