Quarry-Induced Slope Instability at a Broadcasting Transmission Plant near Valcava, Lombardia, Italy

Monica Barbero, Assistant professor, Politecnico di Torino (Torino, Italy); email: monica.barbero@polito.it
Fabrizio Barpi, Assistant professor, Politecnico di Torino (Torino, Italy); email: fabrizio.barpi@polito.it

ABSTRACT: *Since 2006, a broadcasting tower and ancillary buildings on the top of a hill adjacent to a large, active limestone quarry, in northern Italy near the village of Valcava, has been heavily damaged by ground deformation due to slope instability. In 2005, the quarry began to work the slope toward the broadcasting plant, releasing bedding planes that affected the tower site: a number of fractures occurred in the warehouse and in the ground around it, that grew particularly during significant rainfalls. In October 2006 a landslide occurred in the quarry area, close to the broadcasting site. In order to understand what induced the fracture process in the buildings and define a support system to stabilize the broadcasting site, a detailed geotechnical survey and a number of numerical slope stability analyses were carried out. One of the main goals of the paper is t

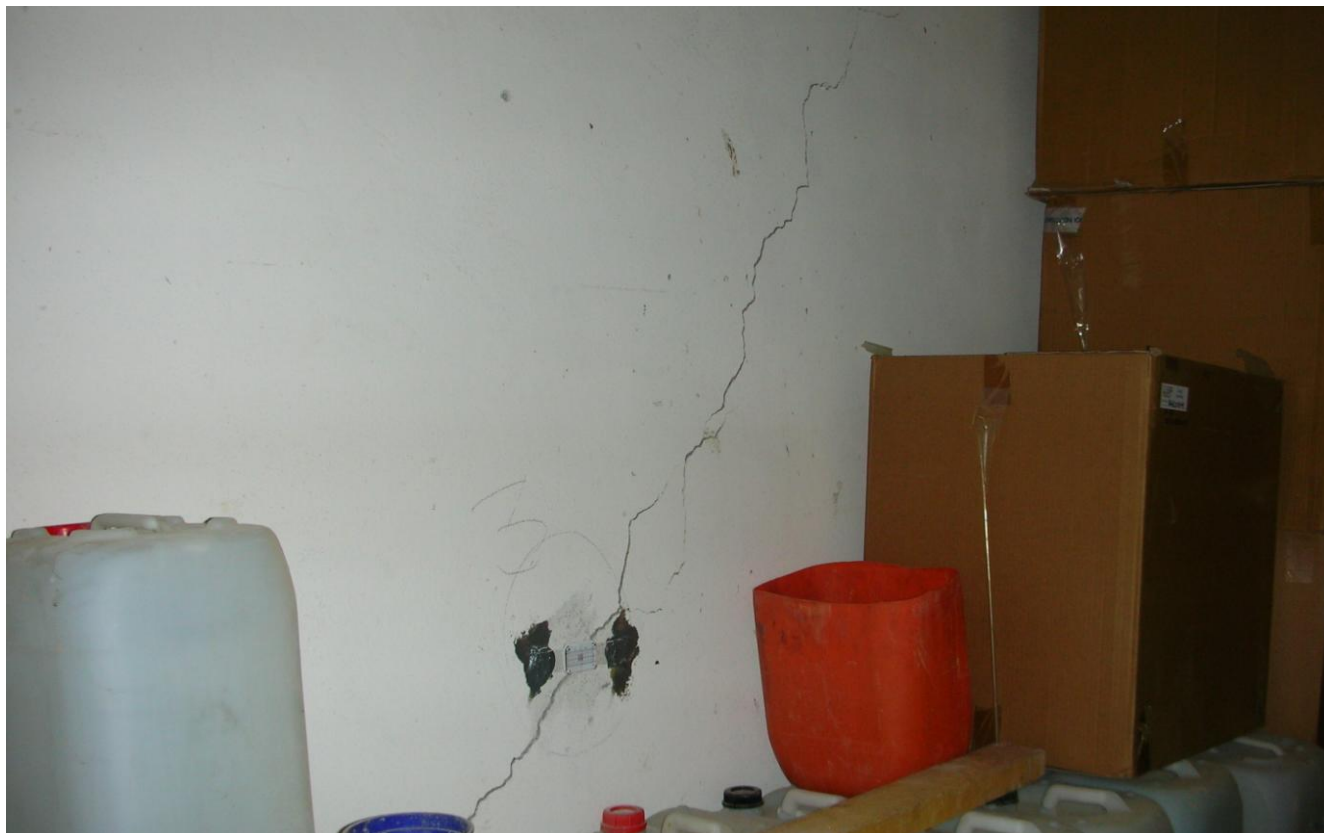
In 2005, quarry operations initiated at the slope toward the broadcasting tower. In May 2006, tension cracks developed in the ground at the top of the hill and many cracks appeared in the walls and floor of the building (Figures 2 and 3). The cracks were parallel to the slope face, suggesting a downward movement of the slope. In October 2006, after two days of medium-high intensity rains, a landslide with a volume of about 27000 m³ occurred in the pit (Figure 4 and 5) at a distance of about 45 m below the warehouse area (Figure 6) and the cracks in the warehouse and in the ground increased, the latter reaching openings of some centimeters. The intense rains of the winter 2006 quickened instability phenomena (Barbero et al., 2008).

Figure 2. Wall damage inside the warehouse.

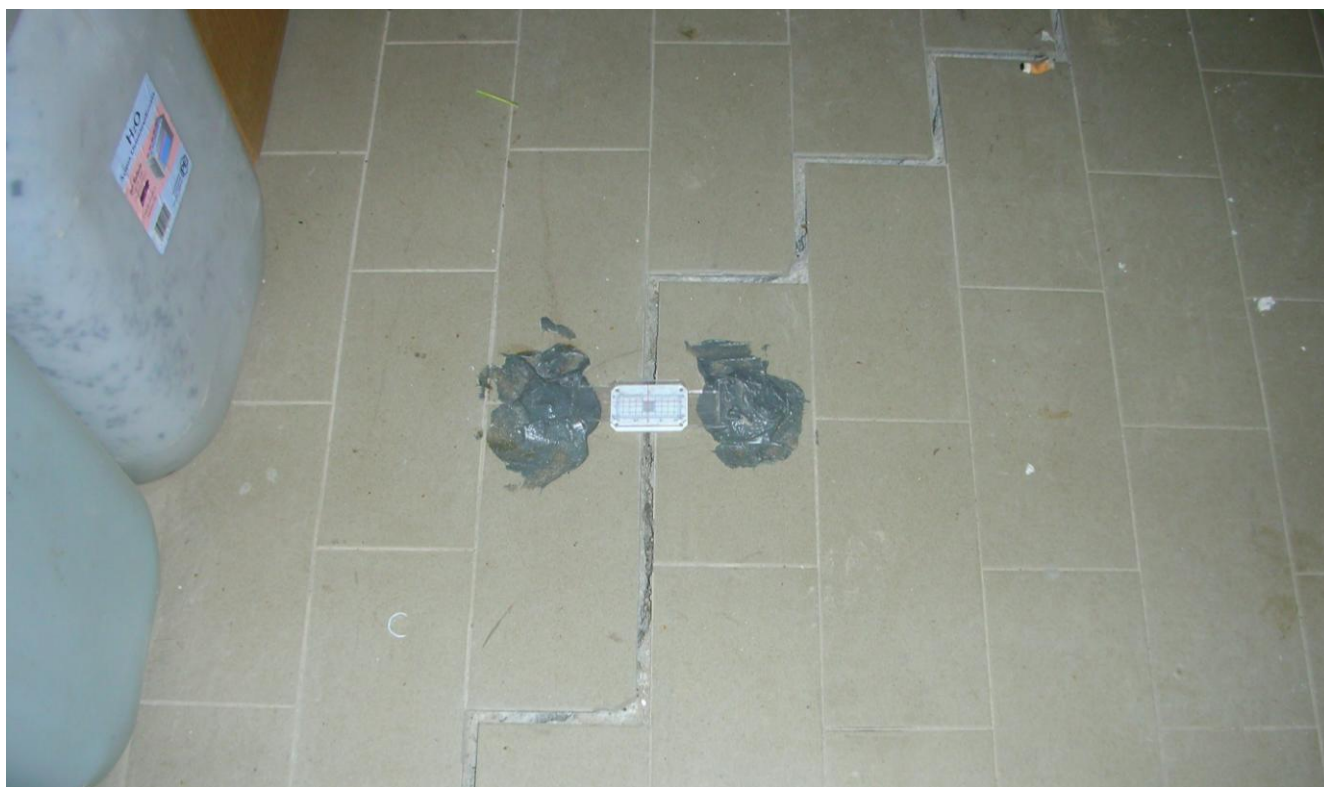
Figure 3. Floor damage inside the warehouse.

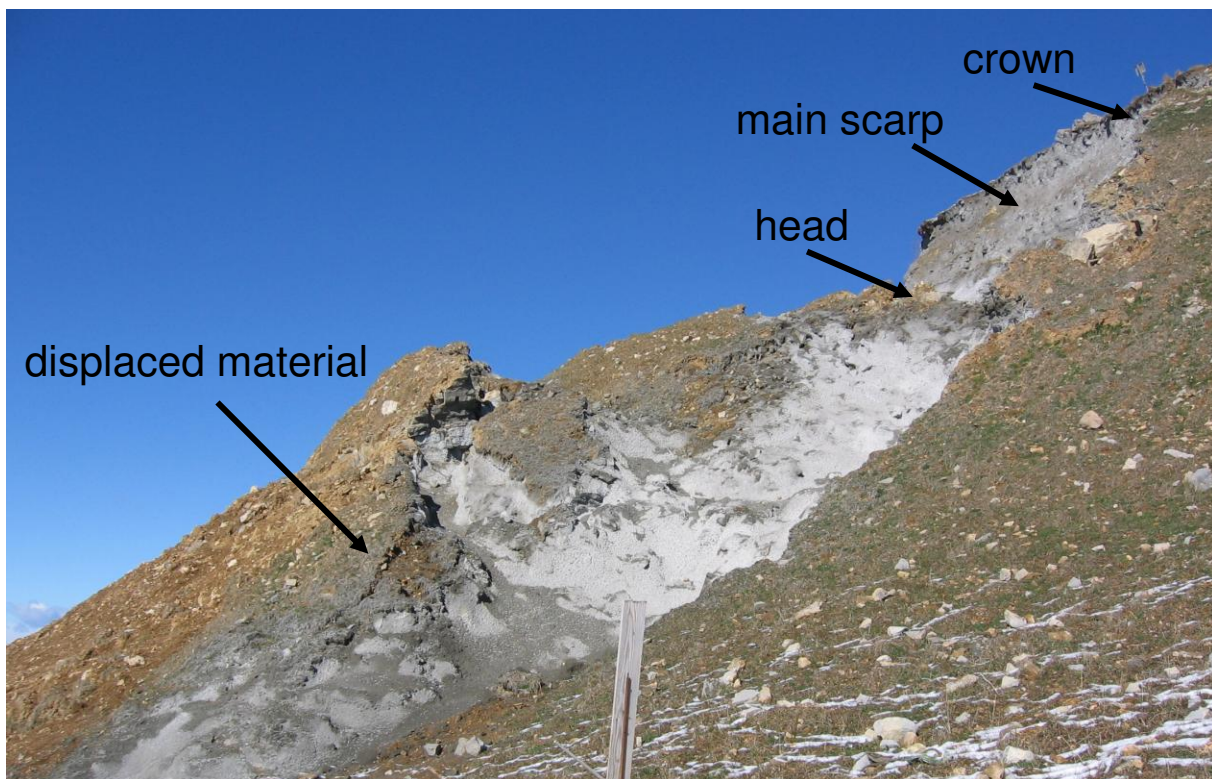
Figure 5. Top of the landslide.

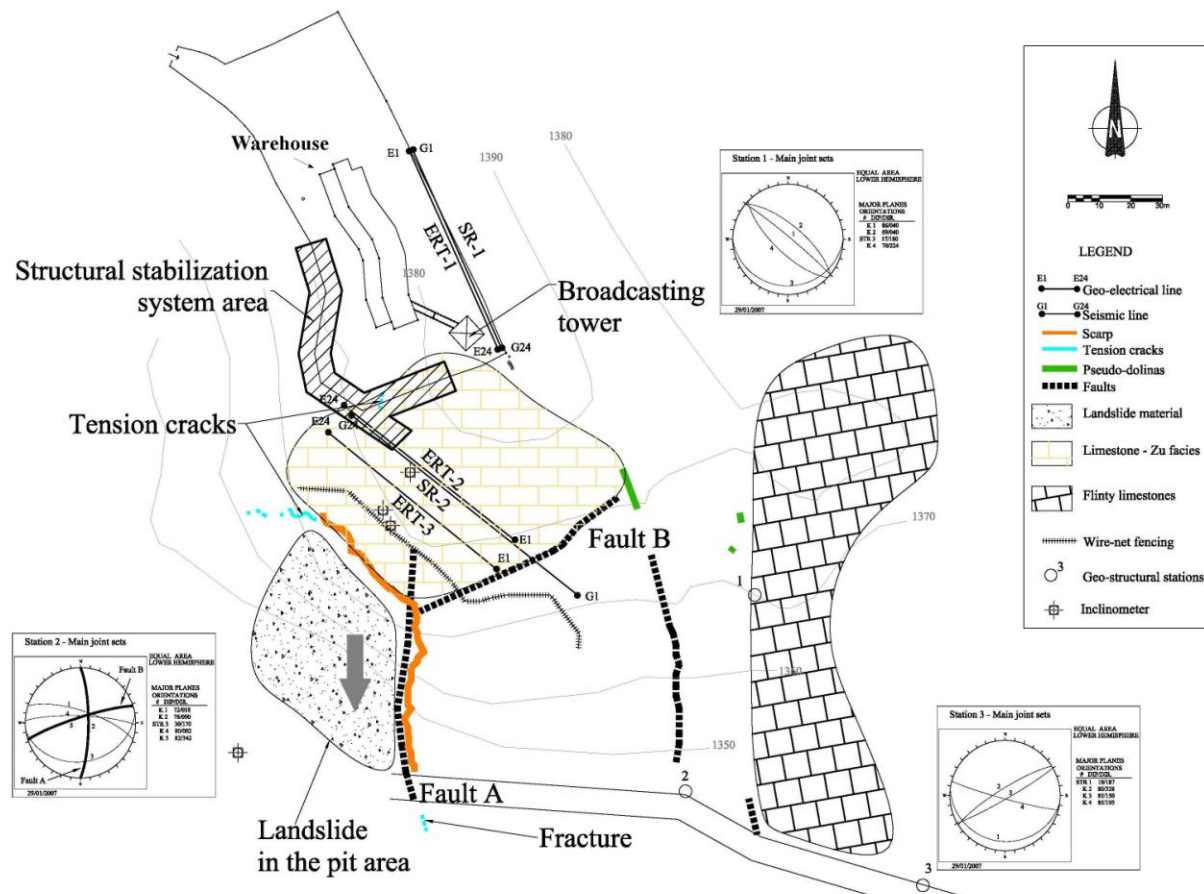
1. Two limestone facies characterized the slope: the Zu limestone and the Sedrina limestone. The geological boundary has tectonic origin and is represented by fault B, in Figure 6. The landslide occurred in the Zu limestone facies, where the presence of marly and argillitic layers facilitated the sliding along the bedding planes;

2. A second fault is present in the slope area (fault A in Figure 6) which intersects the fault B causing strong cataclasis in both facies, with a remarkable reduction of the rock mass quality;

The geological-geostructural survey was performed in three structural stations (shown in Figure 6). Four main discontinuities sets were found to characterize the rock mass (stereographic projections in Figure 6): 10°-15° down slope dipping bedding planes, two sub-vertical sets that can be potential tension cracks and a set parallel to fault B.

Figure 6. Map of the unstable area and results of the geotechnical survey.

The results of the field surveys have shown that many natural weakness elements affect the site. Fault A marks the east boundary of the landslide. Its intersection with fault B (Figures 6 and 7) induces heavy fracturing in the limestone to significant depths contributing to the instability of the area. The downslope dipping bedding planes predispose the slope to sliding and the two sub-vertical sets of discontinuities can become preferential paths for water percolation.

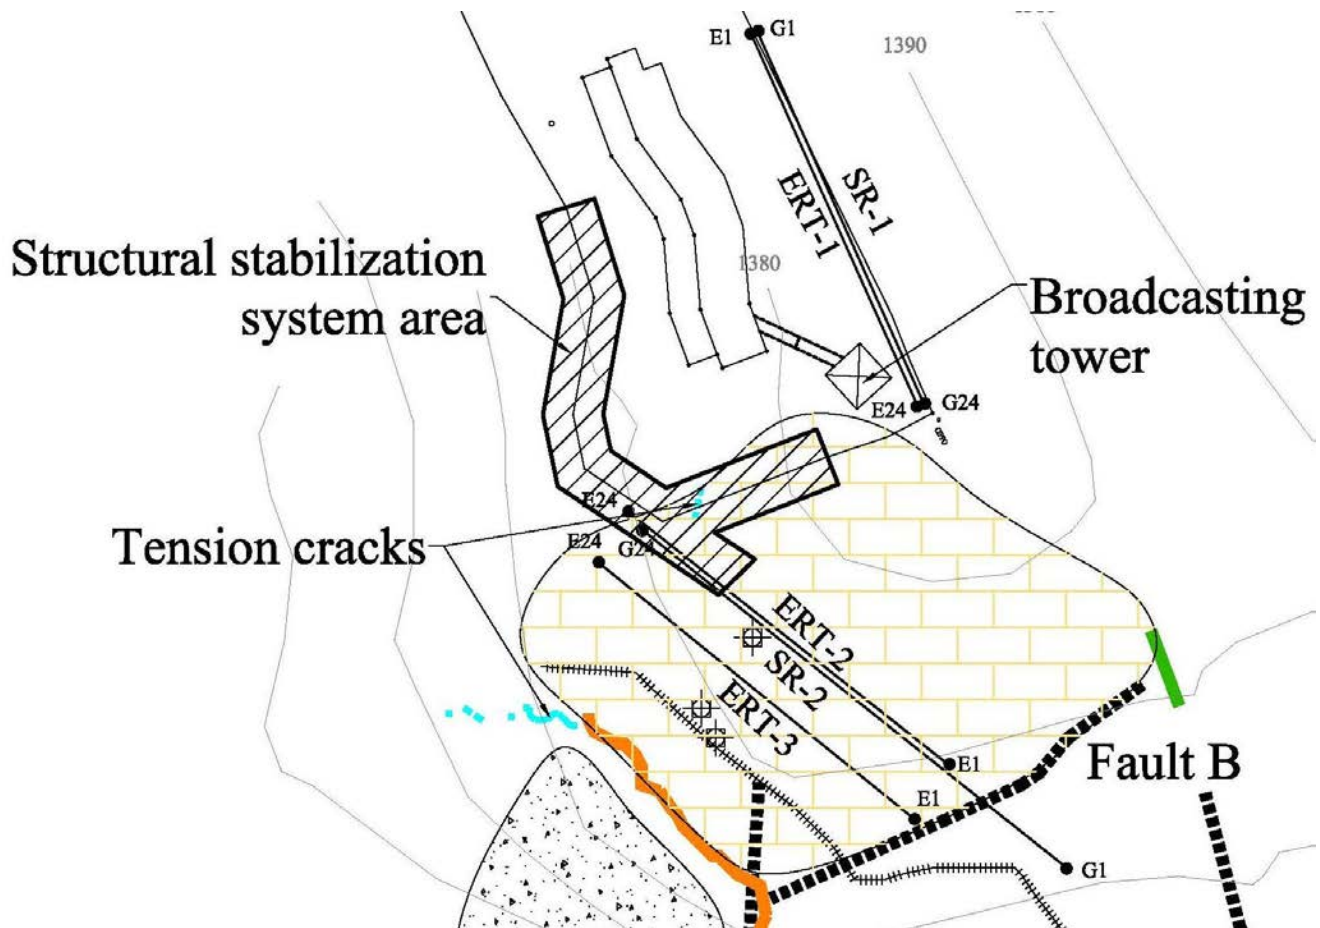
Figure 15. Map of the site with the location of the stabilization system.

In order to confine the strain effects of the stress release induced by the landslide, the broadcasting site has to be isolated from the unstable slope. For this purpose, a structural stabilization system in the warehouse square was suggested (Figure

15 and 17). It was conceived to be a bulkhead consisting of 27 m long micropiles reinforced with steel pipes, 139.7 mm of diameter and 10 mm thick. The micropiles are connected at their head level by a reinforced concrete beam. The bulkhead extends as shown in Figure 15 and is anchored in the head to the undamaged rock mass by means of 28 m long four strands steel anchors, at center distance of 3 m and with a down dipping of 25°. During the construction of the bulkhead, any karst cavities will be filled.

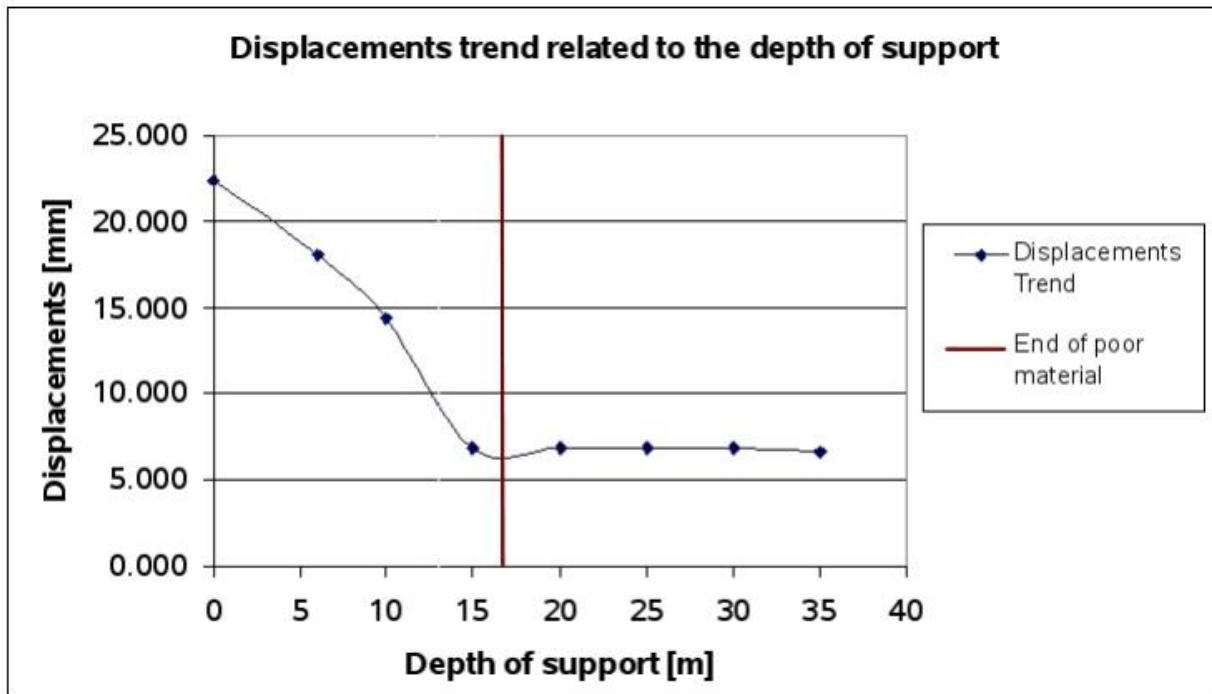
The results (Figure 16) confirm that the minimum length for the micropiles is about 16 m (the depth at which the boundary between the weaker layer and the undisturbed rock mass is located). On the other hand micropile lengths greater than 20 m don't provide further benefit to the plant stability. It is possible to conclude that 27 m is a good estimate of the length for the micropiles.

Figure 16. Model displacements in the area upstream the bulkhead, related to the length of the micropiles (assuming that in-situ bedrock is at 16 m depth).
