Quarry-Induced Slope Instability at a Broadcasting Transmission Plant near Valcava, Lombardia, Italy

Monica Barbero, Assistant professor, Politecnico di Torino (Torino, Italy); email: monica.barbero@polito.it
Fabrizio Barpi, Assistant professor, Politecnico di Torino (Torino, Italy); email: fabrizio.barpi@polito.it

ABSTRACT: *Since 2006, a broadcasting tower and ancillary buildings on the top of a hill adjacent to a large, active limestone quarry, in northern Italy near the village of Valcava, has been heavily damaged by ground deformation due to slope instability. In 2005, the quarry began to work the slope toward the broadcasting plant, releasing bedding planes that affected the tower site: a number of fractures occurred in the warehouse and in the ground around it, that grew particularly during significant rainfalls. In October 2006 a landslide occurred in the quarry area, close to the broadcasting site. In order to understand what induced the fracture process in the buildings and define a support system to stabilize the broadcasting site, a detailed geotechnical survey and a number of numerical slope stability analyses were carried out. One of the main goals of the paper is t

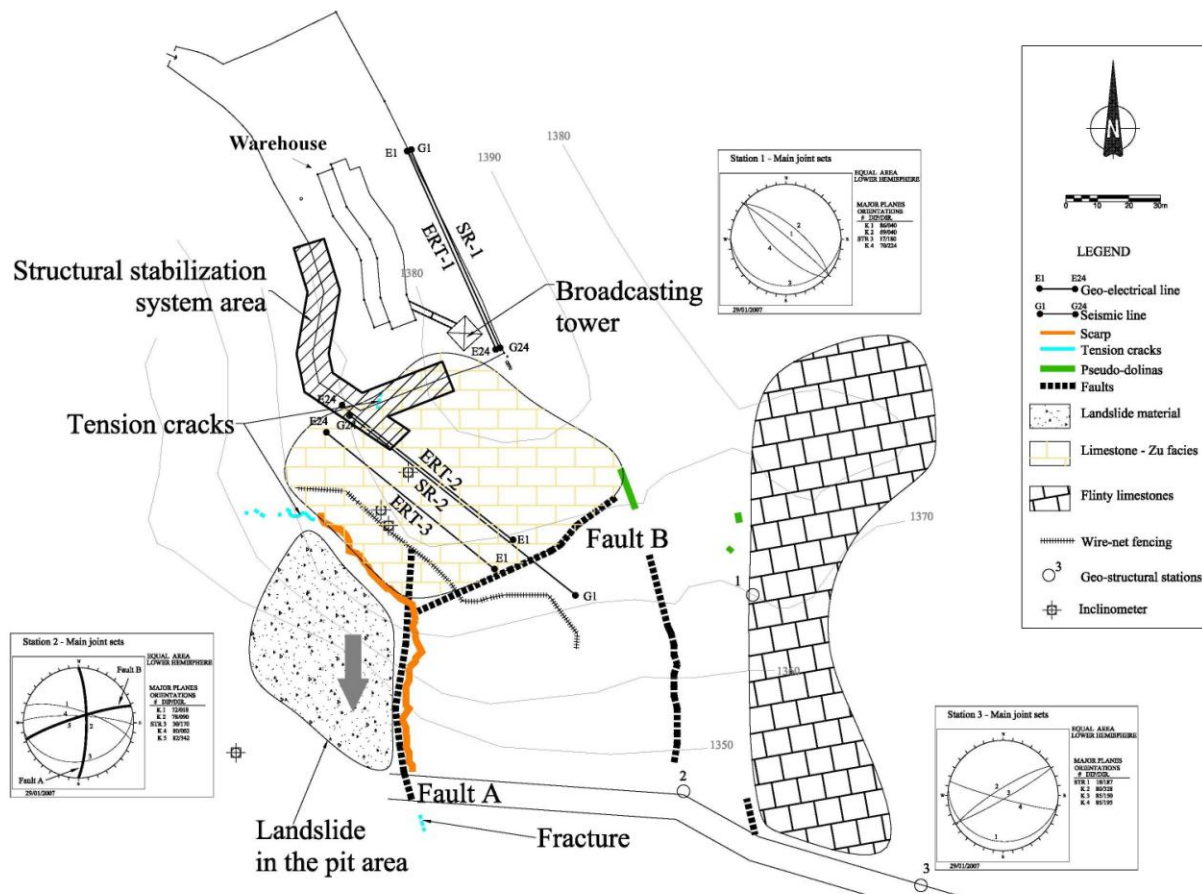
1. Two limestone facies characterized the slope: the Zu limestone and the Sedrina limestone. The geological boundary has tectonic origin and is represented by fault B, in Figure 6. The landslide occurred in the Zu limestone facies, where the presence of marly and argillitic layers facilitated the sliding along the bedding planes;

2. A second fault is present in the slope area (fault A in Figure 6) which intersects the fault B causing strong cataclasis in both facies, with a remarkable reduction of the rock mass quality;

The geological-geostructural survey was performed in three structural stations (shown in Figure 6). Four main discontinuities sets were found to characterize the rock mass (stereographic projections in Figure 6): 10°-15° down slope dipping bedding planes, two sub-vertical sets that can be potential tension cracks and a set parallel to fault B.

Figure 6. Map of the unstable area and results of the geotechnical survey.
