Quarry-Induced Slope Instability at a Broadcasting Transmission Plant near Valcava, Lombardia, Italy

Monica Barbero, Assistant professor, Politecnico di Torino (Torino, Italy); email: monica.barbero@polito.it
Fabrizio Barpi, Assistant professor, Politecnico di Torino (Torino, Italy); email: fabrizio.barpi@polito.it

Reference: Barbero, M., Barpi, F. (2011). *Quarry-Induced Slope Instability at a Broadcasting Transmission Plant Near Valcava, Lombardia, Italy*. International Journal of Geoengineering Case histories, <http://casehistories.geoengineer.org>, Vol.2, Issue 2, p.163-181. doi: 10.4417/IJGCH-02-02-04

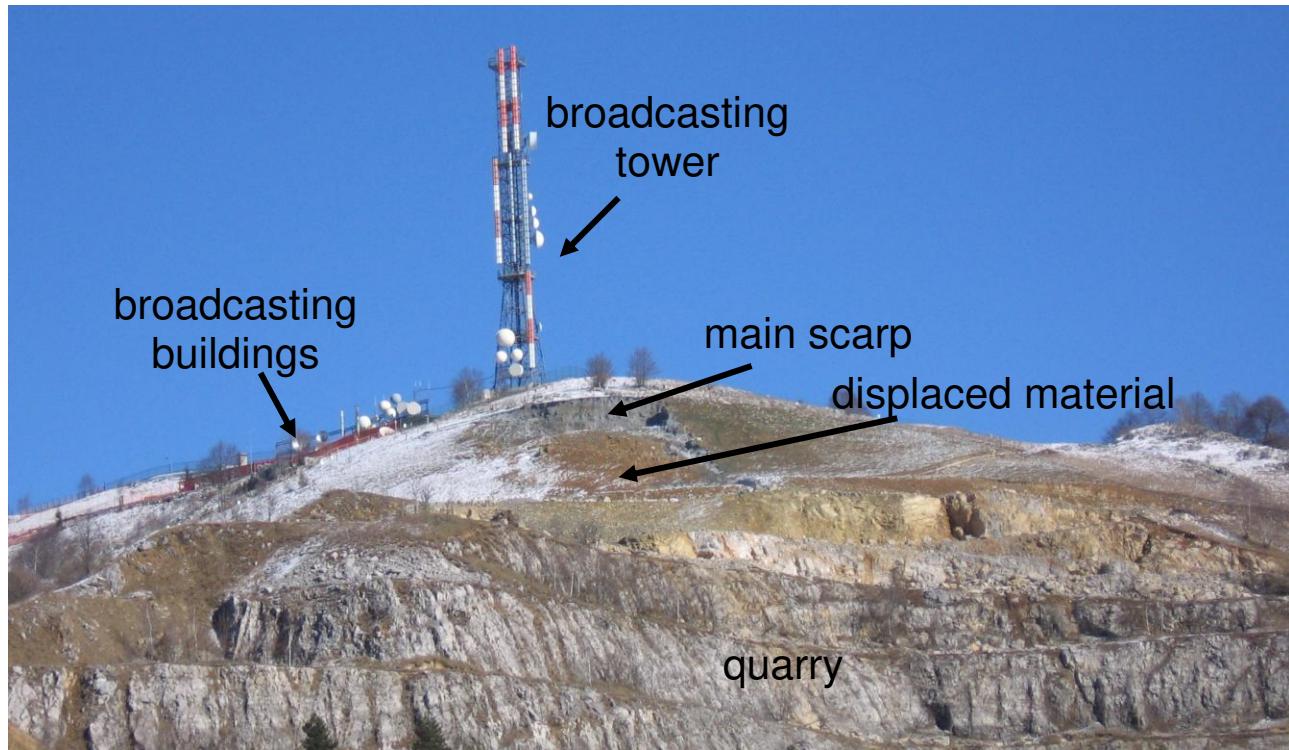
Figure 4. The landslide in the pit area.

3. Fault A marks the eastern boundary of the landslide in the pit area. This involves a 30 m slope height and has a crown length of about 35 m;
4. In the west side of the edge and in the toe of the landslide, many opened cracks were observed, suggesting that the instability phenomenon is not completed yet and potential landslide progression toward the plant is possible;

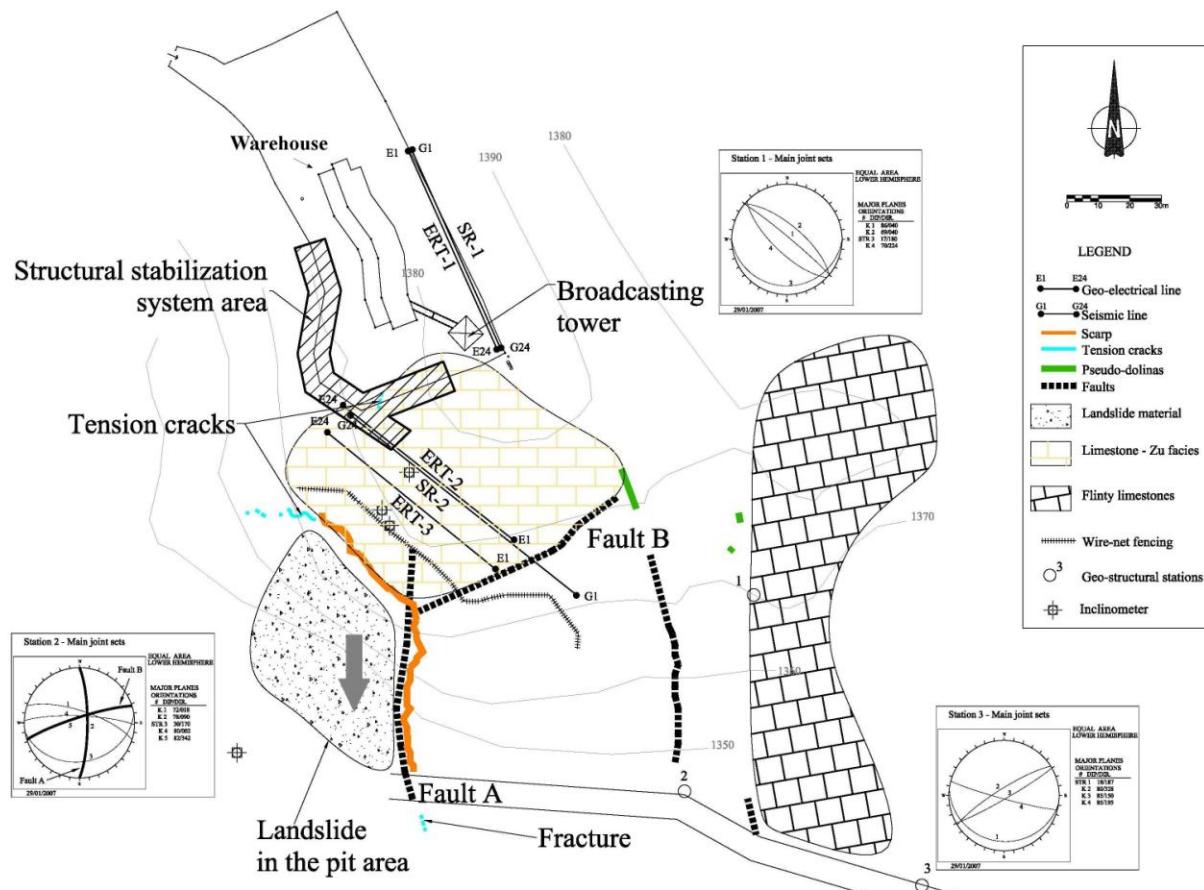
1. Two limestone facies characterized the slope: the Zu limestone and the Sedrina limestone. The geological boundary has tectonic origin and is represented by fault B, in Figure 6. The landslide occurred in the Zu limestone facies, where the presence of marly and argillitic layers facilitated the sliding along the bedding planes;

2. A second fault is present in the slope area (fault A in Figure 6) which intersects the fault B causing strong cataclasism in both facies, with a remarkable reduction of the rock mass quality;

The geological-geostructural survey was performed in three structural stations (shown in Figure 6). Four main discontinuities sets were found to characterize the rock mass (stereographic projections in Figure 6): 10°-15° down slope dipping bedding planes, two sub-vertical sets that can be potential tension cracks and a set parallel to fault B.

Figure 6. Map of the unstable area and results of the geotechnical survey.

The results of the field surveys have shown that many natural weakness elements affect the site. Fault A marks the east boundary of the landslide. Its intersection with fault B (Figures 6 and 7) induces heavy fracturing in the limestone to significant depths contributing to the instability of the area. The downslope dipping bedding planes predispose the slope to sliding and the two sub-vertical sets of discontinuities can become preferential paths for water percolation.

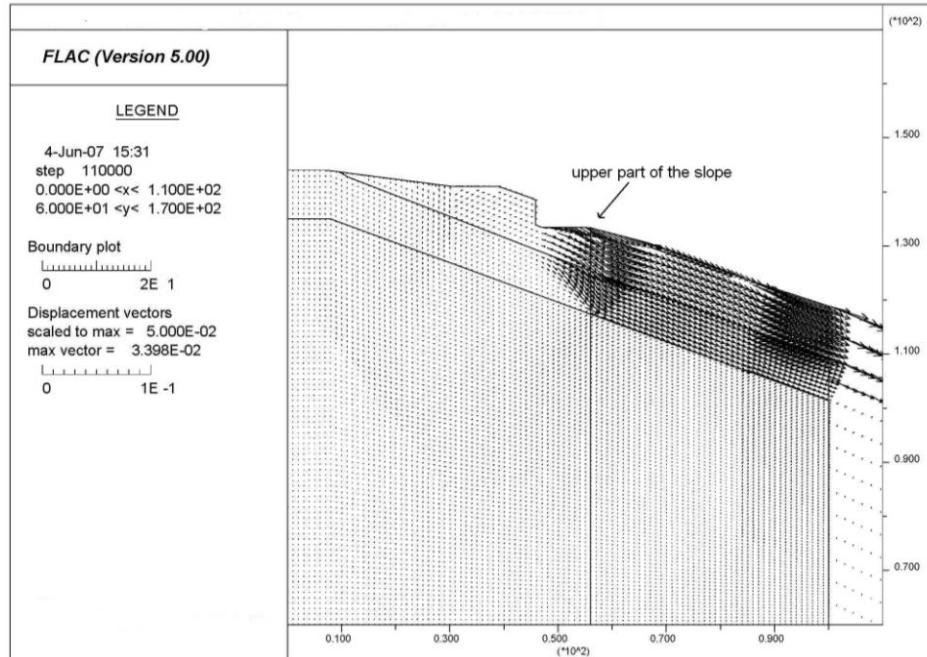
The results show an important displacement increase in the upper part of the slope. The displacements in the warehouse area are appreciable only in the case of water table at 5 m from the level of site (Figure 13). A wide area in the disturbed rock mass reaches the plastic boundary for every hydraulic scenarios. From this, it is possible to reconstruct the slope's stress-strain history. The cuts in the pit area induced a progressive instability in the area immediately below the broadcasting plant, with downwards displacements that started in the pit cut and spread towards the warehouse. The landslide in the pit area quickened the instability phenomenon that worsened with heavy rain falls, leading to considerable displacements in the warehouse area.

Figure 13. Numerical results: displacements in the upper part of the slope.

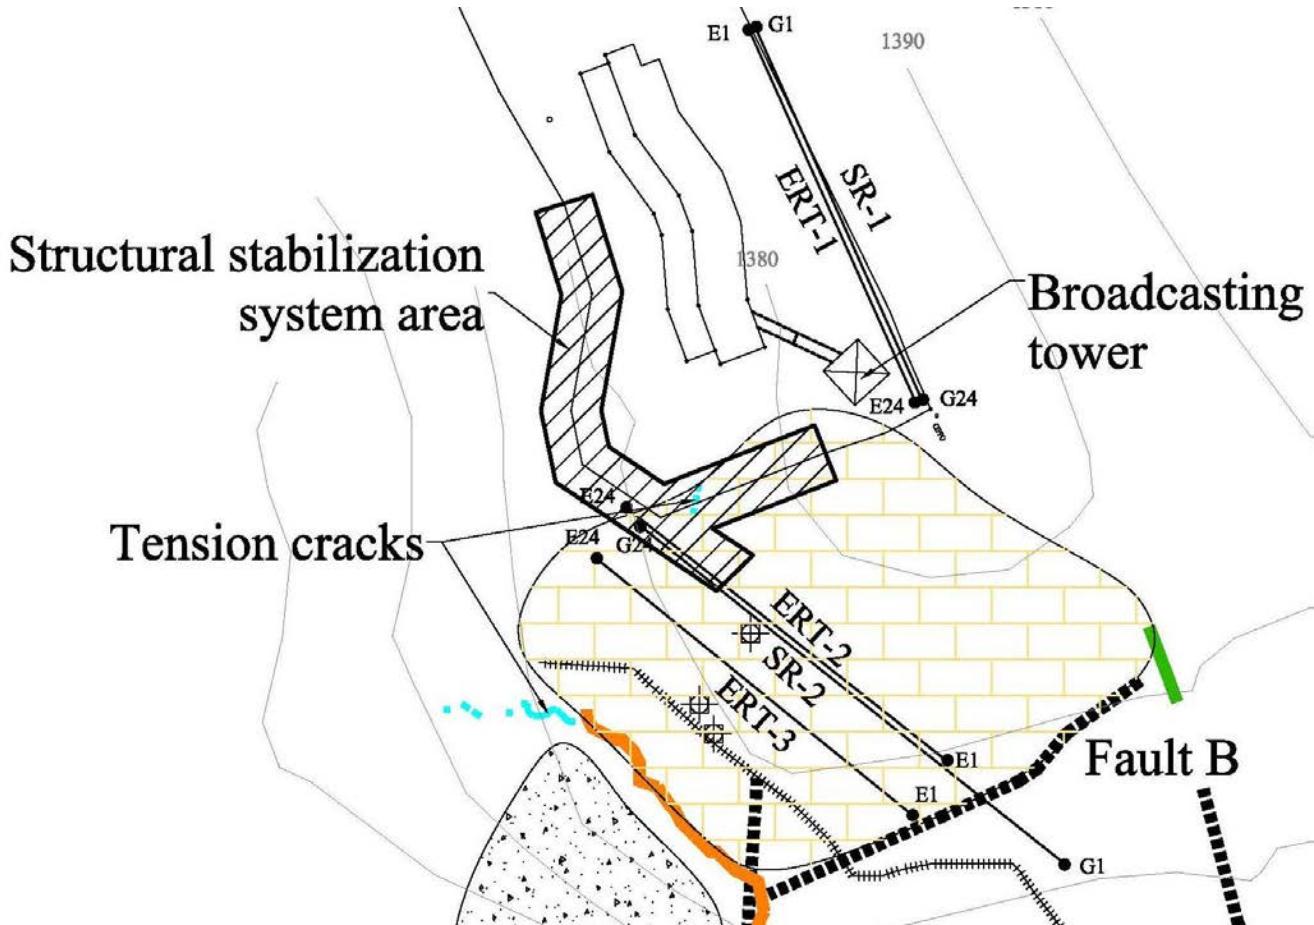
Figure 15. Map of the site with the location of the stabilization system.

In order to confine the strain effects of the stress release induced by the landslide, the broadcasting site has to be isolated from the unstable slope. For this purpose, a structural stabilization system in the warehouse square was suggested (Figure

15 and 17). It was conceived to be a bulkhead consisting of 27 m long micropiles reinforced with steel pipes, 139.7 mm of diameter and 10 mm thick. The micropiles are connected at their head level by a reinforced concrete beam. The bulkhead extends as shown in Figure 15 and is anchored in the head to the undamaged rock mass by means of 28 m long four strands steel anchors, at center distance of 3 m and with a down dipping of 25°. During the construction of the bulkhead, any karst cavities will be filled.
