Quarry-Induced Slope Instability at a Broadcasting Transmission Plant near Valcava, Lombardia, Italy

Monica Barbero, Assistant professor, Politecnico di Torino (Torino, Italy); email: monica.barbero@polito.it
Fabrizio Barpi, Assistant professor, Politecnico di Torino (Torino, Italy); email: fabrizio.barpi@polito.it

ABSTRACT: *Since 2006, a broadcasting tower and ancillary buildings on the top of a hill adjacent to a large, active limestone quarry, in northern Italy near the village of Valcava, has been heavily damaged by ground deformation due to slope instability. In 2005, the quarry began to work the slope toward the broadcasting plant, releasing bedding planes that affected the tower site: a number of fractures occurred in the warehouse and in the ground around it, that grew particularly during significant rainfalls. In October 2006 a landslide occurred in the quarry area, close to the broadcasting site. In order to understand what induced the fracture process in the buildings and define a support system to stabilize the broadcasting site, a detailed geotechnical survey and a number of numerical slope stability analyses were carried out. One of the main goals of the paper is t

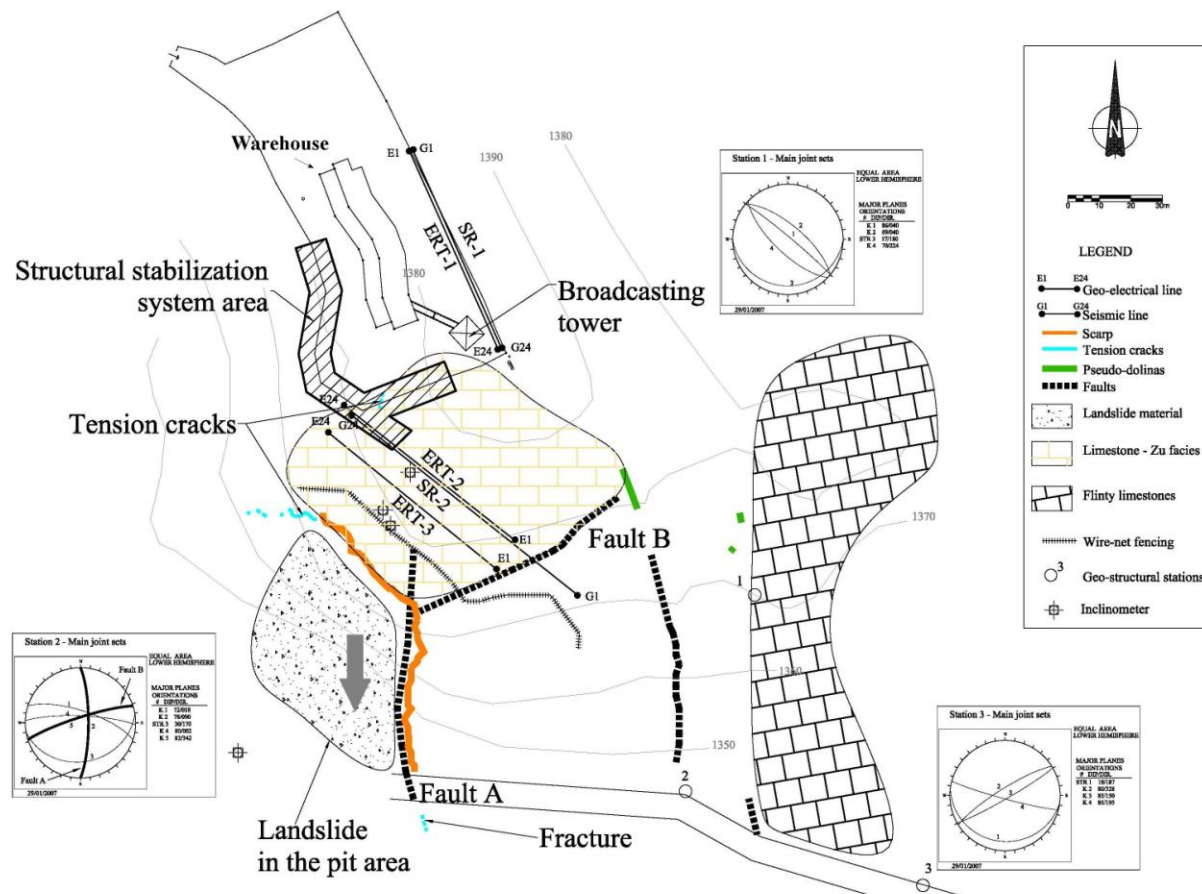
1. Two limestone facies characterized the slope: the Zu limestone and the Sedrina limestone. The geological boundary has tectonic origin and is represented by fault B, in Figure 6. The landslide occurred in the Zu limestone facies, where the presence of marly and argillitic layers facilitated the sliding along the bedding planes;

2. A second fault is present in the slope area (fault A in Figure 6) which intersects the fault B causing strong cataclasis in both facies, with a remarkable reduction of the rock mass quality;

The geological-geostructural survey was performed in three structural stations (shown in Figure 6). Four main discontinuities sets were found to characterize the rock mass (stereographic projections in Figure 6): 10°-15° down slope dipping bedding planes, two sub-vertical sets that can be potential tension cracks and a set parallel to fault B.

Figure 6. Map of the unstable area and results of the geotechnical survey.

The results of the field surveys have shown that many natural weakness elements affect the site. Fault A marks the east boundary of the landslide. Its intersection with fault B (Figures 6 and 7) induces heavy fracturing in the limestone to significant depths contributing to the instability of the area. The downslope dipping bedding planes predispose the slope to sliding and the two sub-vertical sets of discontinuities can become preferential paths for water percolation.
