# Embankment Failure in Residual Soils at Nivsar, Ratnagiri

**ABSTRACT:** The Nivsar Yard embankment was constructed by the Konkan Railways in 1994. Near the station building, the 22m high embankment runs parallel to the Kajali River for a stretch of about 100m. This stretch has experienced failure and settlement related problems since the record-breaking July 2005 rainfall. Corrective ground improvement measures were implemented immediately after the monsoon. However, these measures were inadequate because the failure surface reappeared during the following monsoon. The failure surface mirrored the shape and size of the failure observed in 2005. Since then after nearly every monsoon, the embankment has moved despite precautionary measures taken by the railway to arrest the movement. The hydrogeological and geotechnical properties which affect slope stability are first discussed. The stability of the embankment is then evaluated at 5 sections drawn along the slope. Two cases are considered. In the first case, the stability of the unreinforced slope is calculated. In the second case, calculations are done using the slope reinforced with soil nails and micropiles installed in 2005 a

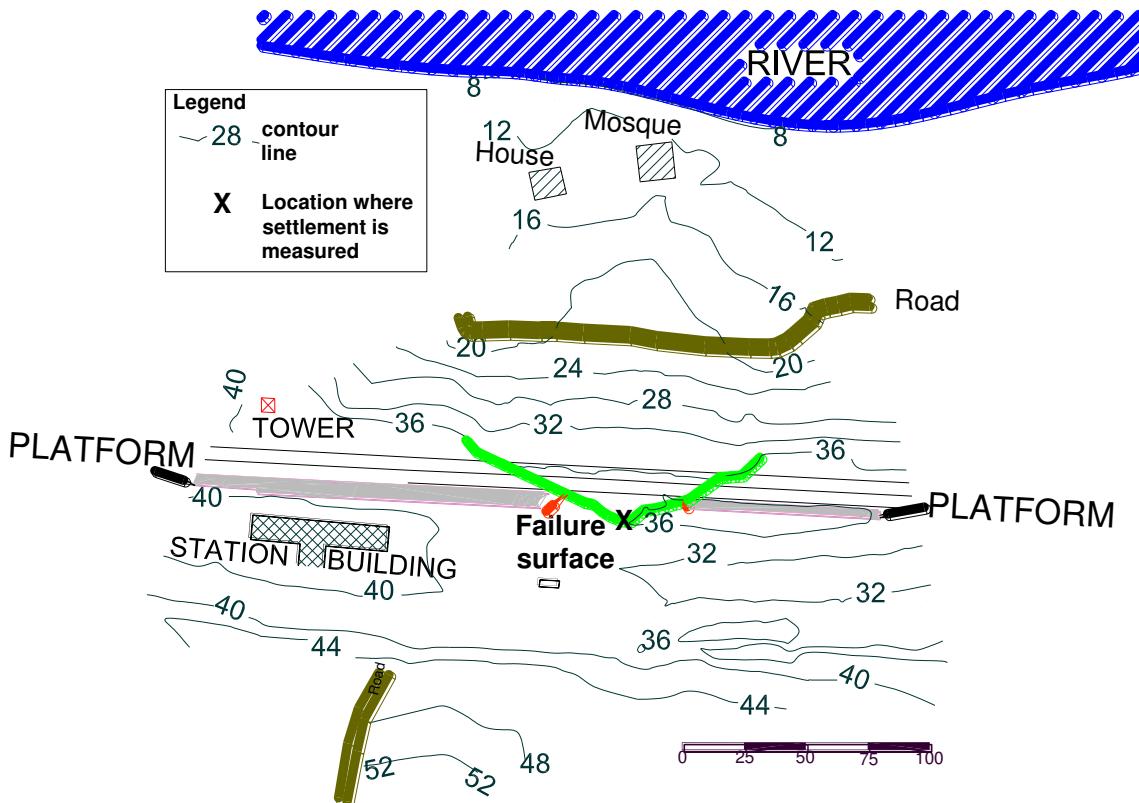
site until the year 2005. In that year, cracks in the embankment developed between chainage km 218.8 and 218.9 following record-breaking rainfall. Heavy rain occurred for 3 days between July 24<sup>th</sup> and 26<sup>th</sup>. Cracks opened up to 20mm width over a period of 15 to 20 days. During the same time, the slope settled by more than 150mm. The total settlement was about 550mm towards the end of the 2005 monsoon. At the end of this period, the cracks took shape of a parabola with its vertex close to the station platform. The parabola sloped downhill for about 100 to 120m towards the river. Figure 2 shows the extent of the slope failure observed in 2005.

Figure 2. Failure at Nivsar Yard Embankment

Soon after the observed failure, and when the 2005 monsoon was over, soil nails and micro-piles were installed to prevent further damage to the embankment. Table 1 shows details of the ground improvement works undertaken at the site in 2005. However, the 100mm wide and 130m long crack reappeared during the 2006 monsoon. As in the previous year, the crack encompassed all 3 railway lines, including the main line. The shape and size of the crack mirrored the shape and size observed following the 2005 monsoon. The embankment settled throughout the 2006 monsoon reaching a high value of 2930mm at the station platform.

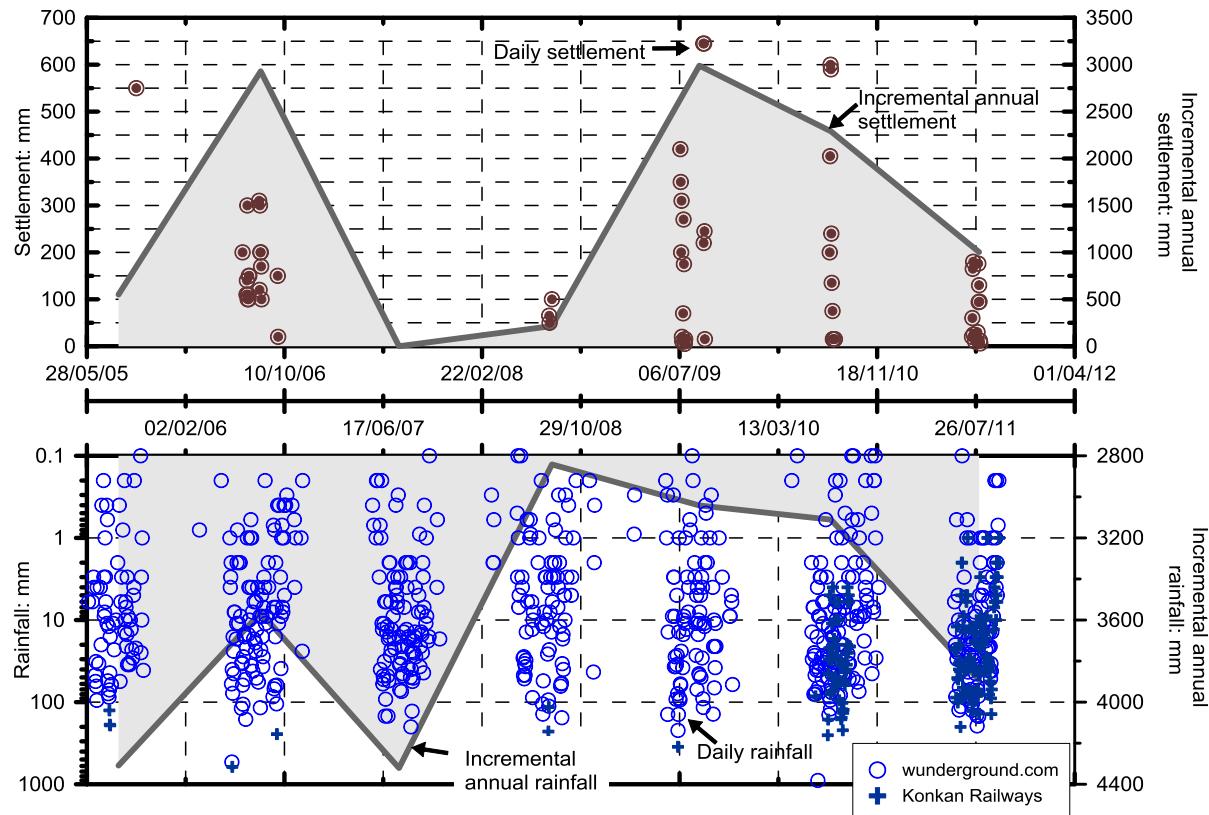
Figure 3 shows the recorded settlement of the embankment from the year 2005. The settlement was measured at top of the embankment near the station platform and its location is shown in Figure 2. Figure 3 also shows the record of rainfall in this region. The rainfall record was obtained from the web pages of <http://www.wunderground.com/> and from the data maintained by Konkan Railways. A clear trend between the magnitude of rainfall and slope movement can be observed in Figure 3. For instance, rainfall of over 200mm per day was invariably followed by more than 100mm settlement every year except during the 2007 and 2008 monsoons. The embankment did not move during the 2007 monsoon. Movement occurred only after more than half of the 2008 monsoon was complete. It appears that the stabilisation work completed before the onset of the 2007 monsoon was insufficient and effective only for a year, before losing effectiveness during the 2008 monsoon. It is likely that the slip planes redeveloped along the original failure surface during the 2008 ground failure. All effects of the soil improvement vanished before the onset of the 2009 monsoon, resulting in rapid movement of the embankment towards the river. The failure cracks that developed in 2009 are shown in Figures 4a-c. Figures 4a and b show the top few meters of the micro-piles that were exposed because of the steady soil-flow down the hill, and Figure 4c shows the transverse cracks observed along the road.

Figure 3. Settlement and rainfall record at Nivsar Yard Embankment.

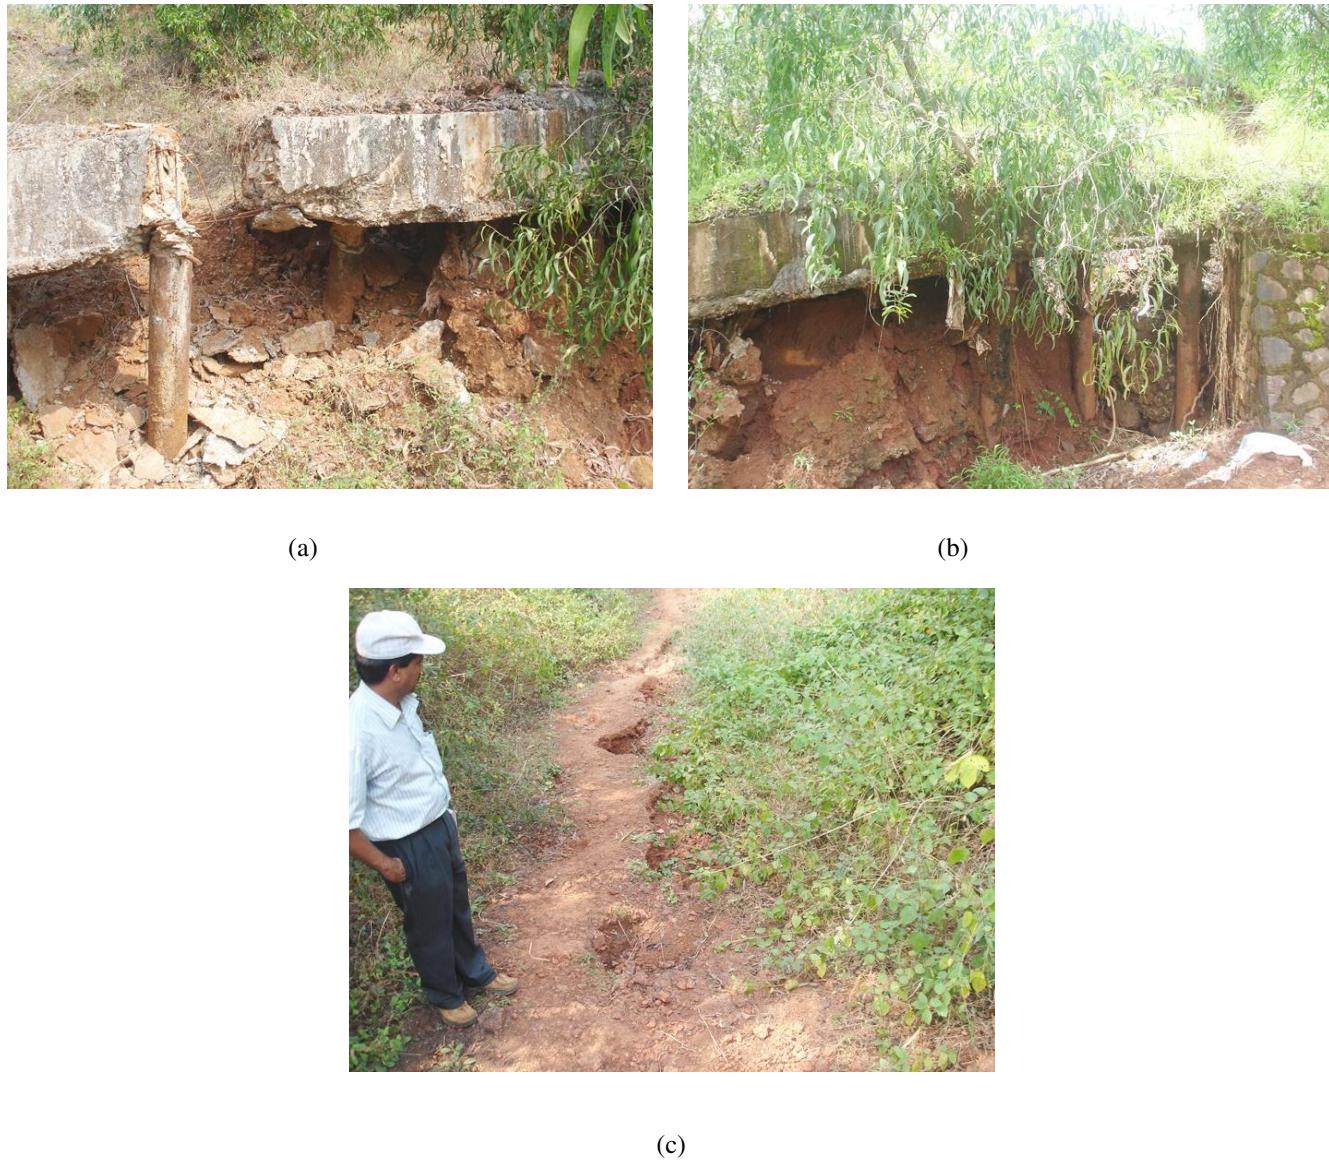
*Figures 4a-c. Failure of micropiles and curtain grouting: (a) and (b) Exposed pile foundation; and (c) Location of transverse cracks along the road (curtain grouting was conducted around this location).*

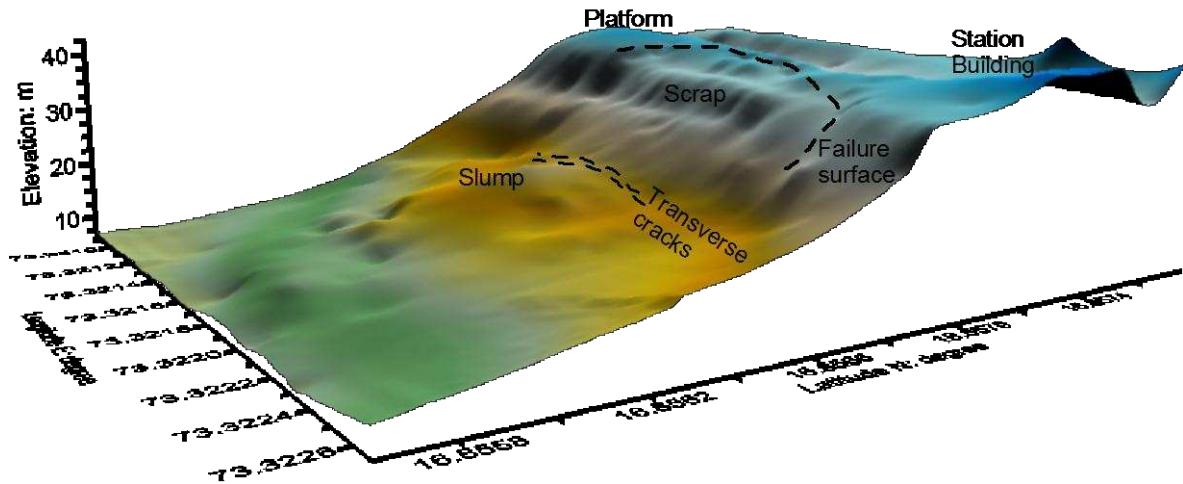
Figure 5 shows the map of the failure surface at the Nivsar Yard Station. In the figure, the latitudes and longitudes were obtained from the local coordinates using the WGS84 method (Chen and Hill 2005). The location of the slump, transverse cracks, and the failure surface are marked in the figure. The position of the transverse cracks was obtained by superimposing the observations made in Figure 4c onto Figure 5. All of the above, and the location of slope-reversal and scarp shown by the tilted trees and the cracked brick walls in Figure 6, suggest that they are parts of a landslide event.

Figure 5. Three dimensional view of the failure surface at Nivsar Yard Station.

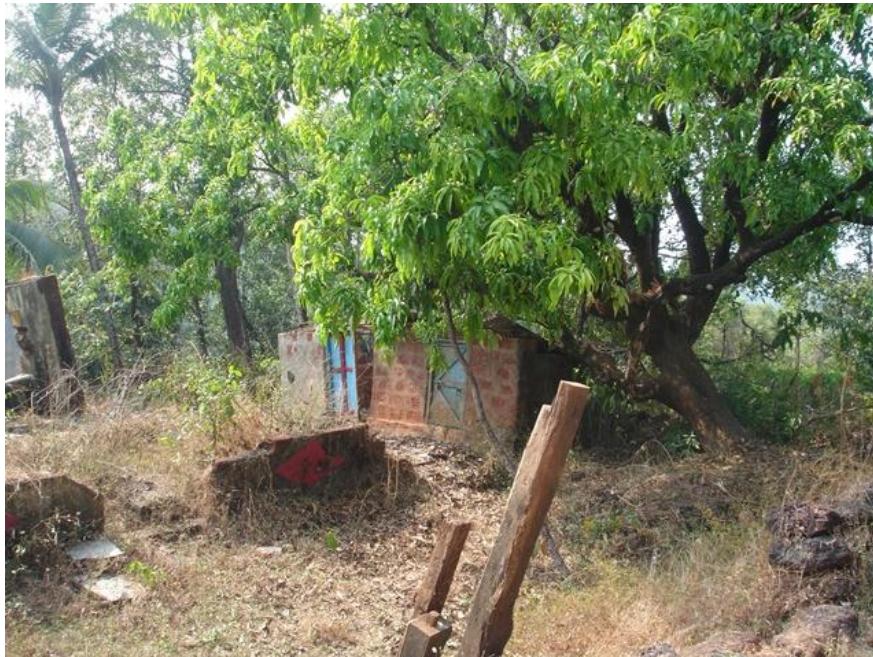
Figure 6. Tilted trees and cracked brick walls observed along the slope.

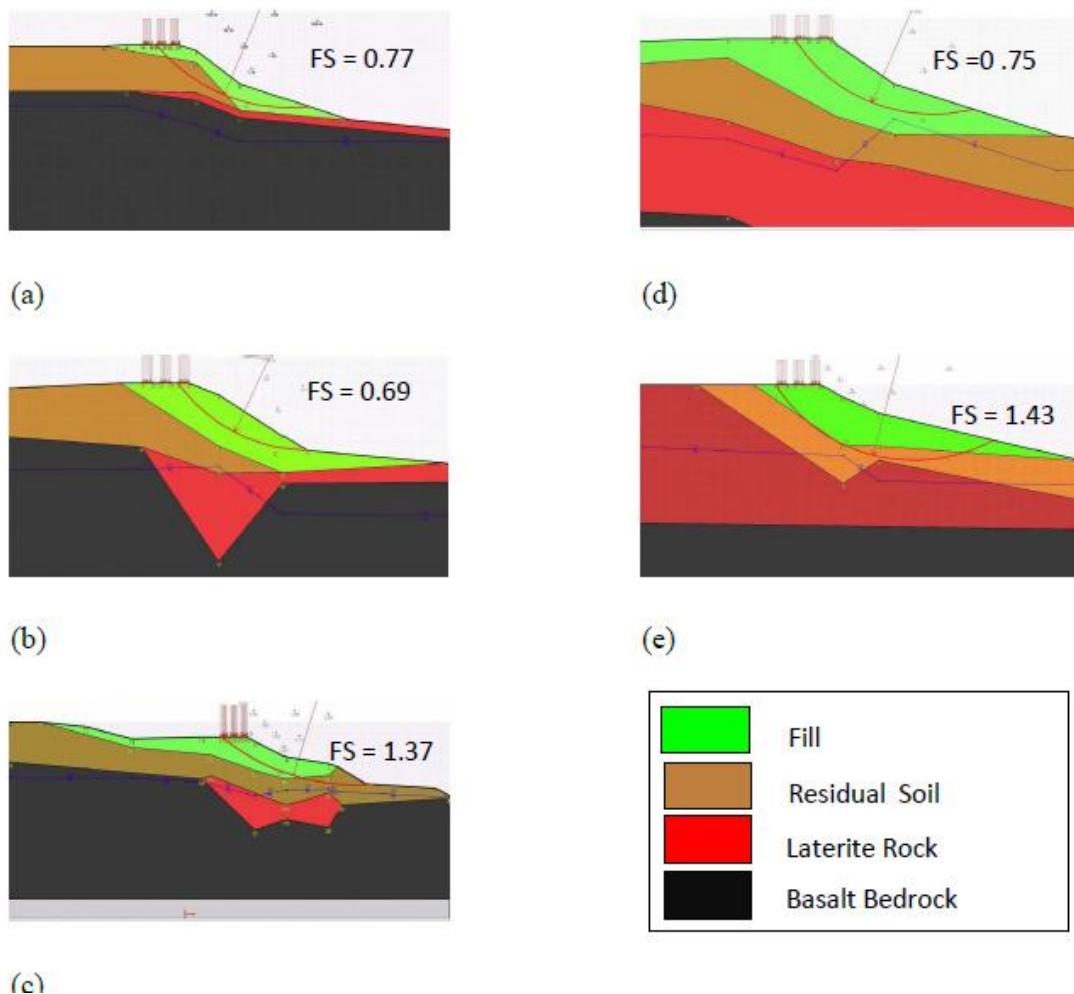
Figures 11a-e show the minimum safety factor and the location of the critical circle in sections A-A to E-E for the dry season. It is surprising to note that the minimum safety factor in 3 out of 4 sections is less than one, despite the fact that the slope was known to be stable and did not show any distress during the dry season. These sections are A-A, B-B and D-D in the figures. Figures 11a to 11e also show that the ground water level is below the critical failure circle in all 4 cases. Therefore, even if it is argued that the hydrological conditions which led to the 2005 failure and those measured in 2010 and 2011 may not be the same, it is unlikely that the position of the water table could influence the stability of the slope during the dry season.

Figures 11a-e. Safety factor during dry season with original parameters for section: (a) A-A; (b) B-B; (c) C-C; (d) D-D; and (e) E-E.

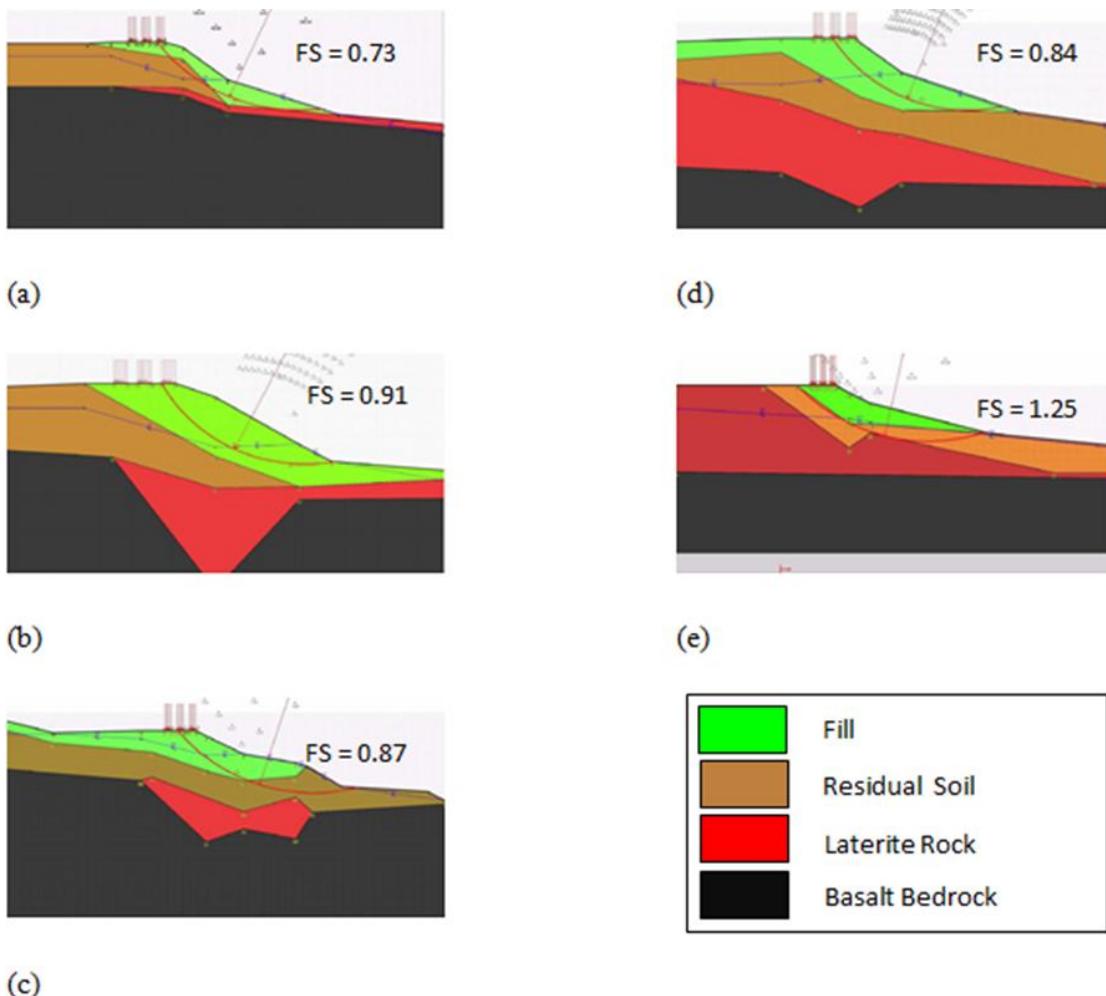
Figures 12a-e. Safety factor during wet season with modified parameters for section: (a) A-A; (b) B-B; (c) C-C; (d) D-D; and (e) E-E.

Figures 12a to 12e show the minimum safety factor and the location of critical circles in sections A-A to E-E for the wet (monsoon) season. In all the figures, the critical slip circle passes through the toe of the embankment, which is similar to the observations made at the site (see Figure 5). Similarly, the top of the circle in Figure 12c intersects the rail tracks and lie close to point X in Figure 2. The safety factor of all the 5 sections for the dry and the wet seasons are compared in Table 8. As can be seen, the safety factor reduced to less than one with the rise in ground water table in all sections, except in section EE. Figure 12e shows that only section E-E was stable during the wet season. This section was far beyond the failure zone shown in Figure 7. Regardless of the above observation, it is plausible that factors such as deep-rooted trees present at the site may have affected the safety factor. All the same, the effect of vegetation on the slope stability cannot readily be incorporated within this simplistic framework (Bernhardt et al. 2011).

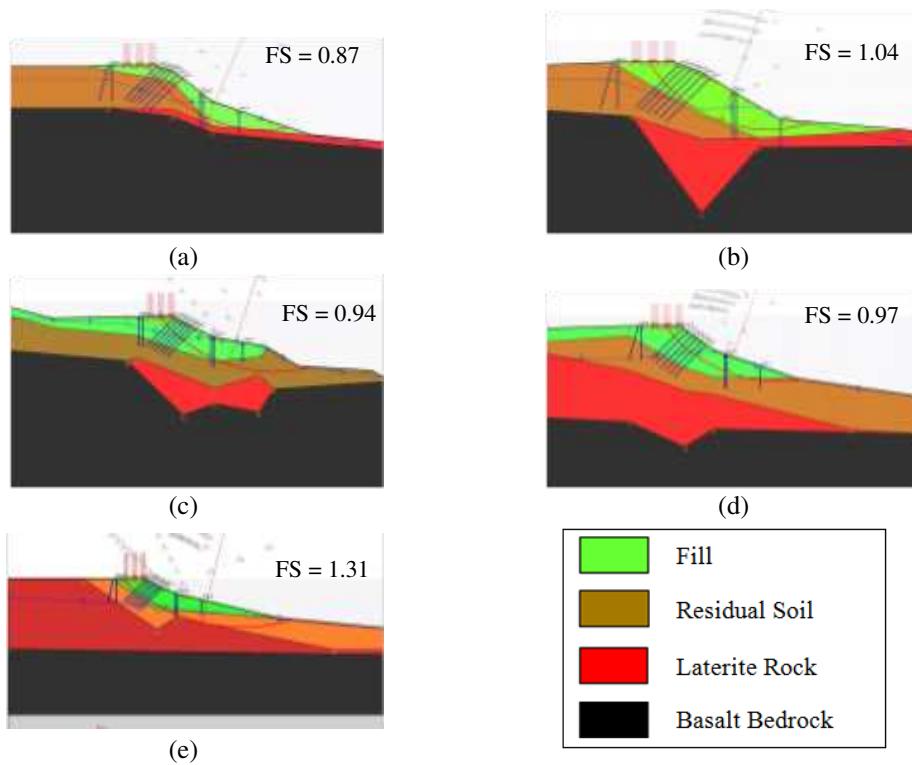
Soil nails and micropiles were installed in November 2005. These reinforcements failed and could not arrest the slope movement during the 2006 monsoon. Subsequently, two new rows of micropiles installed in January 2007 also failed during the 2008 monsoon. It was therefore appropriate to also study the stability of the 2006 and 2008 reinforced slope failures. In this analysis, the location, diameter and spacing of the reinforcement elements were taken from Table 1. Ground conditions and the slope geometry were identical to those used in the previous case. Figures 14a-e and 15a-e show the minimum safety factors and the location of critical circles in sections A-A to E-E for the 2006 and 2008 wet (monsoon) season, respectively. As can be seen, the safety factor is less than one in sections A-A, C-C and D-D for both years, indicating that the soil nails and micropiles installed in November 2005 and January 2007 were indeed inadequate to resist the slope movement. It is also interesting to note from Figures 12a-e and 14a-e to 15a-e that the reinforcement has little influence on the shape and size of the critical slip circle.

Figures 14a-e. Safety factor and critical slip circle during wet season with November 2005 ground improvement scheme for section: (a) A-A; (b) B-B; (c) C-C; (d) D-D; and (e) E-E.

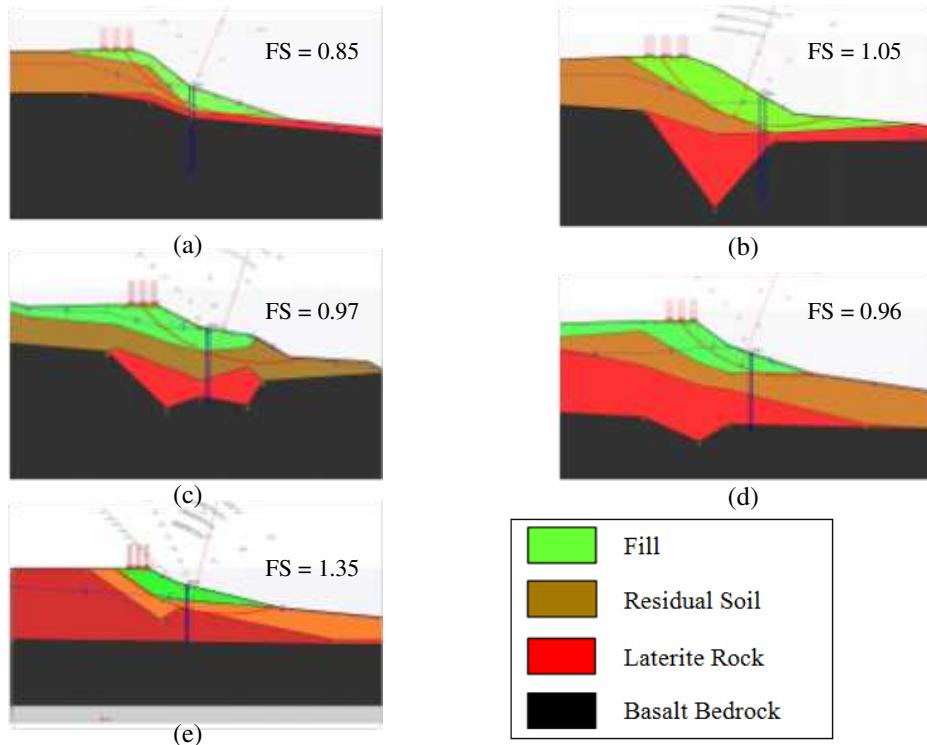
Figures 15a-e. Safety factor and critical slip circle during wet season with January 2007 ground improvement scheme for section: (a) A-A; (b) B-B; (c) C-C; (d) D-D; and (e) E-E.

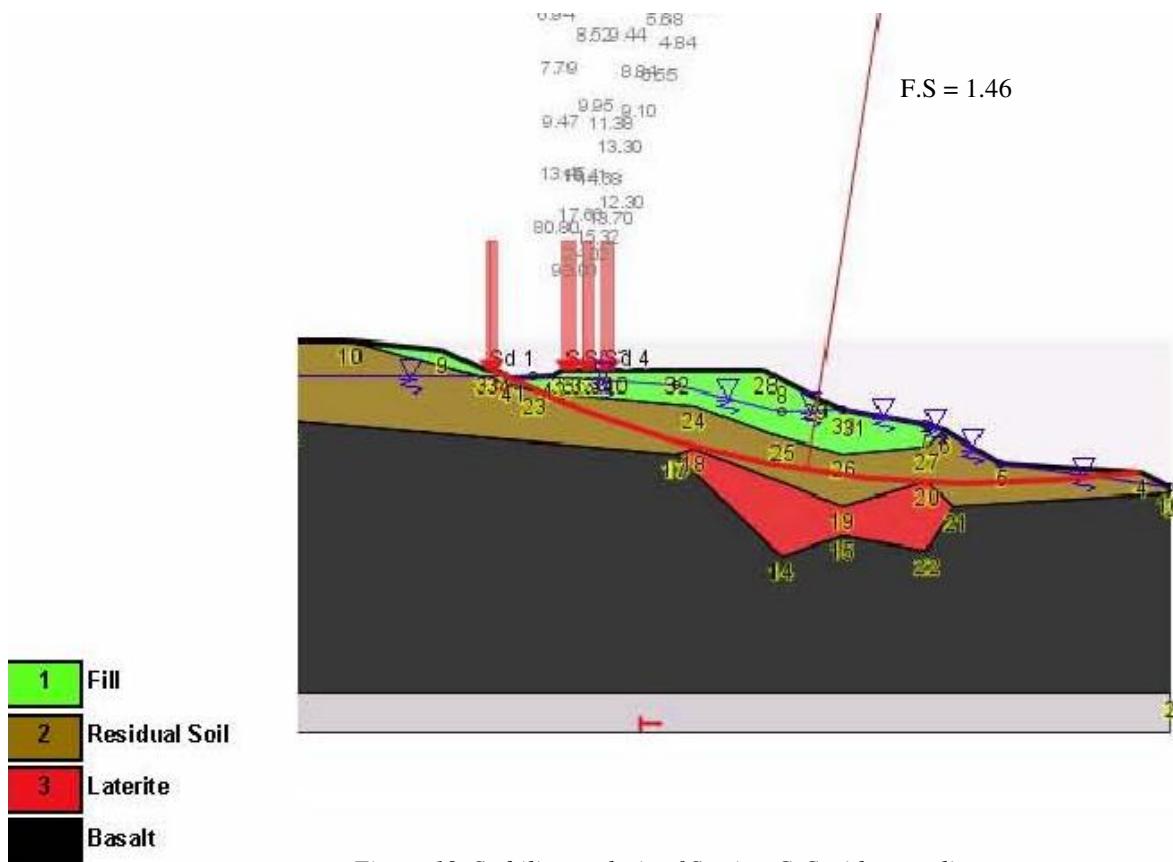
Figure 19. Stability analysis of Section C-C with new alignment.

The cost to use the bored pile wall was over 200 million Indian Rupees (US\$ 3.6 million) and appeared to be prohibitive. As an alternative to this design, the old rail alignment was removed and replaced by a new alignment. The new alignment consisted of 3 loop-lines and 1 main-line. Figure 18 shows section C-C along with the location of the new alignment. In this section, the top left side of the hill was slightly levelled to accommodate the main line and the loop lines. Section C-C was chosen because the new alignment was closest to the failure surface at this section. The horizontal distance from the vertex of the failure surface and the 4 lines was 16m, 21.3m, 26.2m and 46.4m, respectively. The stability of the slope was then reinvestigated using the computer program Talren-4 (Terrsol 2005). As in the previous case, all the lines were loaded by 125 kN/m<sup>2</sup>. This assumption was unduly conservative in absence of strict guidelines (RDSO 2003b). Nonetheless, it permitted trains with more overtaking opportunities on the passing-loops. The ground water level was modeled using the highest RL recorded in Table 5. The failure circles are shown in Figure 19. As can be seen, the minimum safety factor is

more than 1.4. The slope was therefore considered to be safe and unlikely to fail under the new loads. This new alignment has been implemented since 2011. It has been constructed at less than 20 percent of the cost incurred to improve the ground. The railways have also removed speed restriction at Nivsar which has resulted in additional savings during the monsoon.
