Embankment Failure in Residual Soils at Nivsar, Ratnagiri

ABSTRACT: *The Nivsar Yard embankment was constructed by the Konkan Railways in 1994. Near the station building, the 22m high embankment runs parallel to the Kajali River for a stretch of about 100m. This stretch has experienced failure and settlement related problems since the record-breaking July 2005 rainfall. Corrective ground improvement measures were implemented immediately after the monsoon. However, these measures were inadequate because the failure surface reappeared during the following monsoon. The failure surface mirrored the shape and size of the failure observed in 2005. Since then after nearly every monsoon, the embankment has moved despite precautionary measures taken by the railway to arrest the movement. The hydrogeological and geotechnical properties which affect slope stability are first discussed. The stability of the embankment is then evaluated at 5 sections drawn along the slope. Two cases are considered. In the first case, the stability of the unreinforced slope is calculated. In the second case, calculations are done using the slope reinforced with soil nails and micropiles installed in 2005 and 20

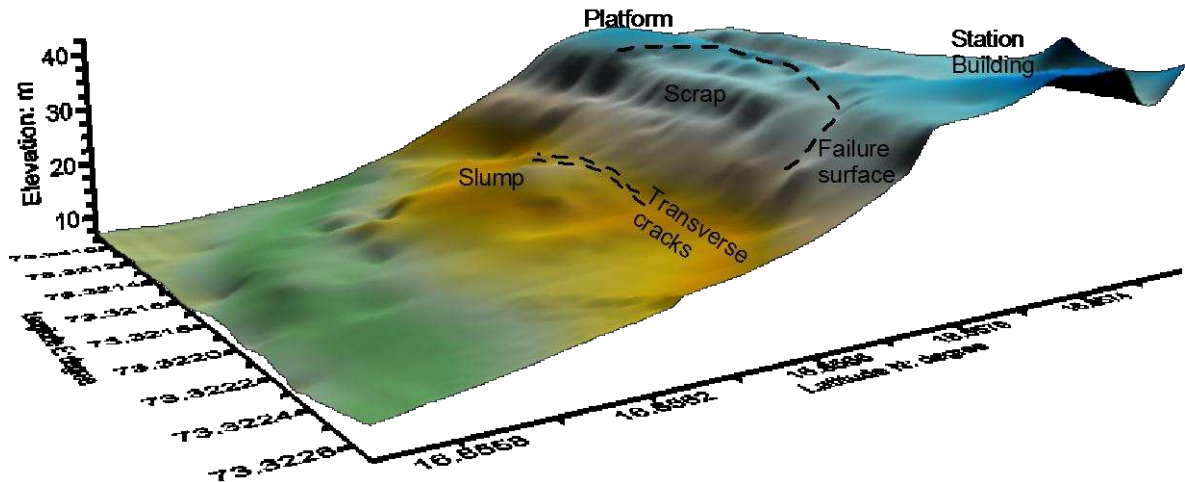
Figure 5 shows the map of the failure surface at the Nivsar Yard Station. In the figure, the latitudes and longitudes were obtained from the local coordinates using the WGS84 method (Chen and Hill 2005). The location of the slump, transverse cracks, and the failure surface are marked in the figure. The position of the transverse cracks was obtained by superimposing the observations made in Figure 4c onto Figure 5. All of the above, and the location of slope-reversal and scarp shown by the tilted trees and the cracked brick walls in Figure 6, suggest that they are parts of a landslide event.

Figure 5. Three dimensional view of the failure surface at Nivsar Yard Station.

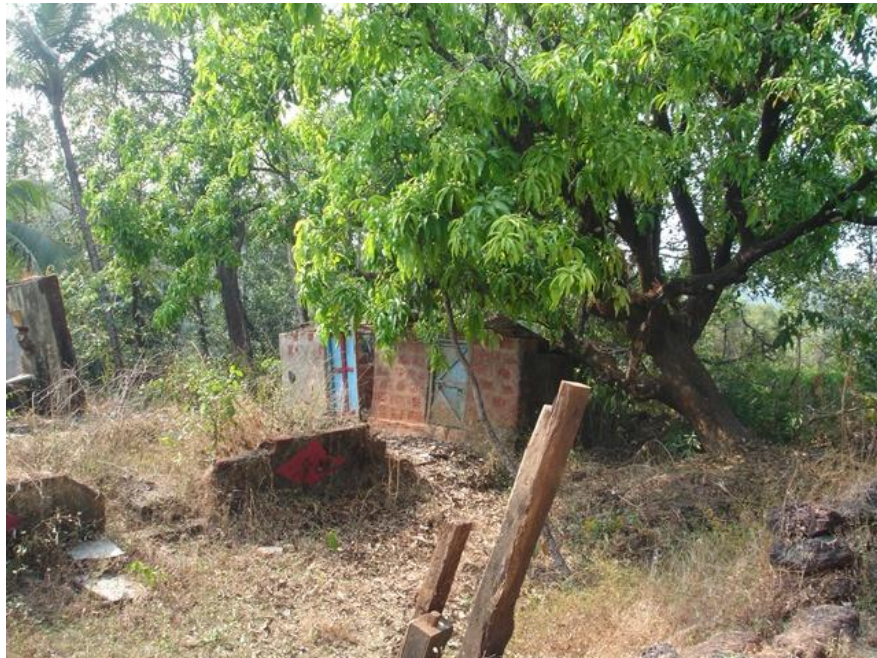
Figure 6. Tilted trees and cracked brick walls observed along the slope.

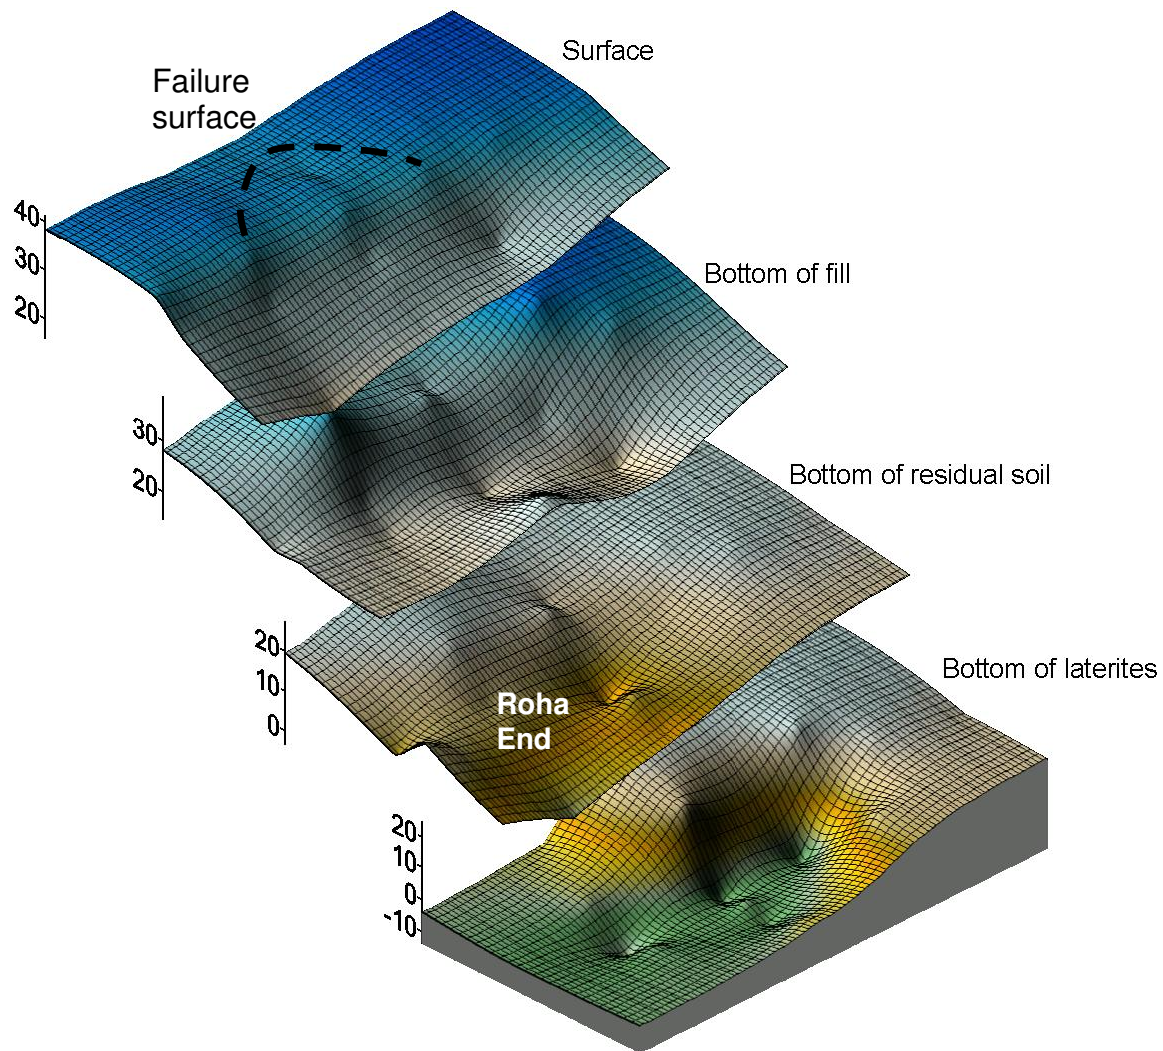
Figure 8. Three dimensional cross-sections of the soil and rock layers

Basalt bedrock: Basalt bedrock was logged from 13m to 49.5m below ground surface. As shown in Figure 8, the top surface of the basalt was undulating which provided a strong grip to the above laterites. The bedrock was weathered at the top with fractures at many locations. The depth from which the quality of the basalt improved to slightly/moderately weathered is shown in Table 3. The UCS of the bedrock was in between 200 kN/m² and 124 MN/m². Table 3 also shows the termination depth in each borehole.

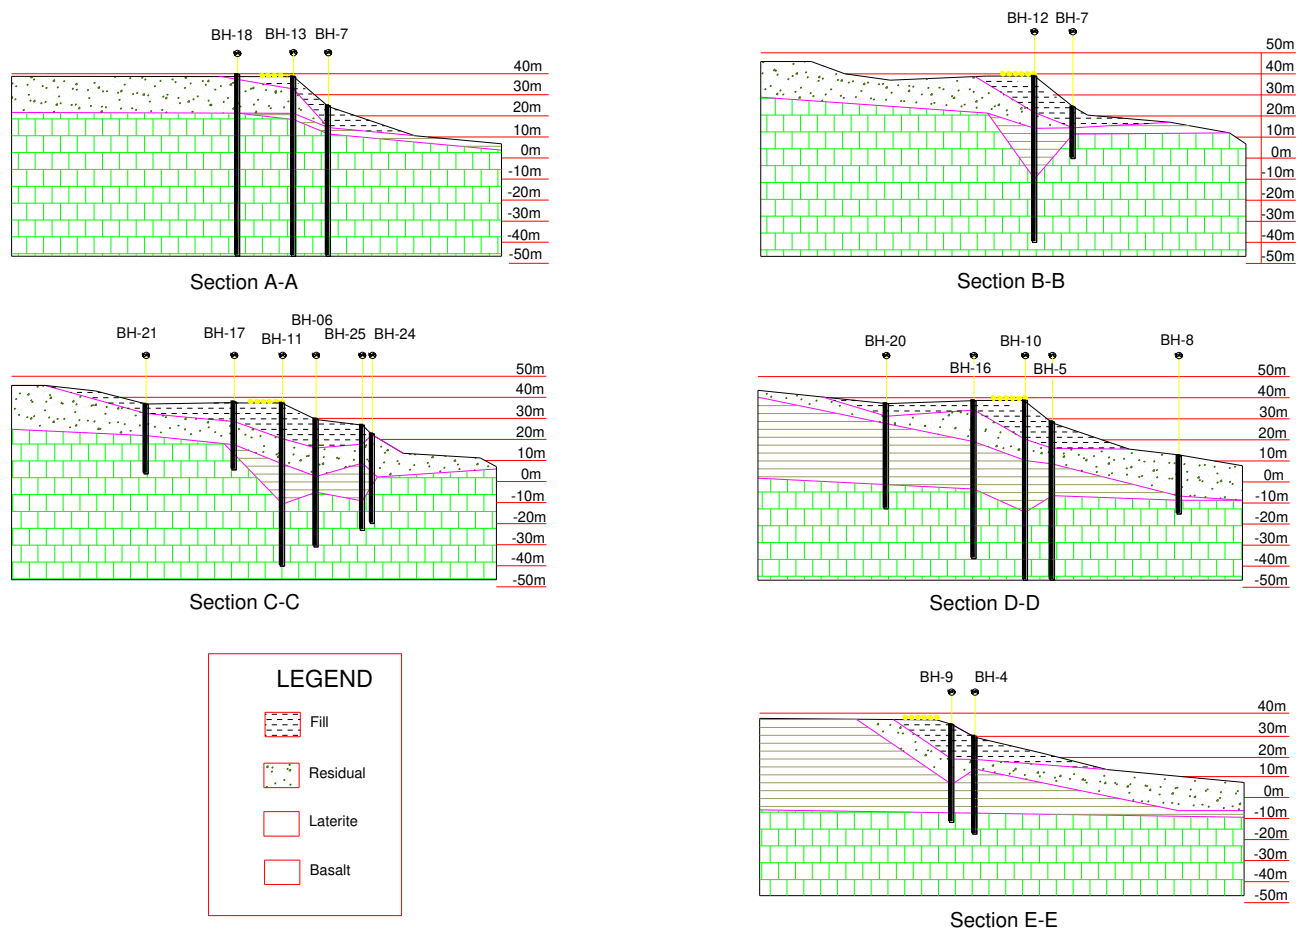
Using the borehole data, five cross-sections were drawn to interpret the subsurface profile of the site. The five sections are marked as A-A to E-E in Figure 7 and are shown in Figure 9. Sections B-B to D-D were chosen to represent the edges and centre of the failure zone. Laterites were nearly absent in section A-A and had the maximum presence in section D-D. The average geotechnical properties at each section are shown in Table 4. The material properties in Table 4 were obtained from the field and laboratory testing programme monitored jointly by Konkan Railways and IIT Bombay. Direct shear tests were conducted to obtain c' and ϕ' . Unconsolidated undrained (UU) triaxial tests were conducted to obtain c_u . The secant Young's modulus, E , of selected samples was obtained from stress-strain curves on UU samples confined with 50 to 200 kN/m² mean stress. Unconfined compression tests were conducted to obtain the c_u of laterites and basalt.

Figure 9. Subsurface profile at the site. Location of sections A-A to E-E are as per Figure 7.

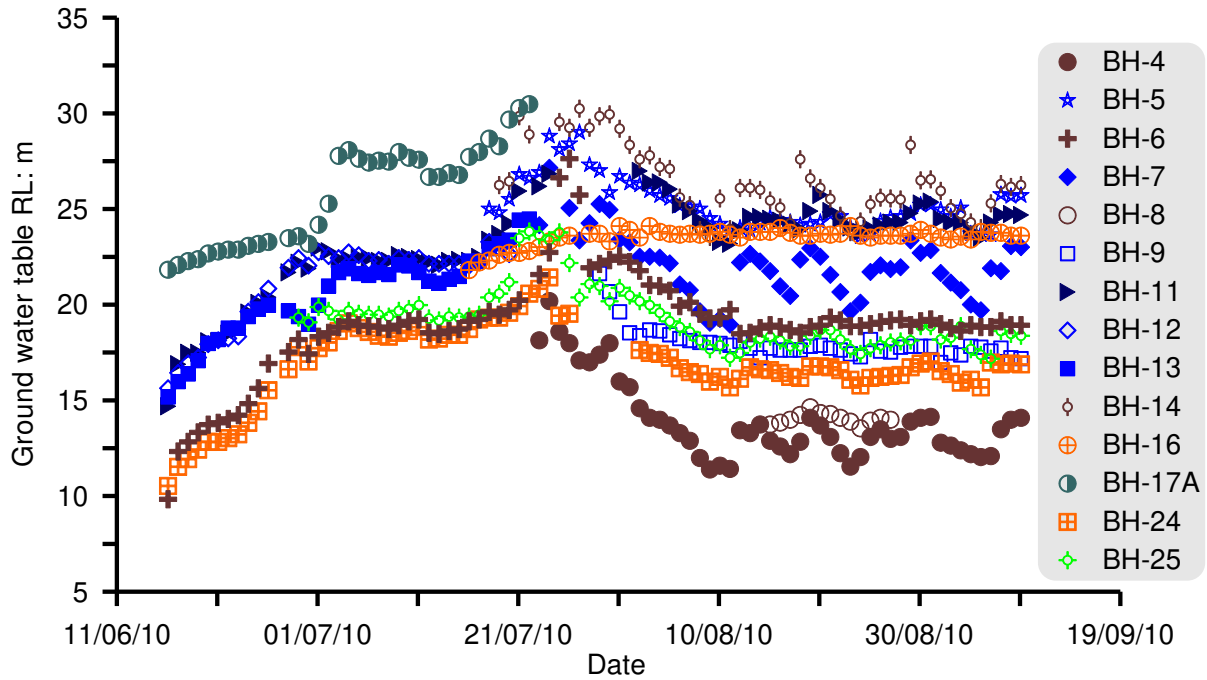
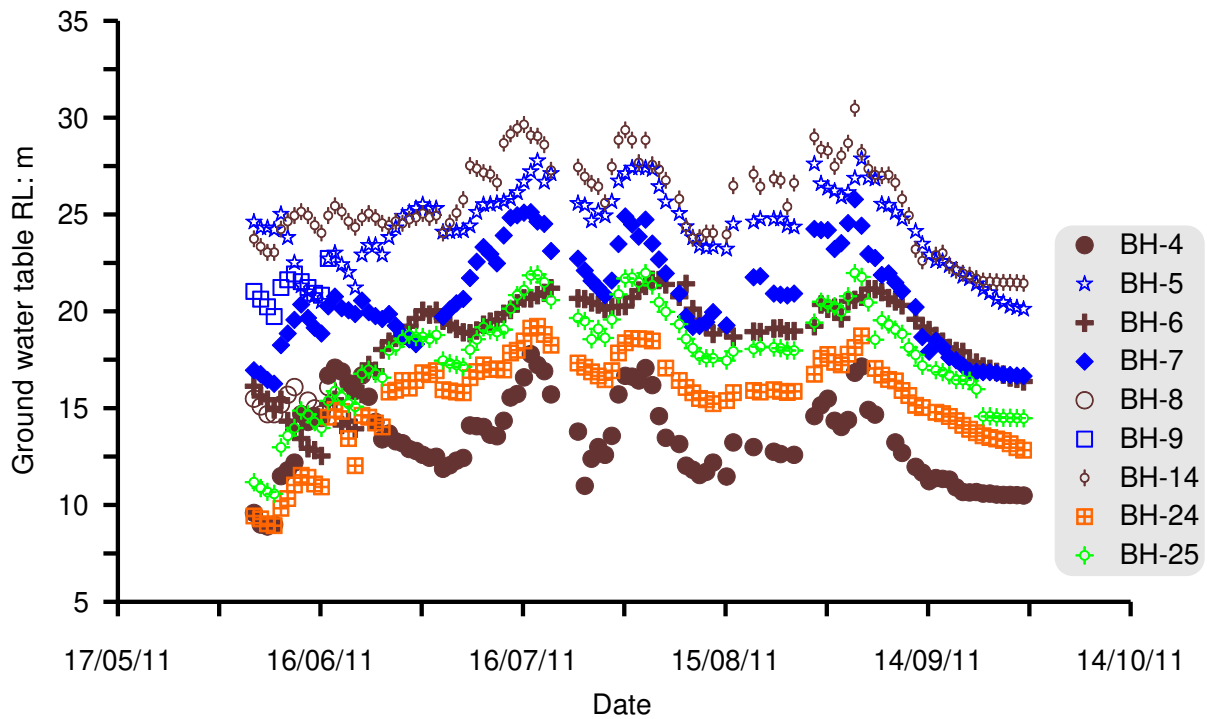
Standpipes were installed in the boreholes after the completion of the drilling. Ground water depths were occasionally recorded in these standpipes for about two years. Figures 10a and 10b show the water table recorded in 2010 and 2011, respectively. The slope movement during the 2010 and 2011 monsoons, sheared-off some of the standpipes. As a result a complete record of ground water data is not available over the monitoring period at these locations. The maximum and minimum water table depths are summarised in Table 5. A few observations may be made from Figures 10a-b and Table 5. First, the water table changed from 12.5m to 20m over the monitoring period in boreholes which were drilled along the centre-line of the failure surface. This variation in the water level possibly created a large pressure gradient. Second, the seasonal variation in the water level was more than 9m in boreholes drilled within the failure zone. There was significant variation in the water level even outside the failure surface. For example, the pressure head difference between boreholes BH-7 and BH-12 was more than 17m although the boreholes were only about 35m apart. Inevitably, these large pressure head difference caused large groundwater flow and significant seepage forces.

Figures 10a-b. Water table in standpipes: (a) In 2010; and (b) In 2011.

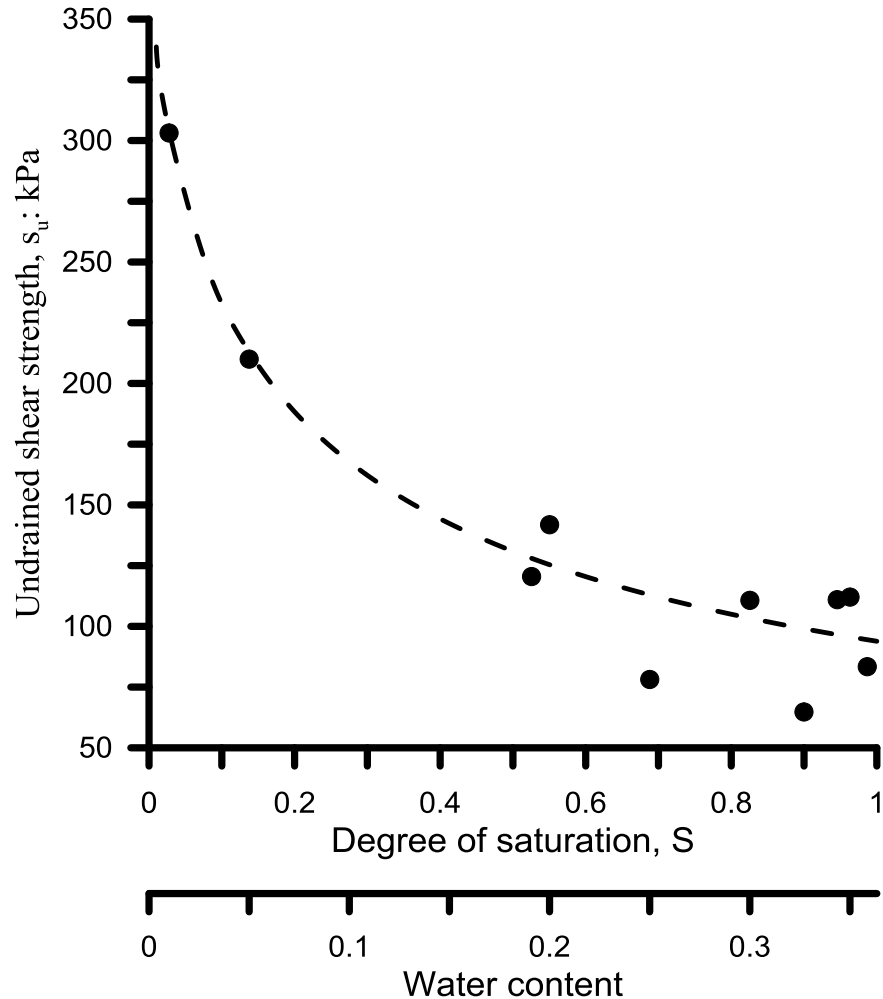
Figure 13. Variation of undrained shear strength, with degree of saturation at constant void ratio/dry density.

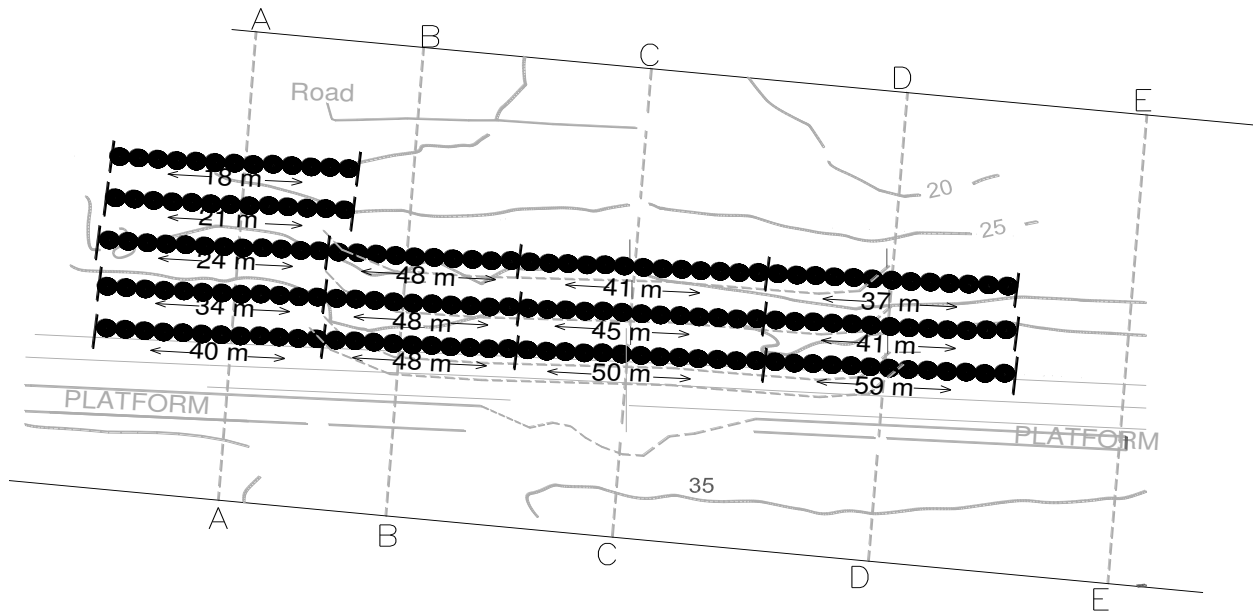
Figure 16. Schematic layout of the proposed 1.2m diameter bored pile wall at 1.2m c/c (contiguous bored pile wall). Note: Numbers below the piles indicate length of the piles.

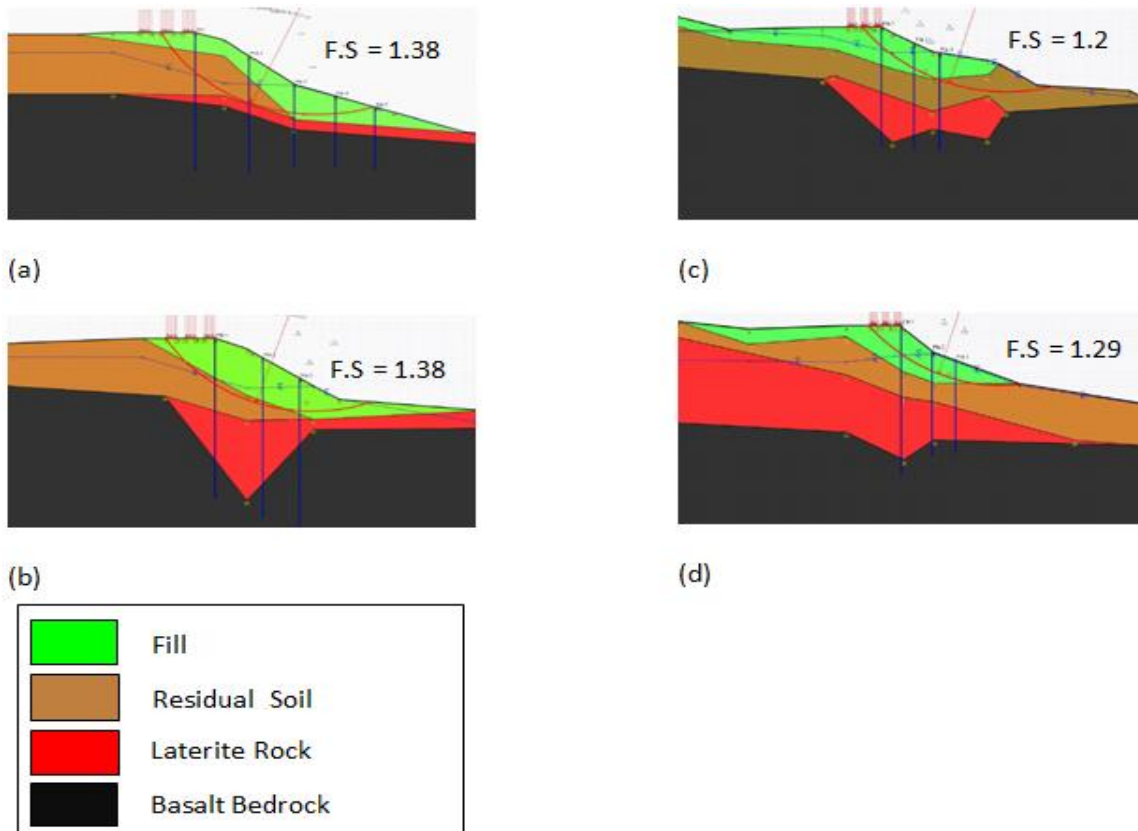
Figures 17a-d. Safety factor during wet season with proposed contiguous bored pile for section: (a) A-A; (b) B-B; (c) C-C; and (d) D-D.

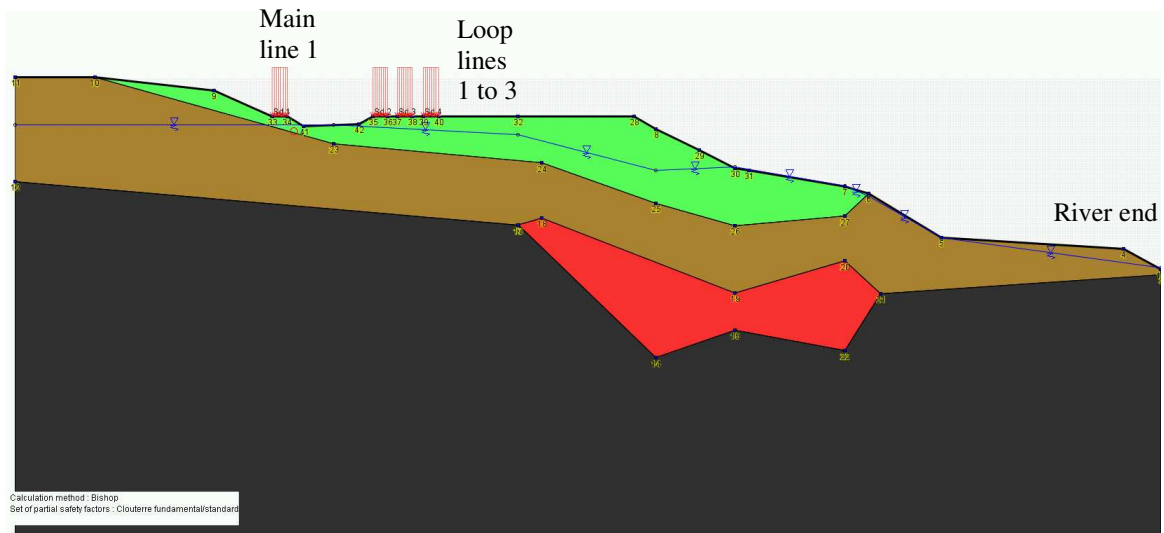
Figure 18. Section C-C with new rail alignment. The main alignment consists of 3 loop lines and 1 main line.

more than 1.4. The slope was therefore considered to be safe and unlikely to fail under the new loads. This new alignment has been implemented since 2011. It has been constructed at less than 20 percent of the cost incurred to improve the ground. The railways have also removed the speed restriction at Nivsar which has resulted in additional savings during the monsoon.
