## Embankment Failure in Residual Soils at Nivsar, Ratnagiri

**ABSTRACT:** *The Nivsar Yard embankment was constructed by the Konkan Railways in 1994. Near the station building, the 22m high embankment runs parallel to the Kajali River for a stretch of about 100m. This stretch has experienced failure and settlement related problems since the record-breaking July 2005 rainfall. Corrective ground improvement measures were implemented immediately after the monsoon. However, these measures were inadequate because the failure surface reappeared during the following monsoon. The failure surface mirrored the shape and size of the failure observed in 2005. Since then after nearly every monsoon, the embankment has moved despite precautionary measures taken by the railway to arrest the movement. The hydrogeological and geotechnical properties which affect slope stability are first discussed. The stability of the embankment is then evaluated at 5 sections drawn along the slope. Two cases are considered. In the first case, the stability of the unreinforced slope is calculated. In the second case, calculations are done using the slope reinforced with soil nails and micropiles installed in 2005

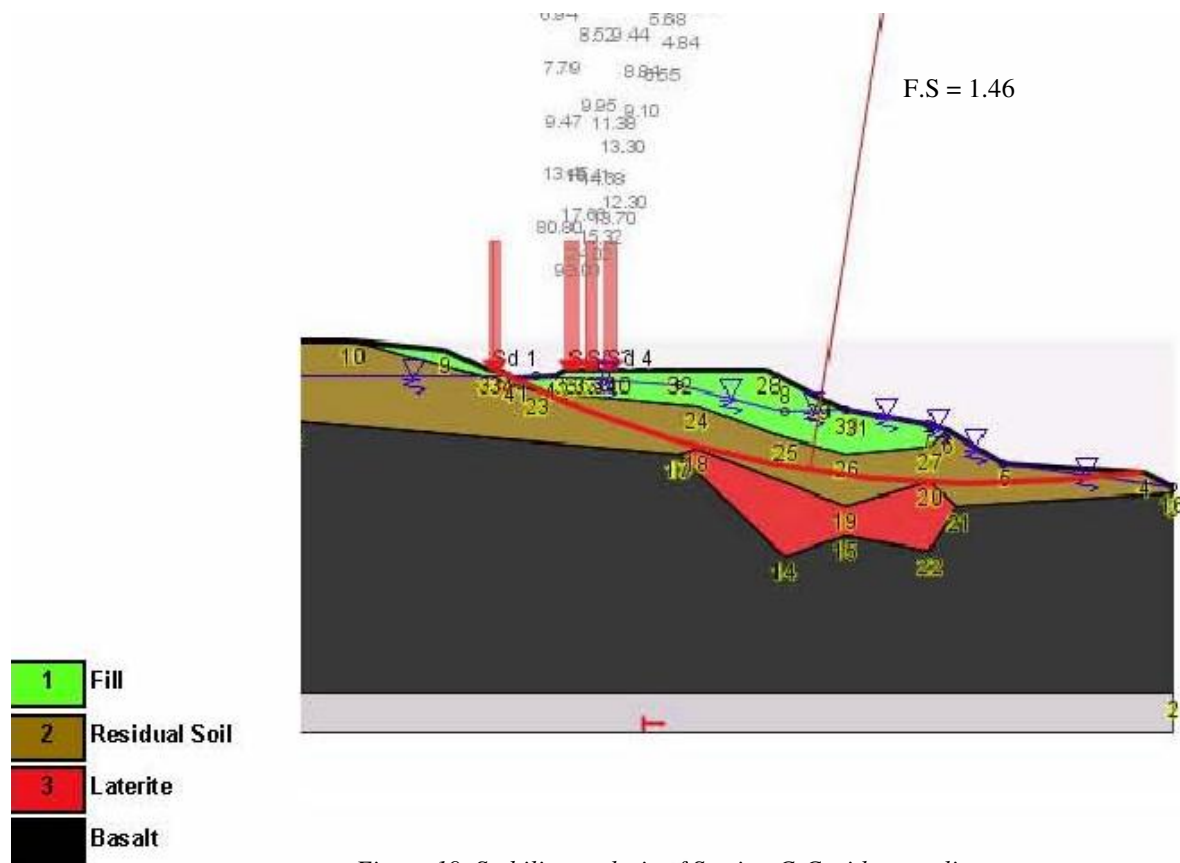
Figure 19. Stability analysis of Section C-C with new alignment.

more than 1.4. The slope was therefore considered to be safe and unlikely to fail under the new loads. This new alignment has been implemented since 2011. It has been constructed at less than 20 percent of the cost incurred to improve the ground. The railways have also removed the speed restriction at Nivsar which has resulted in additional savings during the monsoon.

The cost to use the bored pile wall was over 200 million Indian Rupees (US\$ 3.6 million) and appeared to be prohibitive. As an alternative to this design, the old rail alignment was removed and replaced by a new alignment. The new alignment consisted of 3 loop-lines and 1 main-line. Figure 18 shows section C-C along with the location of the new alignment. In this section, the top left side of the hill was slightly levelled to accommodate the main line and the loop lines. Section C-C was chosen because the new alignment was closest to the failure surface at this section. The horizontal distance from the vertex of the failure surface and the 4 lines was 16m, 21.3m, 26.2m and 46.4m, respectively. The stability of the slope was then reinvestigated using the computer program Talren-4 (Terrasol 2005). As in the previous case, all the lines were loaded by 125 kN/m<sup>2</sup>. This assumption was unduly conservative in absence of strict guidelines (RDSO 2003b). Nonetheless, it permitted trains with more overtaking opportunities on the passing-loops. The ground water level was modeled using the highest RL recorded in Table 5. The failure circles are shown in Figure 19. As can be seen, the minimum safety factor is
