Embankment Failure in Residual Soils at Nivsar, Ratnagiri

ABSTRACT: *The Nivsar Yard embankment was constructed by the Konkan Railways in 1994. Near the station building, the 22m high embankment runs parallel to the Kajali River for a stretch of about 100m. This stretch has experienced failure and settlement related problems since the record-breaking July 2005 rainfall. Corrective ground improvement measures were implemented immediately after the monsoon. However, these measures were inadequate because the failure surface reappeared during the following monsoon. The failure surface mirrored the shape and size of the failure observed in 2005. Since then after nearly every monsoon, the embankment has moved despite precautionary measures taken by the railway to arrest the movement. The hydrogeological and geotechnical properties which affect slope stability are first discussed. The stability of the embankment is then evaluated at 5 sections drawn along the slope. Two cases are considered. In the first case, the stability of the unreinforced slope is calculated. In the second case, calculations are done using the slope reinforced with soil nails and micropiles installed in 2005 and 20

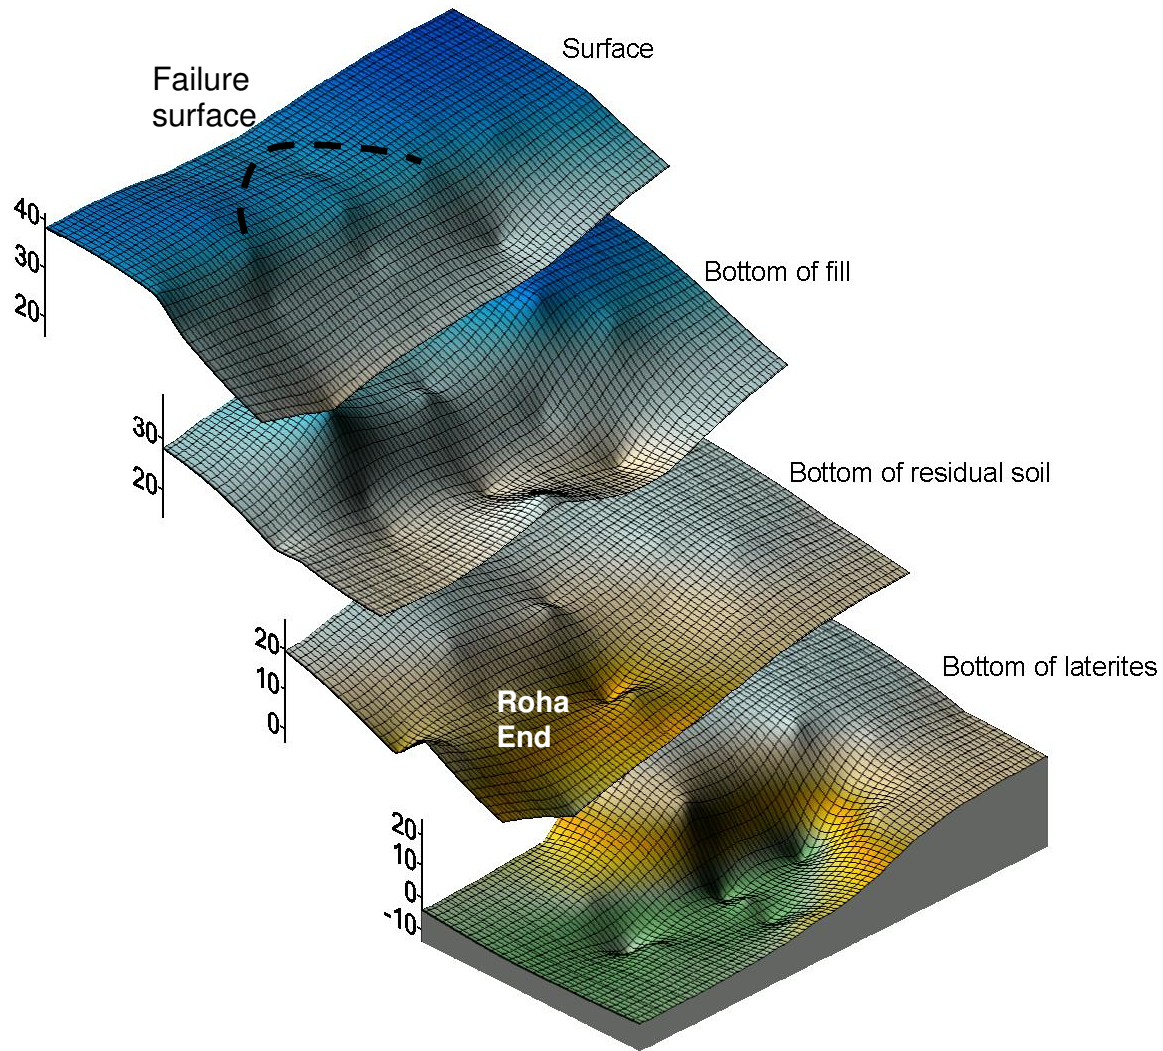
Figure 8. Three dimensional cross-sections of the soil and rock layers

Fill: Fill consisted of reddish brown silty clay and clayey sand. The clay matrix was frequently filled with coarse gravel and cobbles, which made this topmost-soil-layer firm to stiff. The fill was classified as medium to dense at locations where the sand and gravel proportions were in majority. The thickness of the fill was in between 13.5 to 15m in boreholes drilled close to the rail line at top of the hill. The thickness of the fill was surprisingly only 9m in borehole BH-17 drilled near the vertex of the failure surface. Apparently, the slip along the failure surface had caused the fill thickness to reduce at this location. The fill gradually narrowed towards the top flat end of the hilltop. Likewise, boreholes BH-7, BH-8, BH-24 and BH-24 indicate that the fill tapered off downhill at the road level. Figure 8 shows that the fill is bowl-shaped with its edges fused to the edges of the section. From Figure 8, it is interesting to note that the shape of the failure surface mimics the shape of the fill.

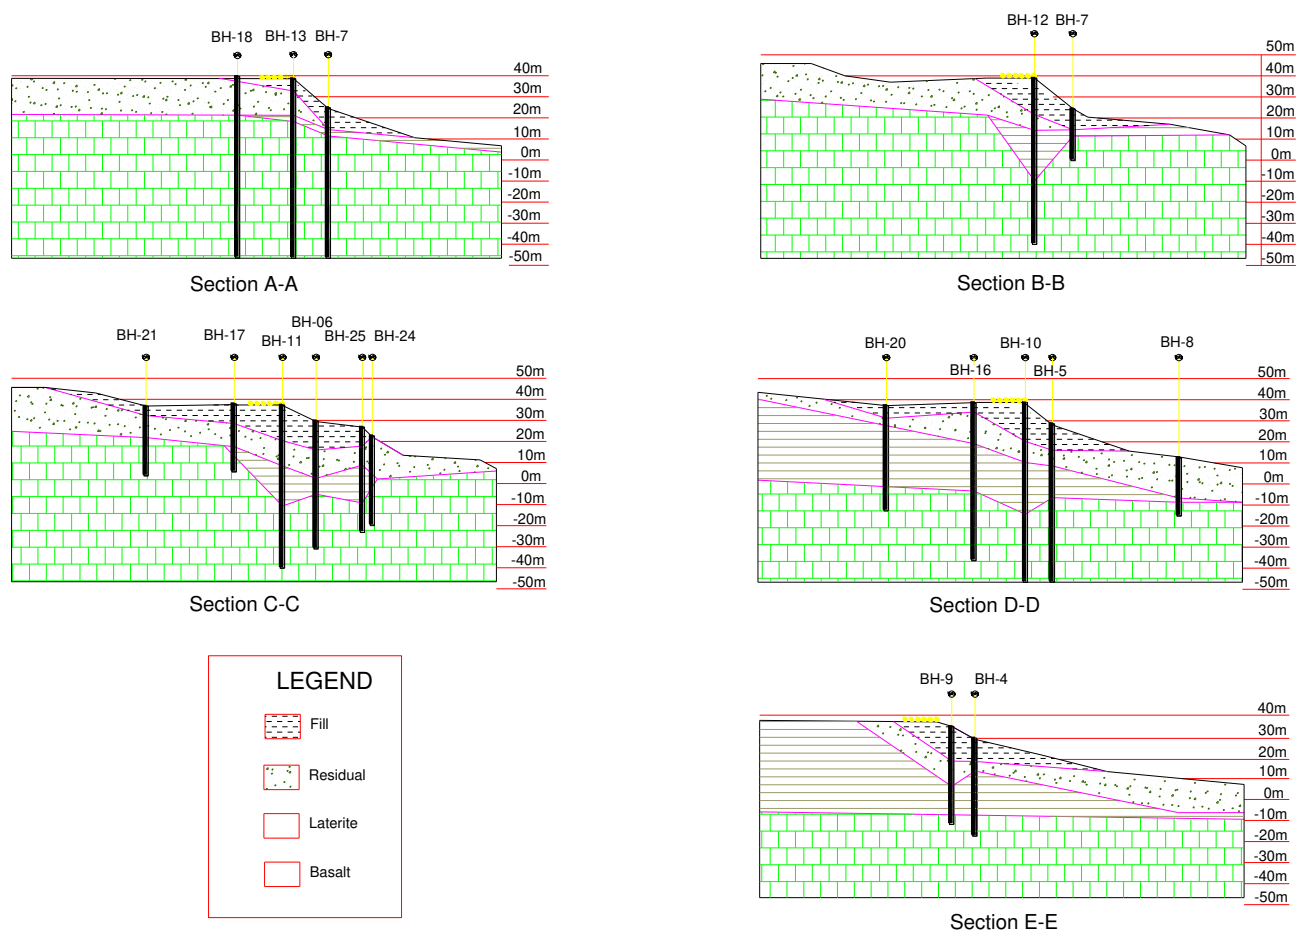
Using the borehole data, five cross-sections were drawn to interpret the subsurface profile of the site. The five sections are marked as A-A to E-E in Figure 7 and are shown in Figure 9. Sections B-B to D-D were chosen to represent the edges and centre of the failure zone. Laterites were nearly absent in section A-A and had the maximum presence in section D-D. The average geotechnical properties at each section are shown in Table 4. The material properties in Table 4 were obtained from the field and laboratory testing programme monitored jointly by Konkan Railways and IIT Bombay. Direct shear tests were conducted to obtain c' and ϕ' . Unconsolidated undrained (UU) triaxial tests were conducted to obtain c_u . The secant Young's modulus, E , of selected samples was obtained from stress-strain curves on UU samples confined with 50 to 200 kN/m² mean stress. Unconfined compression tests were conducted to obtain the c_u of laterites and basalt.

Figure 9. Subsurface profile at the site. Location of sections A-A to E-E are as per Figure 7.

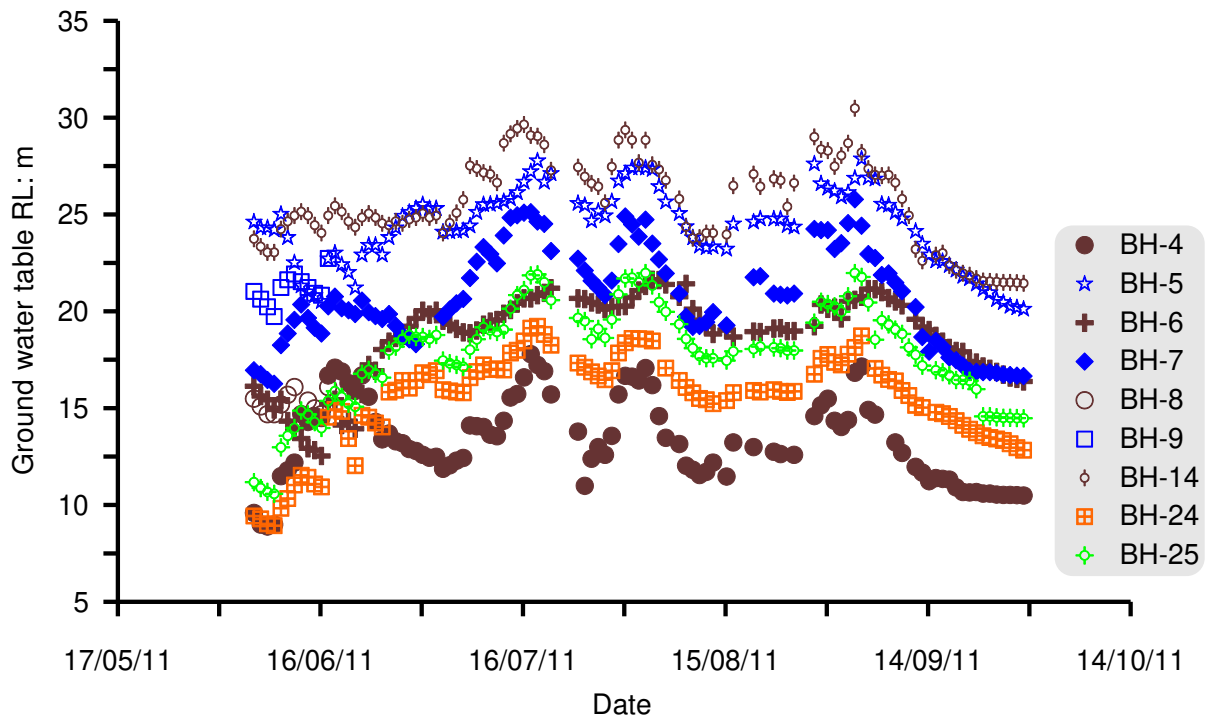
Standpipes were installed in the boreholes after the completion of the drilling. Ground water depths were occasionally recorded in these standpipes for about two years. Figures 10a and 10b show the water table recorded in 2010 and 2011, respectively. The slope movement during the 2010 and 2011 monsoons, sheared-off some of the standpipes. As a result a complete record of ground water data is not available over the monitoring period at these locations. The maximum and minimum water table depths are summarised in Table 5. A few observations may be made from Figures 10a-b and Table 5. First, the water table changed from 12.5m to 20m over the monitoring period in boreholes which were drilled along the centre-line of the failure surface. This variation in the water level possibly created a large pressure gradient. Second, the seasonal variation in the water level was more than 9m in boreholes drilled within the failure zone. There was significant variation in the water level even outside the failure surface. For example, the pressure head difference between boreholes BH-7 and BH-12 was more than 17m although the boreholes were only about 35m apart. Inevitably, these large pressure head difference caused large groundwater flow and significant seepage forces.

Figures 10a-b. Water table in standpipes: (a) In 2010; and (b) In 2011.
