The July 10 2000 Payatas Landfill Slope Failure

ABSTRACT: *This paper presents an investigation of the slope failure in the Payatas landfill in Quezon City, Philippines. This failure, which killed at least 330 persons, occurred July 10th 2000 after two weeks of heavy rain from two typhoons. Slope stability analyses indicate that the raised leachate level, existence of landfill gas created by natural aerobic and anaerobic degradation, and a significantly over-steepened slope contributed to the slope failure. The Hydrologic Evaluation of Landfill Performance (HELP) model was used to predict the location of the leachate level in the waste at the time of the slope failure for analysis purposes. This paper presents a description of the geological and environmental conditions, identification of the critical failure surface, and slope stability analyses to better understand the failure and present recommendations for other landfills in tropical areas. In addition, this case history is used to evaluate uncertainty in parameters used in back-analysis of a landfill slope failure.*

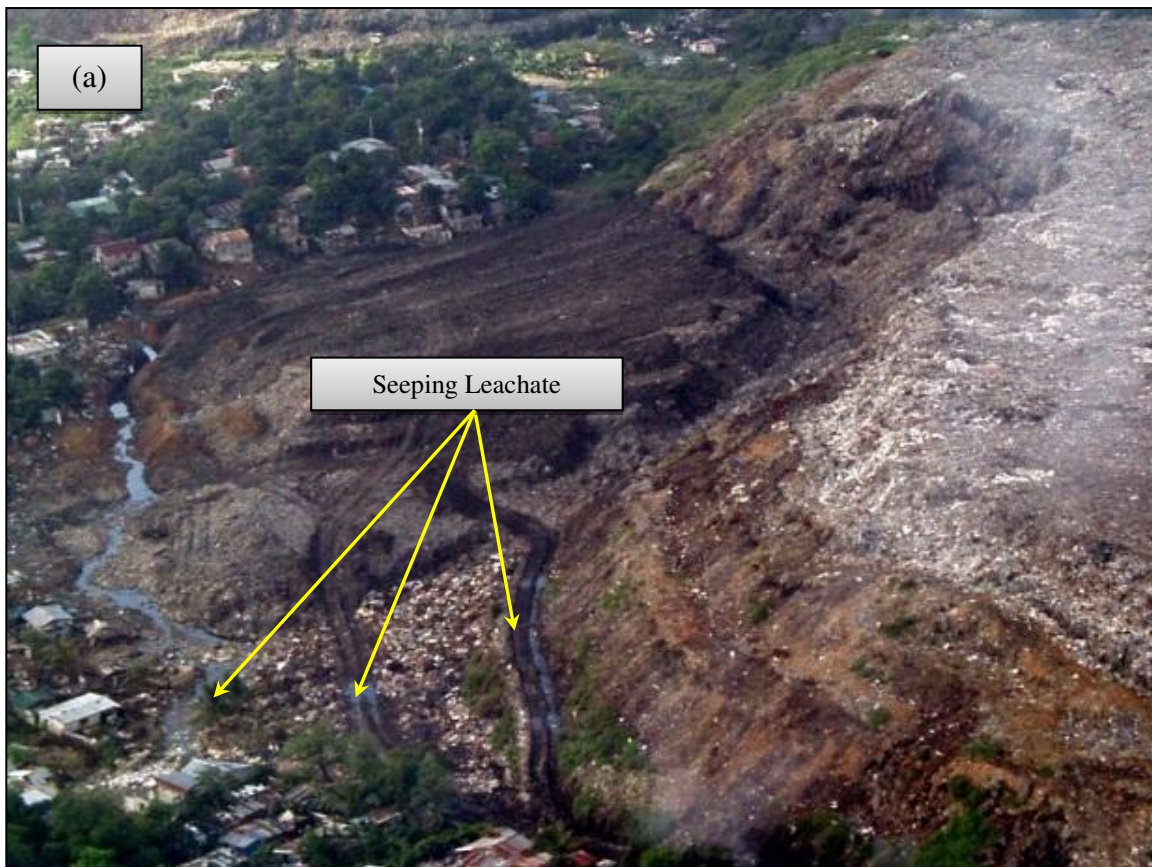
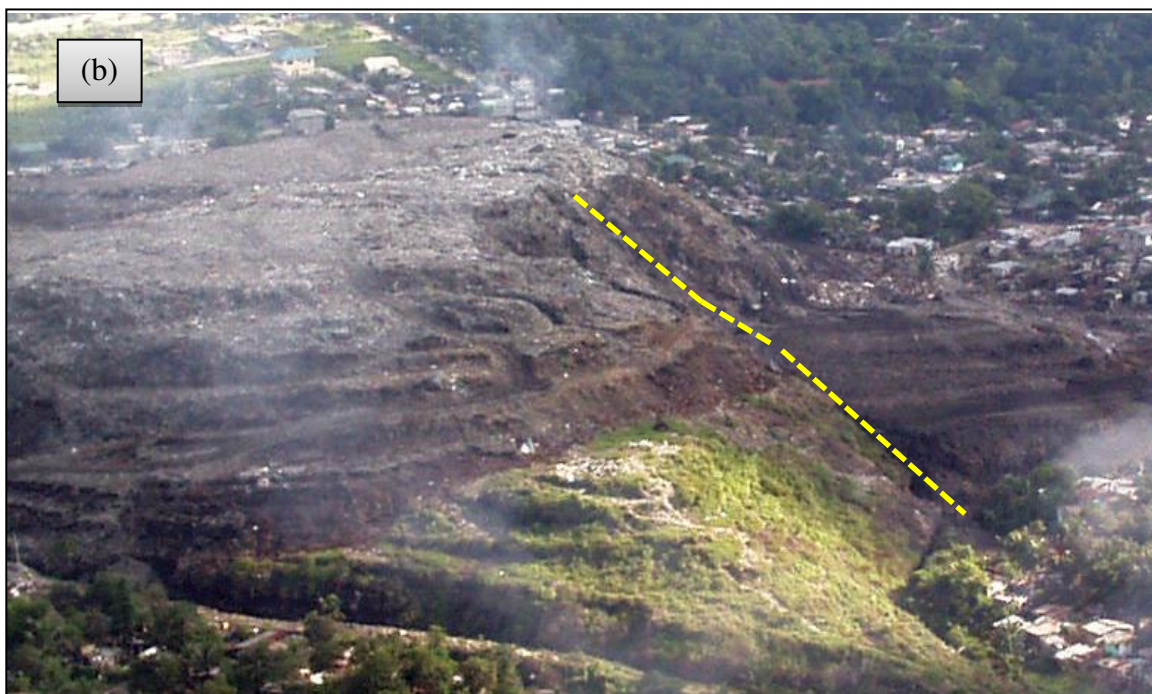
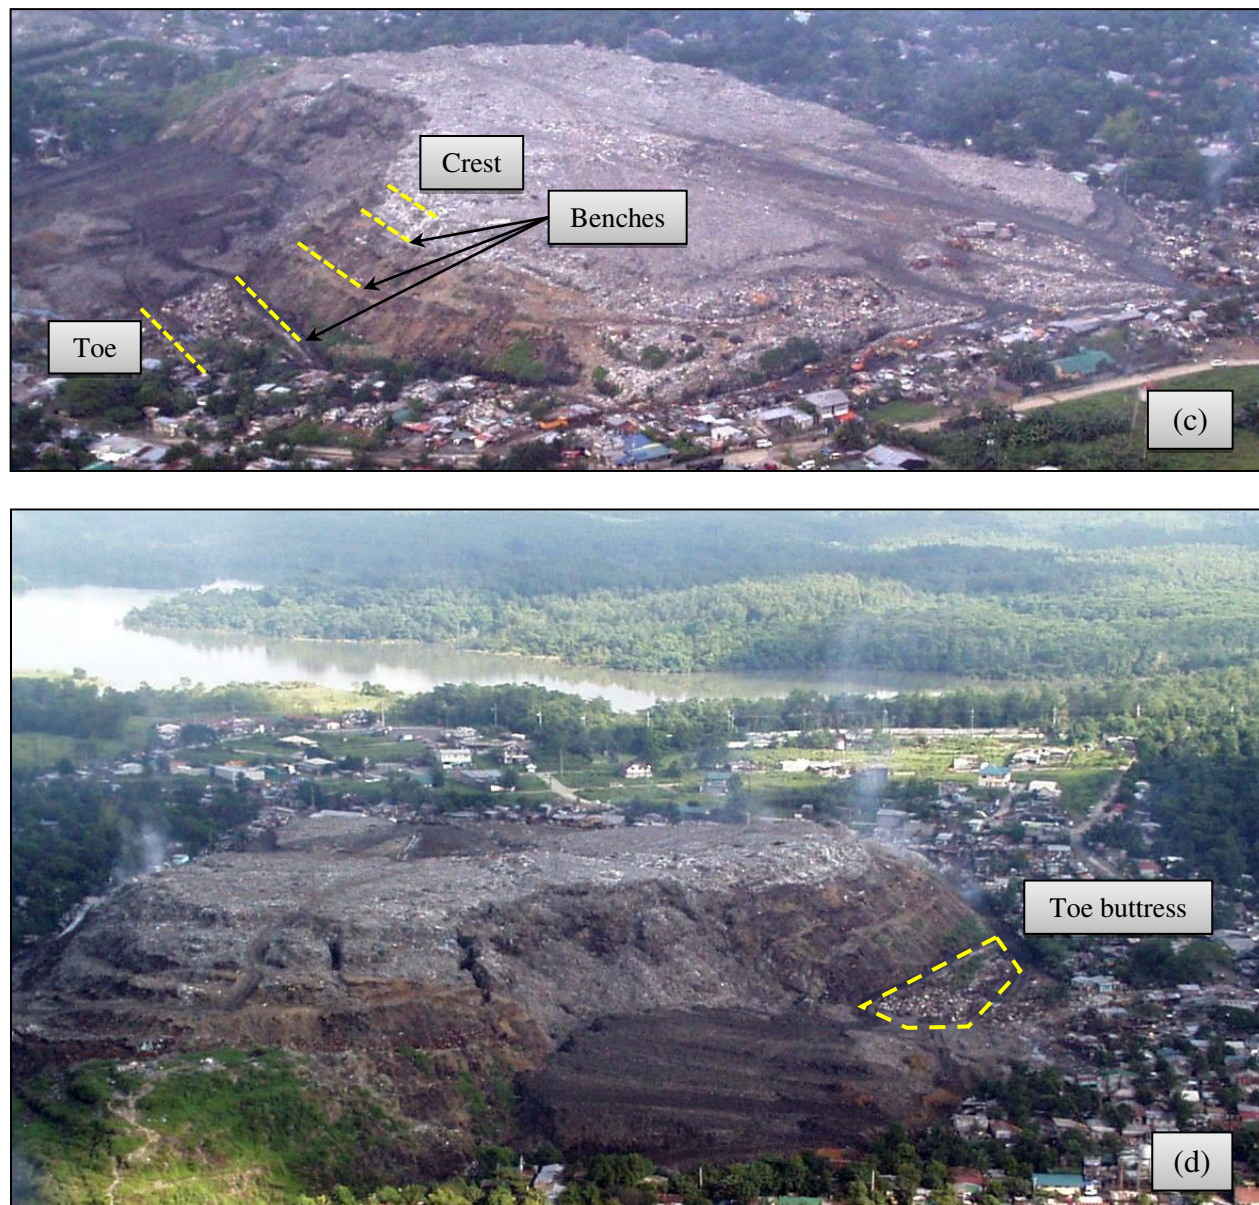
Figure 6 shows a series of aerial views of the waste slide area that were used to understand the failure surface for use in the stability analyses. Figures 6(a) and 6(b) provide side views from the southeast and northwest direction, respectively, of the waste slide. Figure 6(c) highlights benches in the landfill slope, and Figure 6(d) delineates a mildly sloped toe buttress. Digital measurements from these photographs were used to create the cross-section shown in Figure 7. These measurements indicate toe buttress slope angles in the slide area of 1.4H:1V ($\sim 35^\circ$) to 0.84H:1V ($\sim 50^\circ$) and steeper side slopes above the buttress that range from 60° to 70° (Bautista, 2007; UNFCCC, 2007). Additionally, site reconnaissance and pictures both indicate that leachate was seeping from this toe buttress.

Figure 6. Slope geometry and failure surface after failure (a) evidence of seeping leachate, (b) representative slope inclination, (c) location of slope benches, (d) toe buttress (photos by S.M. Merry).

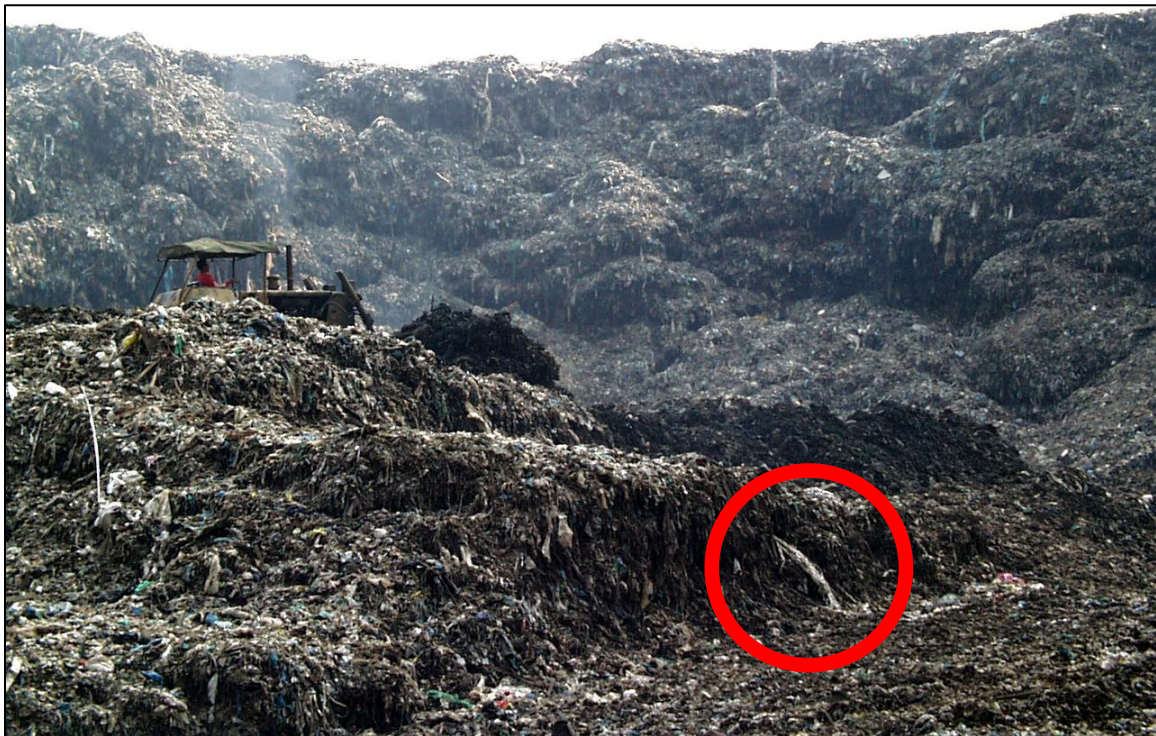
Figure 9. View of the back-scarp of waste slide and leachate flowing from the exposed MSW (photo by S.M. Merry).

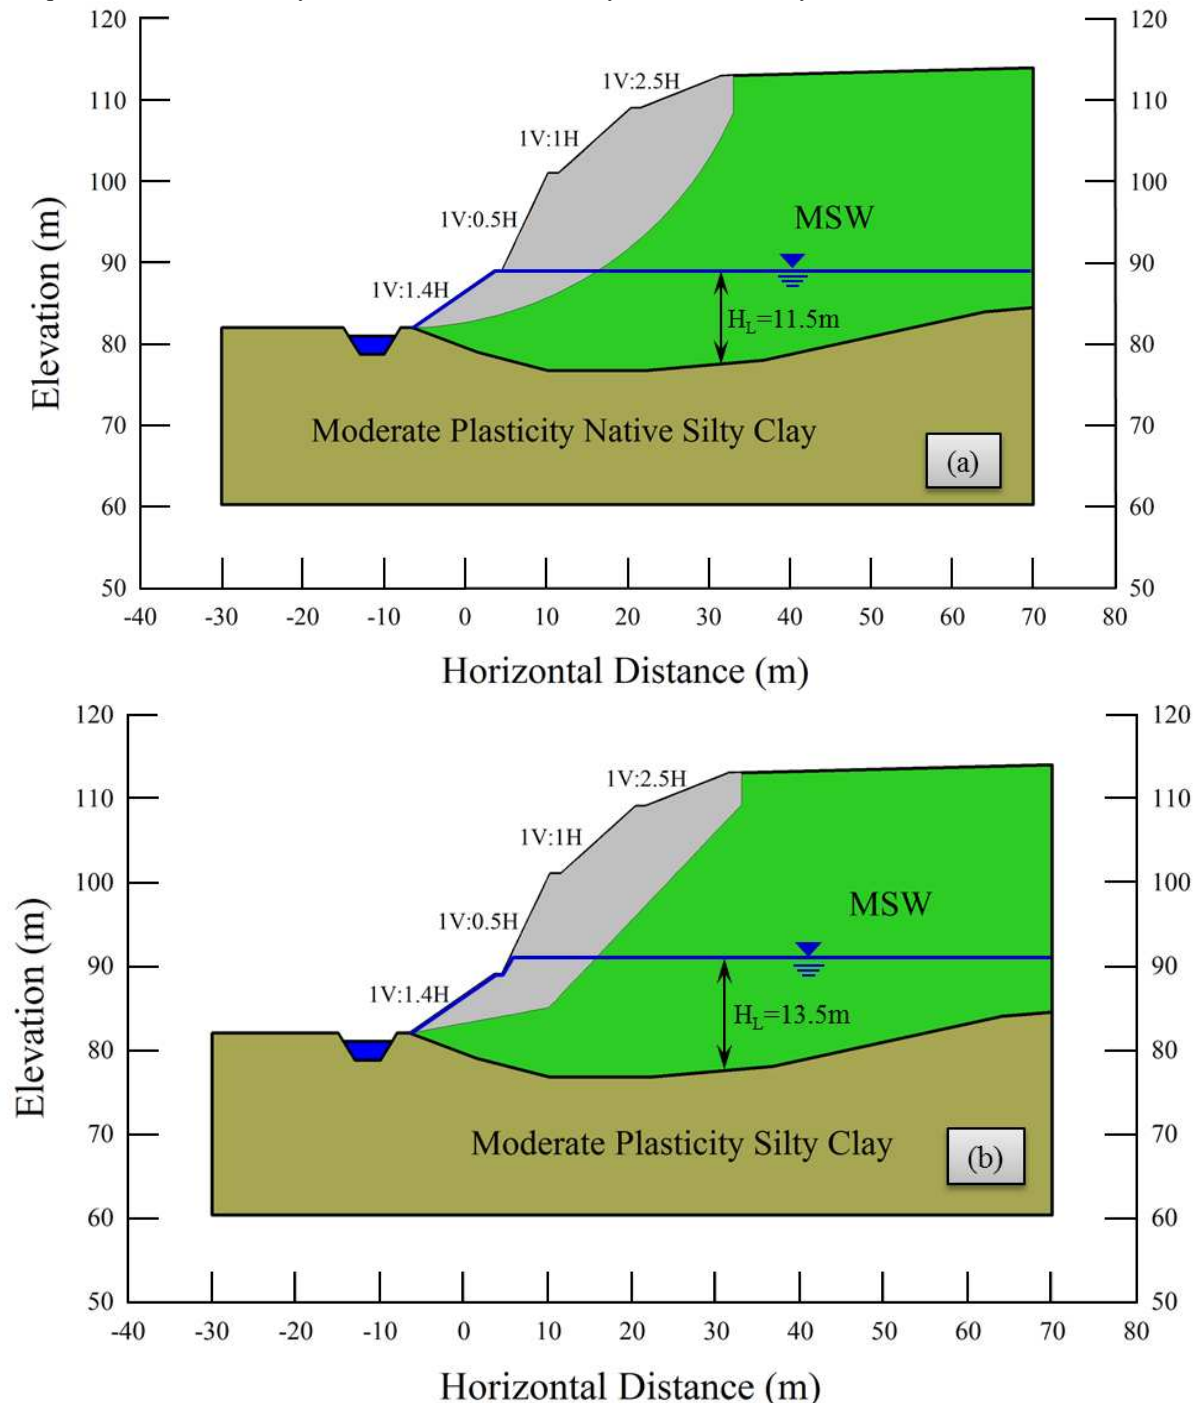
Figure 11. Cross- sections showing location of (a) circular and (b) planar failure surfaces.

The failure surfaces shown in Figure 11 were estimated from photographs in Figures 2, 3, 5, and 6 and consist of a shallow circular and shallow planar failure surface through only the MSW. From Figure 3, the authors surmise that the failure surface is shallow in nature, and the waste mass slid down the side slope as a mass, i.e., a slab or sliver slide. Subsequently, ledges developed along the main scarp formed from vertical blocks toppling over or sliding down (see Figure 3). Therefore, it was concluded that the failure surface passed from the crest of the slope through the MSW, and exited at the slope toe without entering the underlying brown native clayey silt.

Although a circular failure surface indicates a homogenous material, a planar failure surface starting at the toe and daylighting at the top of the landfill was also analyzed. Because the exact location of the failure surface at the crest is not known, the scarp of the waste slide was used to estimate the location of the failure surface at the top of slope that yielded the lowest factor of safety. Furthermore, after the waste slide, the waste was regraded (see Figures 2 and 5) such that the actual slide mass geometry does not represent the possible progression of failure. A helicopter video from a news report (<http://www.abs-cbnnews.com/video/nation/metro-manila/07/10/11/payatas-tragedy-commemorated>) shows an aerial view of the landfill prior to regrading, which was also helpful in estimating the location and geometry of the failure surface. From this video, the failure progresses from the main slide mass and regressing from the initial head scarp to a final scarp that is about 5 m behind the slope crest. Then, an ensuing block of waste toppled from the scarp creating the final geometry shown in Figure 2. Merry et al. (2005) report that a steep (vertical at the top) head scarp remained above the area where heavy machinery had reworked the waste mass.
