## The July 10 2000 Payatas Landfill Slope Failure

**ABSTRACT:** *This paper presents an investigation of the slope failure in the Payatas landfill in Quezon City, Philippines. This failure, which killed at least 330 persons, occurred July 10<sup>th</sup> 2000 after two weeks of heavy rain from two typhoons. Slope stability analyses indicate that the raised leachate level, existence of landfill gas created by natural aerobic and anaerobic degradation, and a significantly over-steepened slope contributed to the slope failure. The Hydrologic Evaluation of Landfill Performance (HELP) model was used to predict the location of the leachate level in the waste at the time of the slope failure for analysis purposes. This paper presents a description of the geological and environmental conditions, identification of the critical failure surface, and slope stability analyses to better understand the failure and present recommendations for other landfills in tropical areas. In addition, this case history is used to evaluate uncertainty in parameters used in back-analysis of a landfill slope failure.*

Reference: Jafari, N. H., Stark, T. D., and Merry, S. (2013). *The July 10 2000 Payatas Land

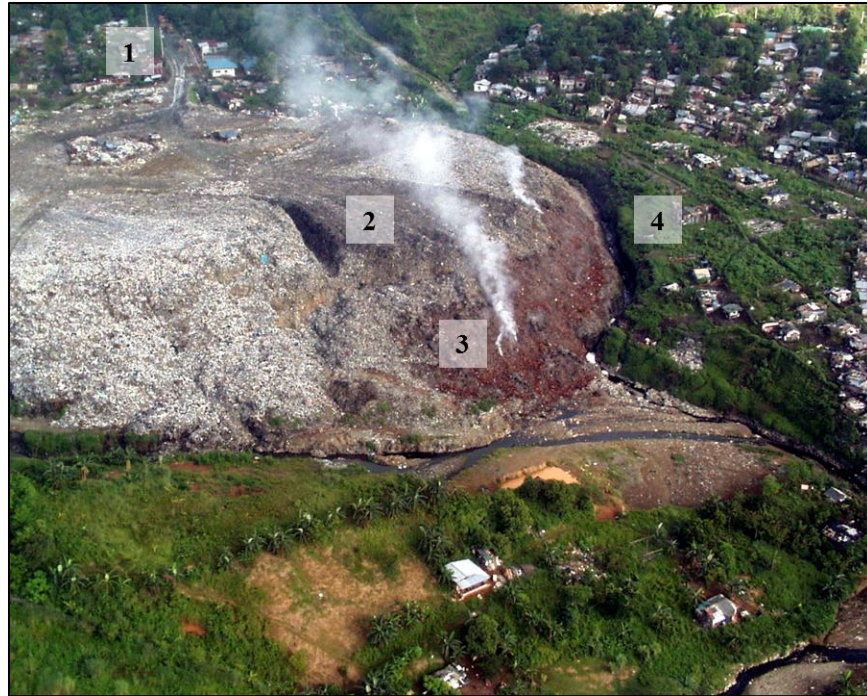
This section describes observations of a smaller landfill immediately southeast of the waste failure that helps interpret the waste slide. These observations are based on both site reconnaissance and photos. Figure 4 shows the slopes at this smaller landfill, which did not fail after both typhoon events although both facilities followed the same landfill operation procedures. The following bulleted sections discuss in numerical order the labels shown in Figure 4:

1. The access road to the landfill is a street through a residential neighborhood. Most likely, waste disposal consisted of dumping at the edge of the road and subsequent pushing down the slightly sloped terrain. The waste height eventually reached the same elevation as the surrounding residential area and waste trucks drove upslope the resulting waste slope for unloading;

2. A deep, man-made trench at the slope crest was excavated to collect and channel surface precipitation. Although this trench did not result in slope failure, a similar trench was observed near the failed waste mass. The trench is believed to have acted as a water-filled tension crack, where the failure plane intersects the bottom of the crack. The tension crack depth increased with frequency of precipitation and subsequent waste erosion. Also, the trench provides a direct conduit of water to lower depths of the landfill, thereby decreasing effective stress in the waste. This landfill, like the landfill with the slope failure, did not have a soil cover on the top of the facility, which allowed for faster infiltrate of precipitation over a large area of the landfill;

3. A combination of steam and smoke is emanating from the slope in the foreground. It is common for steam or smoke to be present because of the large area of uncovered MSW that can result in spontaneous combustion. Residents living downslope of the failure heard a loud explosion before the waste failure (Merry et al., 2005). The explosion may have been facilitated by elevated gas pressures due to MSW degradation and steam or smoke due to spontaneous combustion of the exposed MSW;

4. A leachate collection trench surrounds the landfill periphery and is used to collect and remove leachate seeping from the waste pile.

Figure 4. Stable landfill south of Payatas Landfill with waste slide showing smoke plumes (photo by S.M. Merry).

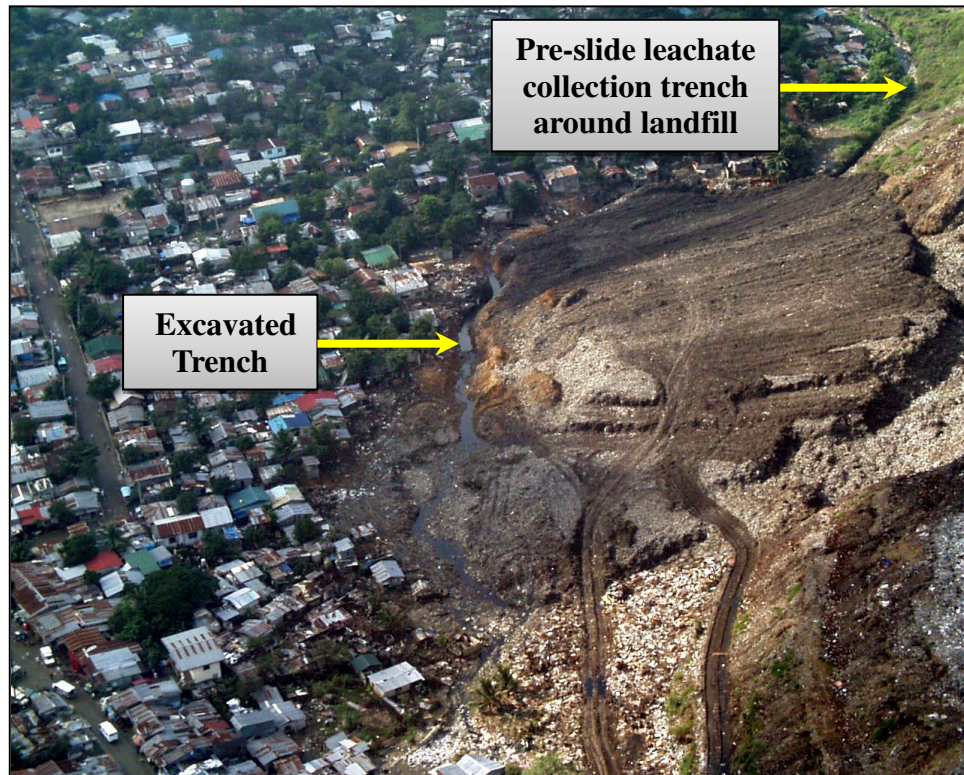
Figure 5 shows a close-up of the slope failure area and scarp in Payatas Landfill. Regrading of the slide mass had started shortly after the failure, which is shown in Figure 5. A leachate collection trench was excavated along the toe of the slide mass and is highlighted by the arrow and text box in Figure 5. The native brown soil underlying the waste and residential area is visible along the toe and sides of this excavated leachate collection trench. Leachate seepage existed prior to and shortly after the slope failure; however, the exact leachate level in the landfill just prior to failure is not known. A smaller landfill leachate collection trench was present along the slope toe prior to the slide and was similar to the trench shown in Figure 4. The leachate collection trench as it existed prior to the slide was covered by the slide mass and hence, is not visible (see the central portion of Figure 5). However, it was visible along the toe of the north-facing slope of the landfill east of the slide mass (see the top of Figure 5 where a small trench separates homes from the landfill toe and is highlighted by an arrow and text box). In summary, Figure 5 indicates that the leachate trench in front of the slide mass was constructed after the slide to collect leachate exiting the slide mass and a considerable volume of leachate existed in the landfill prior to failure but the exact leachate level at failure is not known.

Figure 5. Slope failure showing new and existing leachate trenches along slope toe (photo by S.M. Merry).

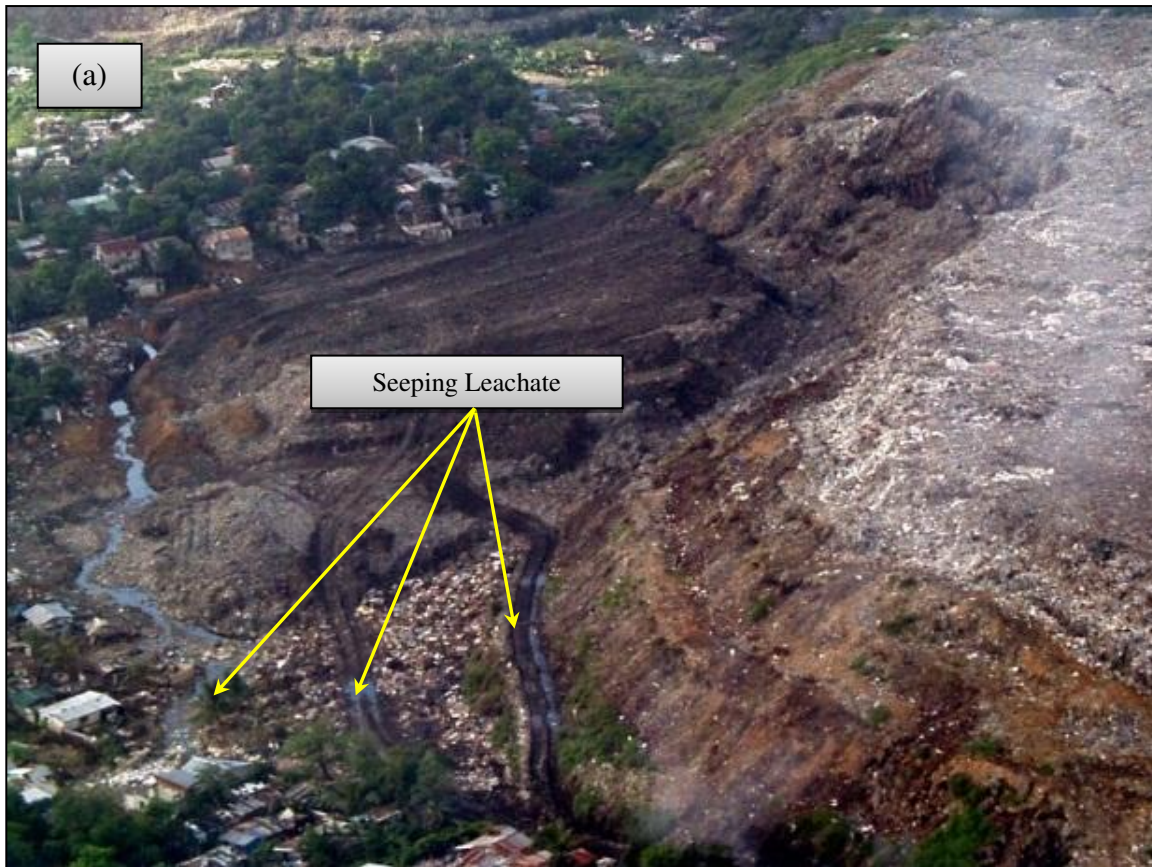
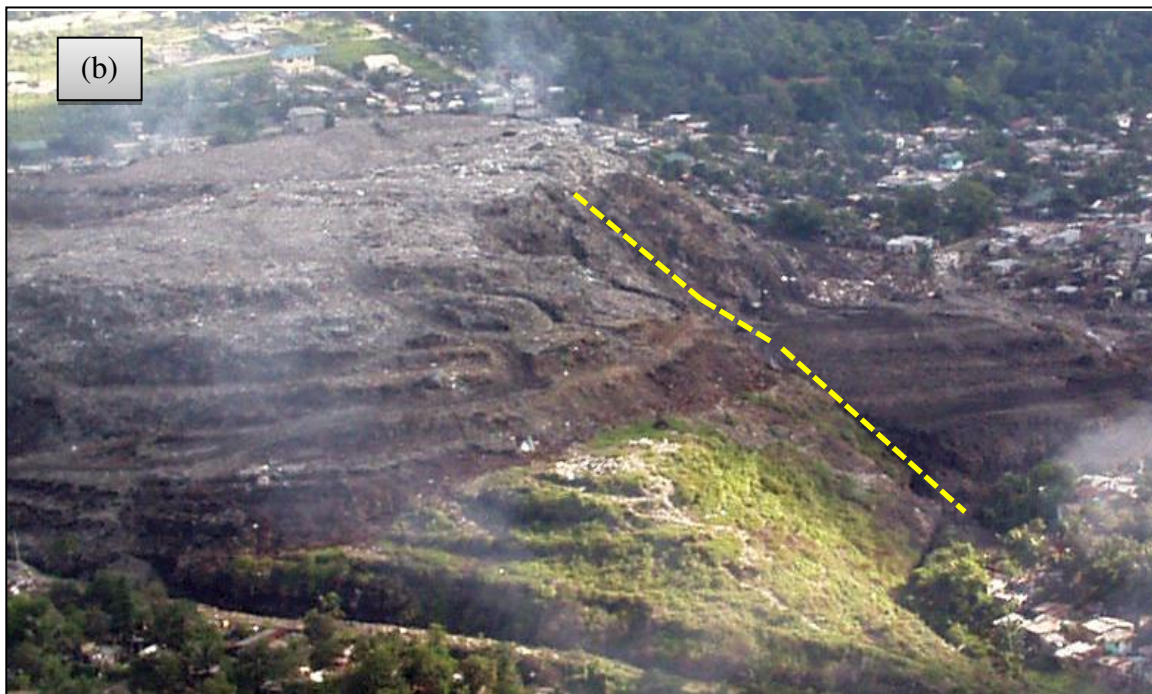
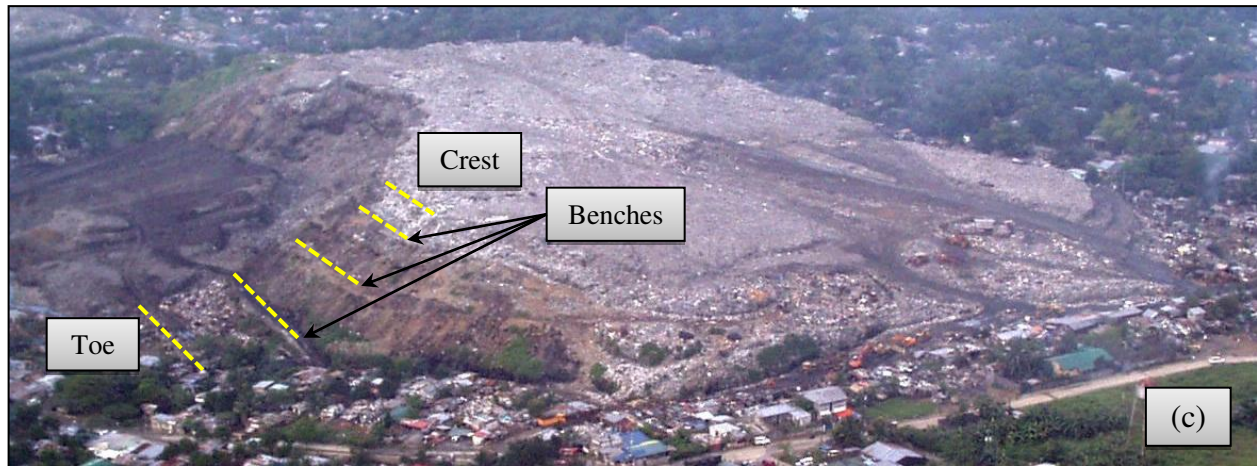
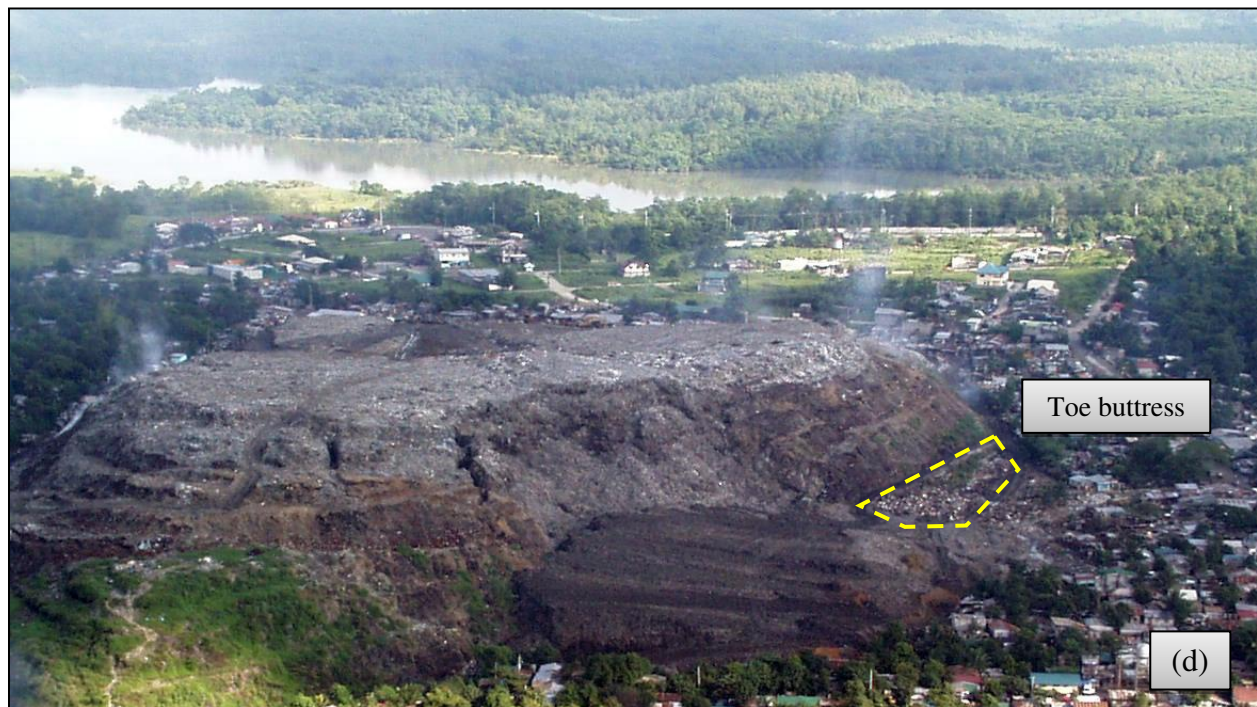
Figure 6 shows a series of aerial views of the waste slide area that were used to understand the failure surface for use in the stability analyses. Figures 6(a) and 6(b) provide side views from the southeast and northwest direction, respectively, of the waste slide. Figure 6(c) highlights benches in the landfill slope, and Figure 6(d) delineates a mildly sloped toe buttress. Digital measurements from these photographs were used to create the cross-section shown in Figure 7. These measurements indicate toe buttress slope angles in the slide area of 1.4H:1V ( $\sim 35^\circ$ ) to 0.84H:1V ( $\sim 50^\circ$ ) and steeper side slopes above the buttress that range from  $60^\circ$  to  $70^\circ$  (Bautista, 2007; UNFCCC, 2007). Additionally, site reconnaissance and pictures both indicate that leachate was seeping from this toe buttress.

Figure 6. Slope geometry and failure surface after failure (a) evidence of seeping leachate, (b) representative slope inclination, (c) location of slope benches, (d) toe buttress (photos by S.M. Merry).

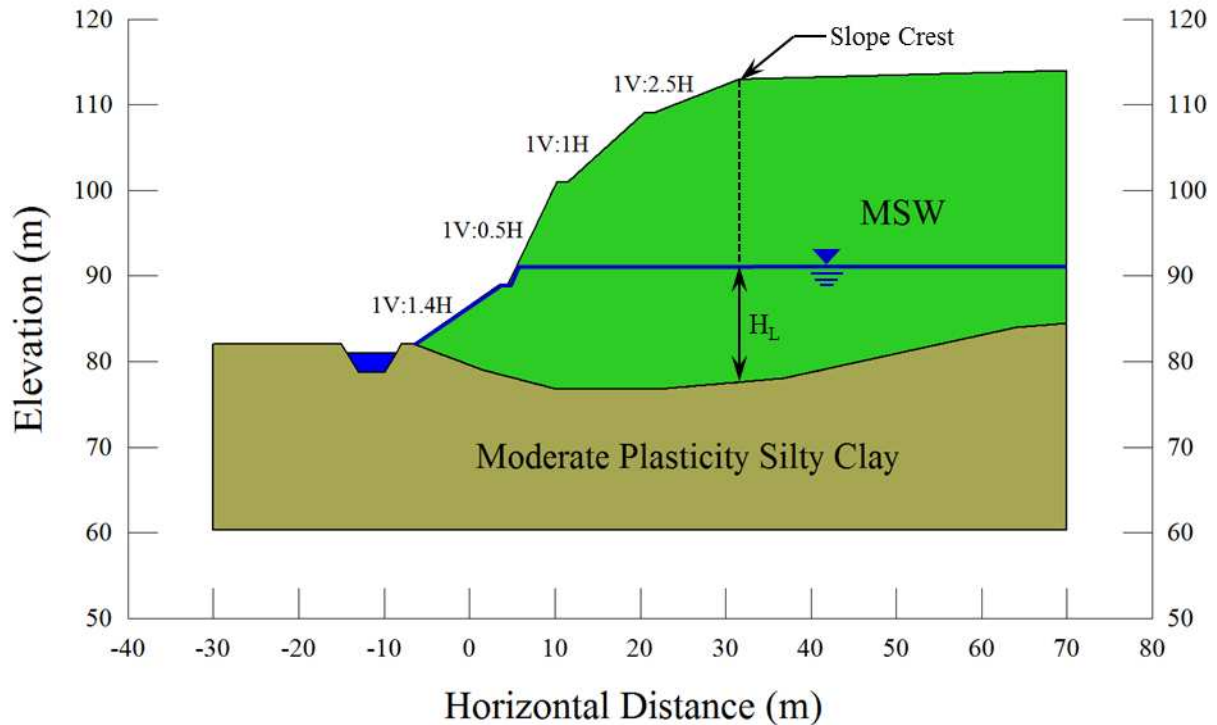
The waste is underlain by a native hard, brown fine-grained loam or adobe, which is a moderate plasticity silty clay (Seman and Rydergren, 1992). In this study, the failure surface was deemed not to have passed into the native brown silty clay because photographs in Figures 2, 5, and 6(c) indicate that the failure surface is relatively shallow and exits the slide mass near the toe of the MSW. This is indicative of a slab or sliver of MSW sliding off the surface of the landfill. In addition, the brown native silty clay is sloped upward (see Figure 7) near the slope toe because waste was initially placed in this depressed area.

Figure 7. Two dimensional cross-section of failed waste slope.

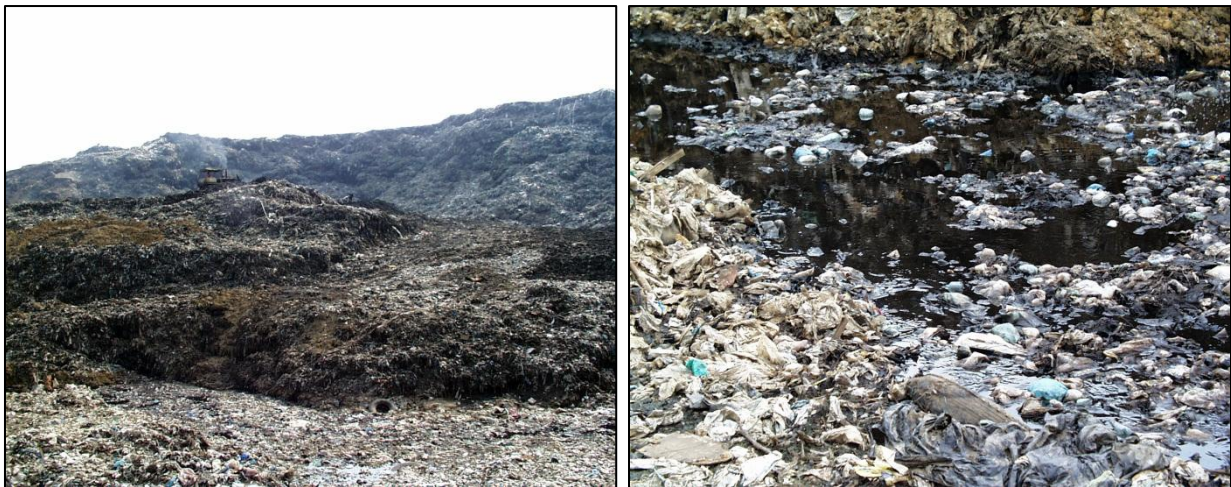
Koelsch (2005) visited the Payatas landfill four weeks after the waste slide and observed that the waste composition included a high concentration of plastics and organics and an absence of certain other materials (e.g., paper, glass, metals). The waste composition in Manila is typical for an urban area in a developing and emerging economy, which results from a large consumption of plastics as package material, a lack of recycling for organic waste, and an outstanding recycling rate for reusable materials, such as aluminum, glass, and paper. As a result, scavengers live nearby collecting cans, scrap metals, bottles, and newspapers for recycling. The waste composition of the slide mass (see Figure 8) consists of large shaped plastic particles intermixed with organic matter. Also, little or no soil cover is evident from Figure 8. Table 1 presents typical waste composition from a solid waste feasibility study for metropolitan Manila (Townsend and Associates, 1989). In this case, the water content, or mass ratio of water to dry waste, is about 82.5%.

Figure 8. Composition of waste mass in slide area with no soil cover (photos by S.M. Merry).

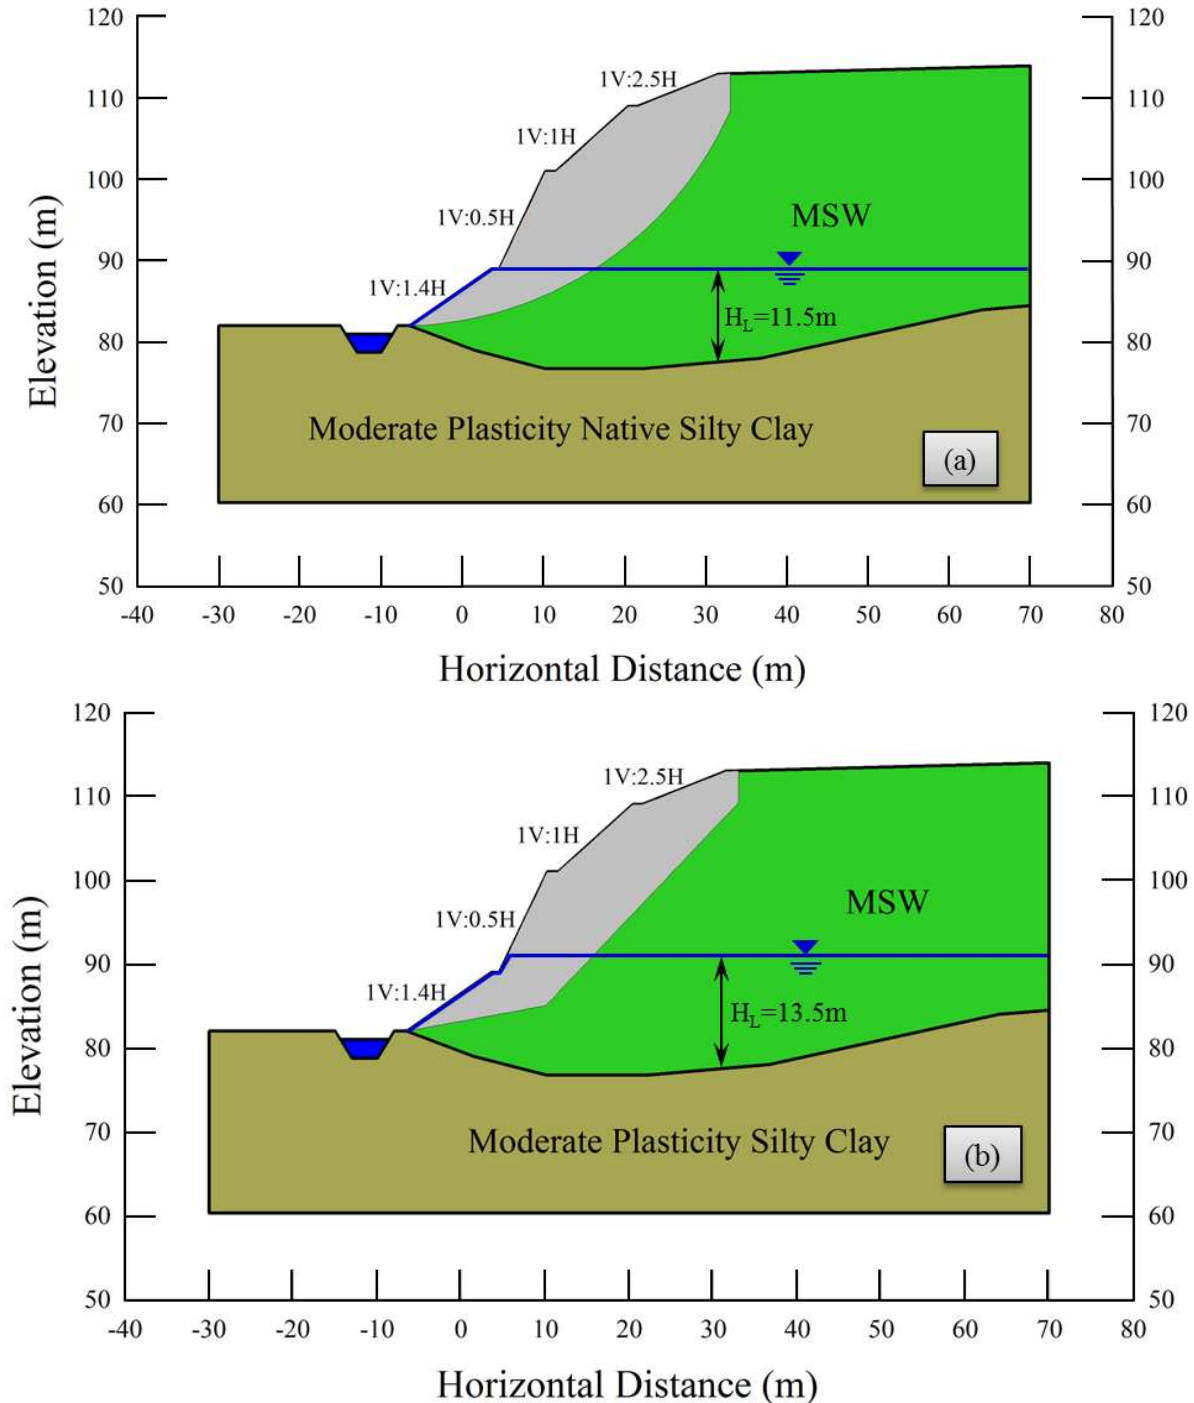
Figure 11. Cross- sections showing location of (a) circular and (b) planar failure surfaces.

The failure surfaces shown in Figure 11 were estimated from photographs in Figures 2, 3, 5, and 6 and consist of a shallow circular and shallow planar failure surface through only the MSW. From Figure 3, the authors surmise that the failure surface is shallow in nature, and the waste mass slid down the side slope as a mass, i.e., a slab or sliver slide. Subsequently, ledges developed along the main scarp formed from vertical blocks toppling over or sliding down (see Figure 3). Therefore, it was concluded that the failure surface passed from the crest of the slope through the MSW, and exited at the slope toe without entering the underlying brown native clayey silt.

Although a circular failure surface indicates a homogenous material, a planar failure surface starting at the toe and daylighting at the top of the landfill was also analyzed. Because the exact location of the failure surface at the crest is not known, the scarp of the waste slide was used to estimate the location of the failure surface at the top of slope that yielded the lowest factor of safety. Furthermore, after the waste slide, the waste was regraded (see Figures 2 and 5) such that the actual slide mass geometry does not represent the possible progression of failure. A helicopter video from a news report (<http://www.abs-cbnnews.com/video/nation/metro-manila/07/10/11/payatas-tragedy-commemorated>) shows an aerial view of the landfill prior to regrading, which was also helpful in estimating the location and geometry of the failure surface. From this video, the failure progresses from the main slide mass and regressing from the initial head scarp to a final scarp that is about 5 m behind the slope crest. Then, an ensuing block of waste toppled from the scarp creating the final geometry shown in Figure 2. Merry et al. (2005) report that a steep (vertical at the top) head scarp remained above the area where heavy machinery had reworked the waste mass.

In the inverse analysis described below, the piezometric surface required to reduce the FS to unity is about 11.5 m and 13.5 m for circular and planar failure surfaces, respectively, using the  $\Delta x=50$  mm MSW shear strength in Table 3. A leachate level ( $H_L$ ) of 11.5 m is greater than usually associated with engineered landfills but it is deemed plausible for the Payatas landfill because no soil cover was present, two recent typhoons impacted the site, limited waste compaction or grading occurred, a precipitation collection trench was excavated at the top of slope, no leachate collection system was installed, and the facility is located in a depressed area. In addition, ponded water/leachate was observed at the top of the landfill during the site reconnaissance which occurred several weeks after the failure (Merry et al., 2005). Finally, Figure 6(a) shows leachate present at the first bench of the landfill several weeks after the failure.
