The July 10 2000 Payatas Landfill Slope Failure

ABSTRACT: This paper presents an investigation of the slope failure in the Payatas landfill in Quezon City, Philippines. This failure, which killed at least 330 persons, occurred July 10th 2000 after two weeks of heavy rain from two typhoons. Slope stability analyses indicate that the raised leachate level, existence of landfill gas created by natural aerobic and anaerobic degradation, and a significantly over-steepened slope contributed to the slope failure. The Hydrologic Evaluation of Landfill Performance (HELP) model was used to predict the location of the leachate level in the waste at the time of the slope failure for analysis purposes. This paper presents a description of the geological and environmental conditions, identification of the critical failure surface, and slope stability analyses to better understand the failure and present recommendations for other landfills in tropical areas. In addition, this case history is used to evaluate uncertainty in parameters used in back-analysis of a landfill slope failure.

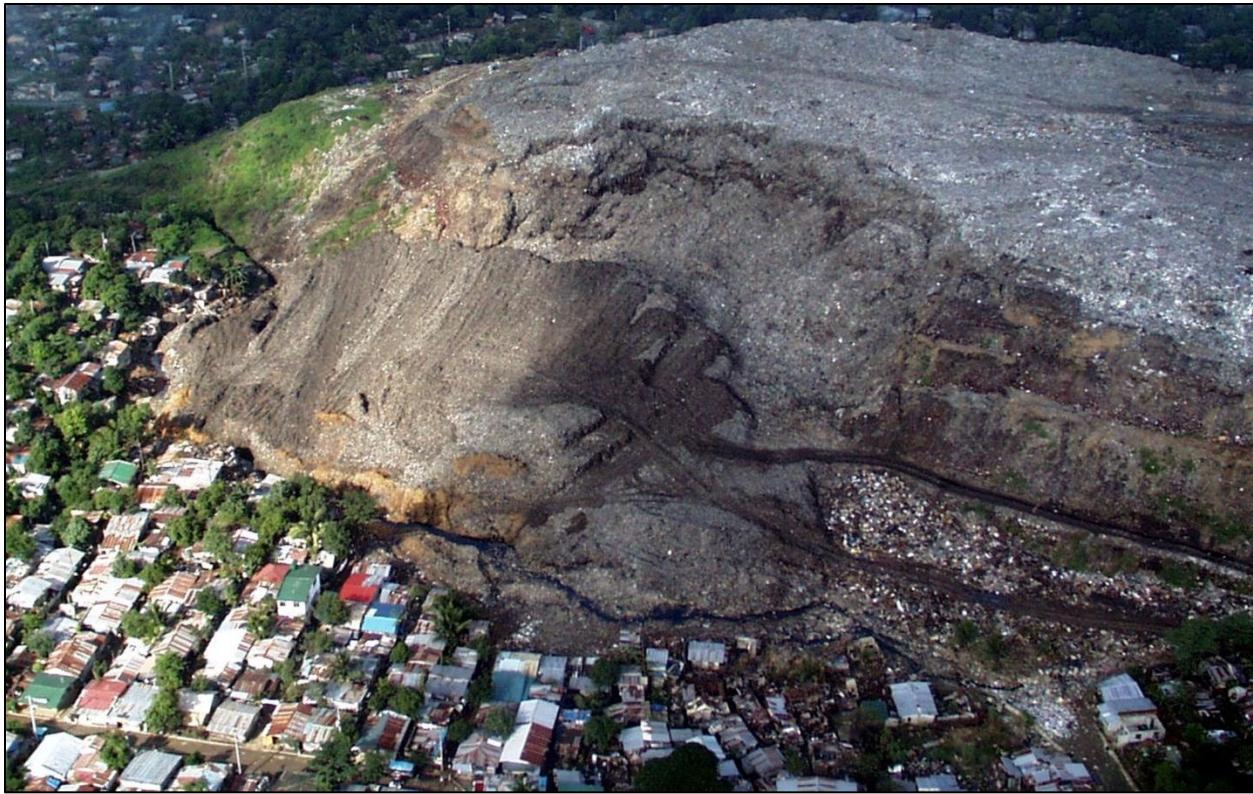
Figure 2. Aerial view of 12.7-hectare Payatas Landfill with slope failure and homes visible in foreground (photo by S.M. Merry).

Each of the above-referenced shear strength recommendations were developed for MSW below its field capacity. When fine-grained materials are intermixed with partially saturated MSW, negative pore pressures may exist in the partially saturated media. If the negative pore pressures are ignored, the total and effective stresses are equal and the shear strength envelopes may be directly compared. The MSW strength envelopes have generally resulted in progressively higher shear strengths, although recent work (e.g., Stark et al., 2009 and Bray et al., 2009) tends to reduce the shear strength at higher normal stresses due to the stress dependent nature of MSW. MSW strengths for effective normal stresses of 500 kPa or less are considered herein because of the shallow nature of the Payatas slope failure suggested by Figure 2.

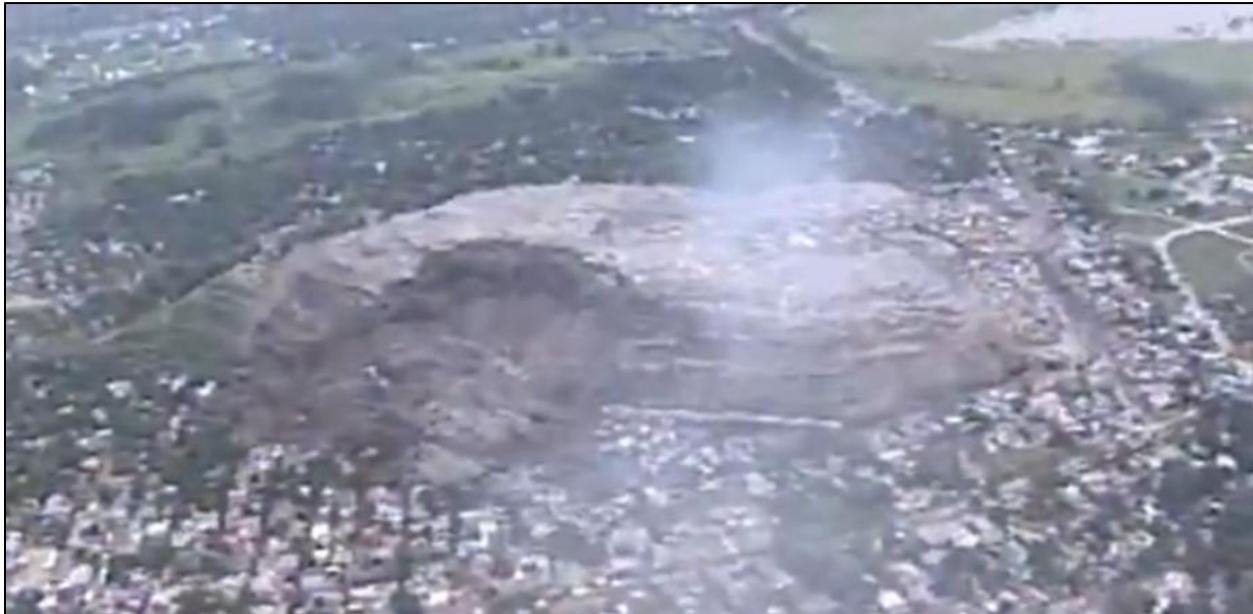
Figure. 3 Aerial view of waste slide from news video before regrading of slide mass (Baua, 2011).

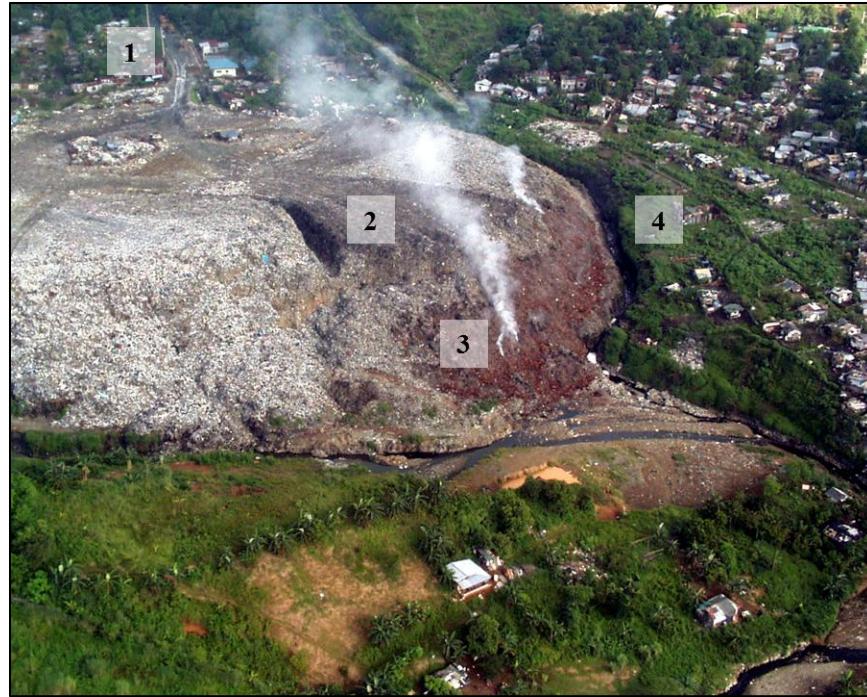
This section describes observations of a smaller landfill immediately southeast of the waste failure that helps interpret the waste slide. These observations are based on both site reconnaissance and photos. Figure 4 shows the slopes at this smaller landfill, which did not fail after both typhoon events although both facilities followed the same landfill operation procedures. The following bulleted sections discuss in numerical order the labels shown in Figure 4:

1. The access road to the landfill is a street through a residential neighborhood. Most likely, waste disposal consisted of dumping at the edge of the road and subsequent pushing down the slightly sloped terrain. The waste height eventually reached the same elevation as the surrounding residential area and waste trucks drove upslope the resulting waste slope for unloading;

2. A deep, man-made trench at the slope crest was excavated to collect and channel surface precipitation. Although this trench did not result in slope failure, a similar trench was observed near the failed waste mass. The trench is believed to have acted as a water-filled tension crack, where the failure plane intersects the bottom of the crack. The tension crack depth increased with frequency of precipitation and subsequent waste erosion. Also, the trench provides a direct conduit of water to lower depths of the landfill, thereby decreasing effective stress in the waste. This landfill, like the landfill with the slope failure, did not have a soil cover on the top of the facility, which allowed for faster infiltration of precipitation over a large area of the landfill;

3. A combination of steam and smoke is emanating from the slope in the foreground. It is common for steam or smoke to be present because of the large area of uncovered MSW that can result in spontaneous combustion. Residents living downslope of the failure heard a loud explosion before the waste failure (Merry et al., 2005). The explosion may have been facilitated by elevated gas pressures due to MSW degradation and steam or smoke due to spontaneous combustion of the exposed MSW;

4. A leachate collection trench surrounds the landfill periphery and is used to collect and remove leachate seeping from the waste pile.

Figure 4. Stable landfill south of Payatas Landfill with waste slide showing smoke plumes (photo by S.M. Merry).

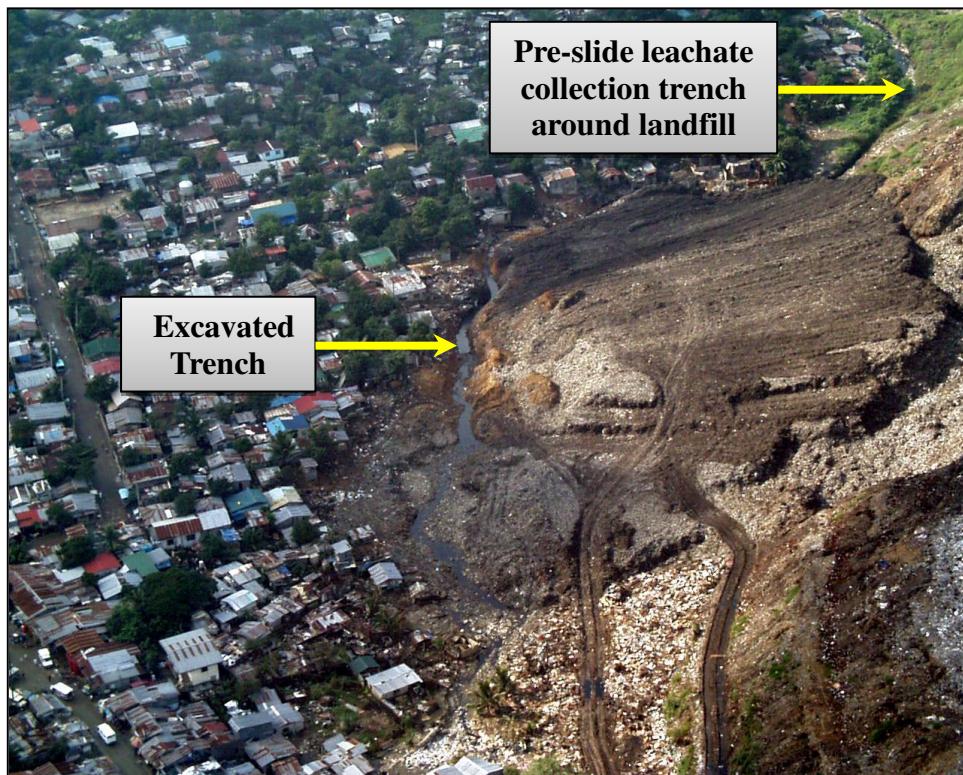
Figure 5 shows a close-up of the slope failure area and scarp in Payatas Landfill. Regrading of the slide mass had started shortly after the failure, which is shown in Figure 5. A leachate collection trench was excavated along the toe of the slide mass and is highlighted by the arrow and text box in Figure 5. The native brown soil underlying the waste and residential area is visible along the toe and sides of this excavated leachate collection trench. Leachate seepage existed prior to and shortly after the slope failure; however, the exact leachate level in the landfill just prior to failure is not known. A smaller landfill leachate collection trench was present along the slope toe prior to the slide and was similar to the trench shown in Figure 4. The leachate collection trench as it existed prior to the slide was covered by the slide mass and hence, is not visible (see the central portion of Figure 5). However, it was visible along the toe of the north-facing slope of the landfill east of the slide mass (see the top of Figure 5 where a small trench separates homes from the landfill toe and is highlighted by an arrow and text box). In summary, Figure 5 indicates that the leachate trench in front of the slide mass was constructed after the slide to collect leachate exiting the slide mass and a considerable volume of leachate existed in the landfill prior to failure but the exact leachate level at failure is not known.

Figure 5. Slope failure showing new and existing leachate trenches along slope toe (photo by S.M. Merry).

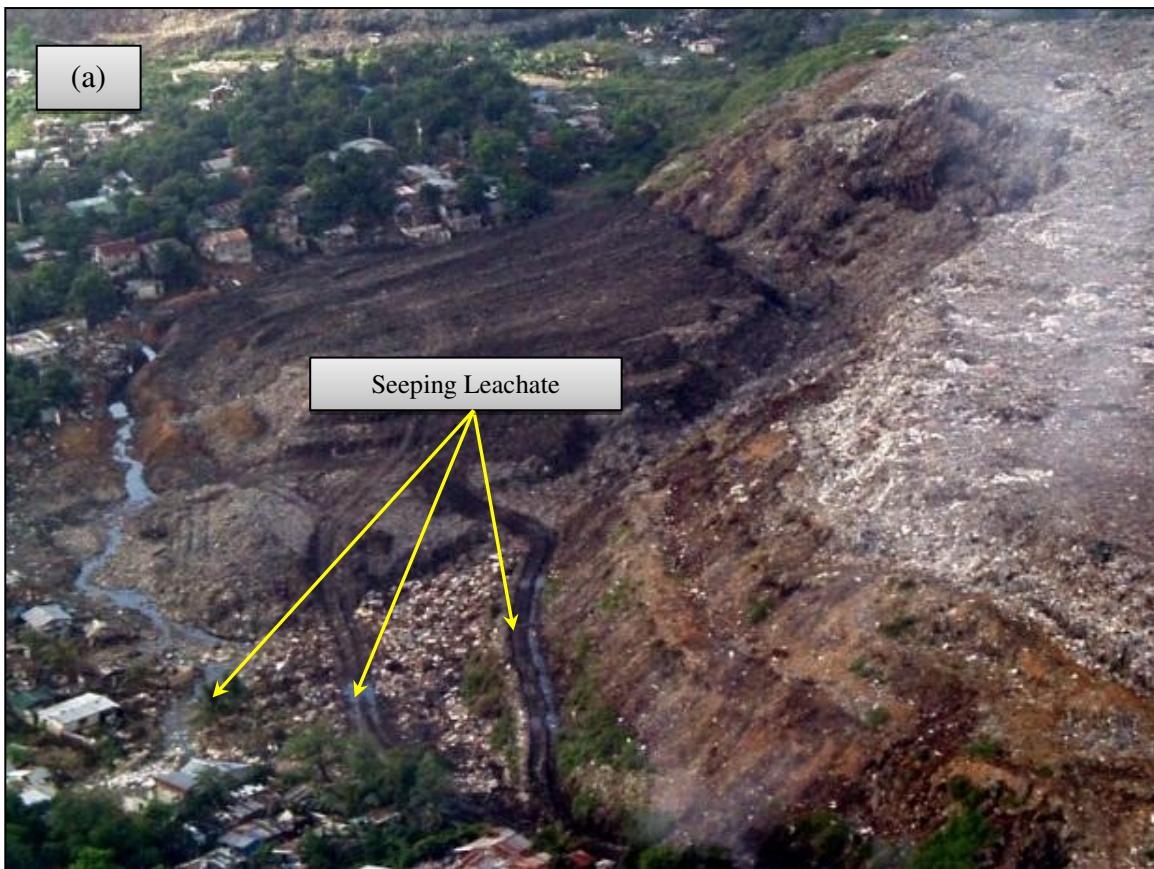
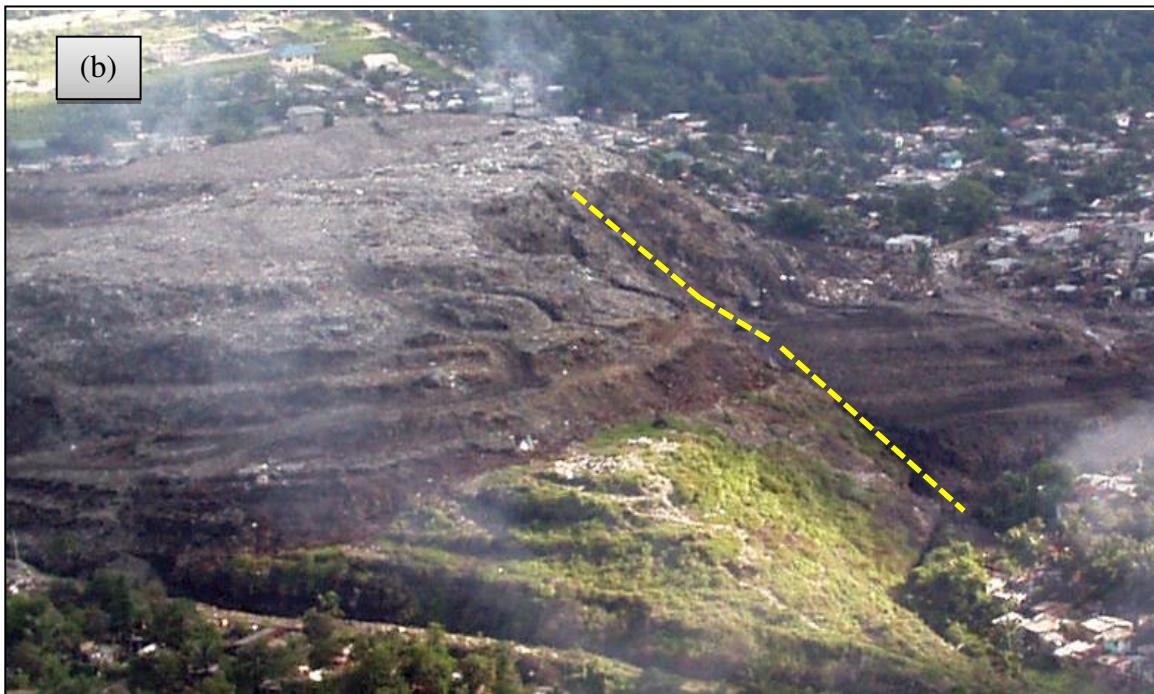
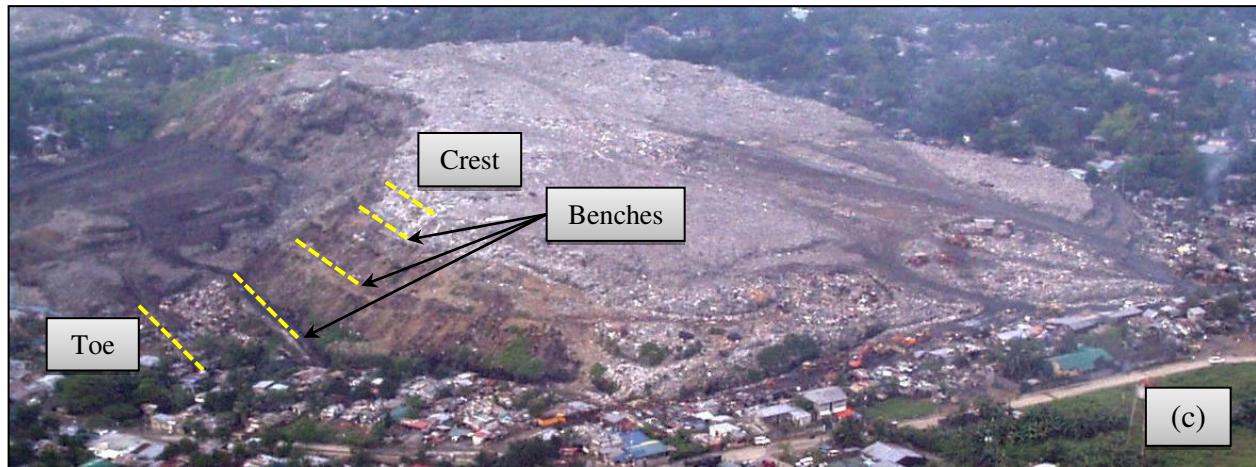
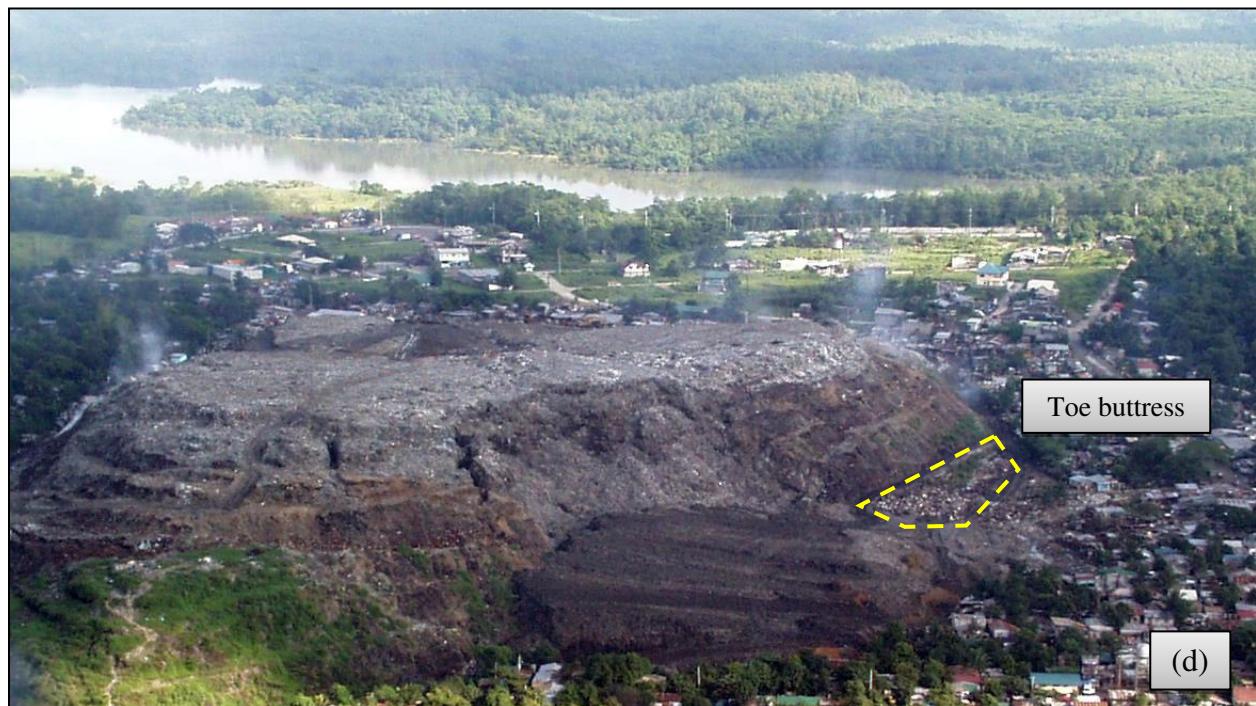
Figure 6 shows a series of aerial views of the waste slide area that were used to understand the failure surface for use in the stability analyses. Figures 6(a) and 6(b) provide side views from the southeast and northwest direction, respectively, of the waste slide. Figure 6(c) highlights benches in the landfill slope, and Figure 6(d) delineates a mildly sloped toe buttress. Digital measurements from these photographs were used to create the cross-section shown in Figure 7. These measurements indicate toe buttress slope angles in the slide area of 1.4H:1V (~35°) to 0.84H:1V (~50°) and steeper side slopes above the buttress that range from 60° to 70° (Bautista, 2007; UNFCCC, 2007). Additionally, site reconnaissance and pictures both indicate that leachate was seeping from this toe buttress.

Figure 6. Slope geometry and failure surface after failure (a) evidence of seeping leachate, (b) representative slope inclination, (c) location of slope benches, (d) toe buttress (photos by S.M. Merry).

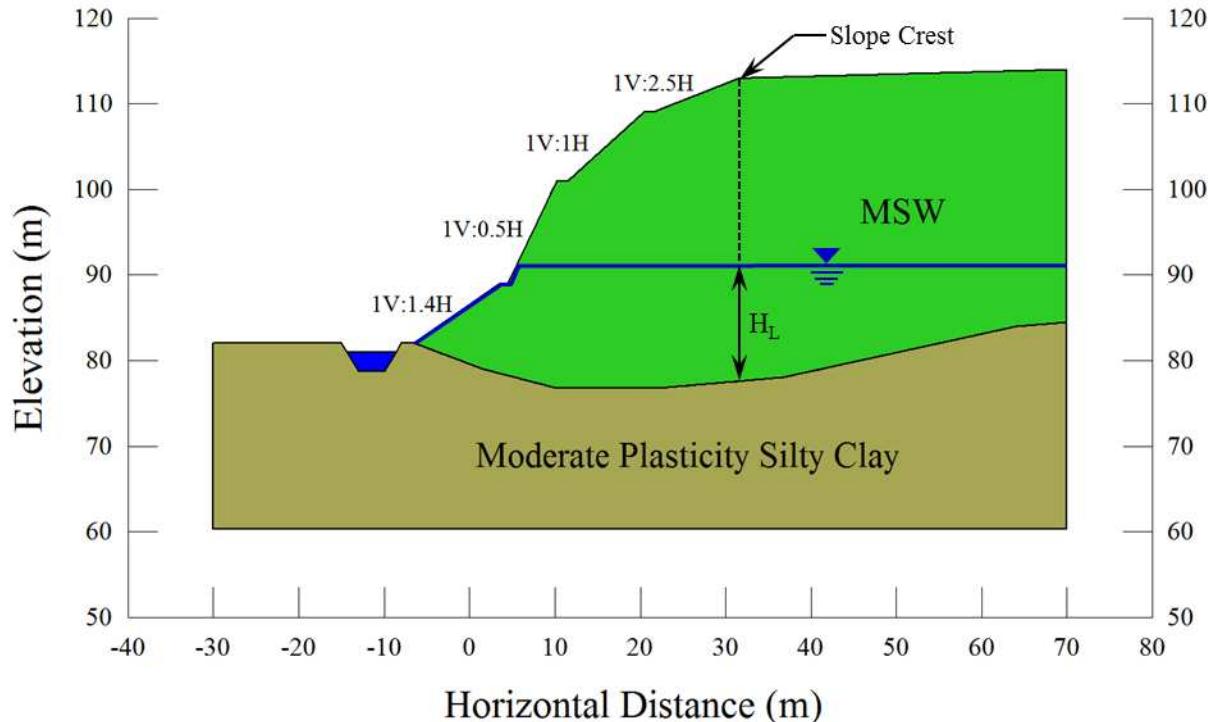
Figure 7. Two dimensional cross-section of failed waste slope.

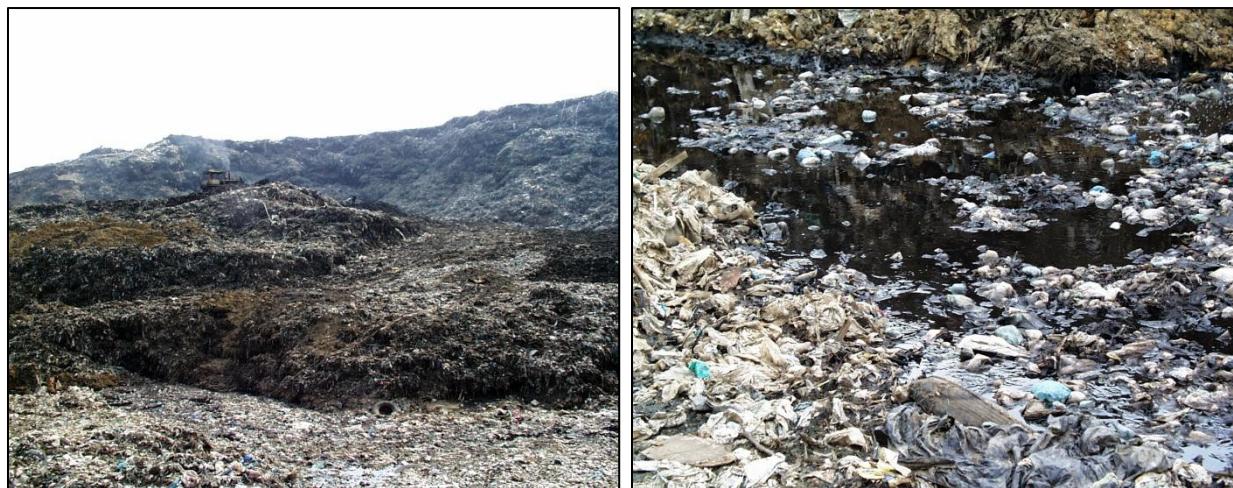
Figure 8. Composition of waste mass in slide area with no soil cover (photos by S.M. Merry).

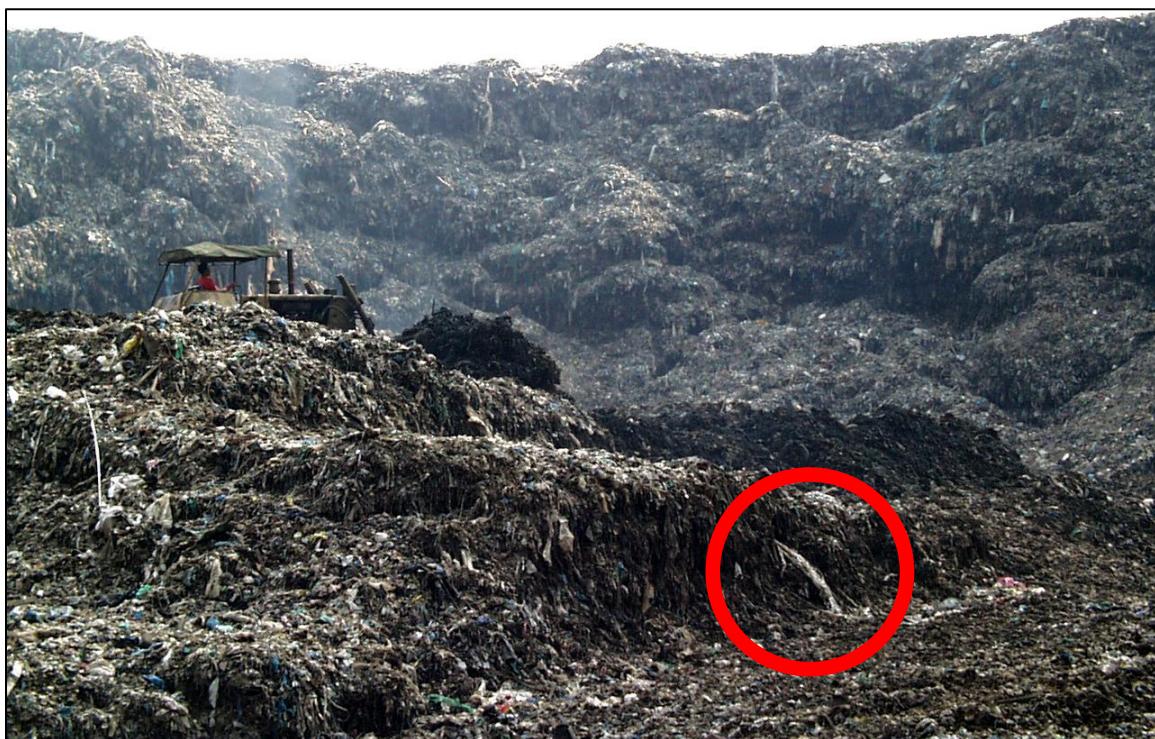
Figure 9. View of the back-scarp of waste slide and leachate flowing from the exposed MSW (photo by S.M. Merry).

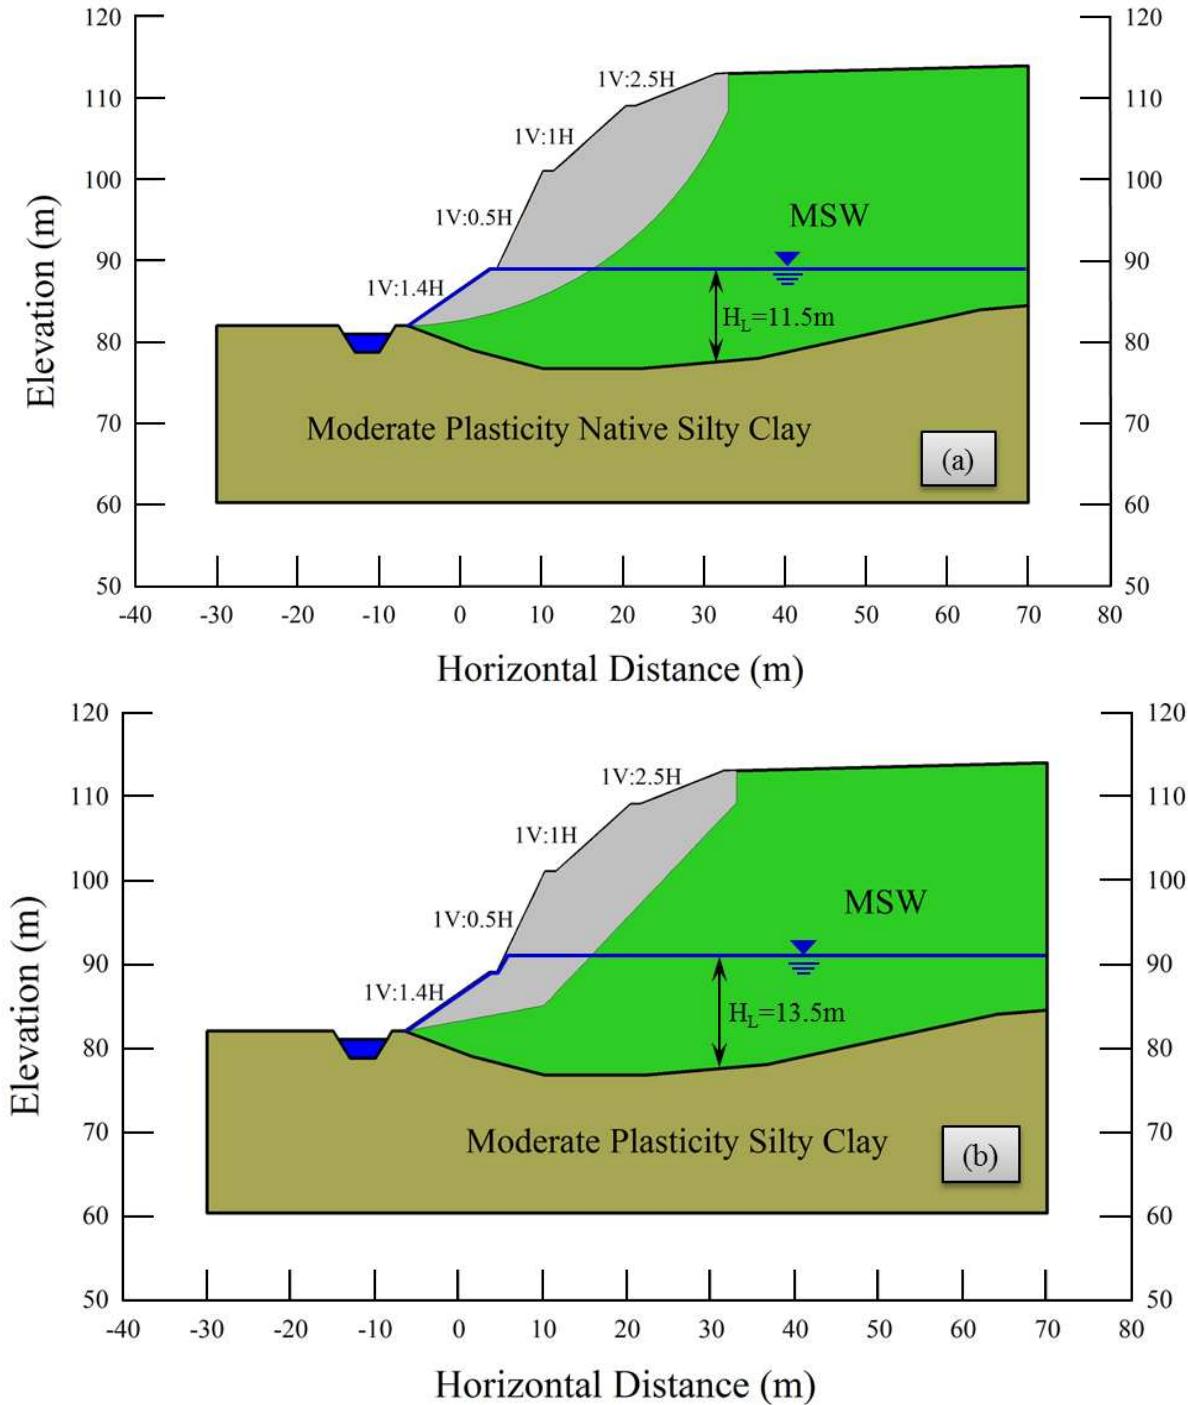
The cross section in Figures 11(a) and 11(b) show the estimated circular and planar failure surface, respectively, based on available photographs (see Figures 2, 3, 5, and 6) and site reconnaissance. The cross sections show the MSW is approximately 31 m thick and is underlain by the brown native clayey silt that slope downward towards the center of the landfill. A leachate trench is shown at the toe of the slope to model the pre-failure slope condition. These cross-sections were used in the inverse analysis described below.

Figure 11. Cross- sections showing location of (a) circular and (b) planar failure surfaces.

The failure surfaces shown in Figure 11 were estimated from photographs in Figures 2, 3, 5, and 6 and consist of a shallow circular and shallow planar failure surface through only the MSW. From Figure 3, the authors surmise that the failure surface is shallow in nature, and the waste mass slid down the side slope as a mass, i.e., a slab or sliver slide. Subsequently, ledges developed along the main scarp formed from vertical blocks toppling over or sliding down (see Figure 3). Therefore, it was concluded that the failure surface passed from the crest of the slope through the MSW, and exited at the slope toe without entering the underlying brown native clayey silt.

Although a circular failure surface indicates a homogenous material, a planar failure surface starting at the toe and daylighting at the top of the landfill was also analyzed. Because the exact location of the failure surface at the crest is not known, the scarp of the waste slide was used to estimate the location of the failure surface at the top of slope that yielded the lowest factor of safety. Furthermore, after the waste slide, the waste was regraded (see Figures 2 and 5) such that the actual slide mass geometry does not represent the possible progression of failure. A helicopter video from a news report (<http://www.abs-cbnnews.com/video/nation/metro-manila/07/10/11/payatas-tragedy-commemorated>) shows an aerial view of the landfill prior to regrading, which was also helpful in estimating the location and geometry of the failure surface. From this video, the failure progresses from the main slide mass and regressing from the initial head scarp to a final scarp that is about 5 m behind the slope crest. Then, an ensuing block of waste toppled from the scarp creating the final geometry shown in Figure 2. Merry et al. (2005) report that a steep (vertical at the top) head scarp remained above the area where heavy machinery had reworked the waste mass.
