Preliminary Field Assessment of Sinkhole Damage in Pokhara, Nepal

ABSTRACT: Since November 2013, numerous sinkholes have been forming in the Armala area of Pokhara Valley, Central Nepal, posing serious threat to local residents. In order to provide measures aimed at reducing sinkhole risk, investigations into the cause and features of the sinkholes are crucial. This paper presents early research results based on two damage surveys conducted in June 2014 and November 2014 in the Armala area. Comparison of photos, taken in the two surveys, clearly indicates not only the formation of new sinkholes, but also the re-activation of filled sinkholes. By means of dynamic cone penetration tests and surface wave method investigations, qualitative characterization of the soil profile was attained, and shallow weak soil layers which are believed to be the location for future sinkholes could be identified. On the basis of the field investigation results, possible sinkhole formation mechanisms are identified for the Armala area. Furthermore, results of a reconnaissance survey conducted in the Armala area in early May 2015 (following the 2015 Gorkha Nepal Earthquake, which occurred on April 25th)

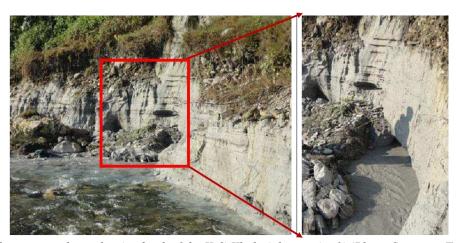
According to local residents, a muddy silty water outlet (shown in Figure 4 corresponding to photo point 1) was observed at the Kali Khola (Small River) riverbank about a week before the first sinkhole appeared in November 2013 (Figure 2). Since then, more than 150 sinkholes developed in this area until June 2014 and more than 200 sinkholes were reported up to November 2014.

Figure 4. Muddy silty water outlet at the riverbank of the Kali Khola (photo point 1) (Photo Courtesy: Technical Research Team, 2014).

Nevertheless, in November 2013, suddenly, a water spring was observed for the first time by local residents (Figure 4). It was rapidly followed by the formation of a number of sinkholes, as already described previously. The authors believe that the formation of the water spring induced a change in the groundwater level i.e. water table decline (Figure 16(b)). The drastic fall in groundwater level and its fluctuation during rainy season, accelerated the erosion process (as evidenced by muddy water observed at the water spring outlet) and cavity enlargement (Figure 16 (c)). The evidence of the erosion process in the ground is shown in Figure 17. The water sample collected from different points in the study area in June 2014 has different turbidity. The water sample collected at the stream or seepage location (water sample (WS) point 3 in

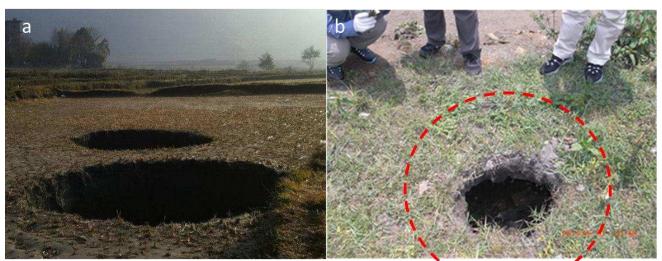
Typical circular-shaped sinkholes that appeared in November 2013 are shown in Figure 5(a). Although the first sinkhole appeared in the northern part of the investigation site, the majority of the sinkholes actually were formed along the Duhuni Khola nearby the main road (as shown by the green dots in Figure 2) between November 25th and December 5th 2013. Later on, the formation of sinkhole extended towards the western side. The depth and size of the sinkholes on level ground along Duhuni Khola were bigger than those developed on sloped ground and increased with time. Eventually, large-size sinkholes ended to connect each other along the Duhuni Khola.

Figure 5. (a) Typical sinkholes formed in November 2013 (Photo Curtesy: Keshab Sharma); and (b) a sinkhole formed in June 2014 (photo point 2).

Figure 5(b) shows a small sinkhole that appeared, at photo point 2, just one day before the survey team visited the damaged area in June 2014. Note that although the sinkhole in Figure 5(b) has a small diameter at the surface, its diameter is in reality much larger in the subsurface (as indicated by the red dashed line). Such spherical shape is due to the fact that the soil in the upper part of the sinkhole was retained by the grass root system supporting the surface soil.

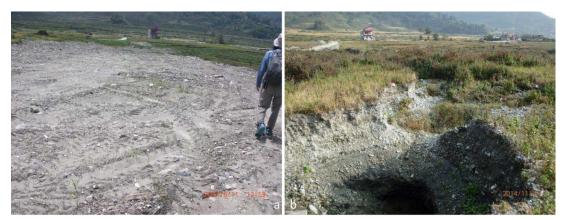
Immediately after the occurrence of the sinkholes, a wide area affected by the cave-in was backfilled by using gravelly soil retrieved from nearby quarries, which is identified by a yellow color filled area in Figure 2. Though, at the time of the first damage survey in June 2014, most of the sinkholes had been fully backfilled (Figure 7a corresponding to photo point 5), the photos taken in November 2014 at the same location clearly show that the backfilling was not an adequate solution as most of the former sinkholes were re-activated (Figure 7b) likely in August 2014 during the peak rainy season in Pokhara Valley.

Figure 7. (a) Sinkholes backfilled area (photo point 5) as seen in June 2014; and (b) Re-activated sinkholes as observed in November 2014.

As mentioned earlier, as an immediate mitigation work, all the old sinkholes were filled by the local government. This practice could disrupt the underground water flow so that ultimately the caving process caused the re-activation of sinkholes. Note that due to loose conditions of backfilled material, it is expected that the development of a re-activated sinkhole is much quicker than that of the original sinkhole where natural compacted soils was gradually eroded by water.

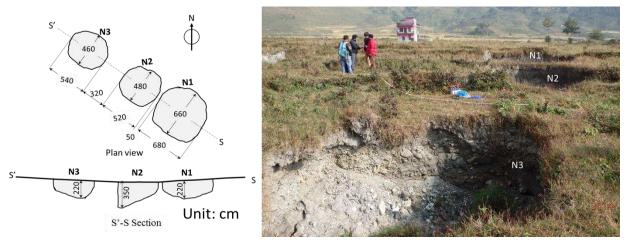
Among many, sinkholes N1, N2 and N3 in the area X shown in Figure 2 were found to be of particular interest. They were developed in a delimited area of approximately 10 m × 20 m, as shown in the schematic map shown in Figure 8. They have a circular pattern and diameters ranging from 4.6 m (N3) to 6.8 m (N1). Their depth measured at the top of the collapsed soil varied from 2.2 m (N1, N3) to a maximum of 3.5 m (N2). According to witnesses, N1 was the first sinkhole to be formed. A few days later, N2 caved-in and finally N3 developed. This progressive formation of several sinkholes along a straight line (moving along the uphill direction from N1 to N3) may suggest that the collapse of N1 caused the complete disruption of underground water flow. Consequently, water started to erode the soil just adjacent to N1 until a new cave-in (N2) was formed. In a similar way, N3 was later developed. The same pattern of sinkhole formation occurred often since November 2013. Most of the newly developed sinkholes are located on the upstream side of the underground water flow.

Figure 8. Series of sinkholes appeared in the area X in Figure 2 (photo point 6).

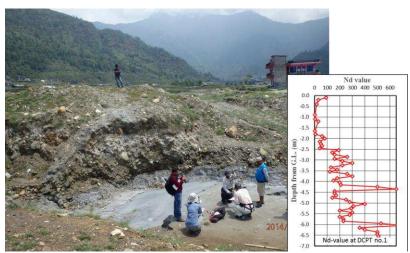
DCPT-1 was carried out at the bottom of a non-filled sinkhole as shown in Figure 10 (corresponding to photo point 7 in Figure 2). As already mentioned, this area is composed of recent flood plain deposits, including a thick gravel layer at shallow depth. Thus, DCPTs could not penetrate more than 6.55m. However, the test results would suggest that the probable depth of the sinkholes should be approximately 4.5-5m, or more precisely 6.5-7 m below the ground level considering that the actual ground level was approximately 2m above the sinkhole bottom.

Figure 10. Result of the Dynamic Cone Penetration Test at DCPT no. 1 at the bottom of a sinkhole.

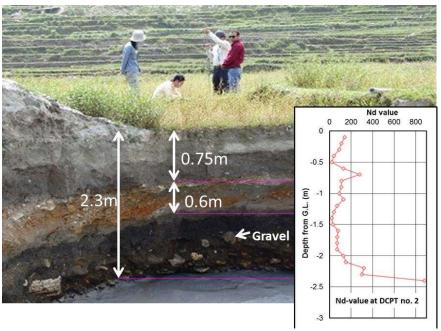
On the other hand, DCPT-2 (Figure 11) was carried out just adjacent to the sinkhole at photo point 8 in Figure 2. The test results were correlated with stratigraphy and structure of the deposits (Figure 11). The converted DCPT N_d -values are plotted in Figure 11. The upper layers of the surface soil could be penetrated until reaching a layer of gravel at a depth of 2.4 m, where even by hitting more than 150 times the penetration process stopped.

Figure 11. Soil profile and DCPT result at DCPT-2 obtained for the sinkhole in photo point 8 (Photo in June 2014).

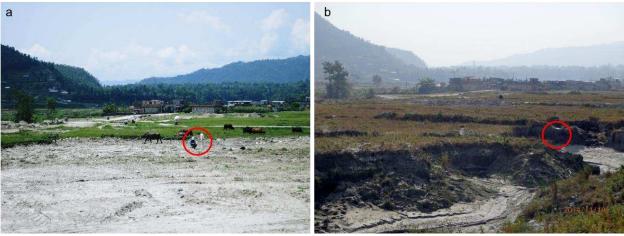
DCPT-3 was carried out at the top of the filled material at photo point 9. As shown in Fig. 12a and 12b, the testing location disappeared due to the collapse of filled material during the rainy season between June and November 2014. From the test results shown in Fig. 13, it is concluded that the used filling materials are sand and gravelly soils. However, the compaction at the surface is not good enough because the $N_{\rm d}$ -value measurement is low. The DCPT results suggest that the cavity bearing formation is below the gravel layer, and then progressively the cavity size increased and finally the loose upper layer collapsed.

Figure 12. a) Dynamic Cone Penetration Test at DCPT no. 3 (photo point 10) on the filled material (photo taken in June 2014) and b) re-activated sinkhole at the same location (photo taken in November 2014).

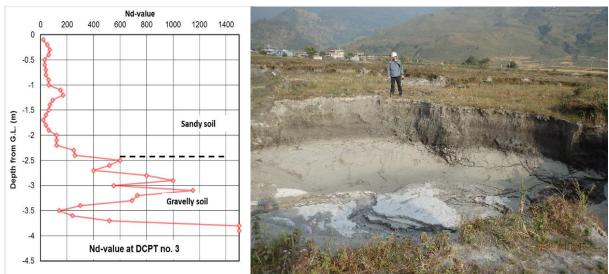
By comparing the $N_{\rm d}$ -values obtained from DCPT-2 and DCPT-3, it is noted that the filled materials are looser than the natural soil. Therefore, the filled material can be easily caved-in and induce the re-activation of filled sinkholes during the rainy season.

Figure 13 (a) Result of DCPT 3 conducted in June 2014 and (b) its location collapsed after the test.

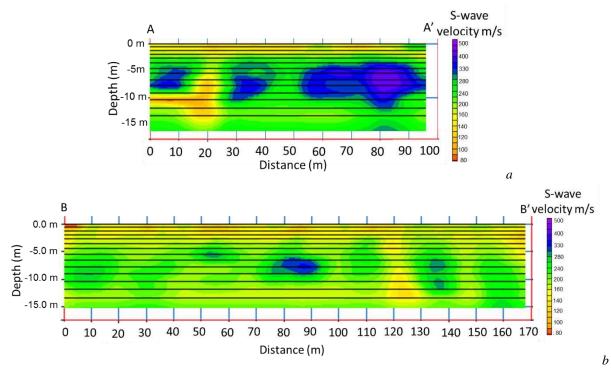
The results of SWM test along sections A-A' and B-B' are shown in Figure 15. It can be seen that the shear wave velocity for the surface layer is in the range of 100-160 m/s, confirming the presence of a loose sand layer of 1.5-m thickness. The underlying gravel has a higher velocity than the surface layer with a shear wave velocity of about 240 m/s. Moreover, the stiff soil below 4 m depth has a shear wave velocity greater than 300 m/s. The velocity of the layer around 10 m depth denotes water flowing path and loose material. A low velocity section observed 20 m far from the starting point in profile A-A' indicates possible cavities in the ground. Similarly, in profile B-B' the loose material at a depth of about 12 m indicates a possible water flowing layer and the weak strata between 120 m to 130 m is a possible future sinkhole.

Figure 15. Profiles of surface wave method: (a) section A-A'; and (b) section B-B'.

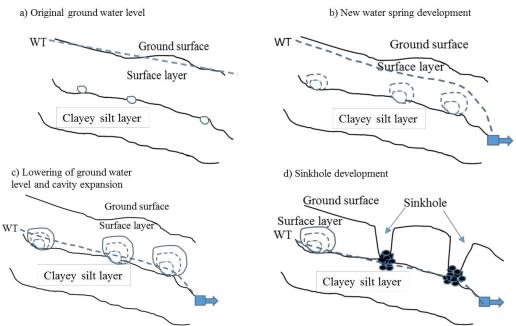
The groundwater flow is the triggering factor involved in the generation of sinkholes observed in this study. In fact, it is assumed that in the Armala area, there has been an active erosion process (probably lasting hundreds of years), where water gradually dissolved soluble soil, creating cavities beneath the ground surface (Figure 16a). However, such cavities were stable and likely small in size. In fact, despite the high sinkhole risk, the formation of sinkholes was rarely observed in past decades in the Armala area.

Figure 2) is clear and has no sediments. On the other hand, water samples collected at WS point 1 and 2 shows high turbidity (Figure 17). This indicates that underground water continues to dissolve the silt and there was a continuous caving process till June 2014. As the process continued, the loose, unconsolidated soil and sand above was gradually washed into the cracks and voids. Depending on how thick and strong the top layer was and how close to the surface the void beneath was, the ground was not able to sustain its own weight. Thus, cavities that before were stable, suddenly became unstable and collapsed (Figure 16(d)).

Figure 16. Probable mechanisms of sinkhole observed in the Armala area.

- prevent irrigation;
- using an effective drainage system and diverting surface runoff;
- remediating existing sinkholes and clogging shallow holes;
- identifying cavities in the soil and filling them by grouting;
- improving the ground by compaction or ground injection to increase the strength and bearing capacity of the soils.
