# Preliminary Field Assessment of Sinkhole Damage in Pokhara, Nepal

**ABSTRACT:** Since November 2013, numerous sinkholes have been forming in the Armala area of Pokhara Valley, Central Nepal, posing serious threat to local residents. In order to provide measures aimed at reducing sinkhole risk, investigations into the cause and features of the sinkholes are crucial. This paper presents early research results based on two damage surveys conducted in June 2014 and November 2014 in the Armala area. Comparison of photos, taken in the two surveys, clearly indicates not only the formation of new sinkholes, but also the re-activation of filled sinkholes. By means of dynamic cone penetration tests and surface wave method investigations, qualitative characterization of the soil profile was attained, and shallow weak soil layers which are believed to be the location for future sinkholes could be identified. On the basis of the field investigation results, possible sinkhole formation mechanisms are identified for the Armala area. Furthermore, results of a reconnaissance survey conducted in the Armala area in early May 2015 (following the 2015 Gorkha Nepal Earthquake, which occurred on April

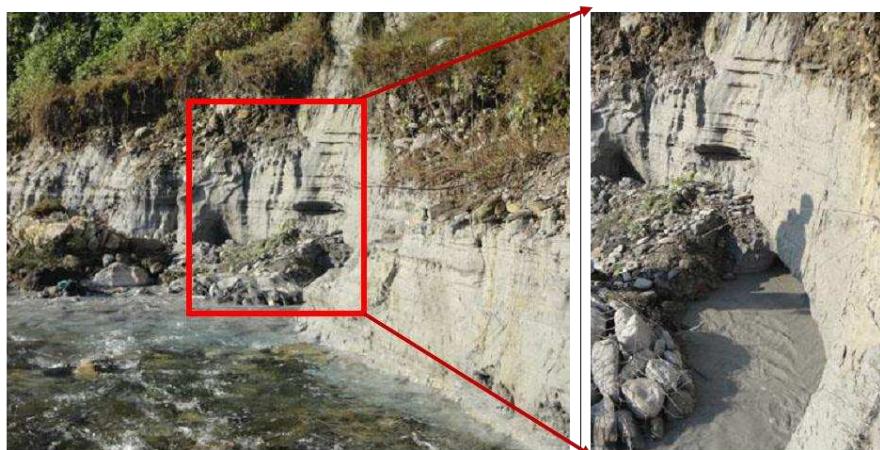
According to local residents, a muddy silty water outlet (shown in Figure 4 corresponding to photo point 1) was observed at the Kali Khola (Small River) riverbank about a week before the first sinkhole appeared in November 2013 (Figure 2). Since then, more than 150 sinkholes developed in this area until June 2014 and more than 200 sinkholes were reported up to November 2014.

Figure 4. Muddy silty water outlet at the riverbank of the Kali Khola (photo point 1) (Photo Courtesy: Technical Research Team, 2014).

Nevertheless, in November 2013, suddenly, a water spring was observed for the first time by local residents (Figure 4). It was rapidly followed by the formation of a number of sinkholes, as already described previously. The authors believe that the formation of the water spring induced a change in the groundwater level i.e. water table decline (Figure 16(b)). The drastic fall in groundwater level and its fluctuation during rainy season, accelerated the erosion process (as evidenced by muddy water observed at the water spring outlet) and cavity enlargement (Figure 16 (c)). The evidence of the erosion process in the ground is shown in Figure 17. The water sample collected from different points in the study area in June 2014 has different turbidity. The water sample collected at the stream or seepage location (water sample (WS) point 3 in

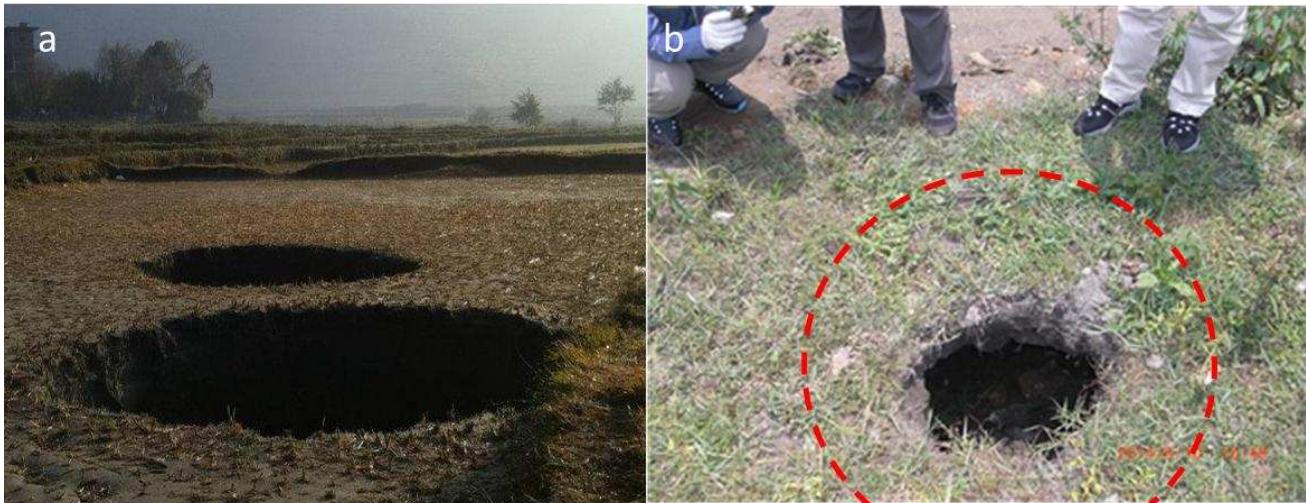
Typical circular-shaped sinkholes that appeared in November 2013 are shown in Figure 5(a). Although the first sinkhole appeared in the northern part of the investigation site, the majority of the sinkholes actually were formed along the Duhuni Khola nearby the main road (as shown by the green dots in Figure 2) between November 25<sup>th</sup> and December 5<sup>th</sup> 2013. Later on, the formation of sinkhole extended towards the western side. The depth and size of the sinkholes on level ground along Duhuni Khola were bigger than those developed on sloped ground and increased with time. Eventually, large-size sinkholes ended to connect each other along the Duhuni Khola.

Figure 5. (a) Typical sinkholes formed in November 2013 (Photo Curtesy: Keshab Sharma); and (b) a sinkhole formed in June 2014 (photo point 2).

Figure 5(b) shows a small sinkhole that appeared, at photo point 2, just one day before the survey team visited the damaged area in June 2014. Note that although the sinkhole in Figure 5(b) has a small diameter at the surface, its diameter is in reality much larger in the subsurface (as indicated by the red dashed line). Such spherical shape is due to the fact that the soil in the upper part of the sinkhole was retained by the grass root system supporting the surface soil.

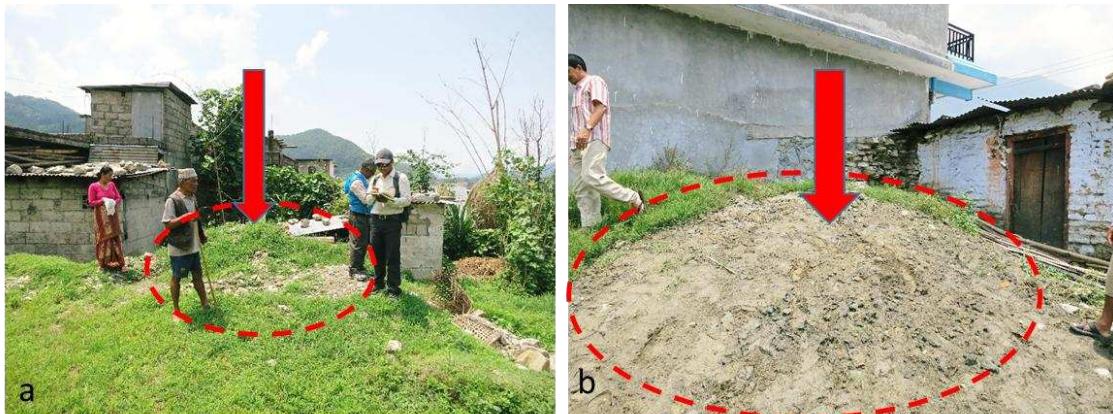
The sinkholes affected not only agricultural farmland. They also caused the collapse of manmade structures like the cowshed shown in Figure 6(a) (corresponding to photo point 3), and the masonry kitchen shown in Figure 6(b) (corresponding to photo point 4). The homeowner reported that about 60 m<sup>3</sup> of filling material were used to fill the sinkhole shown in Figure 6(a).

Figure 6. Typical effects of sinkhole formation on residential properties observed on June 2014 included the collapsed of (a) a cowshed and (b) a masonry kitchen.

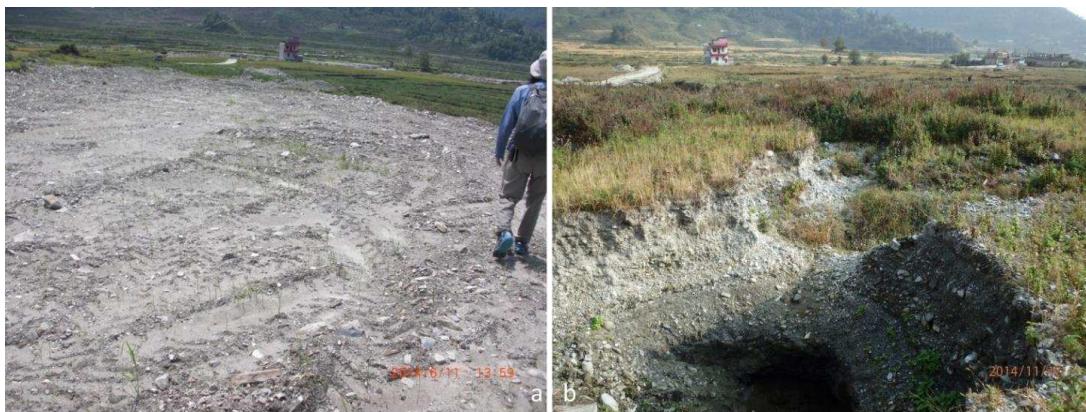
Immediately after the occurrence of the sinkholes, a wide area affected by the cave-in was backfilled by using gravelly soil retrieved from nearby quarries, which is identified by a yellow color filled area in Figure 2. Though, at the time of the first damage survey in June 2014, most of the sinkholes had been fully backfilled (Figure 7a corresponding to photo point 5), the photos taken in November 2014 at the same location clearly show that the backfilling was not an adequate solution as most of the former sinkholes were re-activated (Figure 7b) likely in August 2014 during the peak rainy season in Pokhara Valley.

Figure 7. (a) Sinkholes backfilled area (photo point 5) as seen in June 2014; and (b) Re-activated sinkholes as observed in November 2014.

As mentioned earlier, as an immediate mitigation work, all the old sinkholes were filled by the local government. This practice could disrupt the underground water flow so that ultimately the caving process caused the re-activation of sinkholes. Note that due to loose conditions of backfilled material, it is expected that the development of a re-activated sinkhole is much quicker than that of the original sinkhole where natural compacted soils was gradually eroded by water.

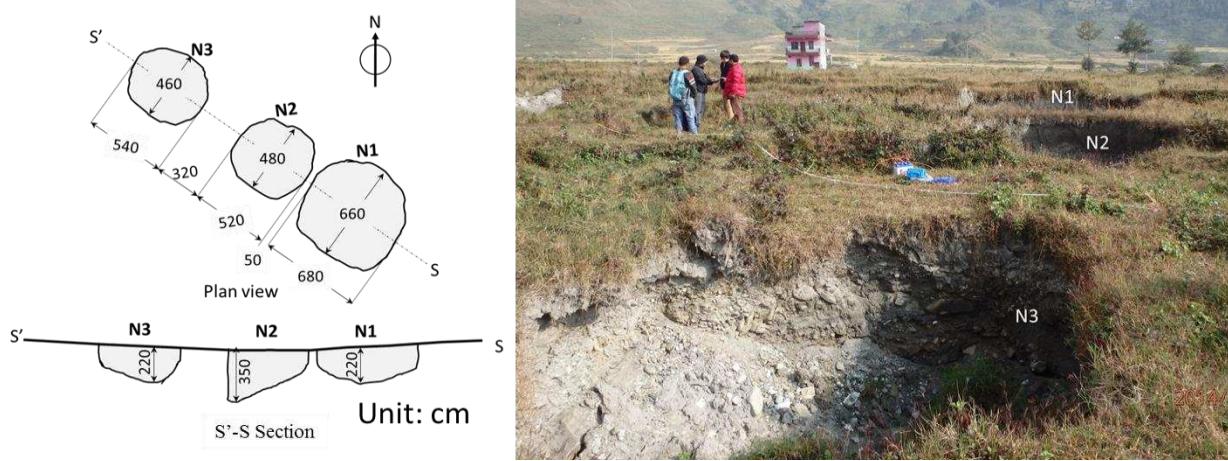
Among many, sinkholes N1, N2 and N3 in the area X shown in Figure 2 were found to be of particular interest. They were developed in a delimited area of approximately  $10\text{ m} \times 20\text{ m}$ , as shown in the schematic map shown in Figure 8. They have a circular pattern and diameters ranging from 4.6 m (N3) to 6.8 m (N1). Their depth measured at the top of the collapsed soil varied from 2.2 m (N1, N3) to a maximum of 3.5 m (N2). According to witnesses, N1 was the first sinkhole to be formed. A few days later, N2 caved-in and finally N3 developed. This progressive formation of several sinkholes along a straight line (moving along the uphill direction from N1 to N3) may suggest that the collapse of N1 caused the complete disruption of underground water flow. Consequently, water started to erode the soil just adjacent to N1 until a new cave-in (N2) was formed. In a similar way, N3 was later developed. The same pattern of sinkhole formation occurred often since November 2013. Most of the newly developed sinkholes are located on the upstream side of the underground water flow.

Figure 8. Series of sinkholes appeared in the area X in Figure 2 (photo point 6).

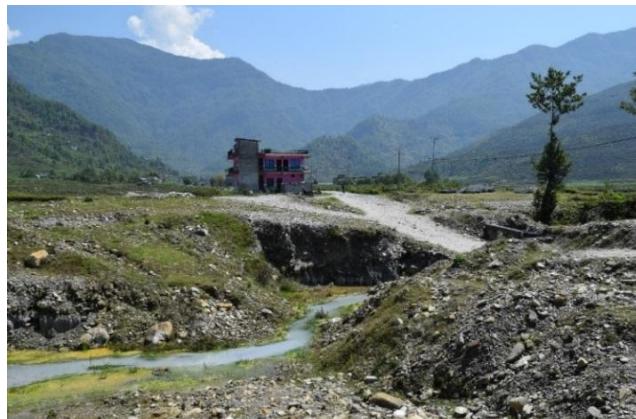
Figure 9. Muddy silty water observed in the sinkhole damaged area (photo point 7) following the 2015 Gorkha Nepal Earthquake.

Following the earthquake, muddy water was observed at the outlet of the local spring (Figure 9) in the Armala area (photo point 7), indicating that the earthquake had altered the subsoil conditions in some ways. Nevertheless, a field survey confirmed that no new sinkholes were formed and the size of existing sinkholes did not change. Yet, as mentioned earlier, muddy water indicates a high content of silt and fines in the water, and thus a process of erosion occurring in the subsoil. The earthquake may have induced a change in groundwater level and/or an increase of pore pressure that re-activated the erosion process. For this reason, the formation of new sinkholes may be anticipated in the near future, especially during the rainy season.

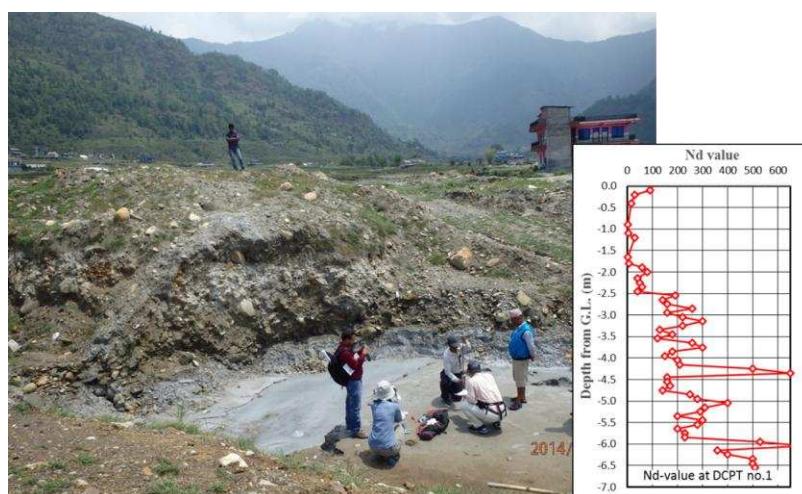
DCPT-1 was carried out at the bottom of a non-filled sinkhole as shown in Figure 10 (corresponding to photo point 7 in Figure 2). As already mentioned, this area is composed of recent flood plain deposits, including a thick gravel layer at shallow depth. Thus, DCPTs could not penetrate more than 6.55m. However, the test results would suggest that the probable depth of the sinkholes should be approximately 4.5-5m, or more precisely 6.5-7 m below the ground level considering that the actual ground level was approximately 2m above the sinkhole bottom.

Figure 10. Result of the Dynamic Cone Penetration Test at DCPT no. 1 at the bottom of a sinkhole.

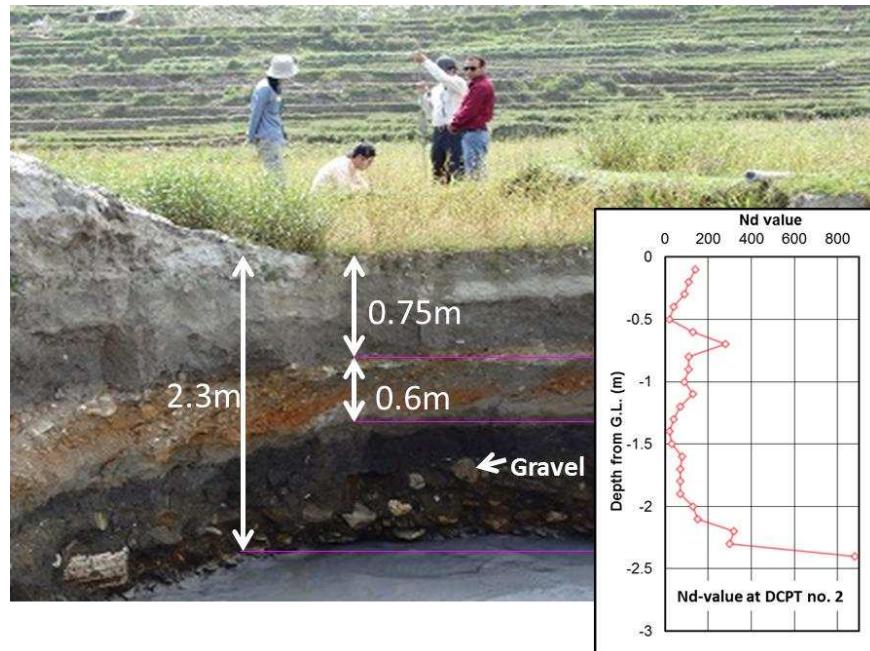
On the other hand, DCPT-2 (Figure 11) was carried out just adjacent to the sinkhole at photo point 8 in Figure 2. The test results were correlated with stratigraphy and structure of the deposits (Figure 11). The converted DCPT  $N_d$ -values are plotted in Figure 11. The upper layers of the surface soil could be penetrated until reaching a layer of gravel at a depth of 2.4 m, where even by hitting more than 150 times the penetration process stopped.

By comparing the  $N_d$  -values obtained from DCPT-2 and DCPT-3, it is noted that the filled materials are looser than the natural soil. Therefore, the filled material can be easily caved-in and induce the re-activation of filled sinkholes during the rainy season.

Figure 11. Soil profile and DCPT result at DCPT-2 obtained for the sinkhole in photo point 8 (Photo in June 2014).

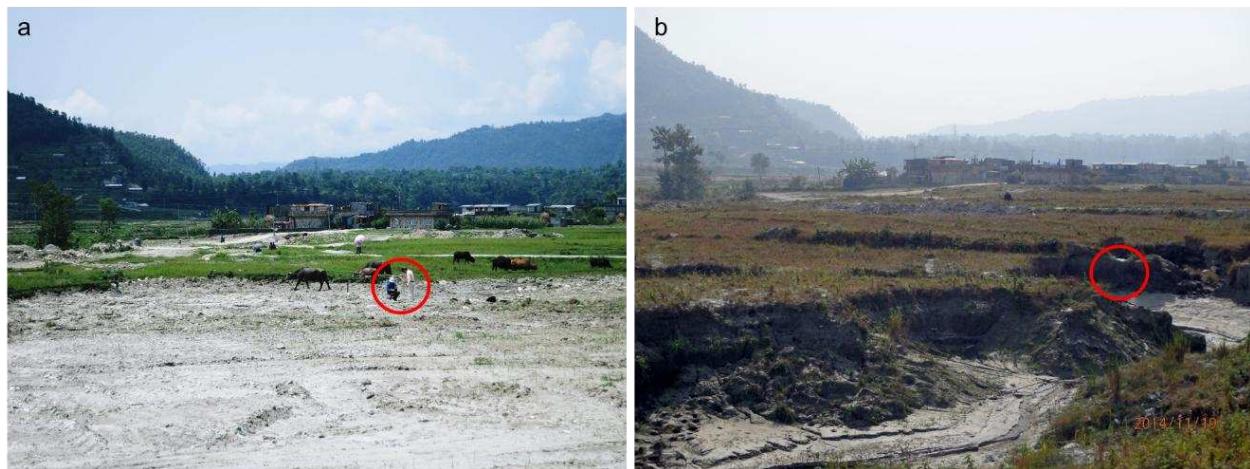
DCPT-3 was carried out at the top of the filled material at photo point 9. As shown in Fig. 12a and 12b, the testing location disappeared due to the collapse of filled material during the rainy season between June and November 2014. From the test results shown in Fig. 13, it is concluded that the used filling materials are sand and gravelly soils. However, the compaction at the surface is not good enough because the  $N_d$ -value measurement is low. The DCPT results suggest that the cavity bearing formation is below the gravel layer, and then progressively the cavity size increased and finally the loose upper layer collapsed.

Figure 12. a) Dynamic Cone Penetration Test at DCPT no. 3 (photo point 10) on the filled material (photo taken in June 2014) and b) re-activated sinkhole at the same location (photo taken in November 2014).

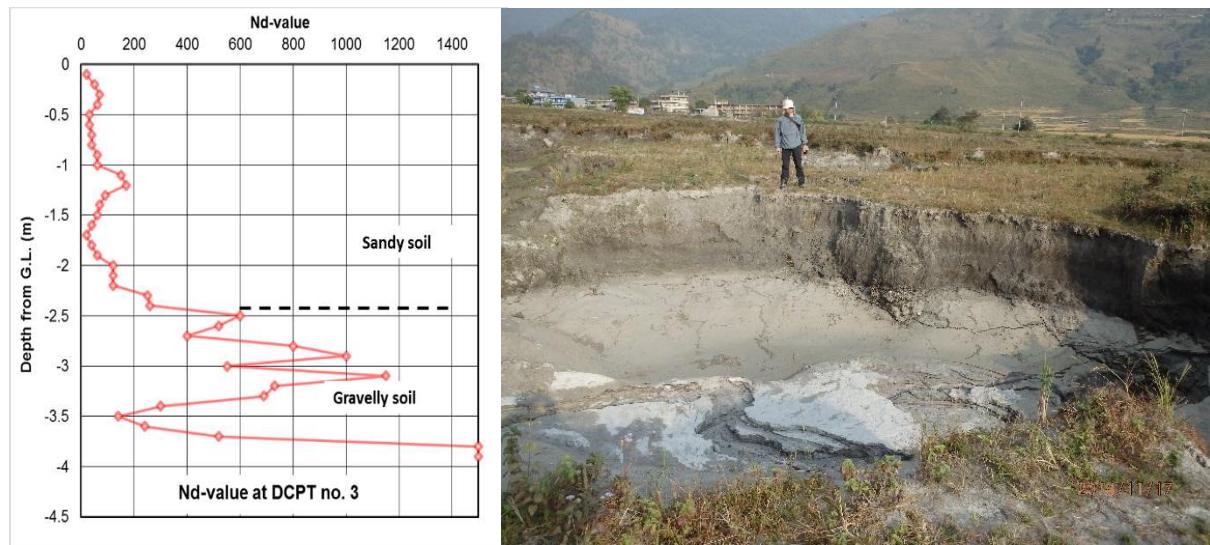
Figure 13 (a) Result of DCPT 3 conducted in June 2014 and (b) its location collapsed after the test.

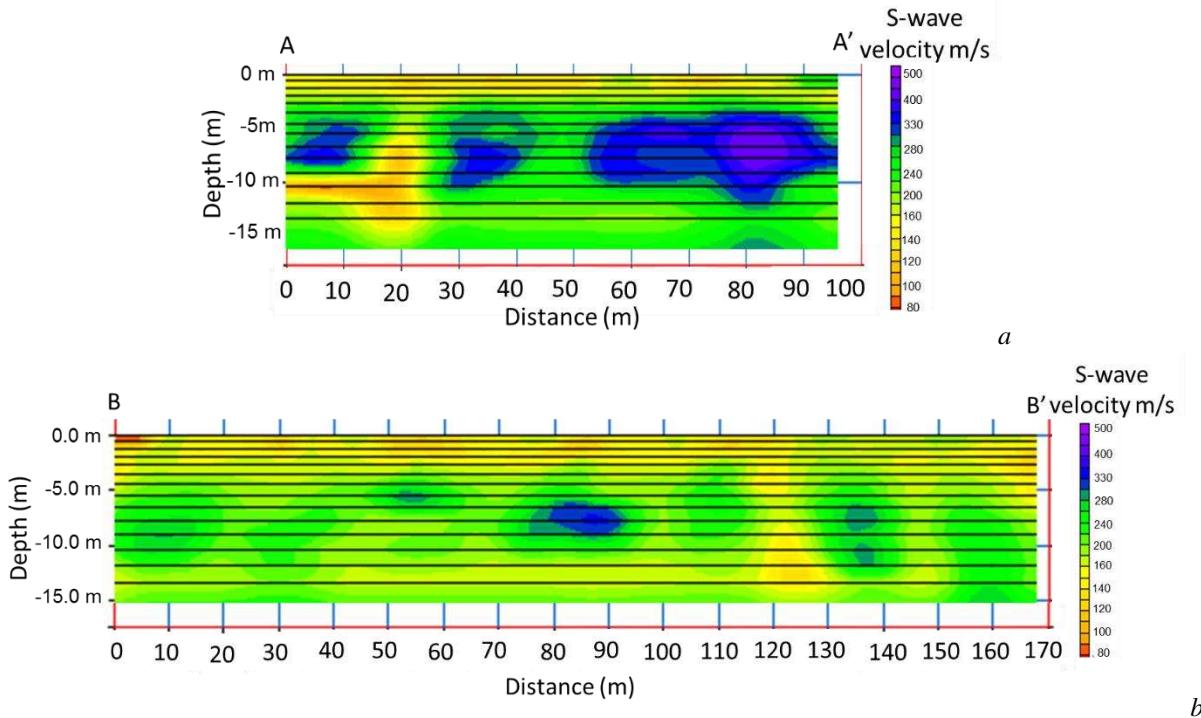
The results of SWM test along sections A-A' and B-B' are shown in Figure 15. It can be seen that the shear wave velocity for the surface layer is in the range of 100-160 m/s, confirming the presence of a loose sand layer of 1.5-m thickness. The underlying gravel has a higher velocity than the surface layer with a shear wave velocity of about 240 m/s. Moreover, the stiff soil below 4 m depth has a shear wave velocity greater than 300 m/s. The velocity of the layer around 10 m depth denotes water flowing path and loose material. A low velocity section observed 20 m far from the starting point in profile A-A' indicates possible cavities in the ground. Similarly, in profile B-B' the loose material at a depth of about 12 m indicates a possible water flowing layer and the weak strata between 120 m to 130 m is a possible future sinkhole.

Figure 15. Profiles of surface wave method: (a) section A-A'; and (b) section B-B'.

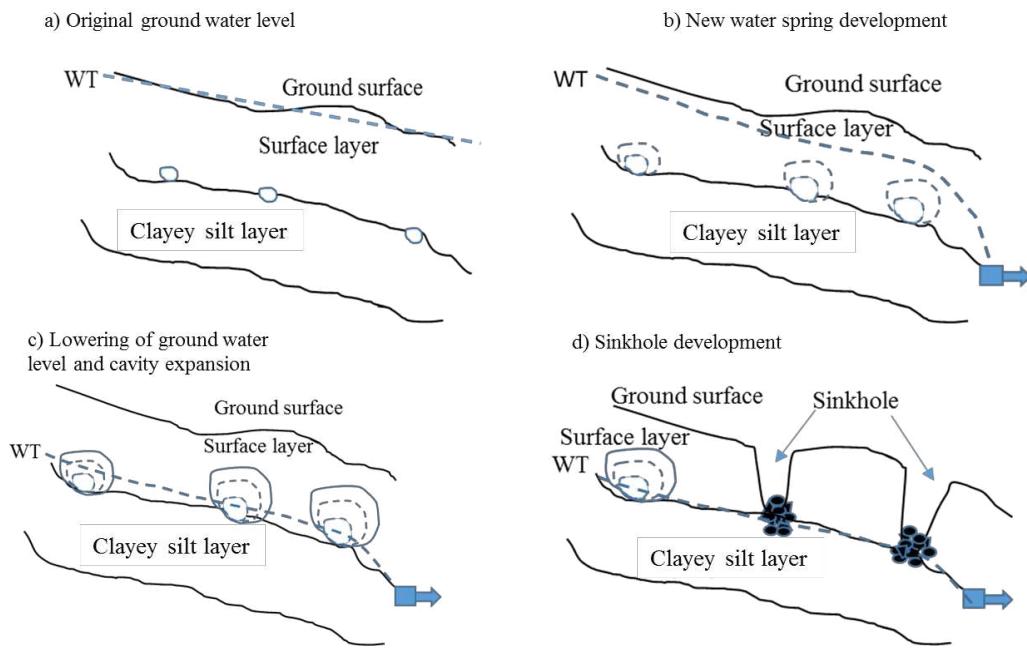
The groundwater flow is the triggering factor involved in the generation of sinkholes observed in this study. In fact, it is assumed that in the Armala area, there has been an active erosion process (probably lasting hundreds of years), where water gradually dissolved soluble soil, creating cavities beneath the ground surface (Figure 16a). However, such cavities were stable and likely small in size. In fact, despite the high sinkhole risk, the formation of sinkholes was rarely observed in past decades in the Armala area.

Figure 2) is clear and has no sediments. On the other hand, water samples collected at WS point 1 and 2 shows high turbidity (Figure 17). This indicates that underground water continues to dissolve the silt and there was a continuous caving process till June 2014. As the process continued, the loose, unconsolidated soil and sand above was gradually washed into the cracks and voids. Depending on how thick and strong the top layer was and how close to the surface the void beneath was, the ground was not able to sustain its own weight. Thus, cavities that before were stable, suddenly became unstable and collapsed (Figure 16(d)).

Figure 16. Probable mechanisms of sinkhole observed in the Armala area.

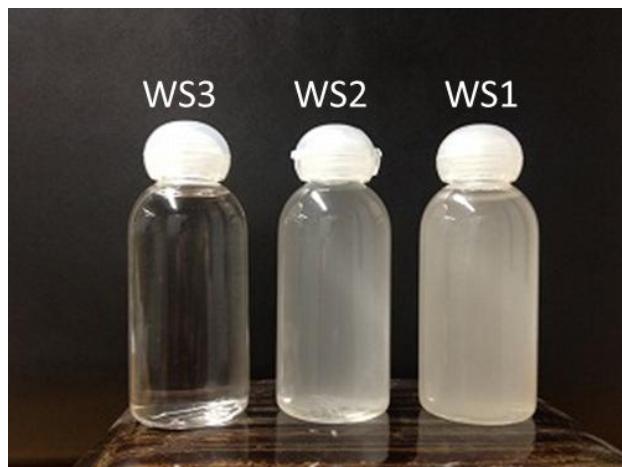
Figure 17. Turbidity of sampled water collected at different point in the Armala area in June 2014 (the water sample locations at ws1, ws2 and ws3 respectively in Figure 2).
