Preliminary Field Assessment of Sinkhole Damage in Pokhara, Nepal

KEYWORDS: sinkholes, site investigation, dynamic cone penetration test, surface wave method, Pokhara

Reference: Pokhrel R.M., Kiyota T., Kuwano R., Chiaro G., Katagiri T. and Arai I. (2015). *Preliminary Field Assessment of sinkhole damage in Pokhara, Nepal*. International Journal of Geoenvironmental Engineering Case histories, <http://casehistories.geoengineer.org>, Vol.3, Issue 2, p.113-125. doi: 10.4417/IJGCH-03-02-04

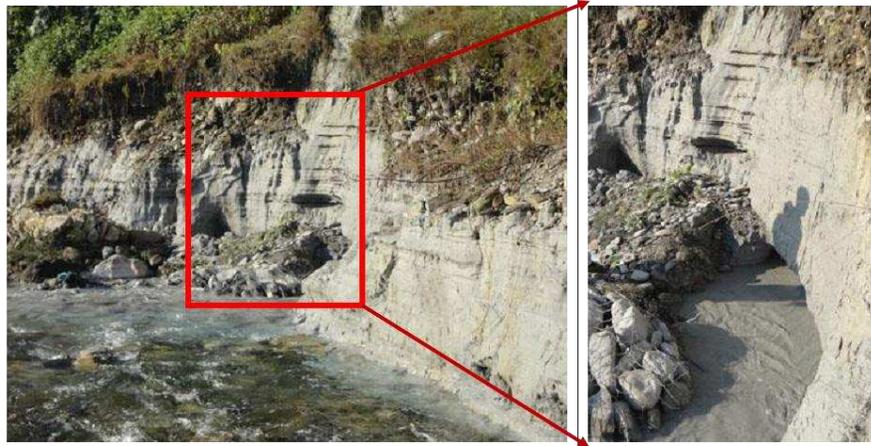
According to local residents, a muddy silty water outlet (shown in Figure 4 corresponding to photo point 1) was observed at the Kali Khola (Small River) riverbank about a week before the first sinkhole appeared in November 2013 (Figure 2). Since then, more than 150 sinkholes developed in this area until June 2014 and more than 200 sinkholes were reported up to November 2014.

Figure 4. Muddy silty water outlet at the riverbank of the Kali Khola (photo point 1) (Photo Courtesy: Technical Research Team, 2014).

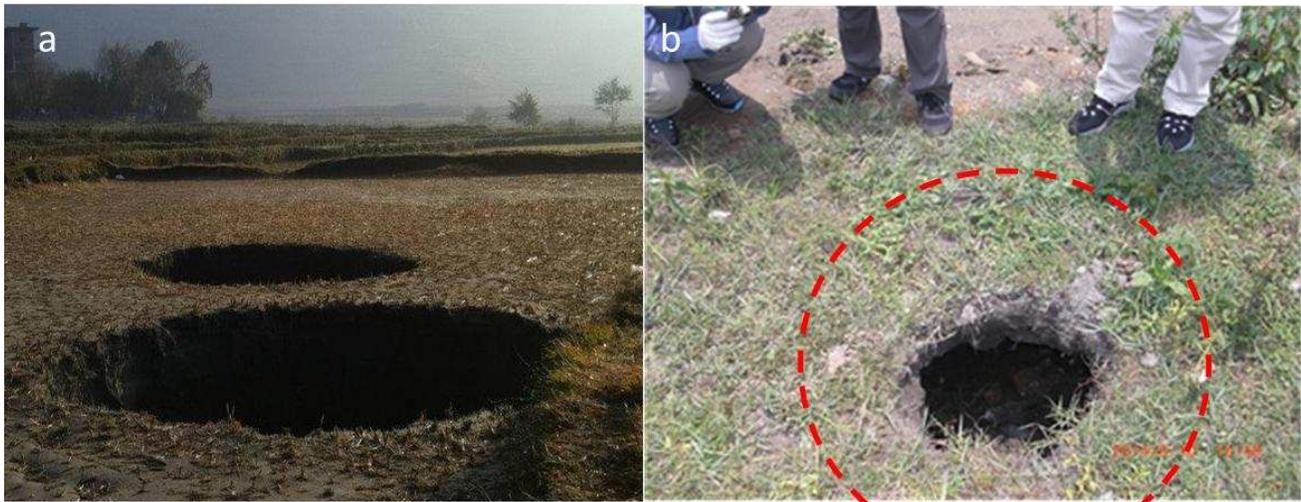
Typical circular-shaped sinkholes that appeared in November 2013 are shown in Figure 5(a). Although the first sinkhole appeared in the northern part of the investigation site, the majority of the sinkholes actually were formed along the Duhuni Khola nearby the main road (as shown by the green dots in Figure 2) between November 25th and December 5th 2013. Later on, the formation of sinkhole extended towards the western side. The depth and size of the sinkholes on level ground along Duhuni Khola were bigger than those developed on sloped ground and increased with time. Eventually, large-size sinkholes ended to connect each other along the Duhuni Khola.

Figure 5. (a) Typical sinkholes formed in November 2013 (Photo Courtesy: Keshab Sharma); and (b) a sinkhole formed in June 2014 (photo point 2).

Figure 5(b) shows a small sinkhole that appeared, at photo point 2, just one day before the survey team visited the damaged area in June 2014. Note that although the sinkhole in Figure 5(b) has a small diameter at the surface, its diameter is in reality much larger in the subsurface (as indicated by the red dashed line). Such spherical shape is due to the fact that the soil in the upper part of the sinkhole was retained by the grass root system supporting the surface soil.

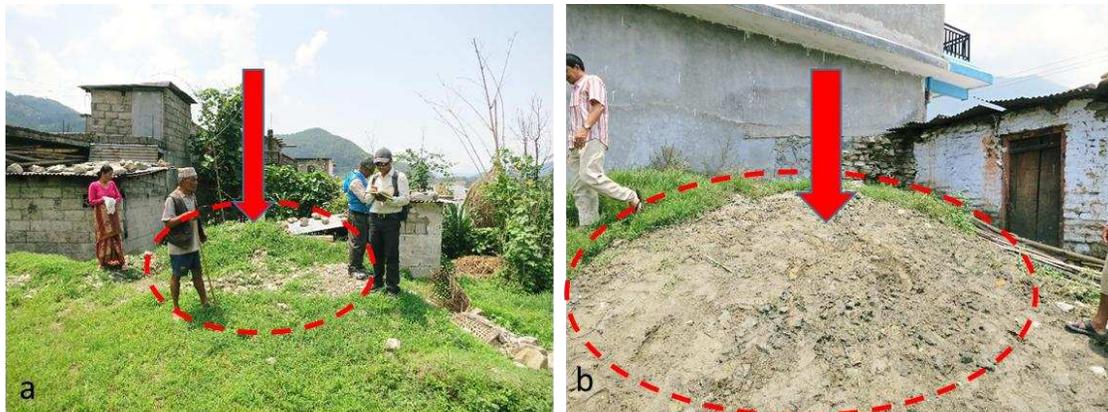
The sinkholes affected not only agricultural farmland. They also caused the collapse of manmade structures like the cowshed shown in Figure 6(a) (corresponding to photo point 3), and the masonry kitchen shown in Figure 6(b) (corresponding to photo point 4). The homeowner reported that about 60 m³ of filling material were used to fill the sinkhole shown in Figure 6(a).

Figure 6. Typical effects of sinkhole formation on residential properties observed on June 2014 included the collapsed of (a) a cowshed and (b) a masonry kitchen.

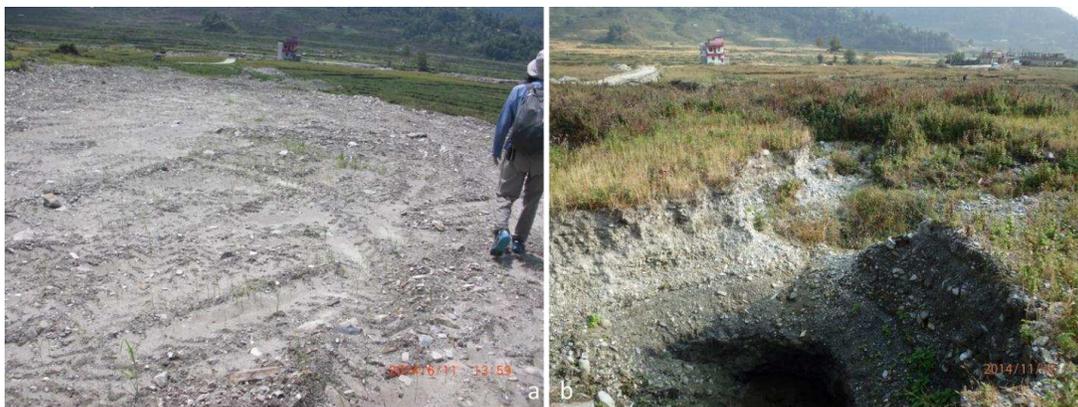
Immediately after the occurrence of the sinkholes, a wide area affected by the cave-in was backfilled by using gravelly soil retrieved from nearby quarries, which is identified by a yellow color filled area in Figure 2. Though, at the time of the first damage survey in June 2014, most of the sinkholes had been fully backfilled (Figure 7a corresponding to photo point 5), the photos taken in November 2014 at the same location clearly show that the backfilling was not an adequate solution as most of the former sinkholes were re-activated (Figure 7b) likely in August 2014 during the peak rainy season in Pokhara Valley.

Figure 7. (a) Sinkholes backfilled area (photo point 5) as seen in June 2014; and (b) Re-activated sinkholes as observed in November 2014.

As mentioned earlier, as an immediate mitigation work, all the old sinkholes were filled by the local government. This practice could disrupt the underground water flow so that ultimately the caving process caused the re-activation of sinkholes. Note that due to loose conditions of backfilled material, it is expected that the development of a re-activated sinkhole is much quicker than that of the original sinkhole where natural compacted soils was gradually eroded by water.

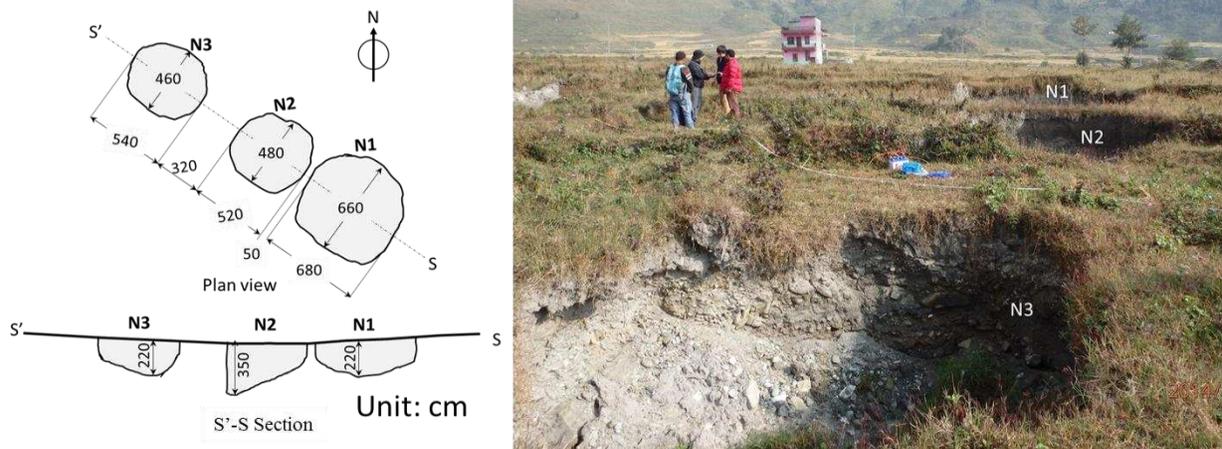
Among many, sinkholes N1, N2 and N3 in the area X shown in Figure 2 were found to be of particular interest. They were developed in a delimited area of approximately 10 m × 20 m, as shown in the schematic map shown in Figure 8. They have a circular pattern and diameters ranging from 4.6 m (N3) to 6.8 m (N1). Their depth measured at the top of the collapsed soil varied from 2.2 m (N1, N3) to a maximum of 3.5 m (N2). According to witnesses, N1 was the first sinkhole to be formed. A few days later, N2 caved-in and finally N3 developed. This progressive formation of several sinkholes along a straight line (moving along the uphill direction from N1 to N3) may suggest that the collapse of N1 caused the complete disruption of underground water flow. Consequently, water started to erode the soil just adjacent to N1 until a new cave-in (N2) was formed. In a similar way, N3 was later developed. The same pattern of sinkhole formation occurred often since November 2013. Most of the newly developed sinkholes are located on the upstream side of the underground water flow.

Figure 8. Series of sinkholes appeared in the area X in Figure 2 (photo point 6).

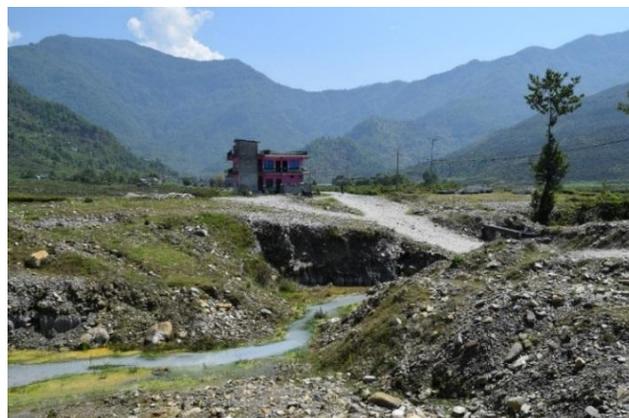
Figure 9. Muddy silty water observed in the sinkhole damaged area (photo point 7) following the 2015 Gorkha Nepal Earthquake.

Following the earthquake, muddy water was observed at the outlet of the local spring (Figure 9) in the Armala area (photo point 7), indicating that the earthquake had altered the subsoil conditions in some ways. Nevertheless, a field survey confirmed that no new sinkholes were formed and the size of existing sinkholes did not change. Yet, as mentioned earlier, muddy water indicates a high content of silt and fines in the water, and thus a process of erosion occurring in the subsoil. The earthquake may have induced a change in groundwater level and/or an increase of pore pressure that re-activated the erosion process. For this reason, the formation of new sinkholes may be anticipated in the near future, especially during the rainy season.

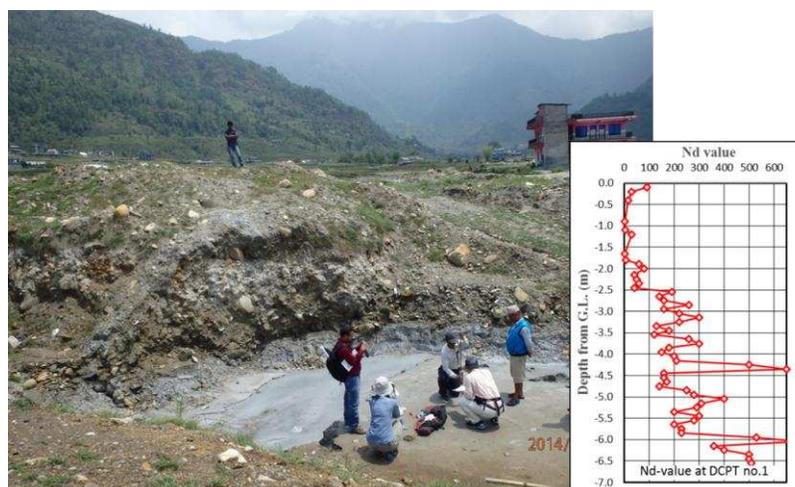
DCPT-1 was carried out at the bottom of a non-filled sinkhole as shown in Figure 10 (corresponding to photo point 7 in Figure 2). As already mentioned, this area is composed of recent flood plain deposits, including a thick gravel layer at shallow depth. Thus, DCPTs could not penetrate more than 6.55m. However, the test results would suggest that the probable depth of the sinkholes should be approximately 4.5-5m, or more precisely 6.5-7 m below the ground level considering that the actual ground level was approximately 2m above the sinkhole bottom.

Figure 10. Result of the Dynamic Cone Penetration Test at DCPT no. 1 at the bottom of a sinkhole.

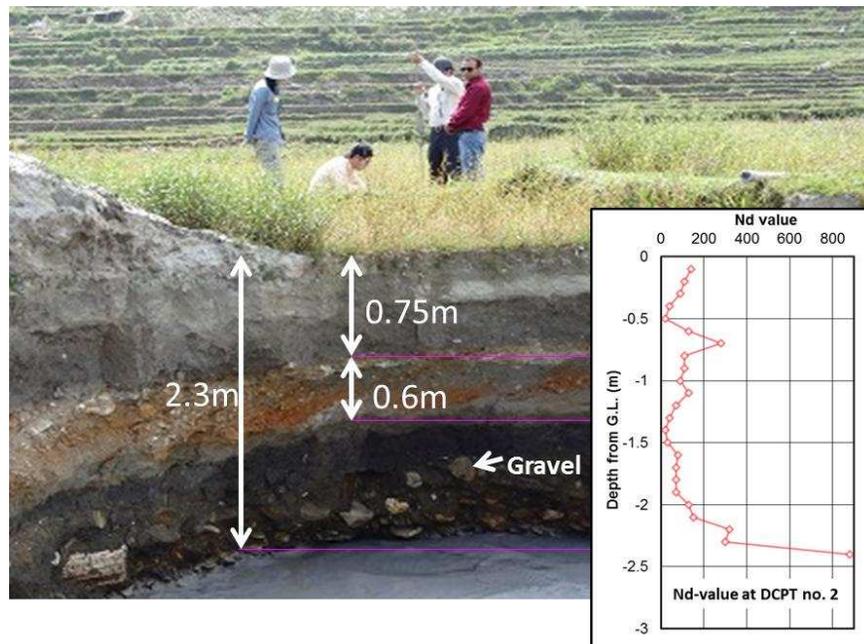
On the other hand, DCPT-2 (Figure 11) was carried out just adjacent to the sinkhole at photo point 8 in Figure 2. The test results were correlated with stratigraphy and structure of the deposits (Figure 11). The converted DCPT N_d -values are plotted in Figure 11. The upper layers of the surface soil could be penetrated until reaching a layer of gravel at a depth of 2.4 m, where even by hitting more than 150 times the penetration process stopped.

Figure 11. Soil profile and DCPT result at DCPT-2 obtained for the sinkhole in photo point 8 (Photo in June 2014).

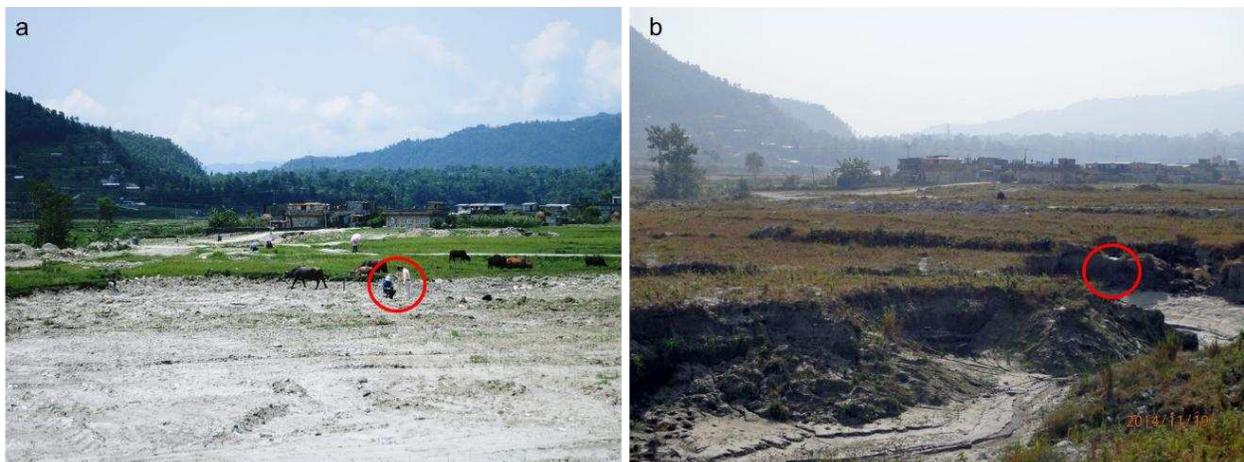
DCPT-3 was carried out at the top of the filled material at photo point 9. As shown in Fig. 12a and 12b, the testing location disappeared due to the collapse of filled material during the rainy season between June and November 2014. From the test results shown in Fig. 13, it is concluded that the used filling materials are sand and gravelly soils. However, the compaction at the surface is not good enough because the N_d -value measurement is low. The DCPT results suggest that the cavity bearing formation is below the gravel layer, and then progressively the cavity size increased and finally the loose upper layer collapsed.

By comparing the N_d -values obtained from DCPT-2 and DCPT-3, it is noted that the filled materials are looser than the natural soil. Therefore, the filled material can be easily caved-in and induce the re-activation of filled sinkholes during the rainy season.

Figure 12. a) Dynamic Cone Penetration Test at DCPT no. 3 (photo point 10) on the filled material (photo taken in June 2014) and b) re-activated sinkhole at the same location (photo taken in November 2014).

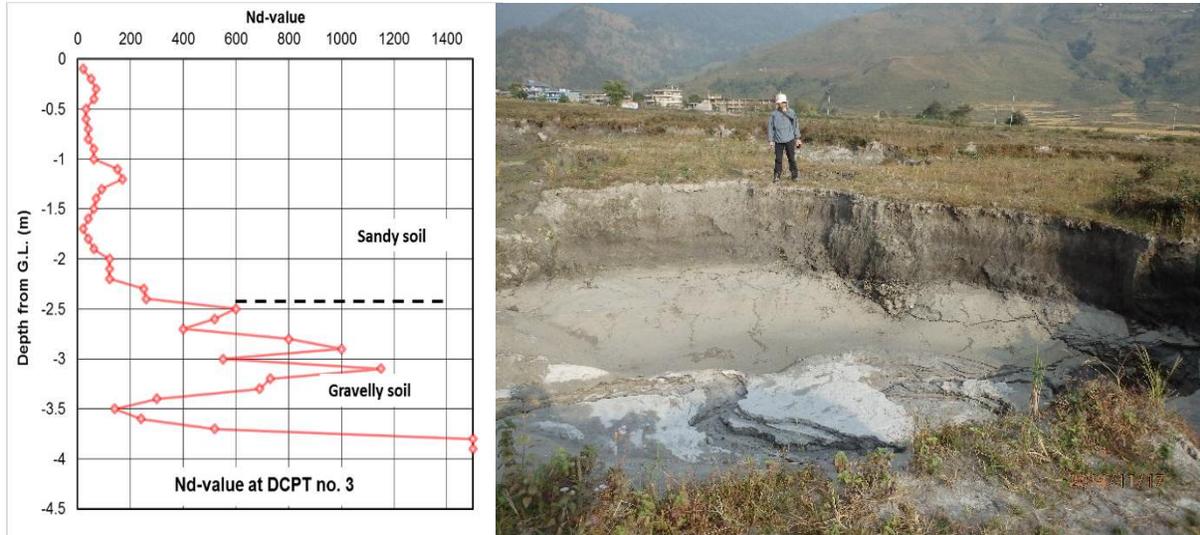
Figure 13 (a) Result of DCPT 3 conducted in June 2014 and (b) its location collapsed after the test.

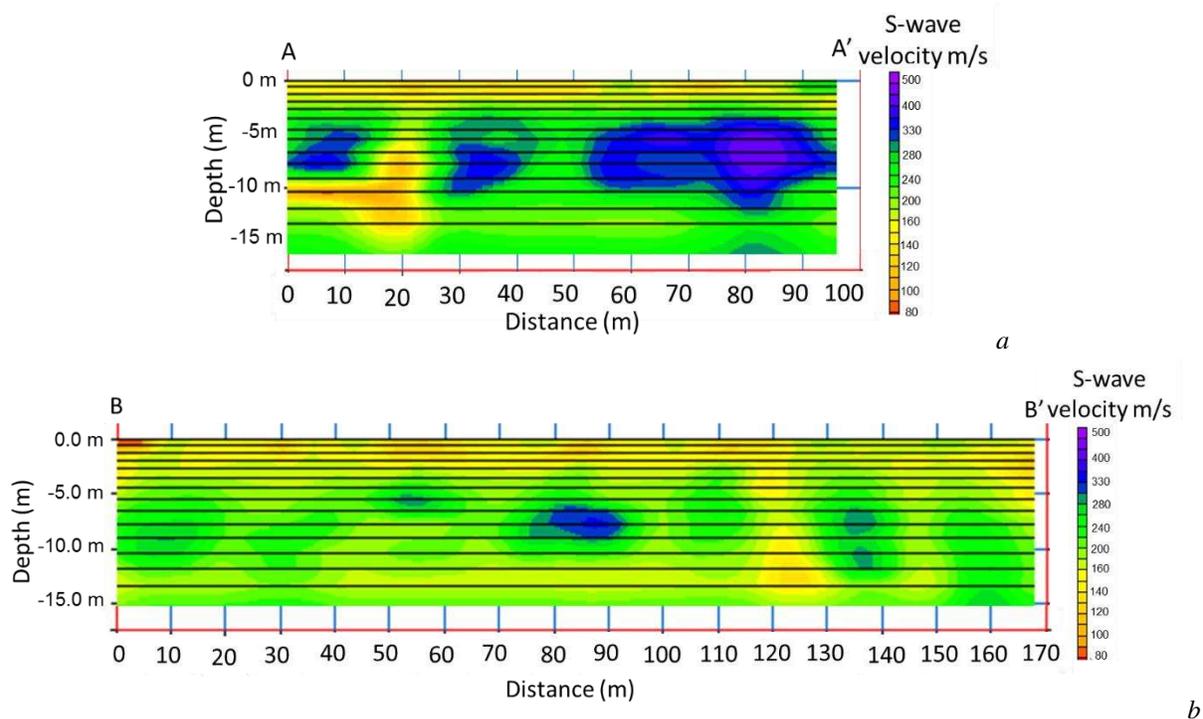
The results of SWM test along sections A-A' and B-B' are shown in Figure 15. It can be seen that the shear wave velocity for the surface layer is in the range of 100-160 m/s, confirming the presence of a loose sand layer of 1.5-m thickness. The underlying gravel has a higher velocity than the surface layer with a shear wave velocity of about 240 m/s. Moreover, the stiff soil below 4 m depth has a shear wave velocity greater than 300 m/s. The velocity of the layer around 10 m depth denotes water flowing path and loose material. A low velocity section observed 20 m far from the starting point in profile A-A' indicates possible cavities in the ground. Similarly, in profile B-B' the loose material at a depth of about 12 m indicates a possible water flowing layer and the weak strata between 120 m to 130 m is a possible future sinkhole.

Figure 15. Profiles of surface wave method: (a) section A-A'; and (b) section B-B'.

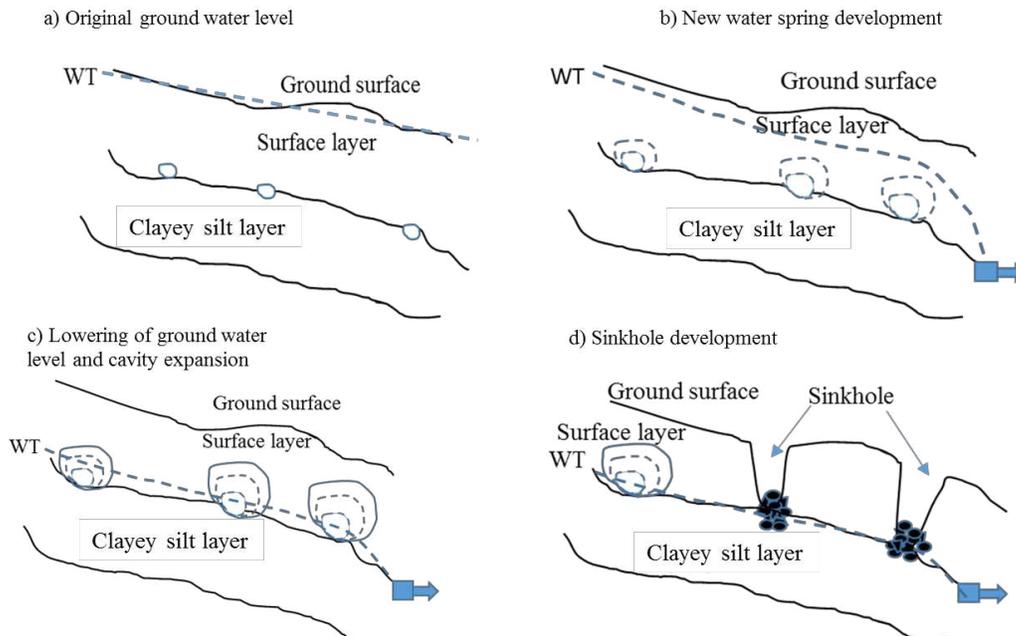
Figure 2) is clear and has no sediments. On the other hand, water samples collected at WS point 1 and 2 shows high turbidity (Figure 17). This indicates that underground water continues to dissolve the silt and there was a continuous caving process till June 2014. As the process continued, the loose, unconsolidated soil and sand above was gradually washed into the cracks and voids. Depending on how thick and strong the top layer was and how close to the surface the void beneath was, the ground was not able to sustain its own weight. Thus, cavities that before were stable, suddenly became unstable and collapsed (Figure 16(d)).

Figure 16. Probable mechanisms of sinkhole observed in the Armala area.

- prevent irrigation;
- using an effective drainage system and diverting surface runoff;
- remediating existing sinkholes and clogging shallow holes;
- identifying cavities in the soil and filling them by grouting;
- improving the ground by compaction or ground injection to increase the strength and bearing capacity of the soils.

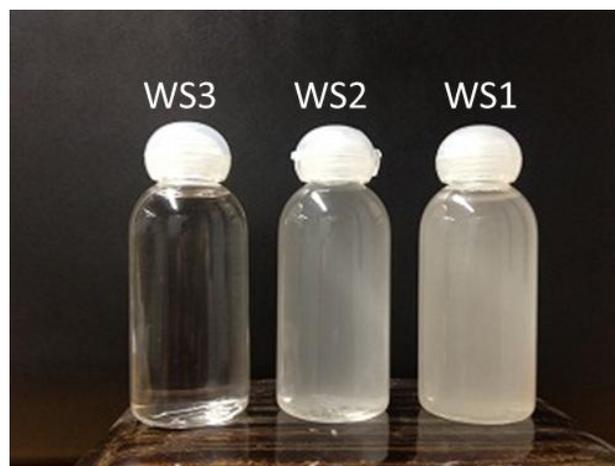
Figure 17. Turbidity of sampled water collected at different point in the Armala area in June 2014 (the water sample locations at ws1, ws2 and ws3 respectively in Figure 2).
