The May 25th 2011 Railroad Embankment Failure in Ann Arbor, Michigan, As a Means for Teaching Geotechnical Engineering

ABSTRACT: A 30-m long railroad embankment failure that occurred on May 25 2011 in the city of Ann Arbor, Michigan, is presented. Emphasis is given on the field observations of the failure, the characterization of the site conditions and the seepage and slope stability analyses, all of which represent important components of the training and practice of a geotechnical engineer. The failure occurred following a record wet season that resulted in ponding water against the embankment and high enough water pressures and exit gradients that resulted in instability of the railroad embankment. Detailed background material and the methodology for using the case history in geotechnical engineering education are presented.

International Journal of Geoengineering Case histories, Vol.3, Issue 4, p.234-245. doi: 10.4417/IJGCH-03-04-03

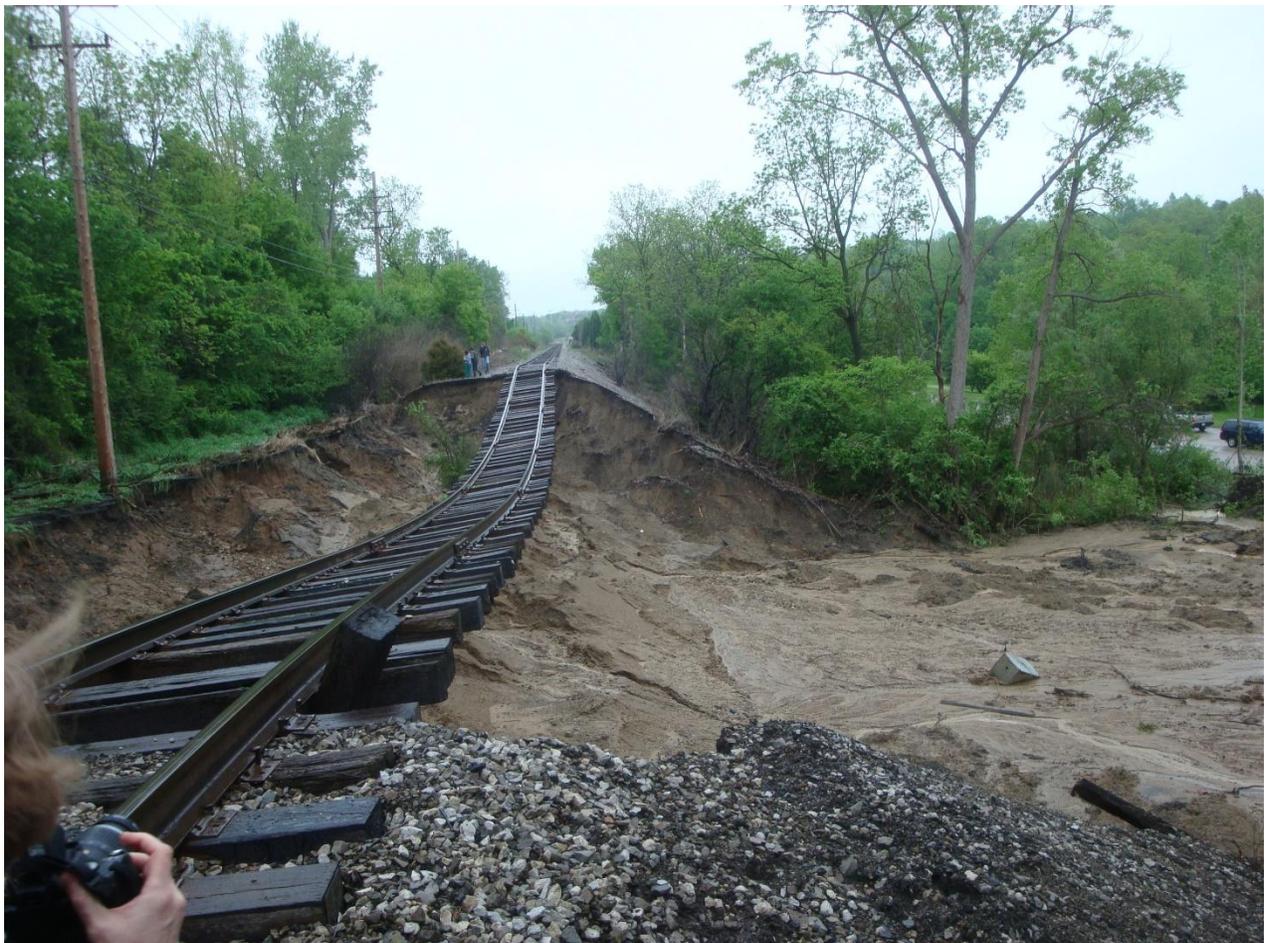
Figure 1. View of the railroad embankment failure looking East.

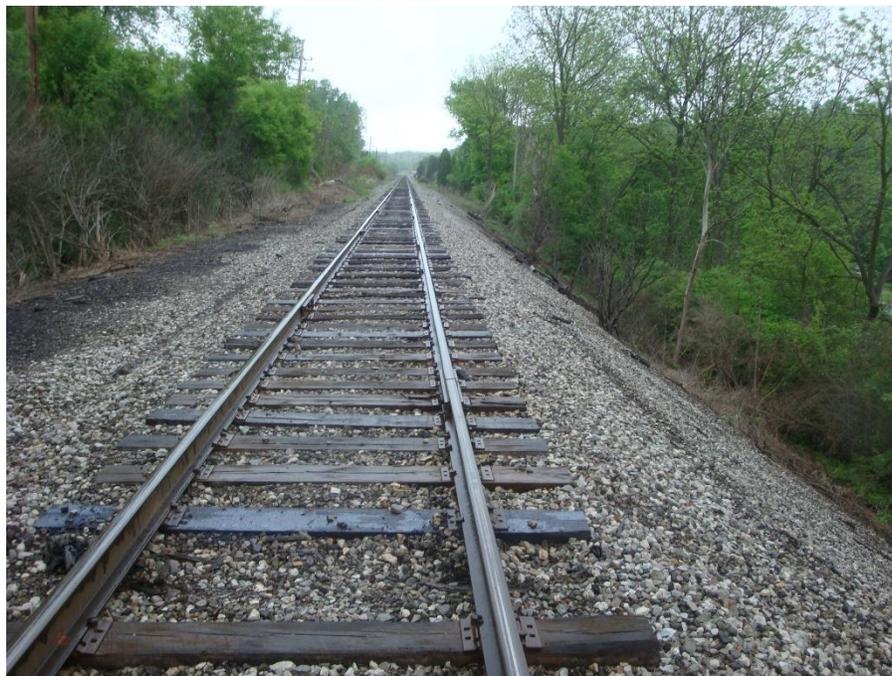
The failure site is located to the north of downtown Ann Arbor in Michigan, USA, as shown in Fig. 2b. The failure took place on the railroad embankment that is heading parallel to Plymouth Rd and adjacent to residential structures. Fig. 3 illustrates an intact portion of the embankment immediately to the East from the failure location. The failure resulted in:

Figure 3. View of intact portion of the embankment immediately to the East of the failure area. One can see that the uphill part of the embankment (left) is supported by natural ground that is at a much higher elevation than the downhill part of the embankment (right).

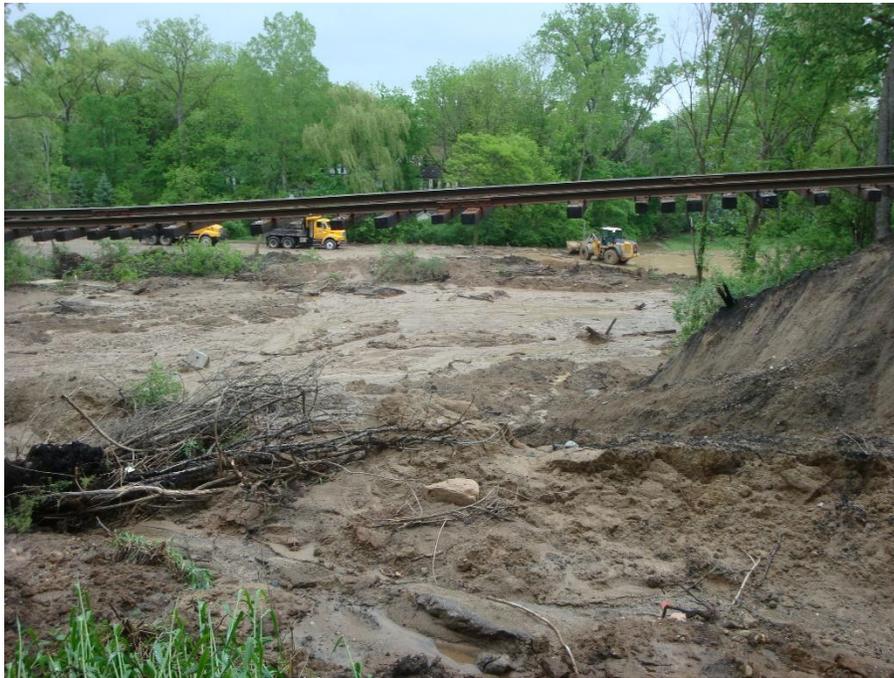
- (a) Shutdown of the railroad for an extended period of time;
- (b) Closure of Plymouth Rd for two days; and
- (c) Flooding and debris deposition on the downslope side of the embankment that damaged a public park southwest of Plymouth Rd and deposited additional sediments in a natural stream, as shown in Fig. 4.

Figure 4. View of the conditions downhill of the failure showing deposition of debris and water. Trucks and dozer are operating on Plymouth Rd. and flooded area further back is a flooded public park.

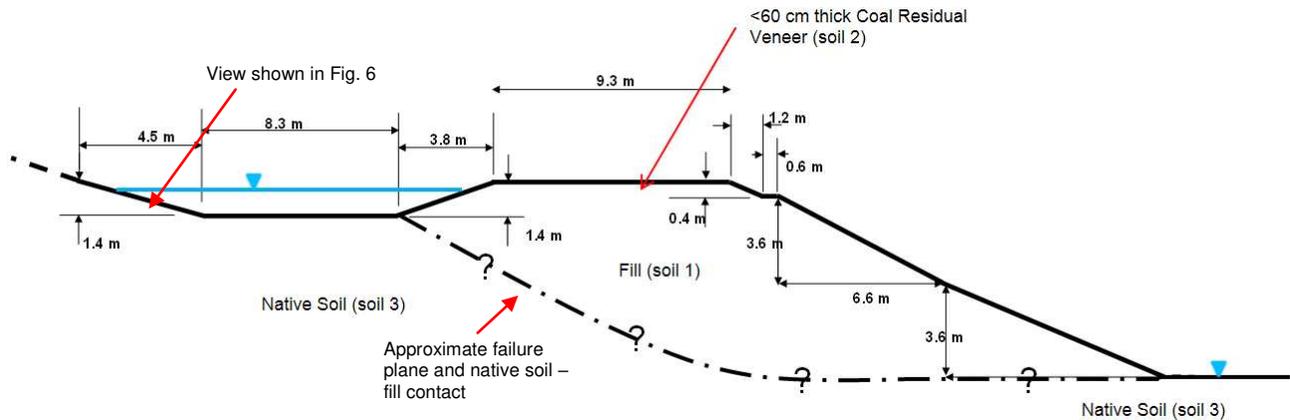
The embankment is constructed partially on a naturally sloping ground and has a total height of 7.6 m as shown in Fig. 5. Its crest, that supports the railroad lines, has a width of 9.3 m. The embankment fill consists of two layers. The main layer (Fill Soil 1) is a silty sand (SM). A surficial layer of very small thickness is also present and consists of coal ash residuals (Soil 2). The natural soil that underlays the embankment is a sandy clay of low plasticity (CL) that geologically is described as very dense glacial deposits (Native Soil-Soil 3).

Figure 5. Cross-section of the railroad embankment at the location of the failure.

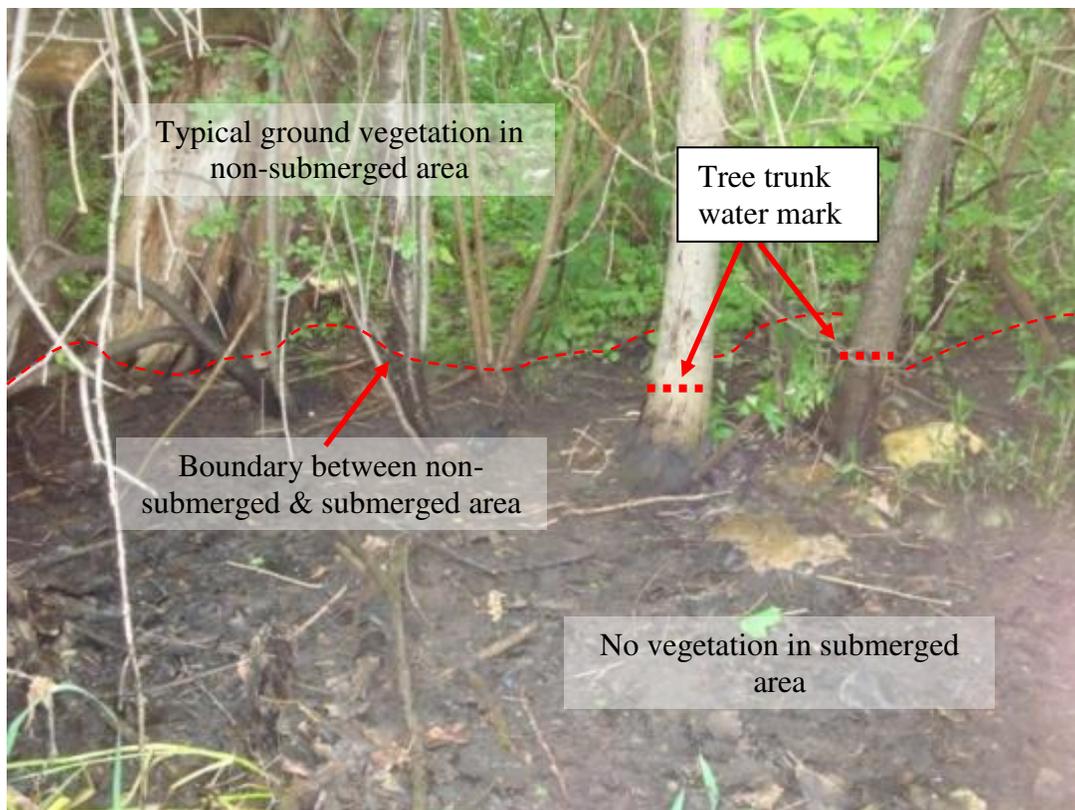
During the site visit, it was observed that the failure location was at a local natural depression that was receiving and accumulating surface water from a wider area. After careful inspection, the authors hypothesized the existence of seasonal ponding water. The surface soil on the uphill side of the embankment was very wet with vegetation that is typical of marshes, such as reeds. Next to the embankment where the water appeared to nearly permanently ponding and below trees there was no vegetation (see web-based supporting information titled “Photos and “Videos”). These conditions were found to be unique compared to other locations along the axis of the embankment. In addition, the level of water could be clearly seen as a watermark on the trunks of trees, as shown in Fig. 6. Based on these observations it was evaluated that the depth of the ponding water could have reached up to 120 cm. Local residents confirmed the existence of ponding water adjacent to the embankment. In fact, it appears that a neighbor used to feed visiting ducks at that location. Retention of ponding water was not part of the original embankment design. It is important to note that ponding water existed for at least some

Figure 6. Area previously covered by ponding water and water mark on tree trunks.

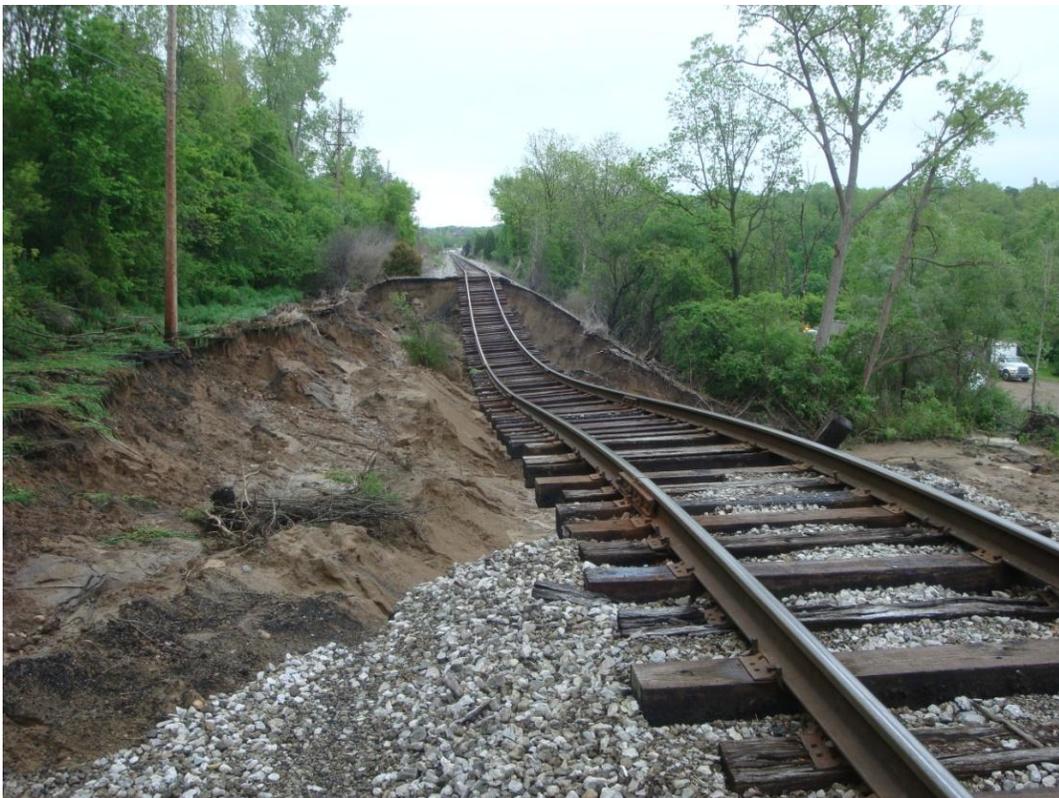
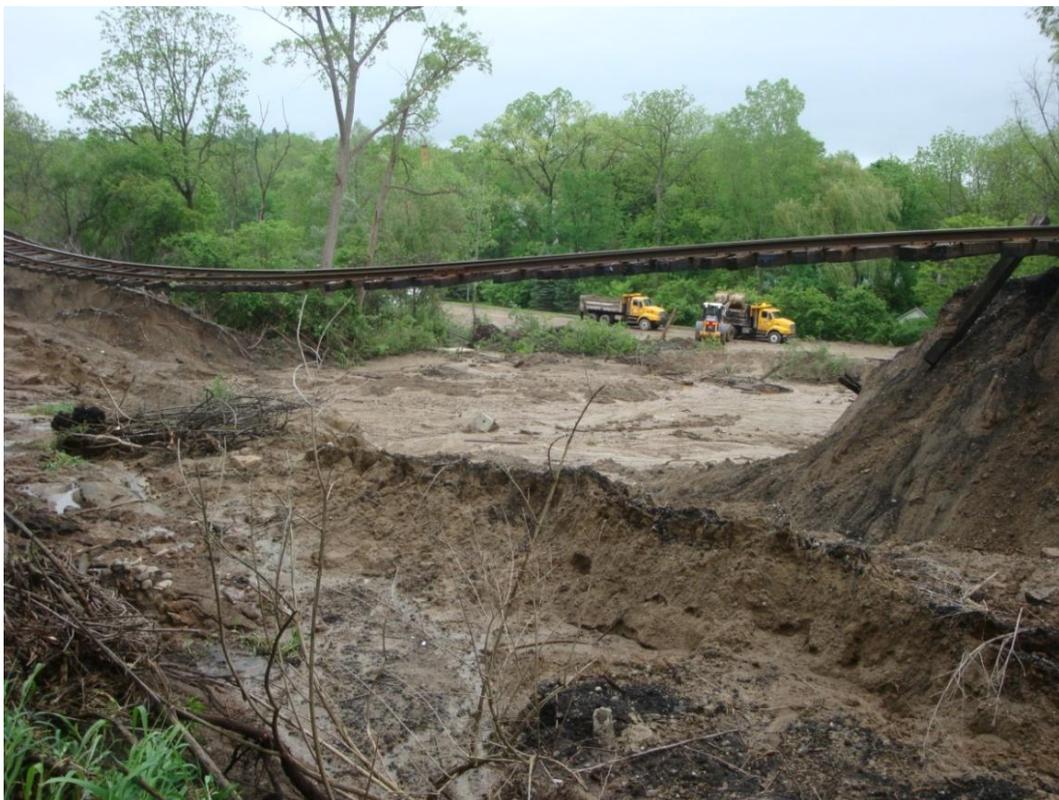
The failure surface appears to engage the entire railroad embankment that is supported on naturally sloping native ground. A 30-m long section of the embankment along the railroad axis slid, and the sliding mass moved a significant distance downslope, removing a number of trees that had grown in the downslope side of the embankment between the railroad embankment and Plymouth Rd. The interpreted failure surface per field observations is shown in Fig. 5 and 7 and is in the vicinity of the contact between the native ground and the embankment fill, but appears to be restricted within the embankment fills and not involve the native soils.

Figure 7. View of the failure along, and perpendicular to, the railroad embankment axis.

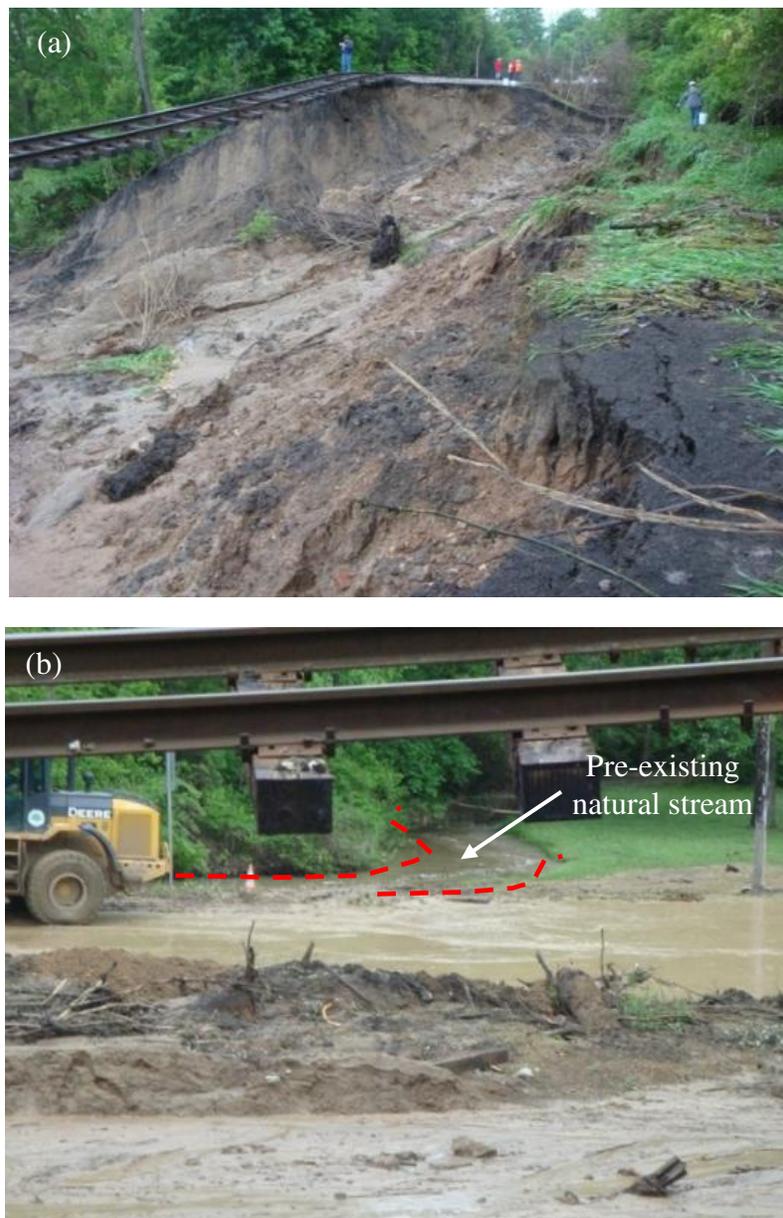
Soil Layer 2: This embankment layer is restricted to the top few cm from the surface and is essentially coal ash residuals that are black in color and can be clearly seen in Fig. 10. The fines are non-plastic and represent only 6.8% of the total mass of the soil, whereas the gravelly size particles are equal to 29.6%. It is classified per USCS as well-graded gravelly sand with silt (SW-SM). This soil layer is not expected to have played a significant role in the failure since it is of very small thickness and restricted at the surface only. Thus, more comprehensive testing to characterize its properties was not conducted.

Figure 10. View of the failure from the crest of the failure surface where (a) the left-in-place embankment is shown; (b) the mass of soil with large amount of water is shown at the toe of the failure reaching the pre-existing natural stream.

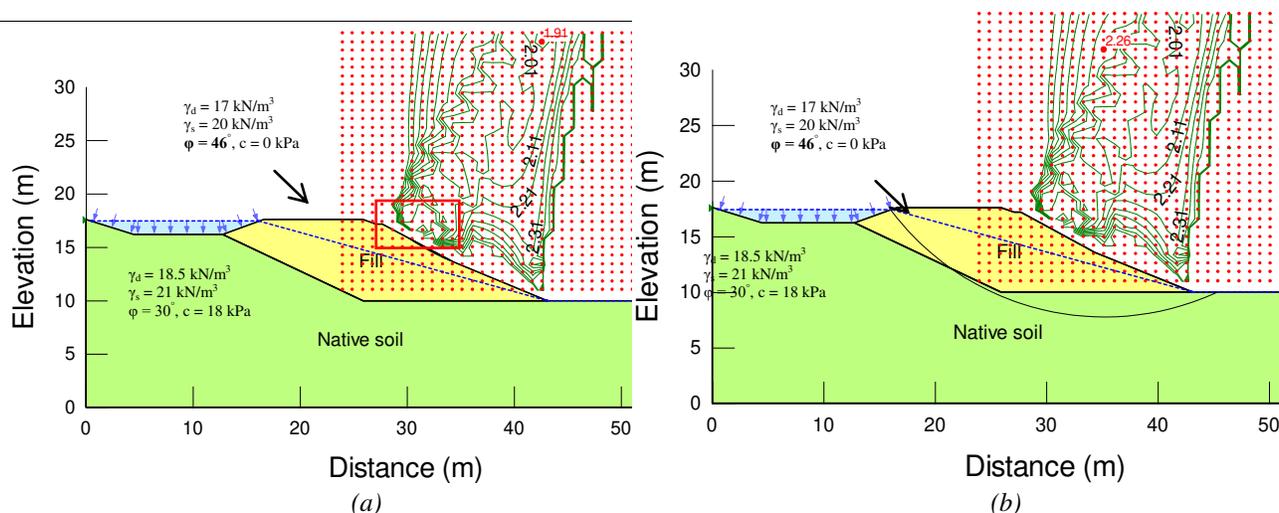
Following site characterization and the assessment of the embankment and failure surface geometry, stability and seepage analyses were conducted using the software programs SEEP/W and SLOPE/W (Geostudio, 2007) and the Spencer method of analysis (Spencer 1967). For stability assessment, parametric analyses were also conducted for reasonable variations of soil properties, as well as variations of the water depth of the ponding water (60 – 120 cm) that is reasonably well documented based on the field observations. These parametric analyses are critical in assessing the impact of uncertainties in the results. The parametric stability analyses indicate that even for the highest ponding water depth, the factor of safety remains significantly higher than one, i.e., it varies between 1.4-1.9 (for friction angles equal to 38° and 46° respectively) for a shallow failure surface that is restricted within the embankment, and is shown in Fig. 11a within the red box. Note that although the failure planes shown are “classic” numerical failure surfaces of purely frictional material with zero cohesion, even for low cohesions of 1-3 kPa, the observation that shallow failure surfaces are most critical remains valid. Higher values of factor of safety that vary between 1.5 and 2.3 were calculated for deeper failure surfaces that intersect the native soil (soil layer 3). Example results of the analyses are presented in Fig. 11.

Figure 11. Indicative results of embankment stability analyses for hydrostatic pore pressures. (a) showing lowest Factor of Safety (FS) of 1.91 for shallow failure planes (in the red box); (b) showing indicative FS of 2.26 for a failure plane that intersects the native soils.

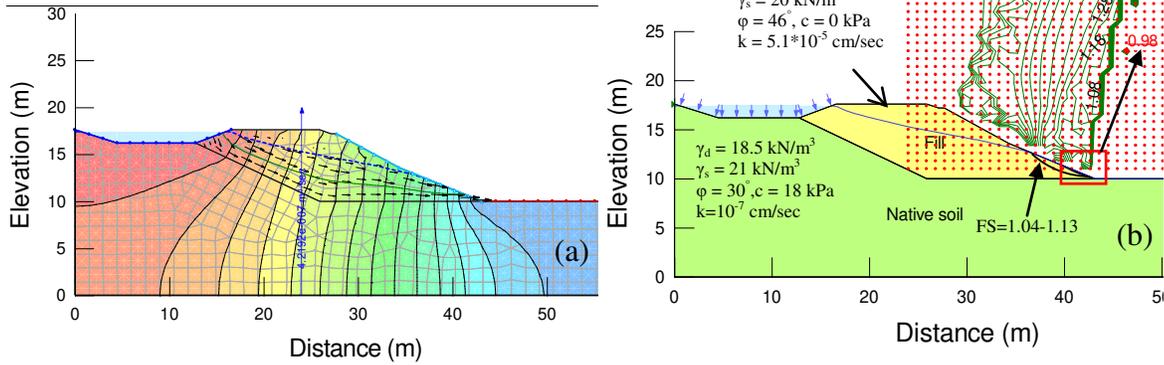
Subsequently, seepage analyses were conducted using the estimated hydraulic conductivities. As described earlier, the natural soil has significantly lower hydraulic conductivity than the embankment soils. Thus, the analyses indicate that when the ponding water depth increases, the exit gradients at the toe of the embankment become high, and vary between 0.48 and 0.78, which are dangerously high and close to critical gradients (~ 0.9). The stability analyses using the calculated hydraulic pressures, indicate failure of the embankment with factors of safety around one, as shown in Fig. 12. Note that this is not surprising as the seepage analysis gives a more realistic pore pressure profile (Fig. 12a) than that of an arbitrarily assumed piezometric surface (e.g., Fig. 11) with the flow concentrating more on the higher hydraulic conductivity soil. The results, indicate that the failure is caused by the high pore pressures that may even cause piping. The numerical results, are supported by the following interesting field observation: The reeds in the ponding water area adjacent to the embankment were found to be bent sideways and positioned horizontally with a direction that was pointing with great accuracy to the exact location where the ponding water initially drained quickly, as shown in Fig. 12.

Figure 12. Indicative results of combined (a) seepage and (b) stability analyses using seepage analyses results

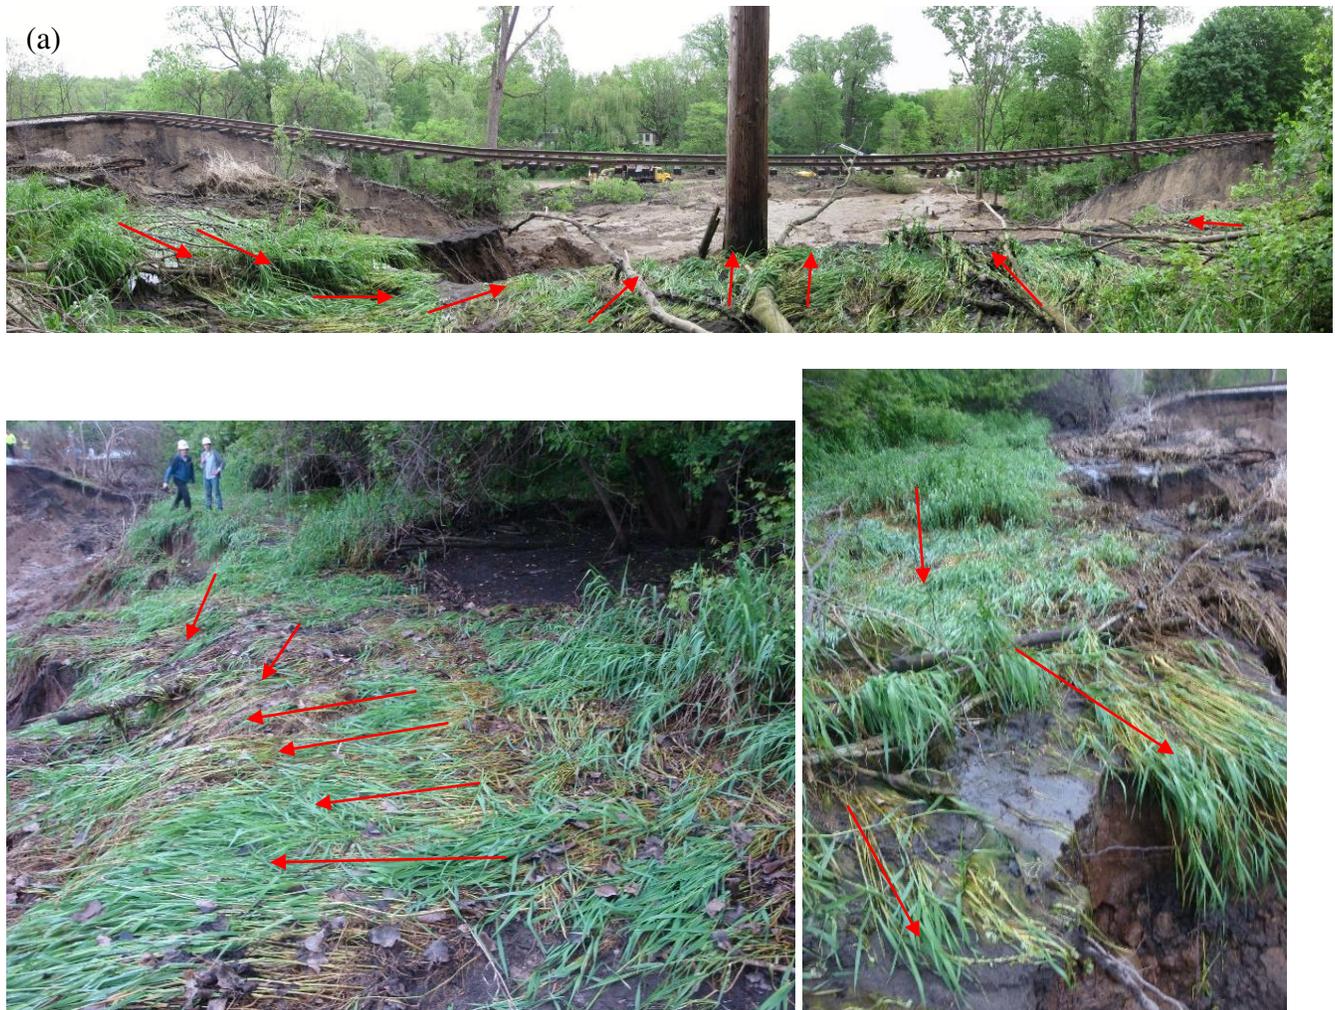
Figure 13. View of the failure and the reeds uphill of the embankment. The arrows are parallel to the direction of the fallen reeds that bent and broke during the abrupt emptying of the ponding water and fell on the ground with their orientation pointing to the initiation point of failure. (Fig. 13a by Karl Jansen, ceephotos.com)
