The May 25th 2011 Railroad Embankment Failure in Ann Arbor, Michigan, As a Means for Teaching Geotechnical Engineering

Reference: Zekkos, D., Athanasopoulos-Zekkos, A., Grizi, A., and Greenwood, W. (2016). *The May 25th 2011 Railroad Embankment Failure in Ann Arbor, Michigan, As a Means for Teaching Geotechnical Engineering*.

International Journal of Geoengineering Case histories, Vol.3, Issue 4, p.234-245. doi: 10.4417/IJGCH-03-04-03

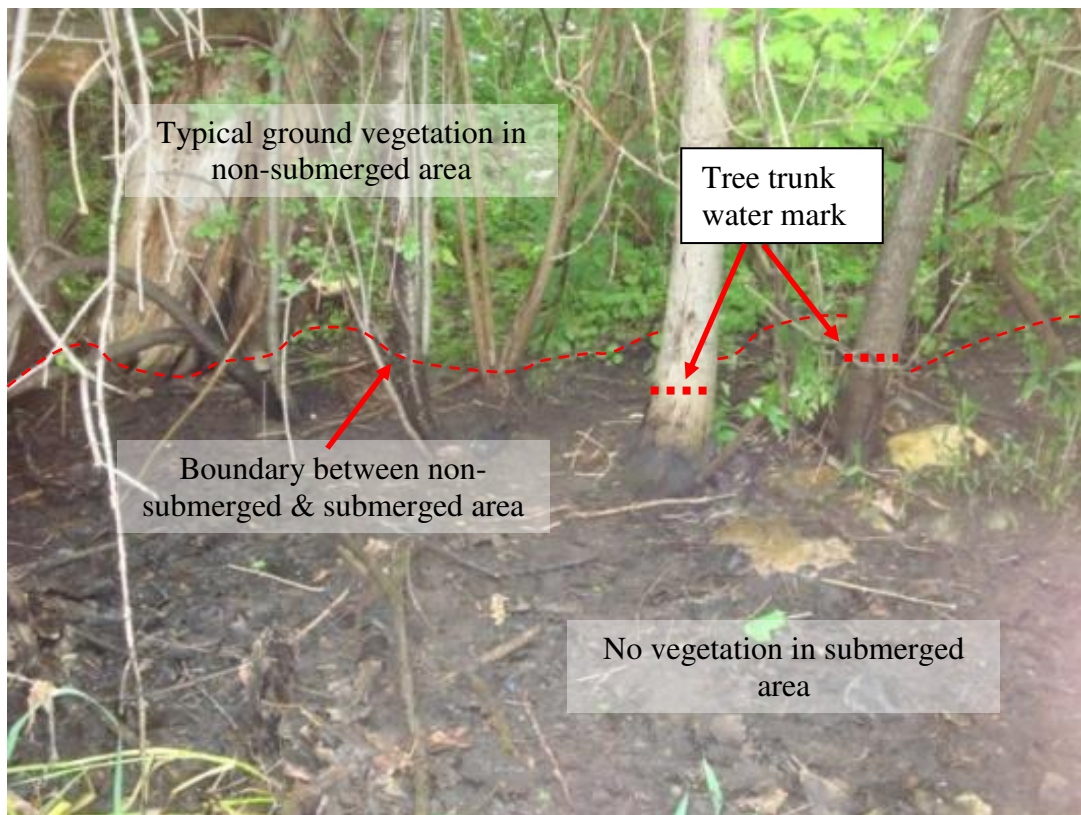
During the site visit, it was observed that the failure location was at a local natural depression that was receiving and accumulating surface water from a wider area. After careful inspection, the authors hypothesized the existence of seasonal ponding water. The surface soil on the uphill side of the embankment was very wet with vegetation that is typical of marshes, such as reeds. Next to the embankment where the water appeared to nearly permanently ponding and below trees there was no vegetation (see web-based supporting information titled “Photos and “Videos”). These conditions were found to be unique compared to other locations along the axis of the embankment. In addition, the level of water could be clearly seen as a watermark on the trunks of trees, as shown in Fig. 6. Based on these observations it was evaluated that the depth of the ponding water could have reached up to 120 cm. Local residents confirmed the existence of ponding water adjacent to the embankment. In fact, it appears that a neighbor used to feed visiting ducks at that location. Retention of ponding water was not part of the original embankment design. It is important to note that ponding water existed for at least some

Figure 6. Area previously covered by ponding water and water mark on tree trunks.

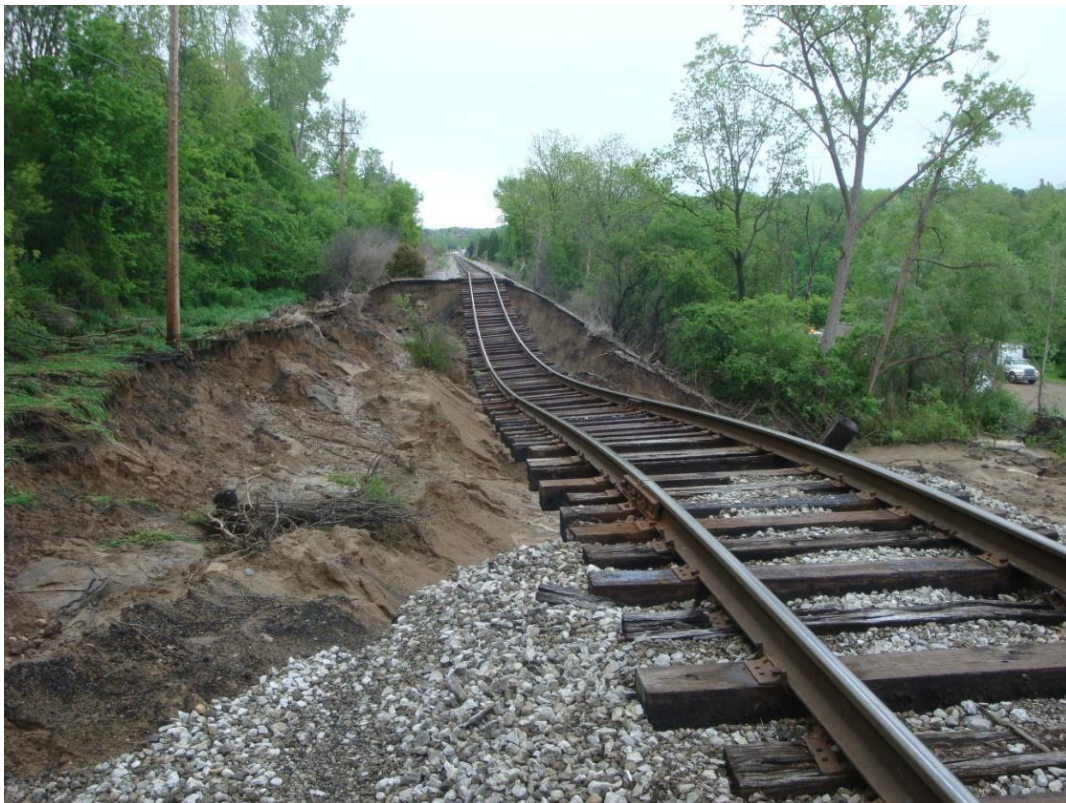
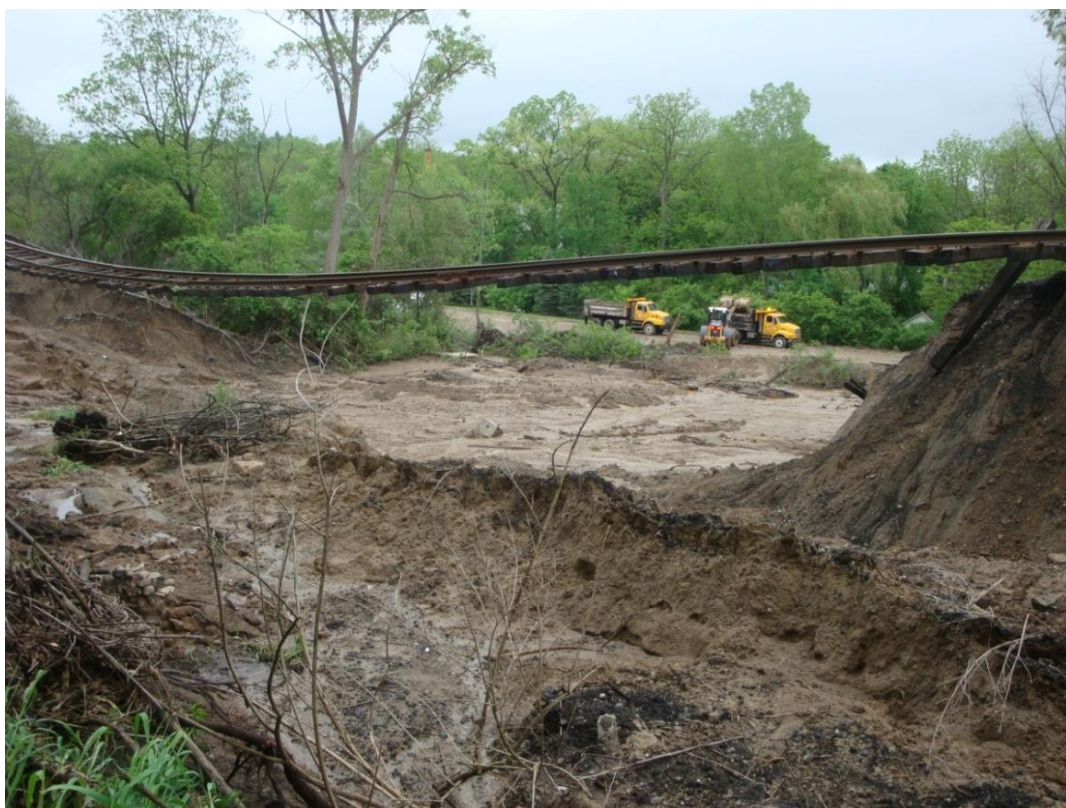
The failure surface appears to engage the entire railroad embankment that is supported on naturally sloping native ground. A 30-m long section of the embankment along the railroad axis slid, and the sliding mass moved a significant distance downslope, removing a number of trees that had grown in the downslope side of the embankment between the railroad embankment and Plymouth Rd. The interpreted failure surface per field observations is shown in Fig. 5 and 7 and is in the vicinity of the contact between the native ground and the embankment fill, but appears to be restricted within the embankment fills and not involve the native soils.

Figure 7. View of the failure along, and perpendicular to, the railroad embankment axis.

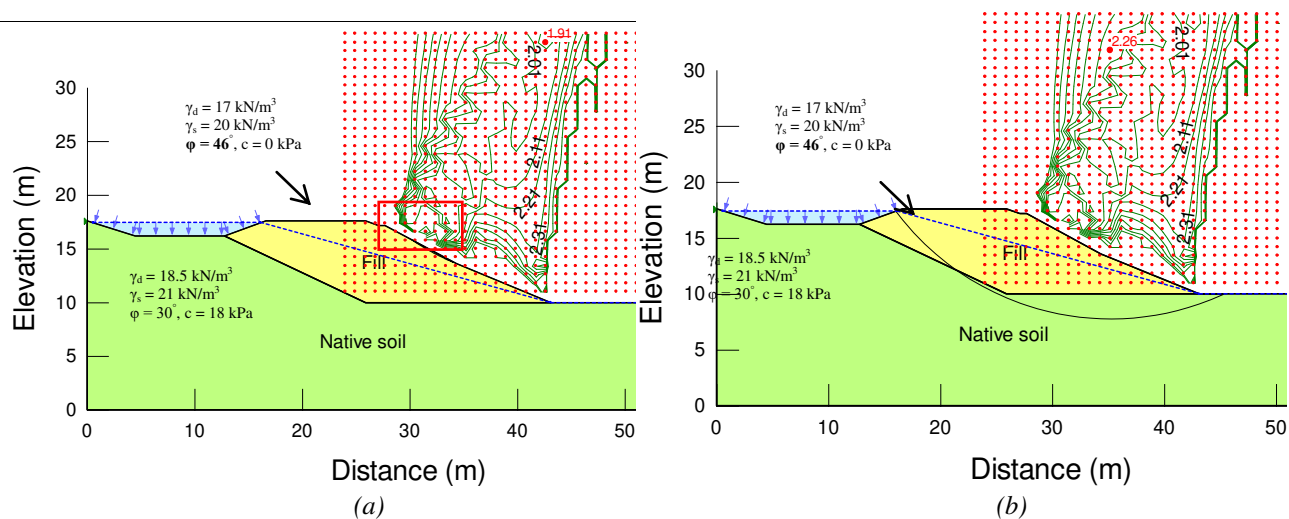
Following site characterization and the assessment of the embankment and failure surface geometry, stability and seepage analyses were conducted using the software programs SEEP/W and SLOPE/W (Geostudio, 2007) and the Spencer method of analysis (Spencer 1967). For stability assessment, parametric analyses were also conducted for reasonable variations of soil properties, as well as variations of the water depth of the ponding water (60 – 120 cm) that is reasonably well documented based on the field observations. These parametric analyses are critical in assessing the impact of uncertainties in the results. The parametric stability analyses indicate that even for the highest ponding water depth, the factor of safety remains significantly higher than one, i.e., it varies between 1.4-1.9 (for friction angles equal to 38° and 46° respectively) for a shallow failure surface that is restricted within the embankment, and is shown in Fig. 11a within the red box. Note that although the failure planes shown are “classic” numerical failure surfaces of purely frictional material with zero cohesion, even for low cohesions of 1-3 kPa, the observation that shallow failure surfaces are most critical remains valid. Higher values of factor of safety that vary between 1.5 and 2.3 were calculated for deeper failure surfaces that intersect the native soil (soil layer 3). Example results of the analyses are presented in Fig. 11.

Figure 11. Indicative results of embankment stability analyses for hydrostatic pore pressures. (a) showing lowest Factor of Safety (FS) of 1.91 for shallow failure planes (in the red box); (b) showing indicative FS of 2.26 for a failure plane that intersects the native soils.

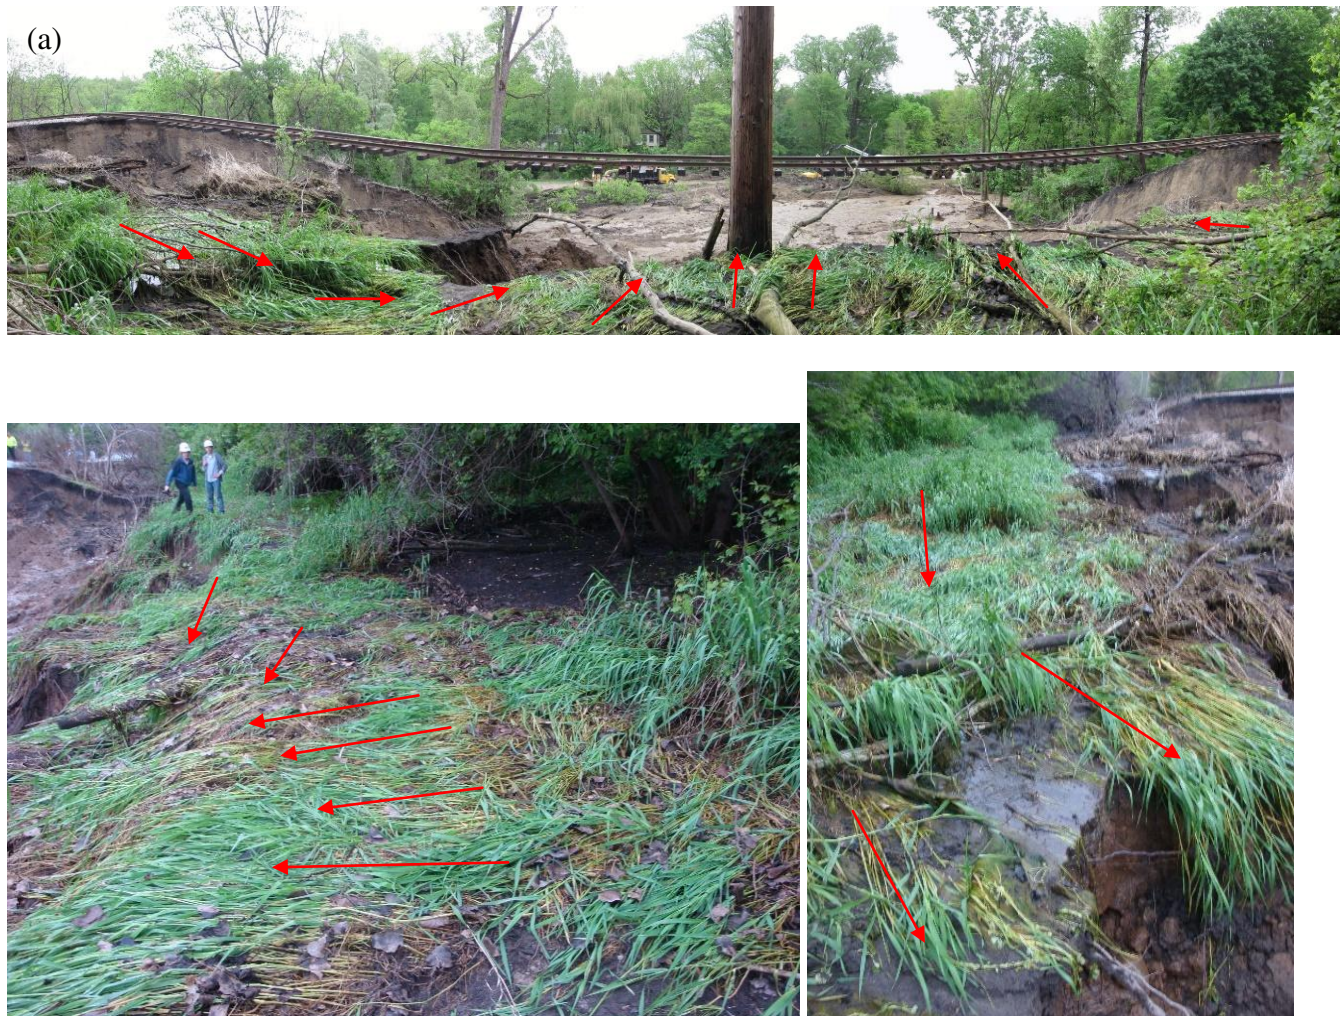
Figure 13. View of the failure and the reeds uphill of the embankment. The arrows are parallel to the direction of the fallen reeds that bent and broke during the abrupt emptying of the ponding water and fell on the ground with their orientation pointing to the initiation point of failure. (Fig. 13a by Karl Jansen, ceephotos.com)
