# The May 25<sup>th</sup> 2011 Railroad Embankment Failure in Ann Arbor, Michigan, As a Means for Teaching Geotechnical Engineering

**ABSTRACT:** A 30-m long railroad embankment failure that occurred on May 25 2011 in the city of Ann Arbor, Michigan, is presented. Emphasis is given on the field observations of the failure, the characterization of the site conditions and the seepage and slope stability analyses, all of which represent important components of the training and practice of a geotechnical engineer. The failure occurred following a record wet season that resulted in ponding water against the embankment and high enough water pressures and exit gradients that resulted in instability of the railroad embankment. Detailed background material and the methodology for using the case history in geotechnical engineering education are presented.

Reference: Zekkos, D., Athanasopoulos-Zekkos, A., Grizi, A., and Greenwood, W. (2016). *The May 25th 2011 Railroad Embankment Failure in Ann Arbor, Michigan, As a Means for Teaching Geotechnical Engineering*.

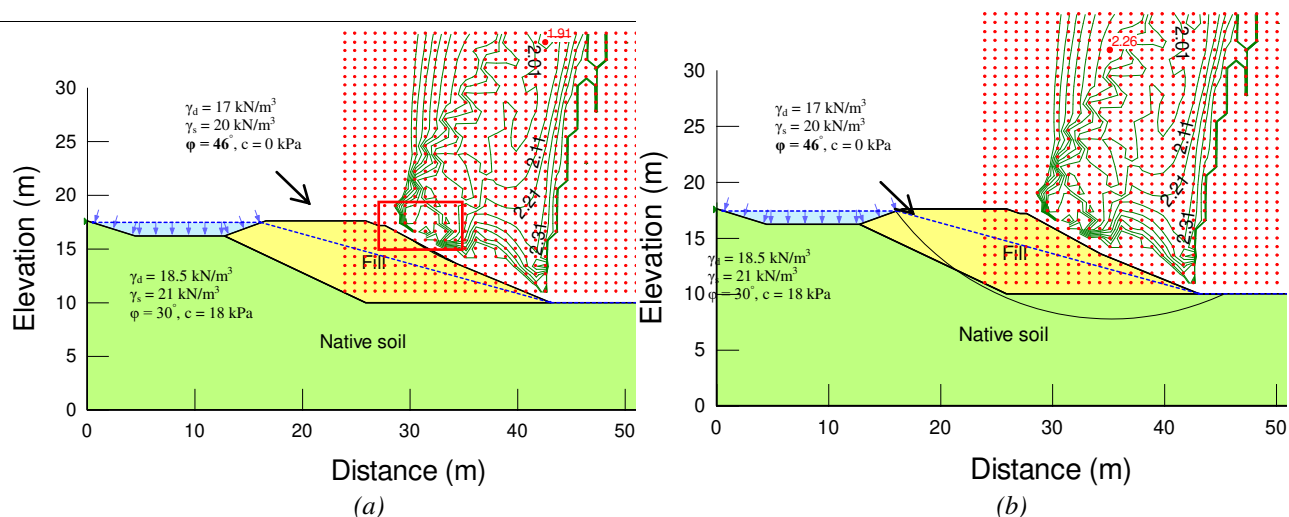
Following site characterization and the assessment of the embankment and failure surface geometry, stability and seepage analyses were conducted using the software programs SEEP/W and SLOPE/W (Geostudio, 2007) and the Spencer method of analysis (Spencer 1967). For stability assessment, parametric analyses were also conducted for reasonable variations of soil properties, as well as variations of the water depth of the ponding water (60 – 120 cm) that is reasonably well documented based on the field observations. These parametric analyses are critical in assessing the impact of uncertainties in the results. The parametric stability analyses indicate that even for the highest ponding water depth, the factor of safety remains significantly higher than one, i.e., it varies between 1.4-1.9 (for friction angles equal to  $38^\circ$  and  $46^\circ$  respectively) for a shallow failure surface that is restricted within the embankment, and is shown in Fig. 11a within the red box. Note that although the failure planes shown are “classic” numerical failure surfaces of purely frictional material with zero cohesion, even for low cohesions of 1-3 kPa, the observation that shallow failure surfaces are most critical remains valid. Higher values of factor of safety that vary between 1.5 and 2.3 were calculated for deeper failure surfaces that intersect the native soil (soil layer 3). Example results of the analyses are presented in Fig. 11.

Figure 11. Indicative results of embankment stability analyses for hydrostatic pore pressures. (a) showing lowest Factor of Safety (FS) of 1.91 for shallow failure planes (in the red box); (b) showing indicative FS of 2.26 for a failure plane that intersects the native soils.
